LBUSD 2022 Facility Master Plan

Long Beach Unified School District
Appendices

July 2022

A Facility Reports: Elementary Schools

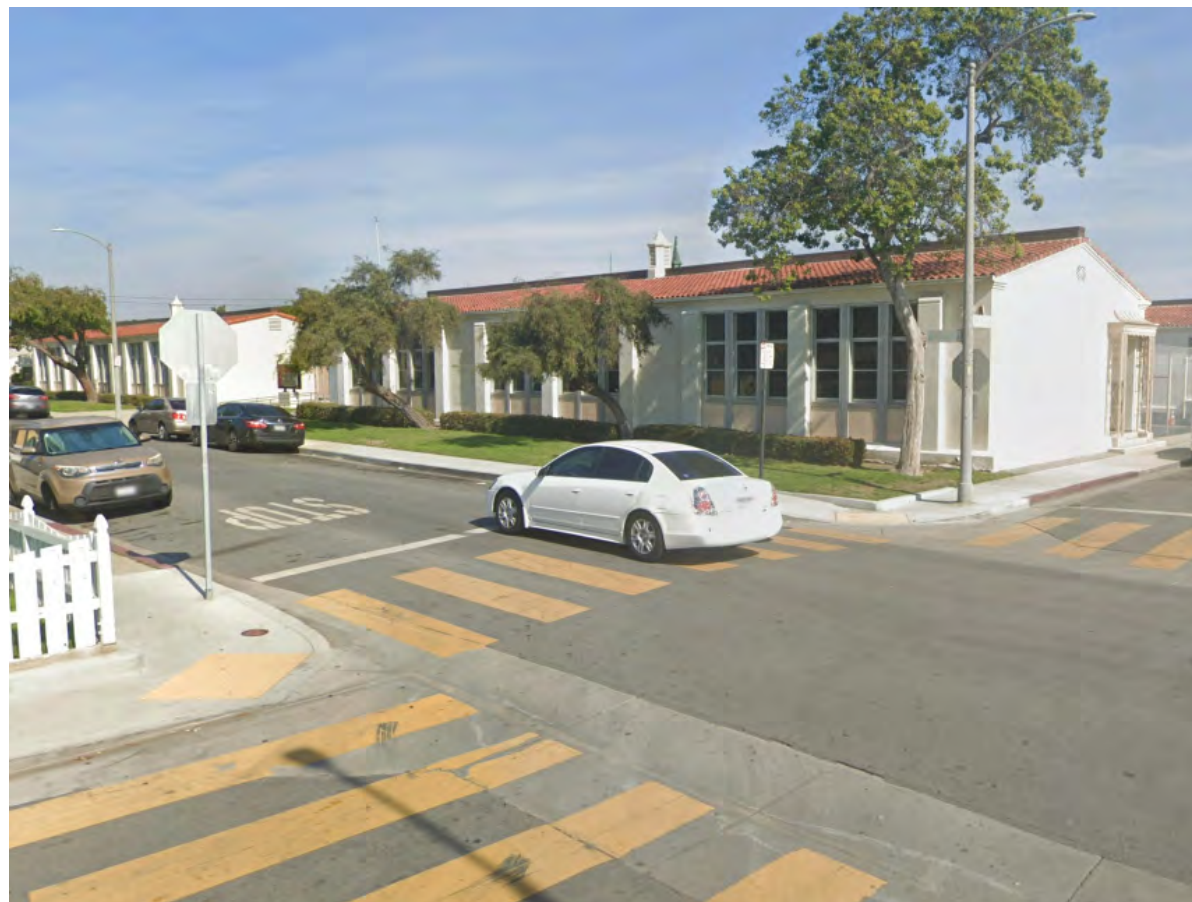
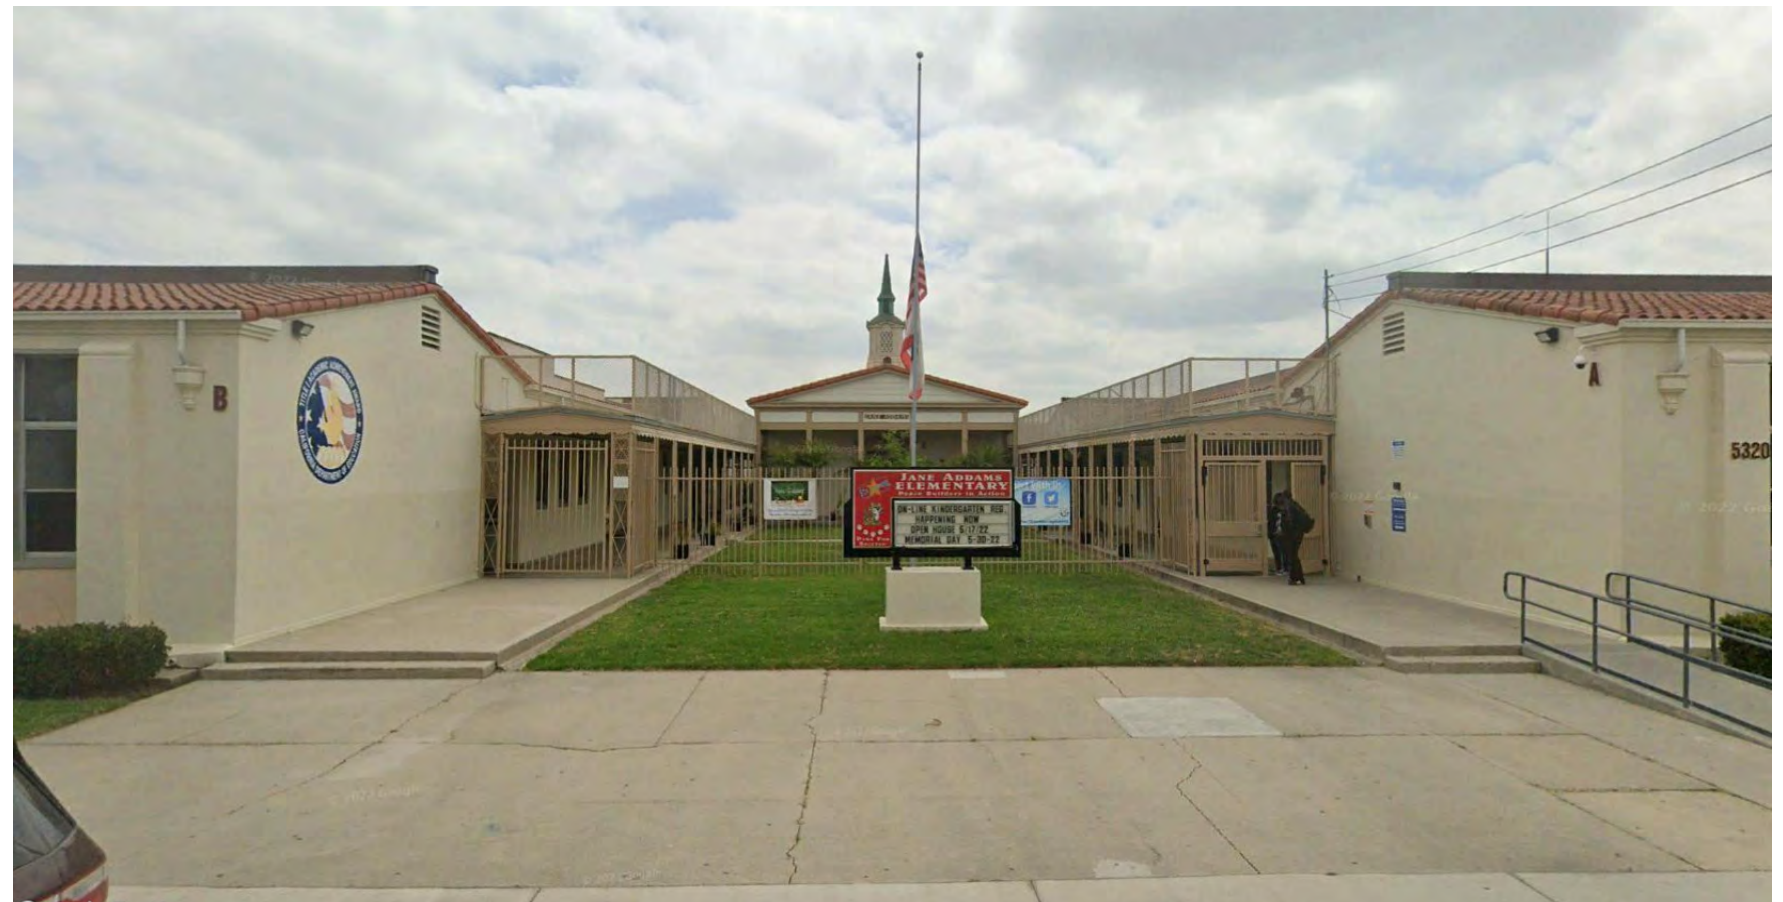
Jane Addams Elementary School – Existing Campus

Campus Observations/Issues

Vehicular Circulation & Parking

- A** Inadequate parking count and lack of parking for visitors
- B** Ease of access/ADA compliance from parking to front door

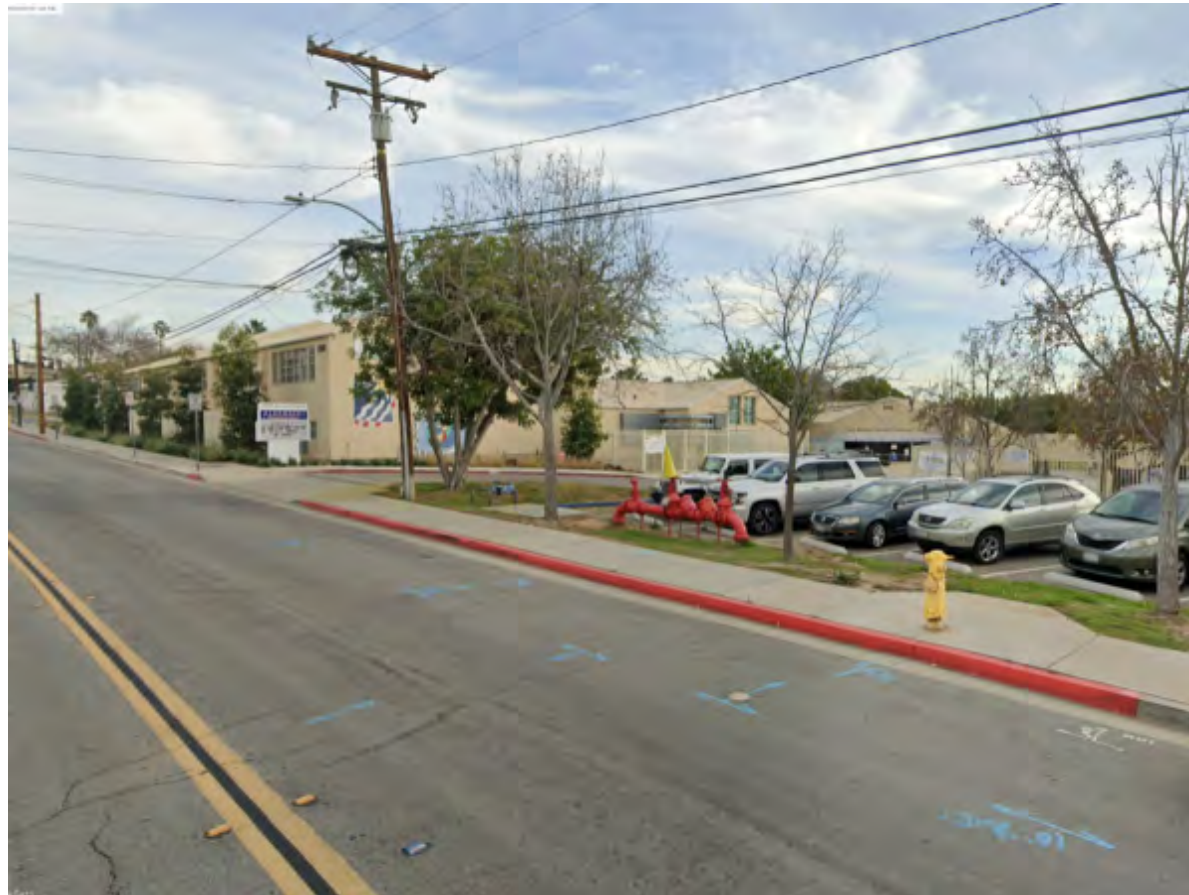
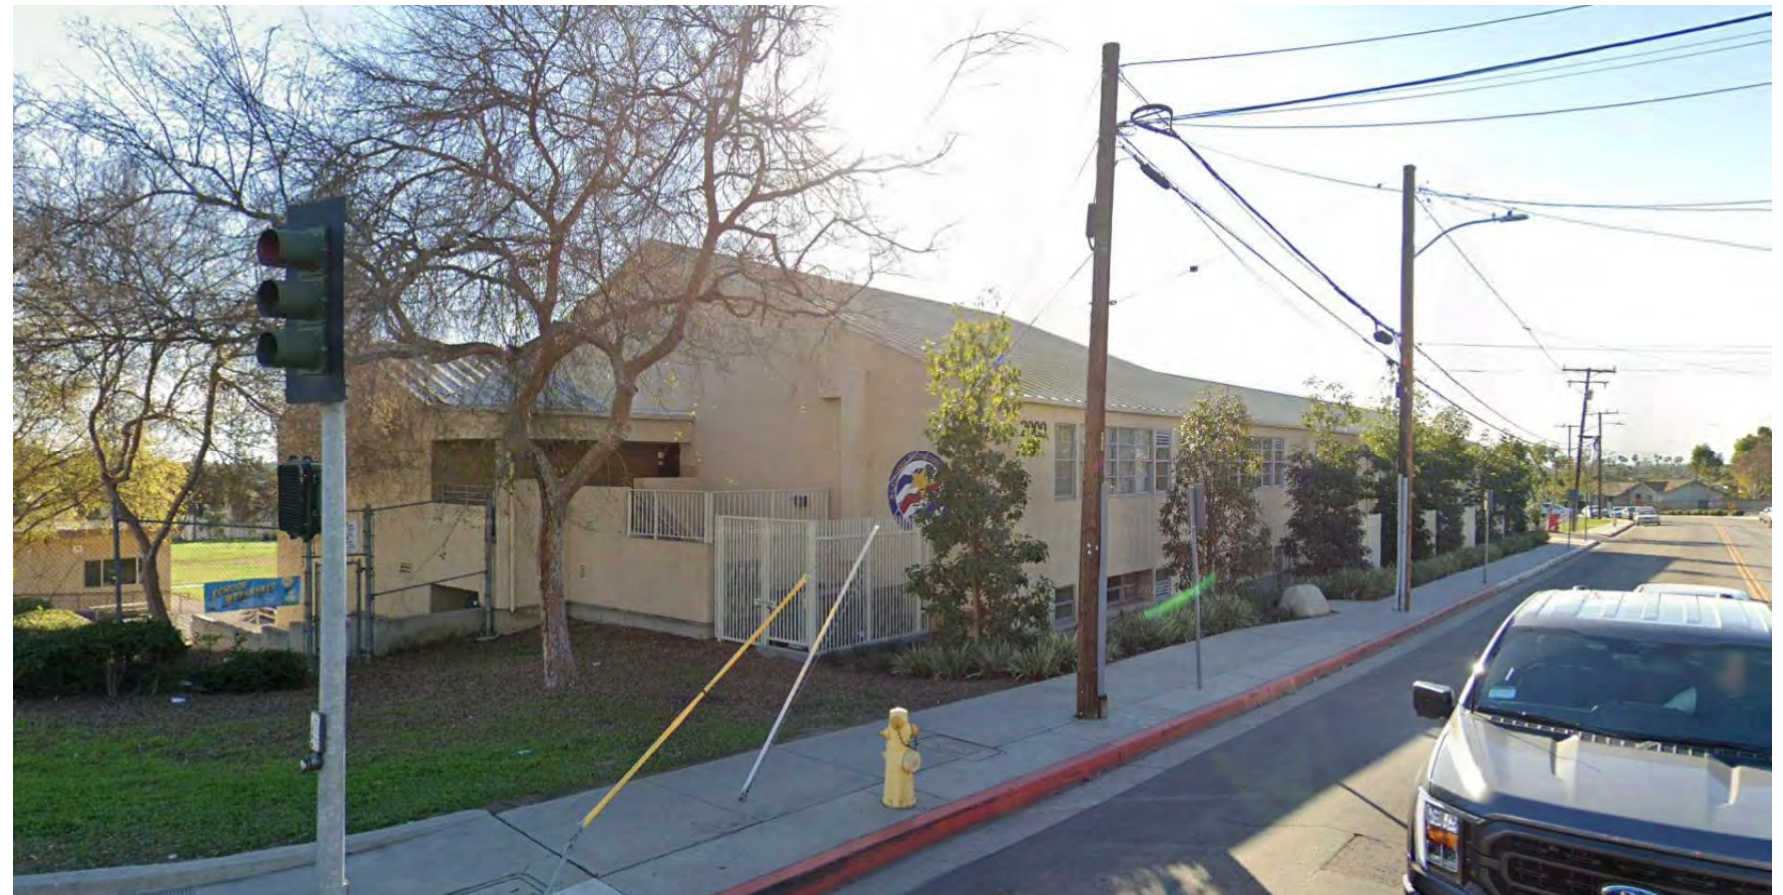
Alvarado Elementary School – Existing Campus

Activity Zone – Athletics/Physical Education

- A Visibility of outdoor Kinder play from street
- B Difficult to read ground games / lack light-colored surfaces

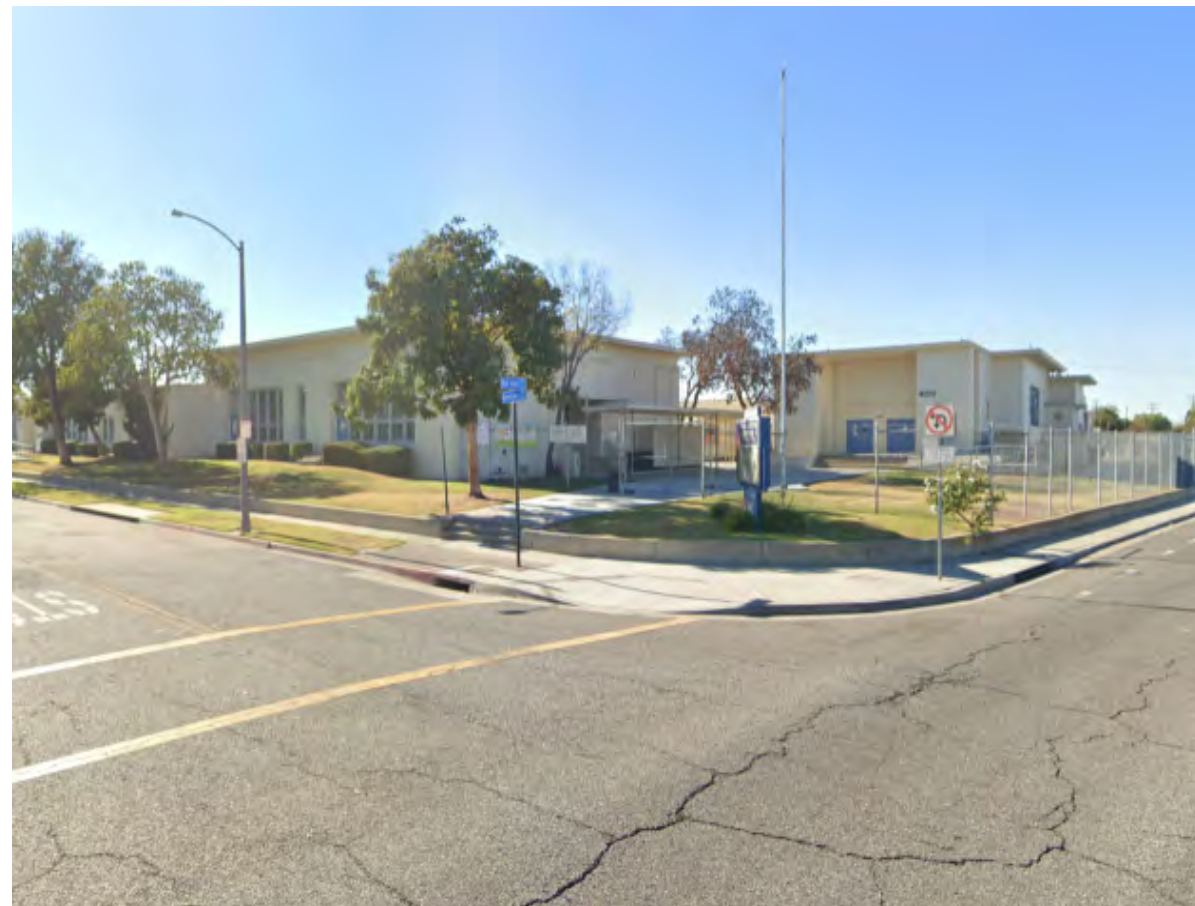
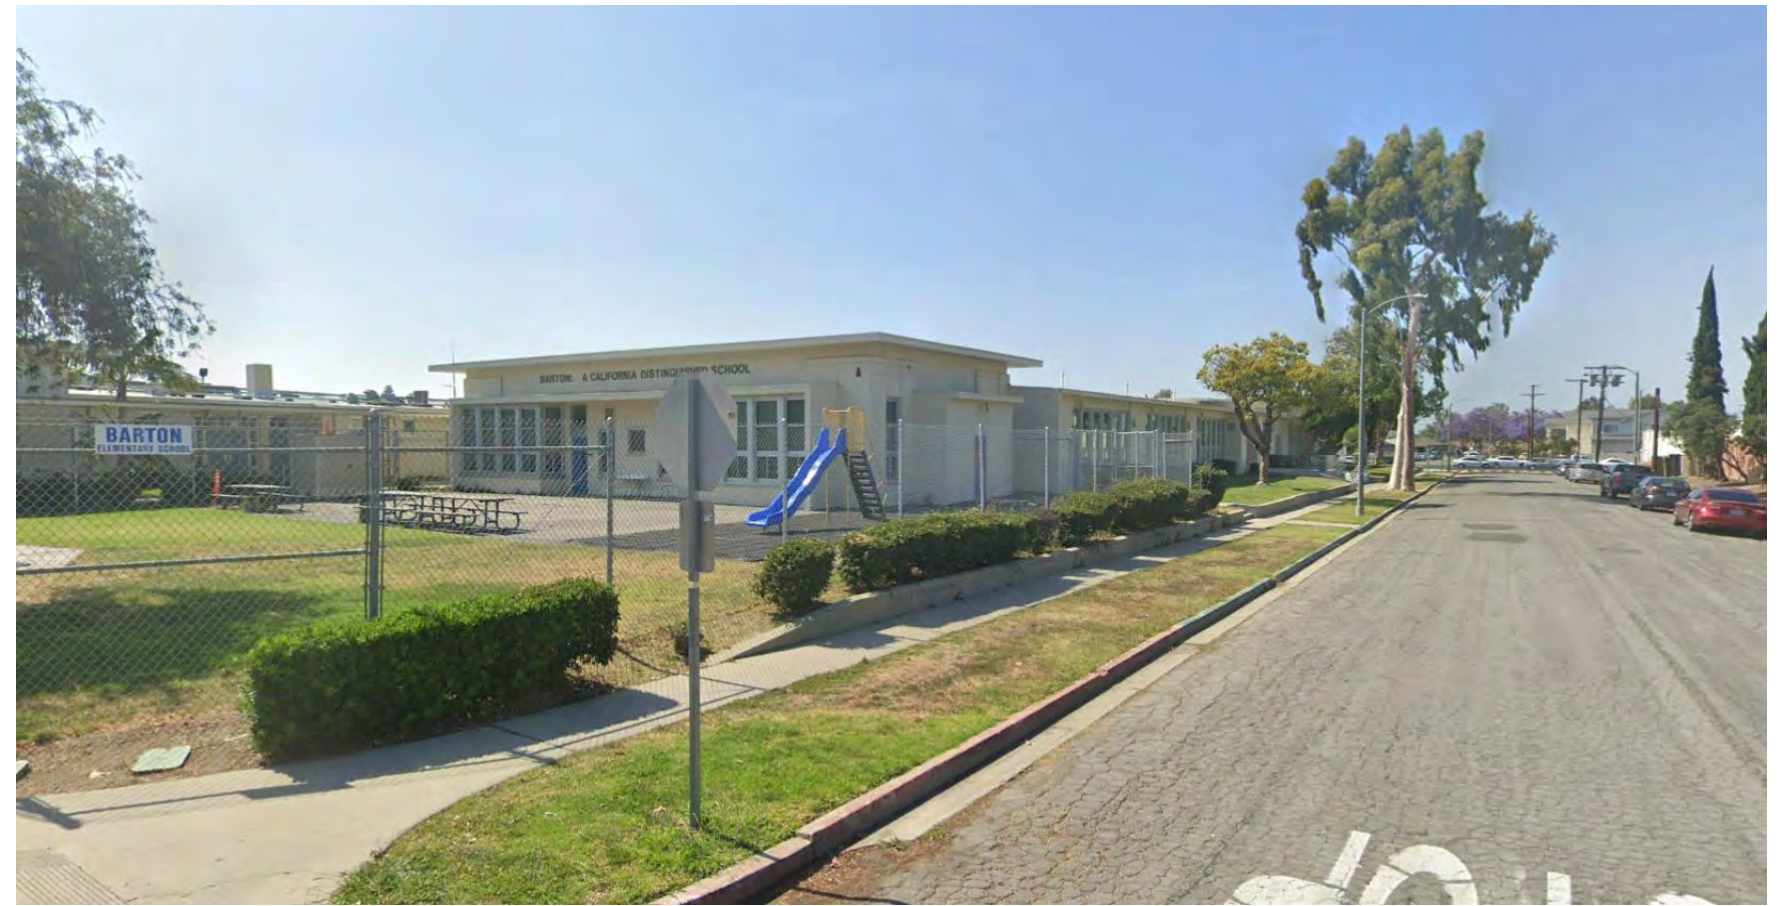
Clara Barton Elementary School – Existing Campus

D Lack of adequate covered outdoor dining

E Significant large areas of blacktop without use of reflective paints to reduce heat island and improve quality of play

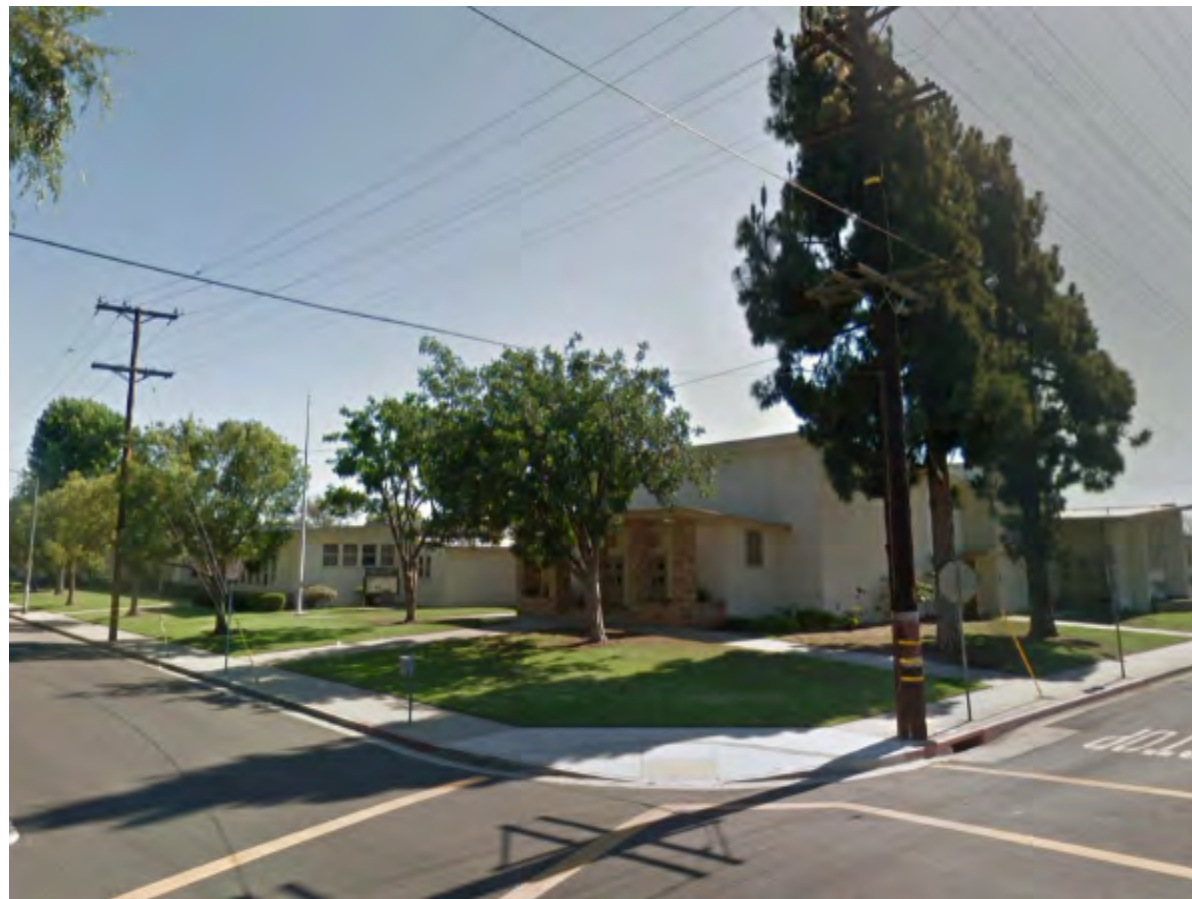
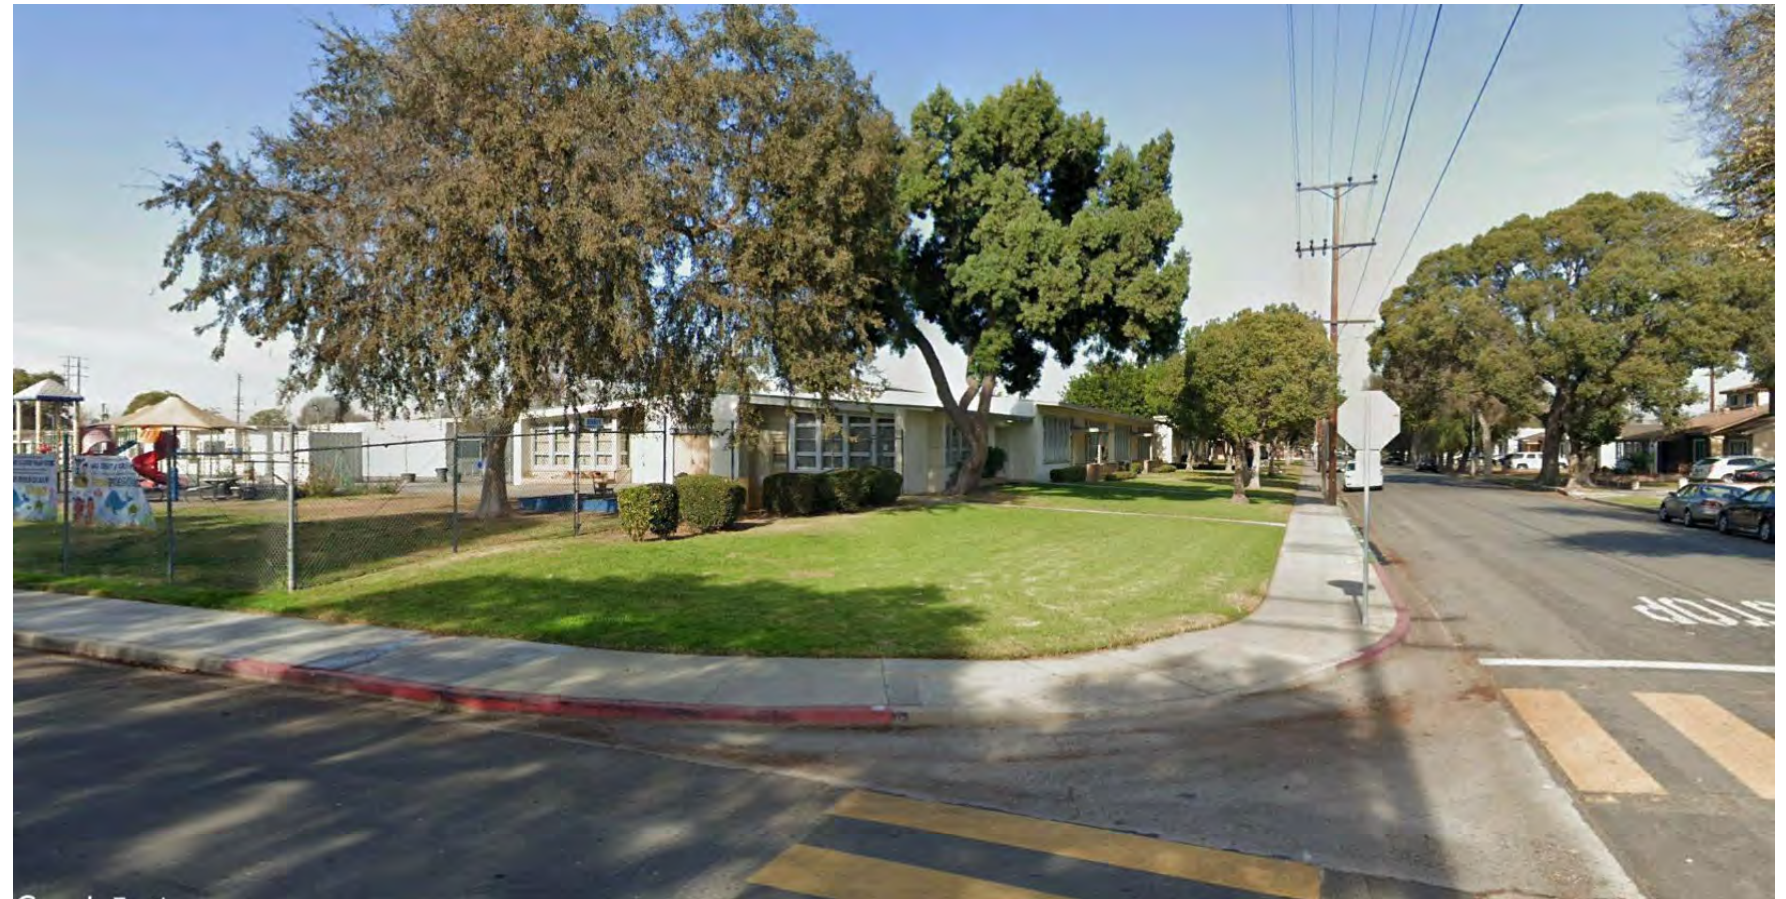
Alice M. Birney Elementary School – Existing Campus

Activity Zone – Athletics/Physical Education

- F** Lack of direct access of PK/TK/K classrooms to outdoor play
- G** Visibility of outdoor Kinder play from street
- H** Difficult to read ground games / lack light-colored surfaces
- J** Significant large areas of blacktop without use of reflective paints to reduce heat island and improve quality of play

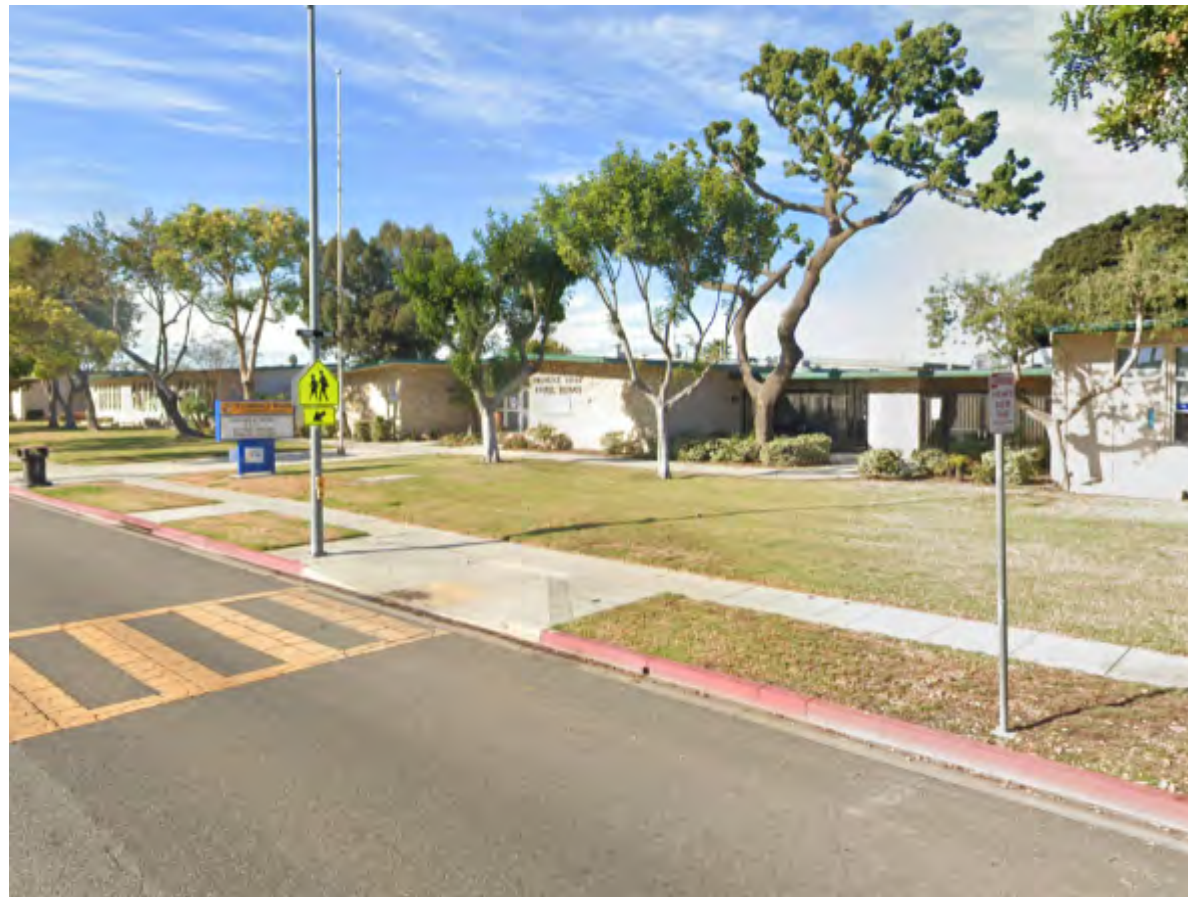
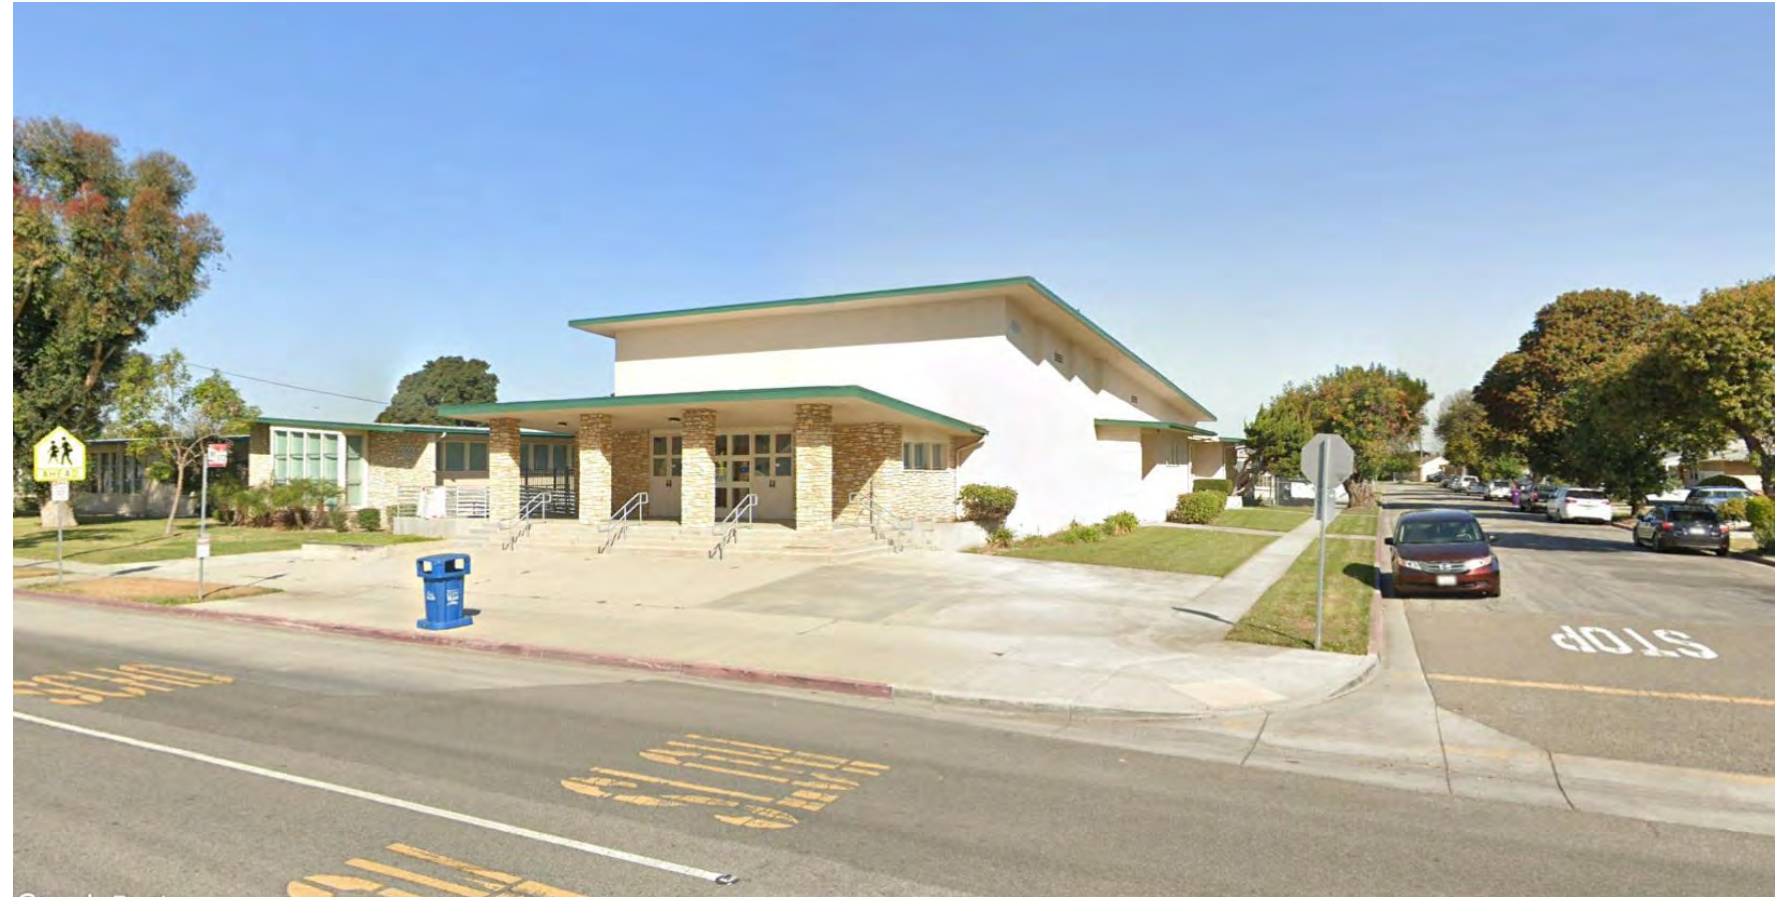
Bixby Elementary School – Existing Campus

D Lack of shade trees and dispersed shade at play area

E Significant large areas of blacktop without use of reflective paints to reduce heat island and improve quality of play

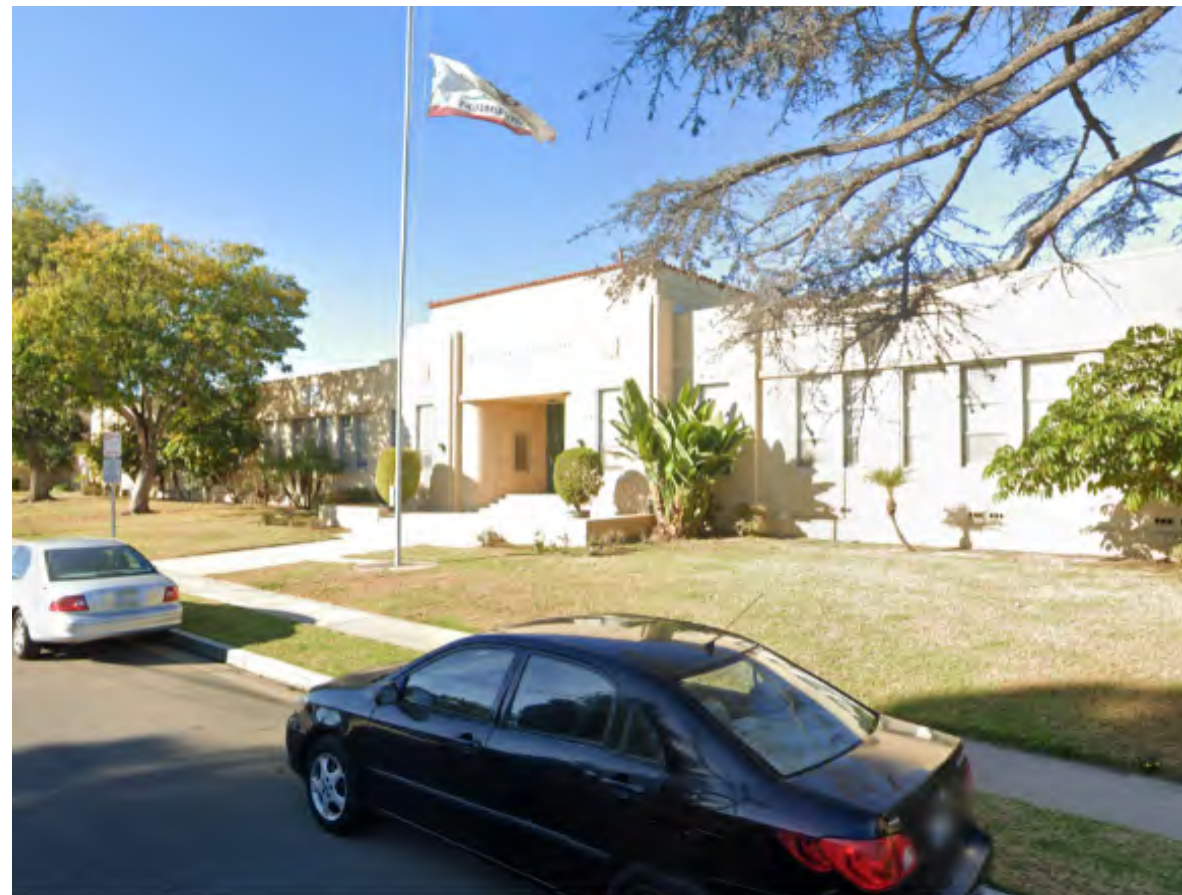
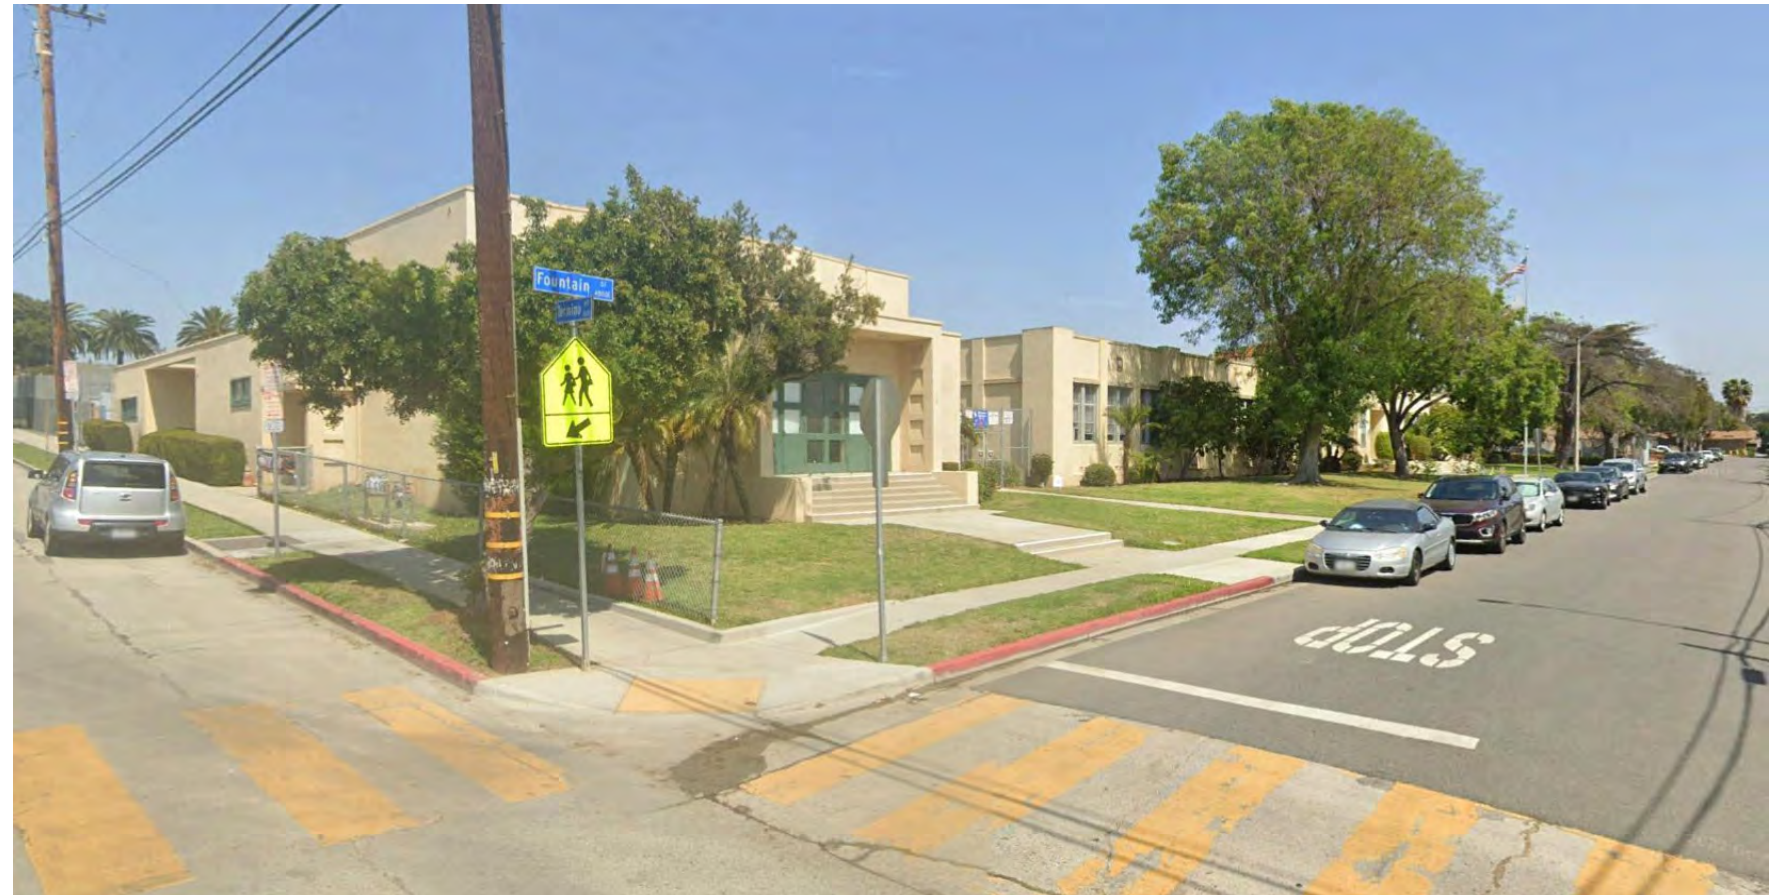
William Cullen Bryant Elementary School – Existing Campus

- A** Inadequate parking count and lack of parking for visitors
- B** Ease of access/ADA compliance from parking to front door

- F** Visibility of outdoor Kinder play from street
- G** Lack of lawn/turf area at main play area
- H** Lack of shade trees and canopied areas at play area
- J** Significant large areas of blacktop without use of reflective paints to reduce heat island and improve quality of play

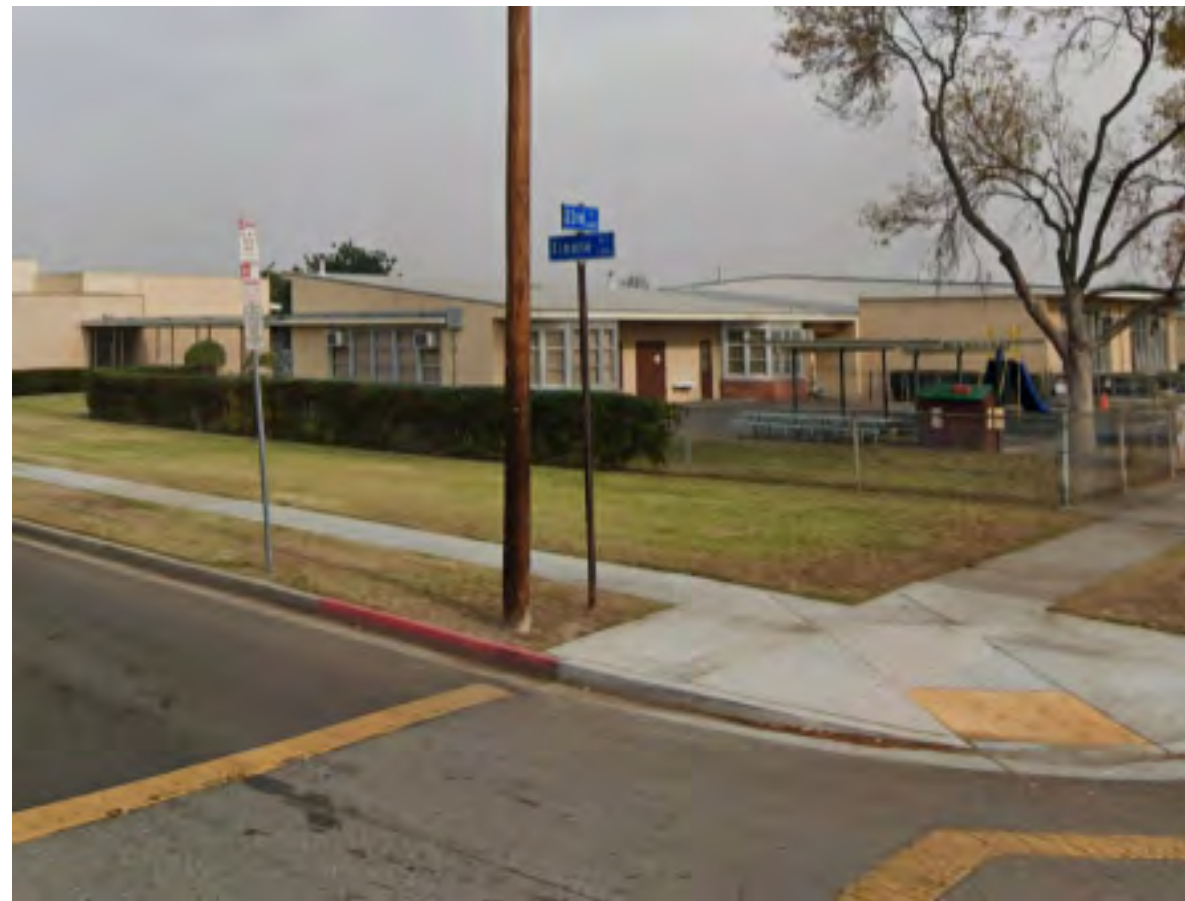
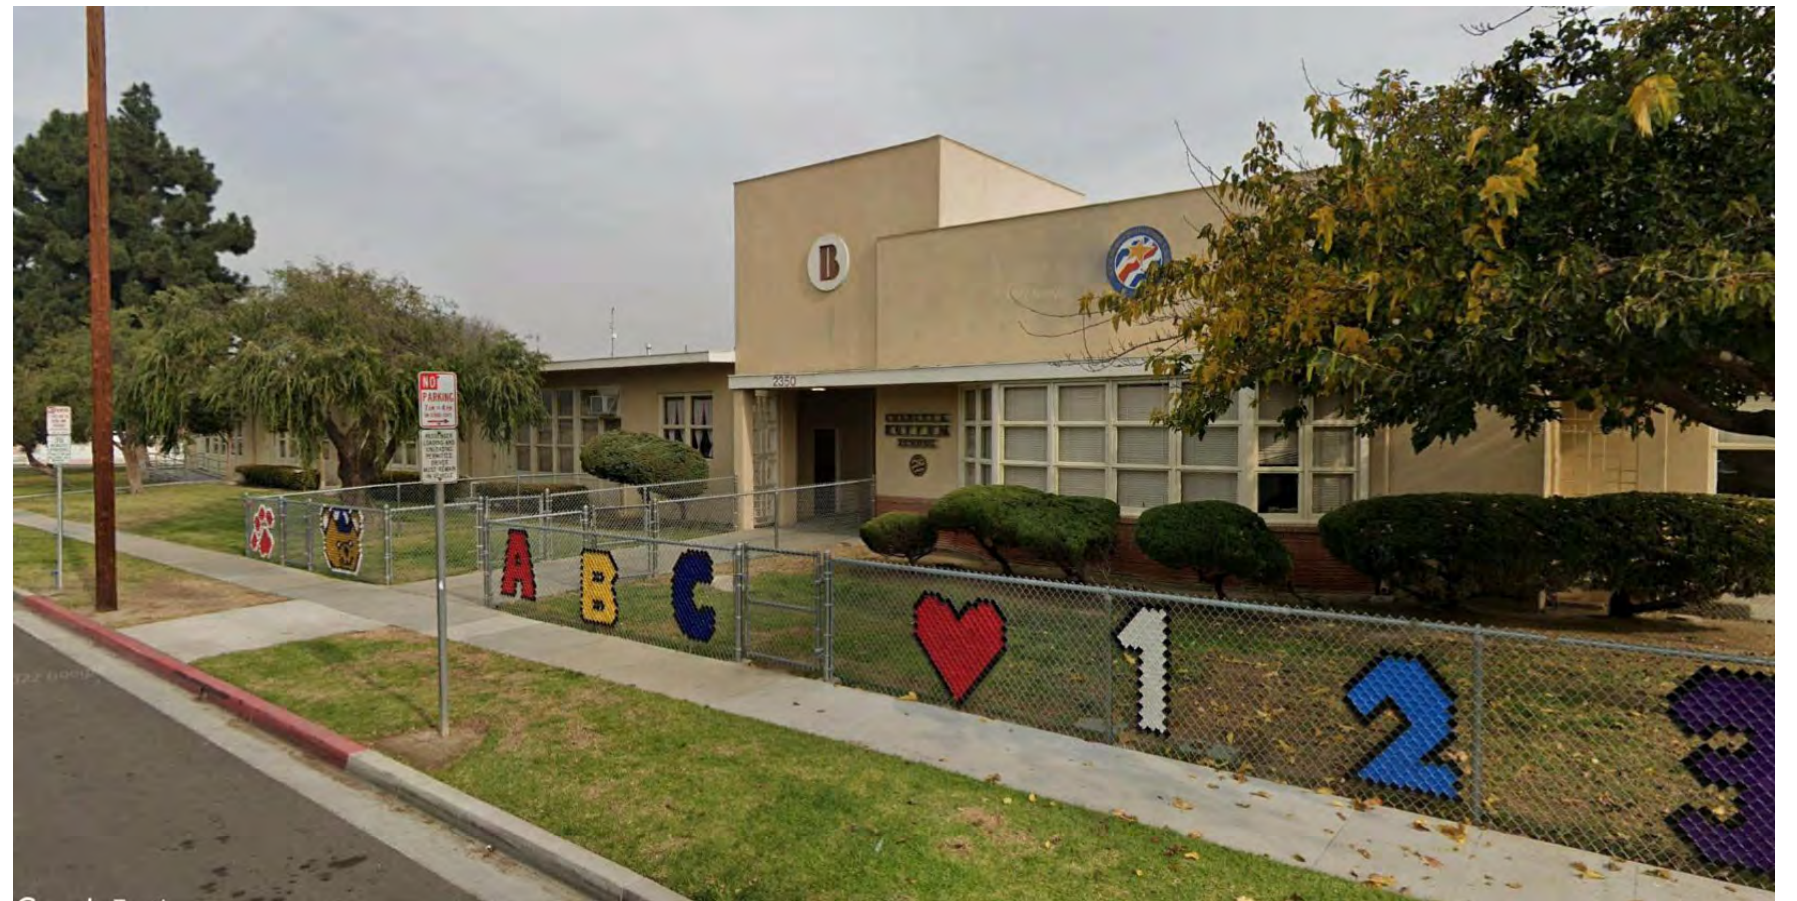
Charles A. Buffum Elementary School – Existing Campus

- C** Visibility of outdoor Kinder play from street
- D** Lack of adequate apparatus play zone for younger learners
- E** Lack of adequate trees and shade structures at play area
- F** Significant large areas of blacktop without use of reflective paints to reduce heat island and improve quality of play

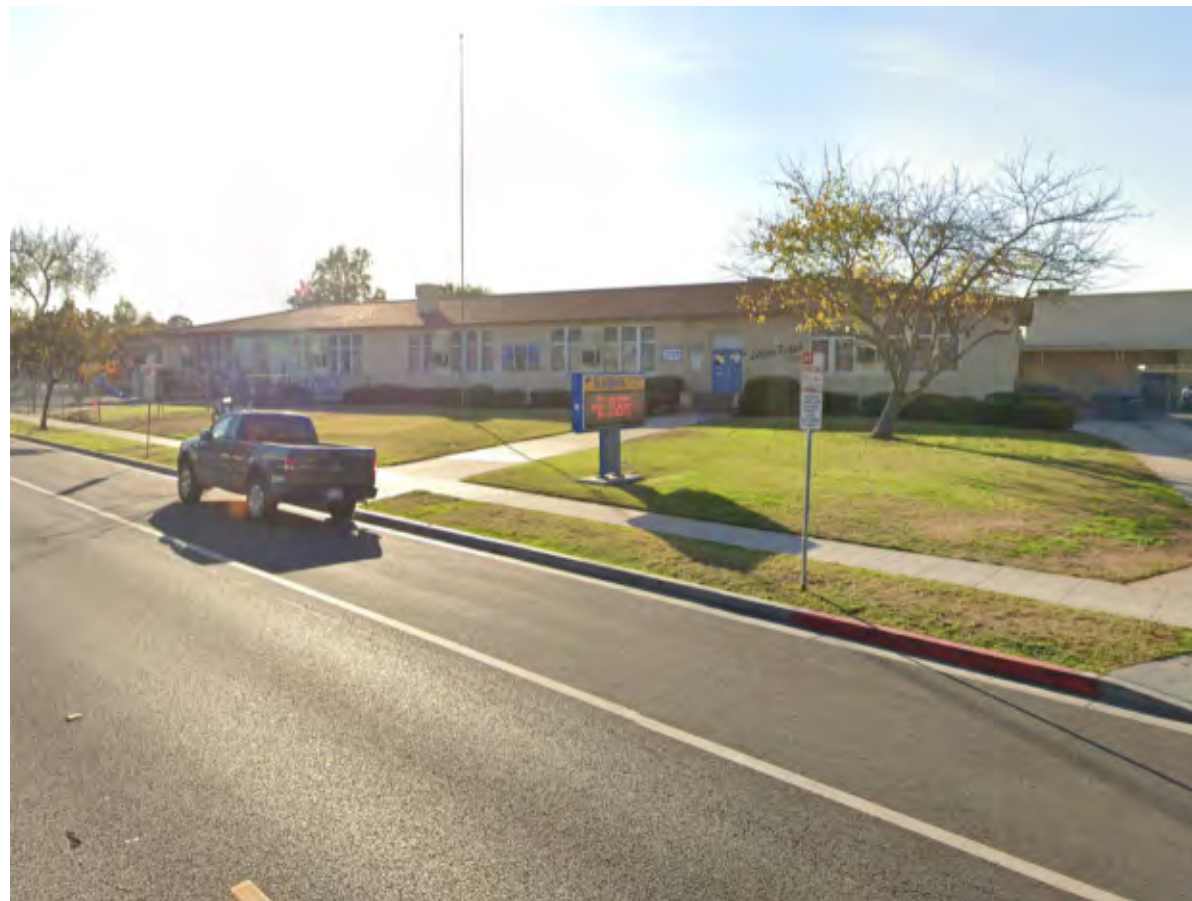
Luther Burbank Elementary School – Existing Campus

- H** Visibility of outdoor PK/Kinder play from street
- J** Significant large areas of blacktop without use of reflective paints to reduce heat island and improve quality of play

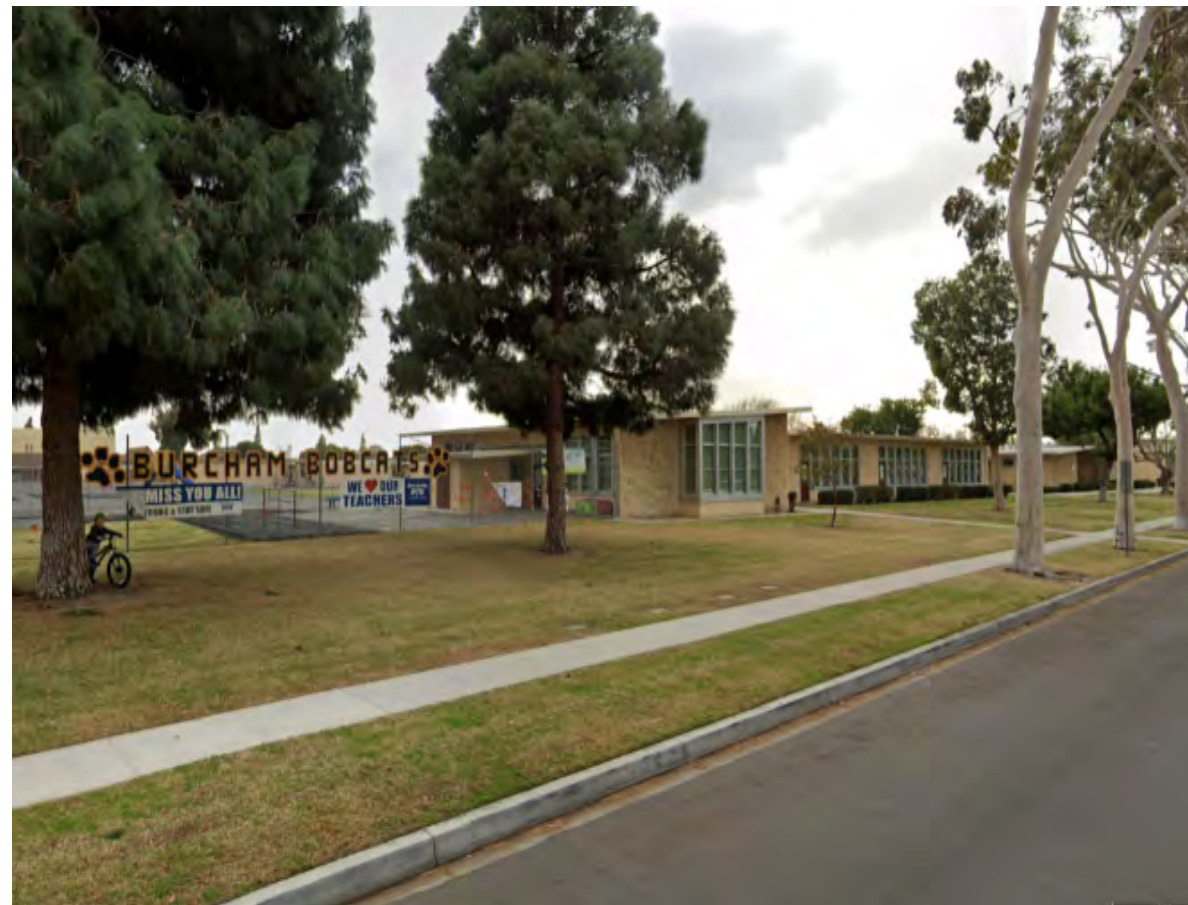
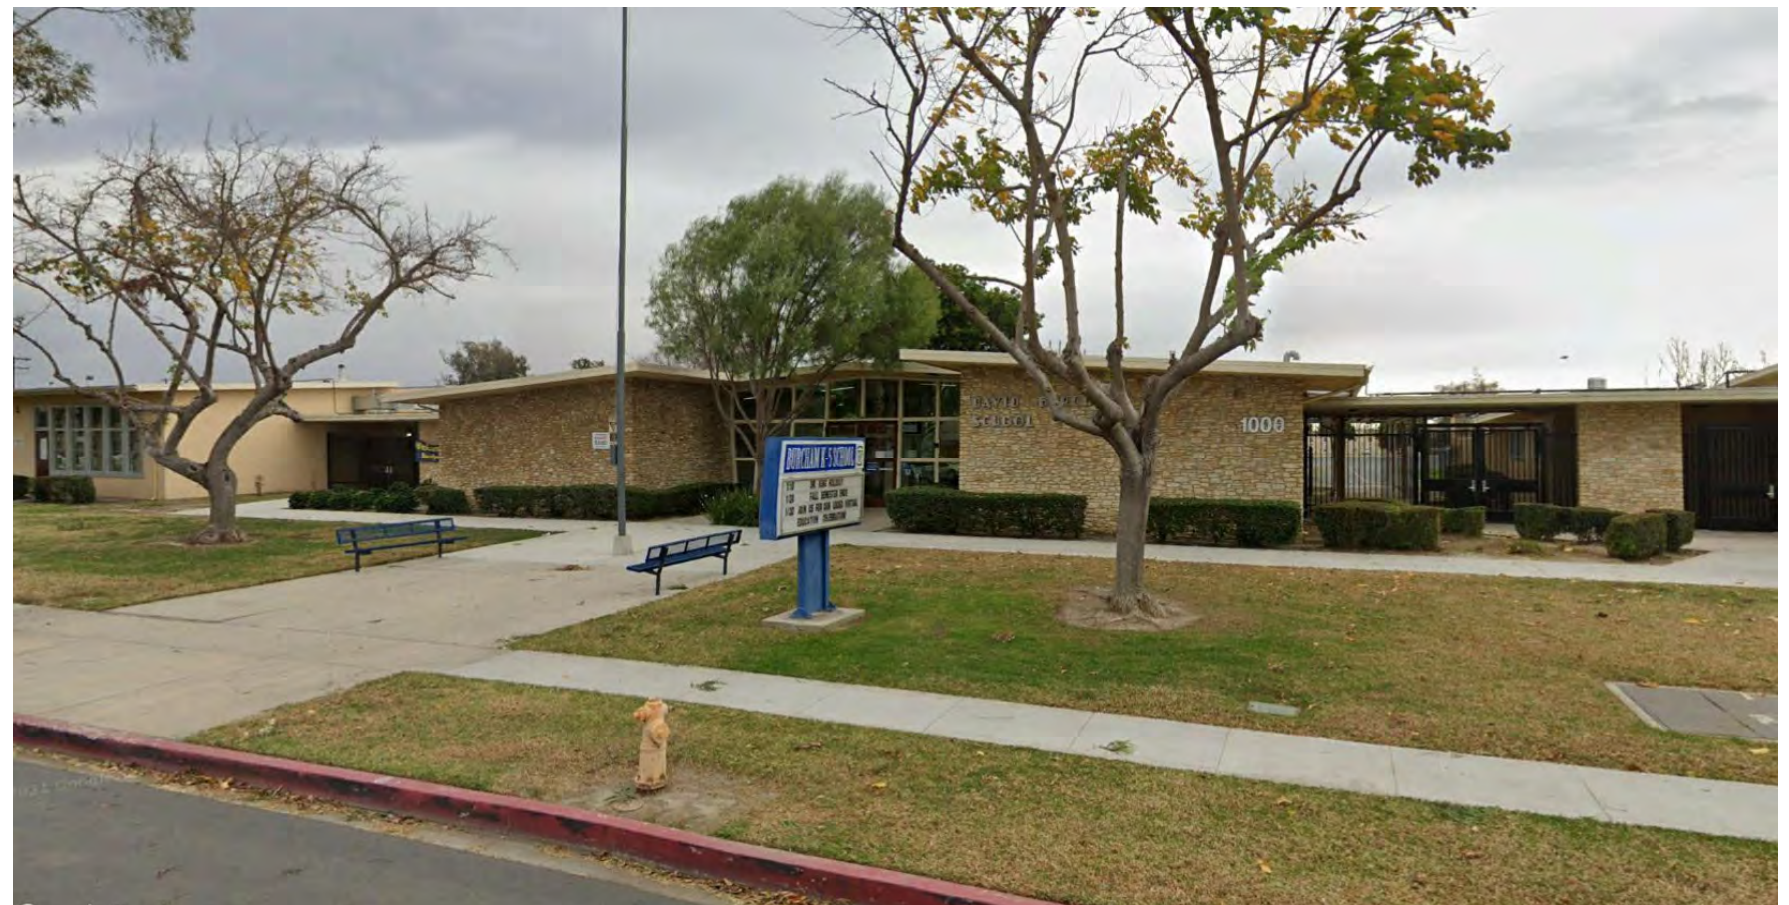
David Burcham Elementary School – Existing Campus

- A** Inadequate parking count and lack of parking for visitors
- B** Ease of access/ADA compliance from parking to front door

- D** Visibility of outdoor Kinder play from street
- E** Lack of shade trees at play area
- F** Significant large areas of blacktop without use of reflective paints to reduce heat island and improve quality of play
