LBUSD 2022 Facility Master Plan

Long Beach Unified School District
Appendices

July 2022

A Facility Reports: Elementary Schools

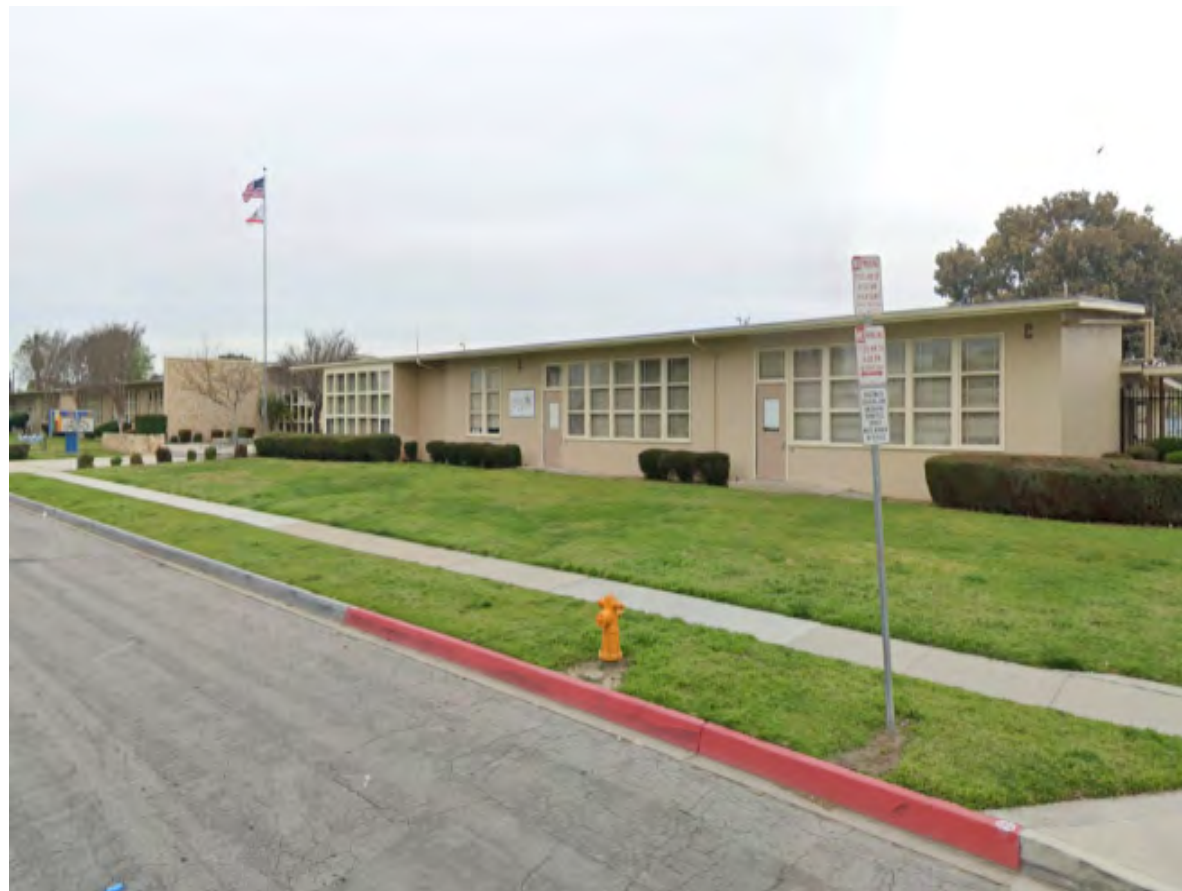
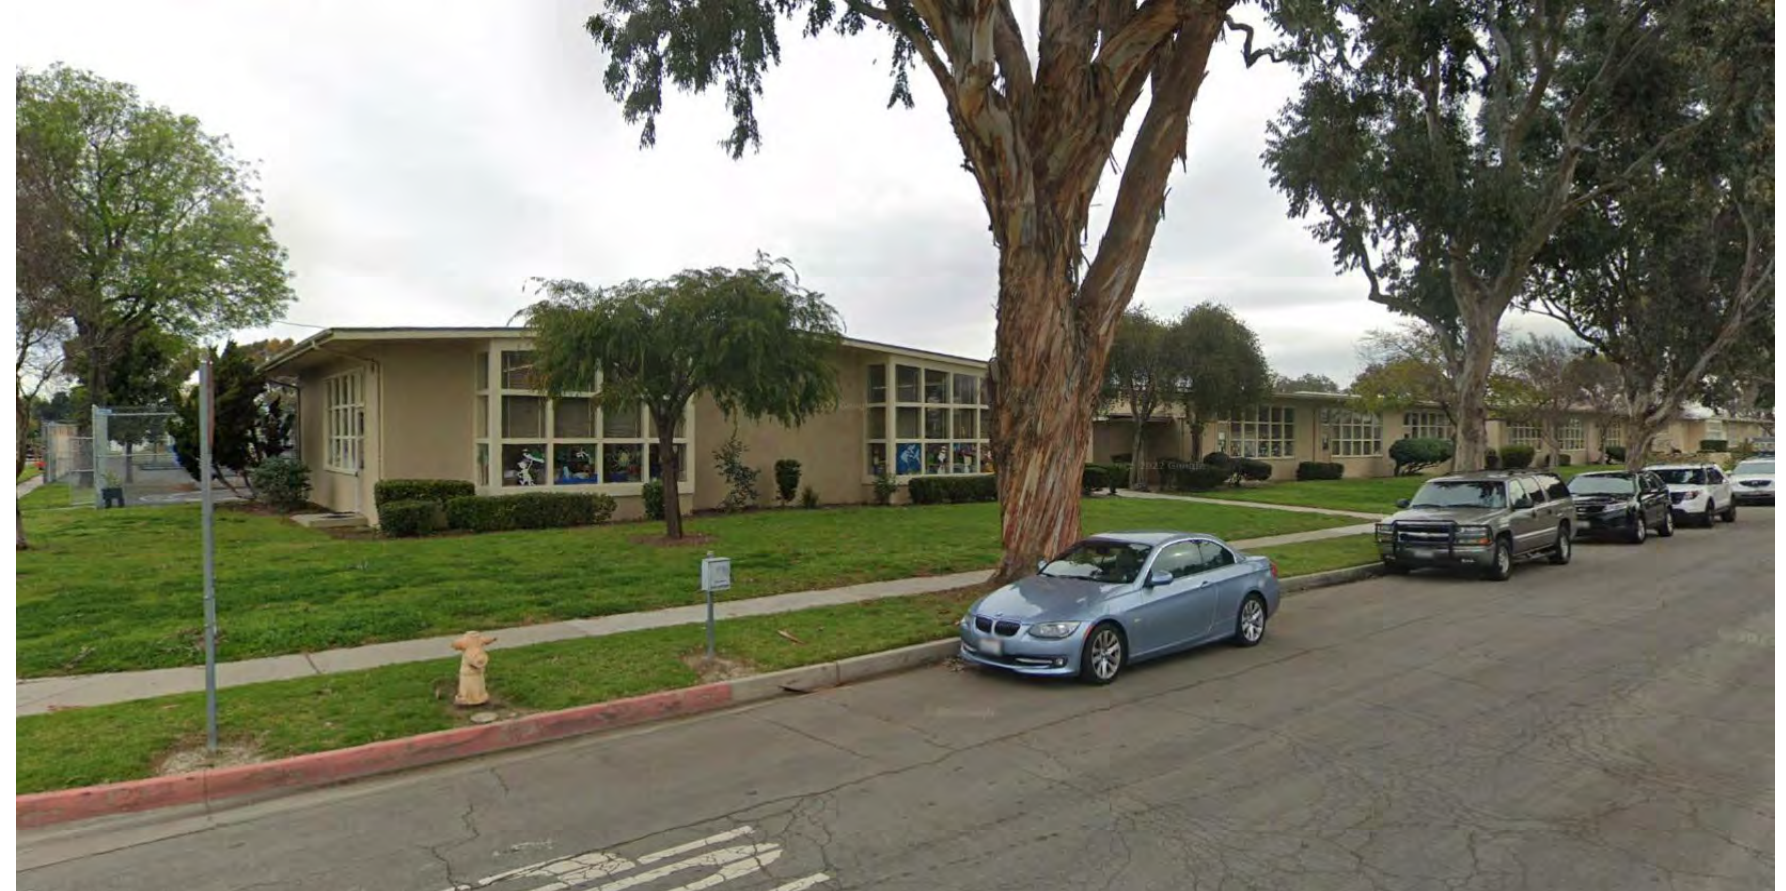
George Washington Carver Elementary School – Existing Campus

- D** Visibility of outdoor Kinder play from street
- E** Lack of lawn/turf area at main play area
- F** Lack of adequate shade trees and canopies at play area
- G** Significant large areas of blacktop without use of reflective paints to reduce heat island and improve quality of play

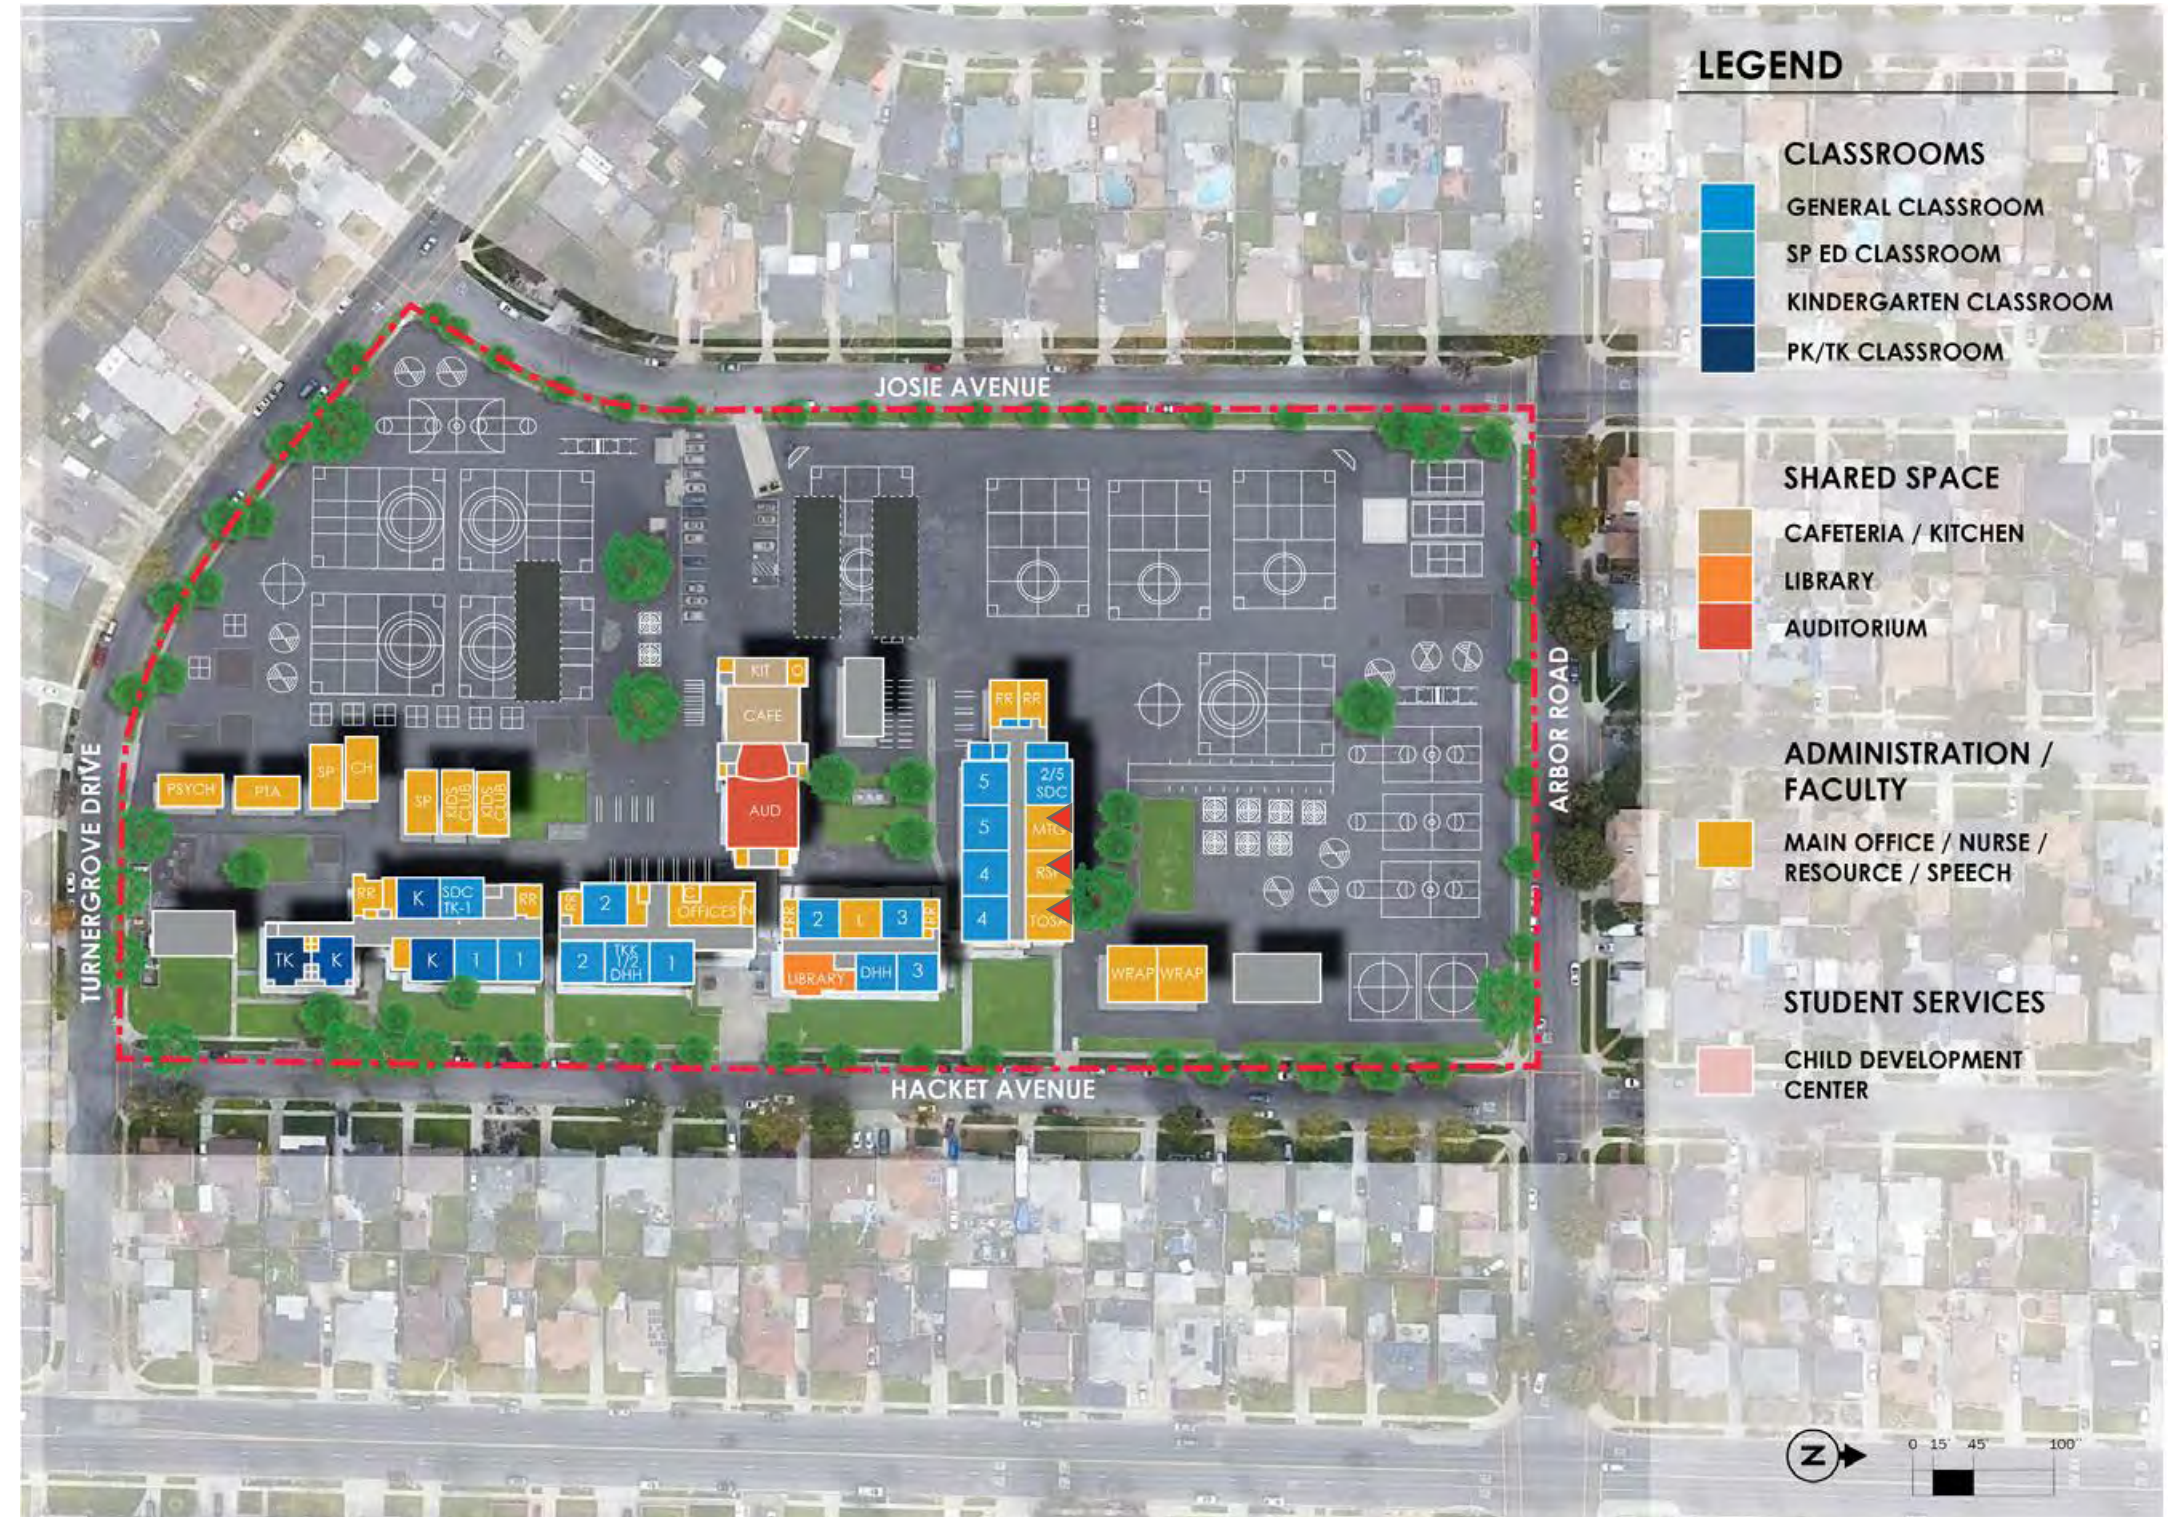
At 723 square feet (including the Dry Storage area), the Cleveland Elementary School kitchen is small and cramped. Though recently renovated as part of the LBUSD HVAC Construction project, the food service areas at Cleveland Elementary School do not meet current ADA or EHS requirements. The kitchen lacks sufficient dedicated dry storage (which shares the space with the supervisor’s office area – an EHS code violation). Chemicals are being stored in the dry storage room. Although not a compliance issue, it is also not considered best practices. Dry storage is supplemented with a remote, exterior storage container. There is no exterior ramp for the storage container which necessitates a step up to access the interior. The layout space for landing chilled product and reheated product is also inadequate. The service line is accessed within the kitchen space. Due to the size constraints of the kitchen, the service aisles for both the staff and the students are undersized and do not meet ADA requirements. Refrigeration is accommodated by (7) units within the kitchen space and supplemented with overflow refrigerated equipment in the cafeteria. Exposed wood in the kitchen is a potential harbinger for pests and/or vermin and is not allowed per EHS code. The wood utility carts, wood end cap to serving counter and the exposed wood guillotine style door near the disposer are not EHS code compliant. One air curtain in the cafeteria is either wired to be switch activated or non-operational at time of site visit. Per EHS code, air curtains should be plunger activated to avoid the possibility of shutting them off while service is in process. Five of the dining tables in the cafeteria do not properly lock in the open position. This is a safety issue for students and staff. The current placement of the cooking equipment below the exhaust hood takes away the required side overhangs and renders the hood non-compliant. Wall flashing is required behind (which includes below) all wet areas including but not limited to sinks and disposers. There is no employee hand sink or dedicated food preparation sink within the kitchen space. This site would benefit from a prototype design to address EHS and DSA code compliance issues and provide an equipment package to meet current and future CNS needs.

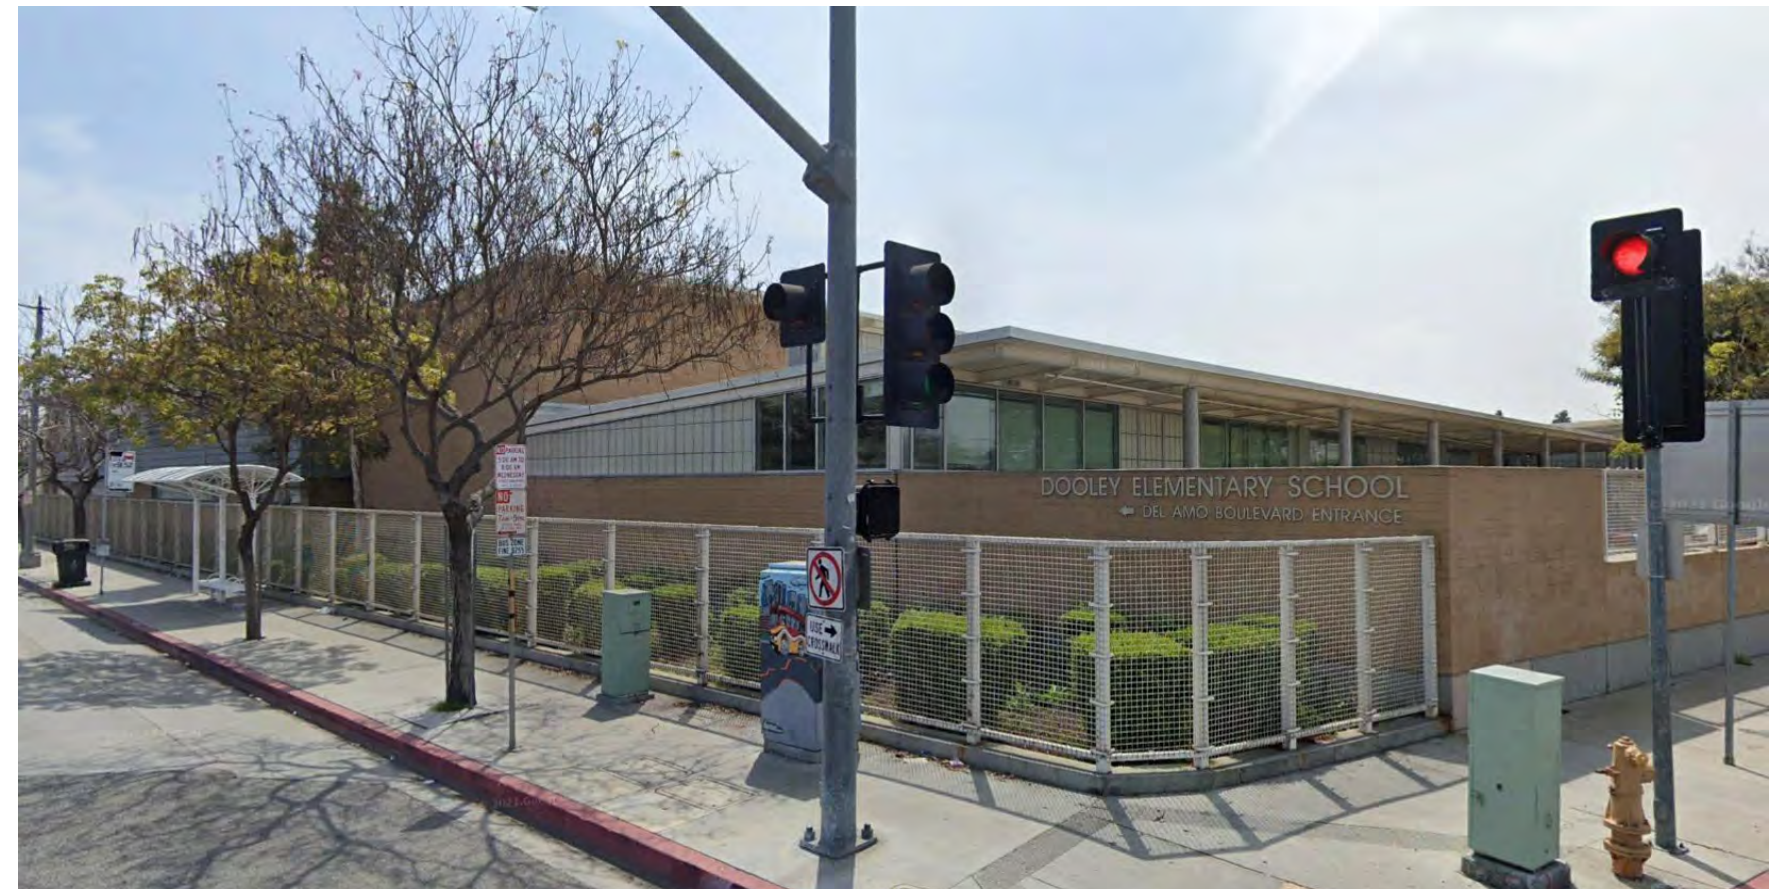
Dooley Elementary School – Existing Campus

- A** Visibility of outdoor Kinder play from street

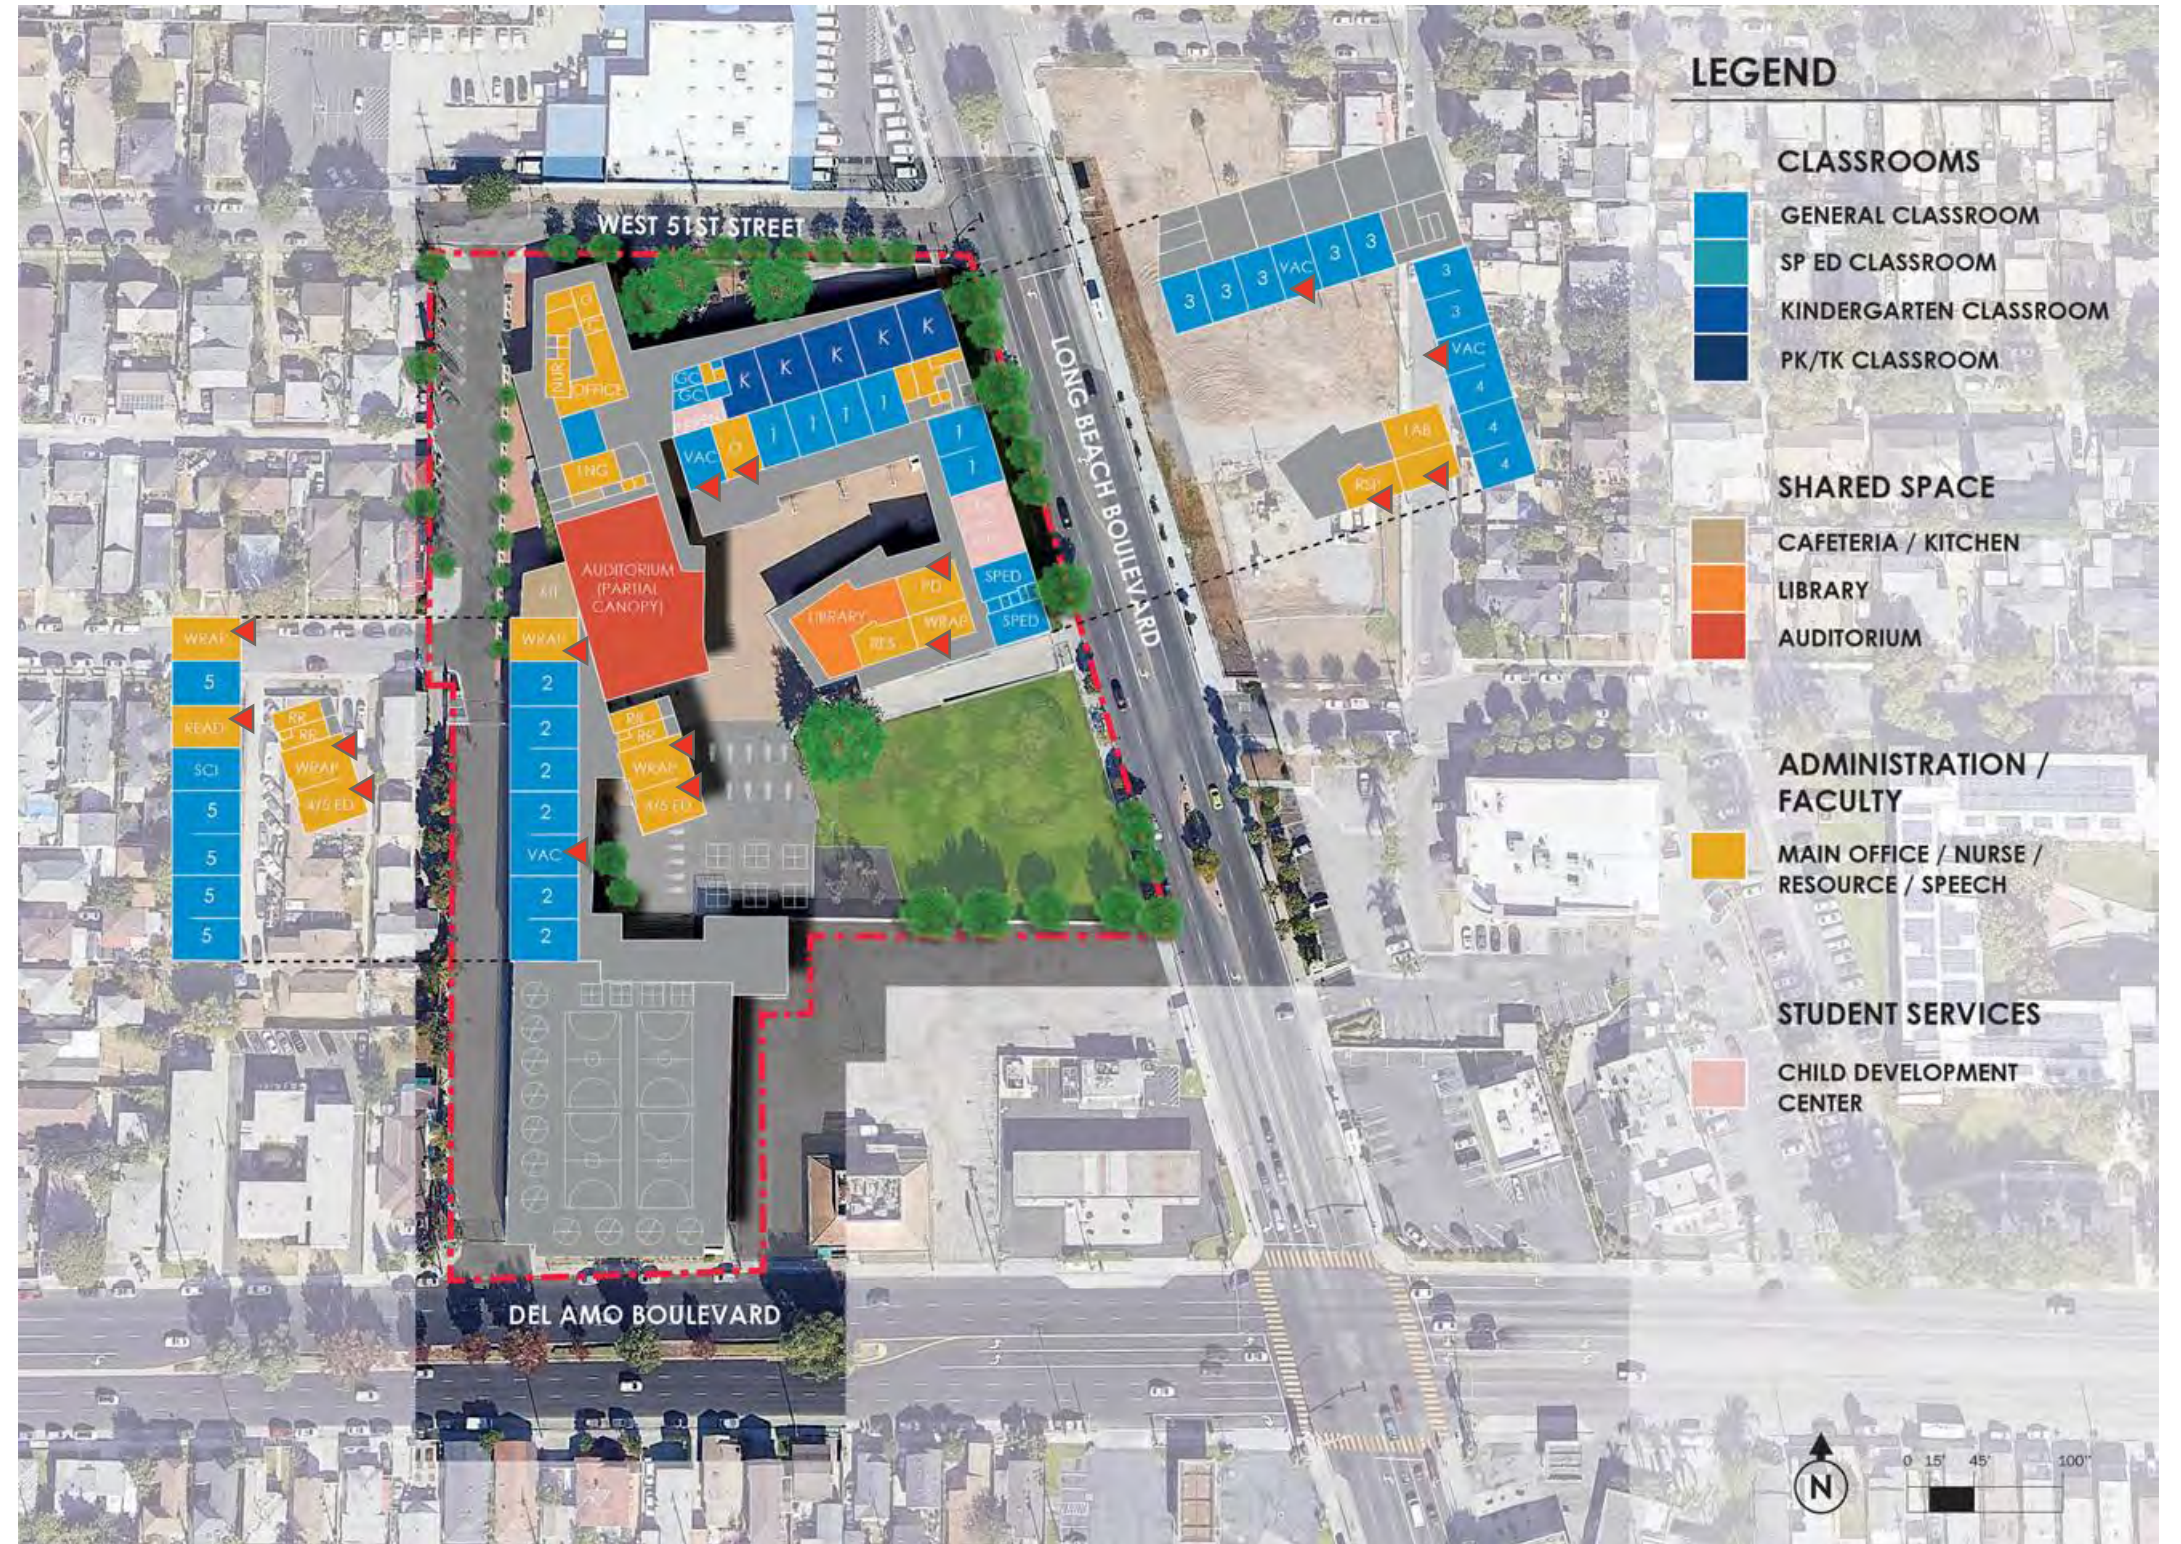
Dooley Elementary School – Nutrition Services Plan 2022-2032

At 1309 square feet (including the Dry Storage area), the Dooley Elementary School kitchen is large. This space is oversized for the 2021-2022 Enrollment and service model. The kitchen has sufficient dedicated dry storage. Refrigeration is accommodated by a walk-in cooler and freezer. These units were locked at the time of site visit and therefore cannot be evaluated. The walk-ins are supplemented with a self-contained refrigerator and (2) milk coolers within the kitchen space and an additional refrigerator in the cafeteria. The food service areas at Dooley Elementary School meet current ADA and EHS requirements, however, the ingress and egress for the mobile service line is not ADA compliant. The line would need to be moved 1 to 2 feet deeper into the kitchen (measurement is dependent on whether the tray rails are being utilized) to accommodate ADA requirements. The service aisle for the staff would then be out of compliance for the very same reason. There are (3) double exit doors in the cafeteria that do not have EHS required, full width, plunger activated air curtains. This site would benefit from a prototype design to address EHS and DSA code compliance issues and provide an equipment package to meet current and future CNS needs.

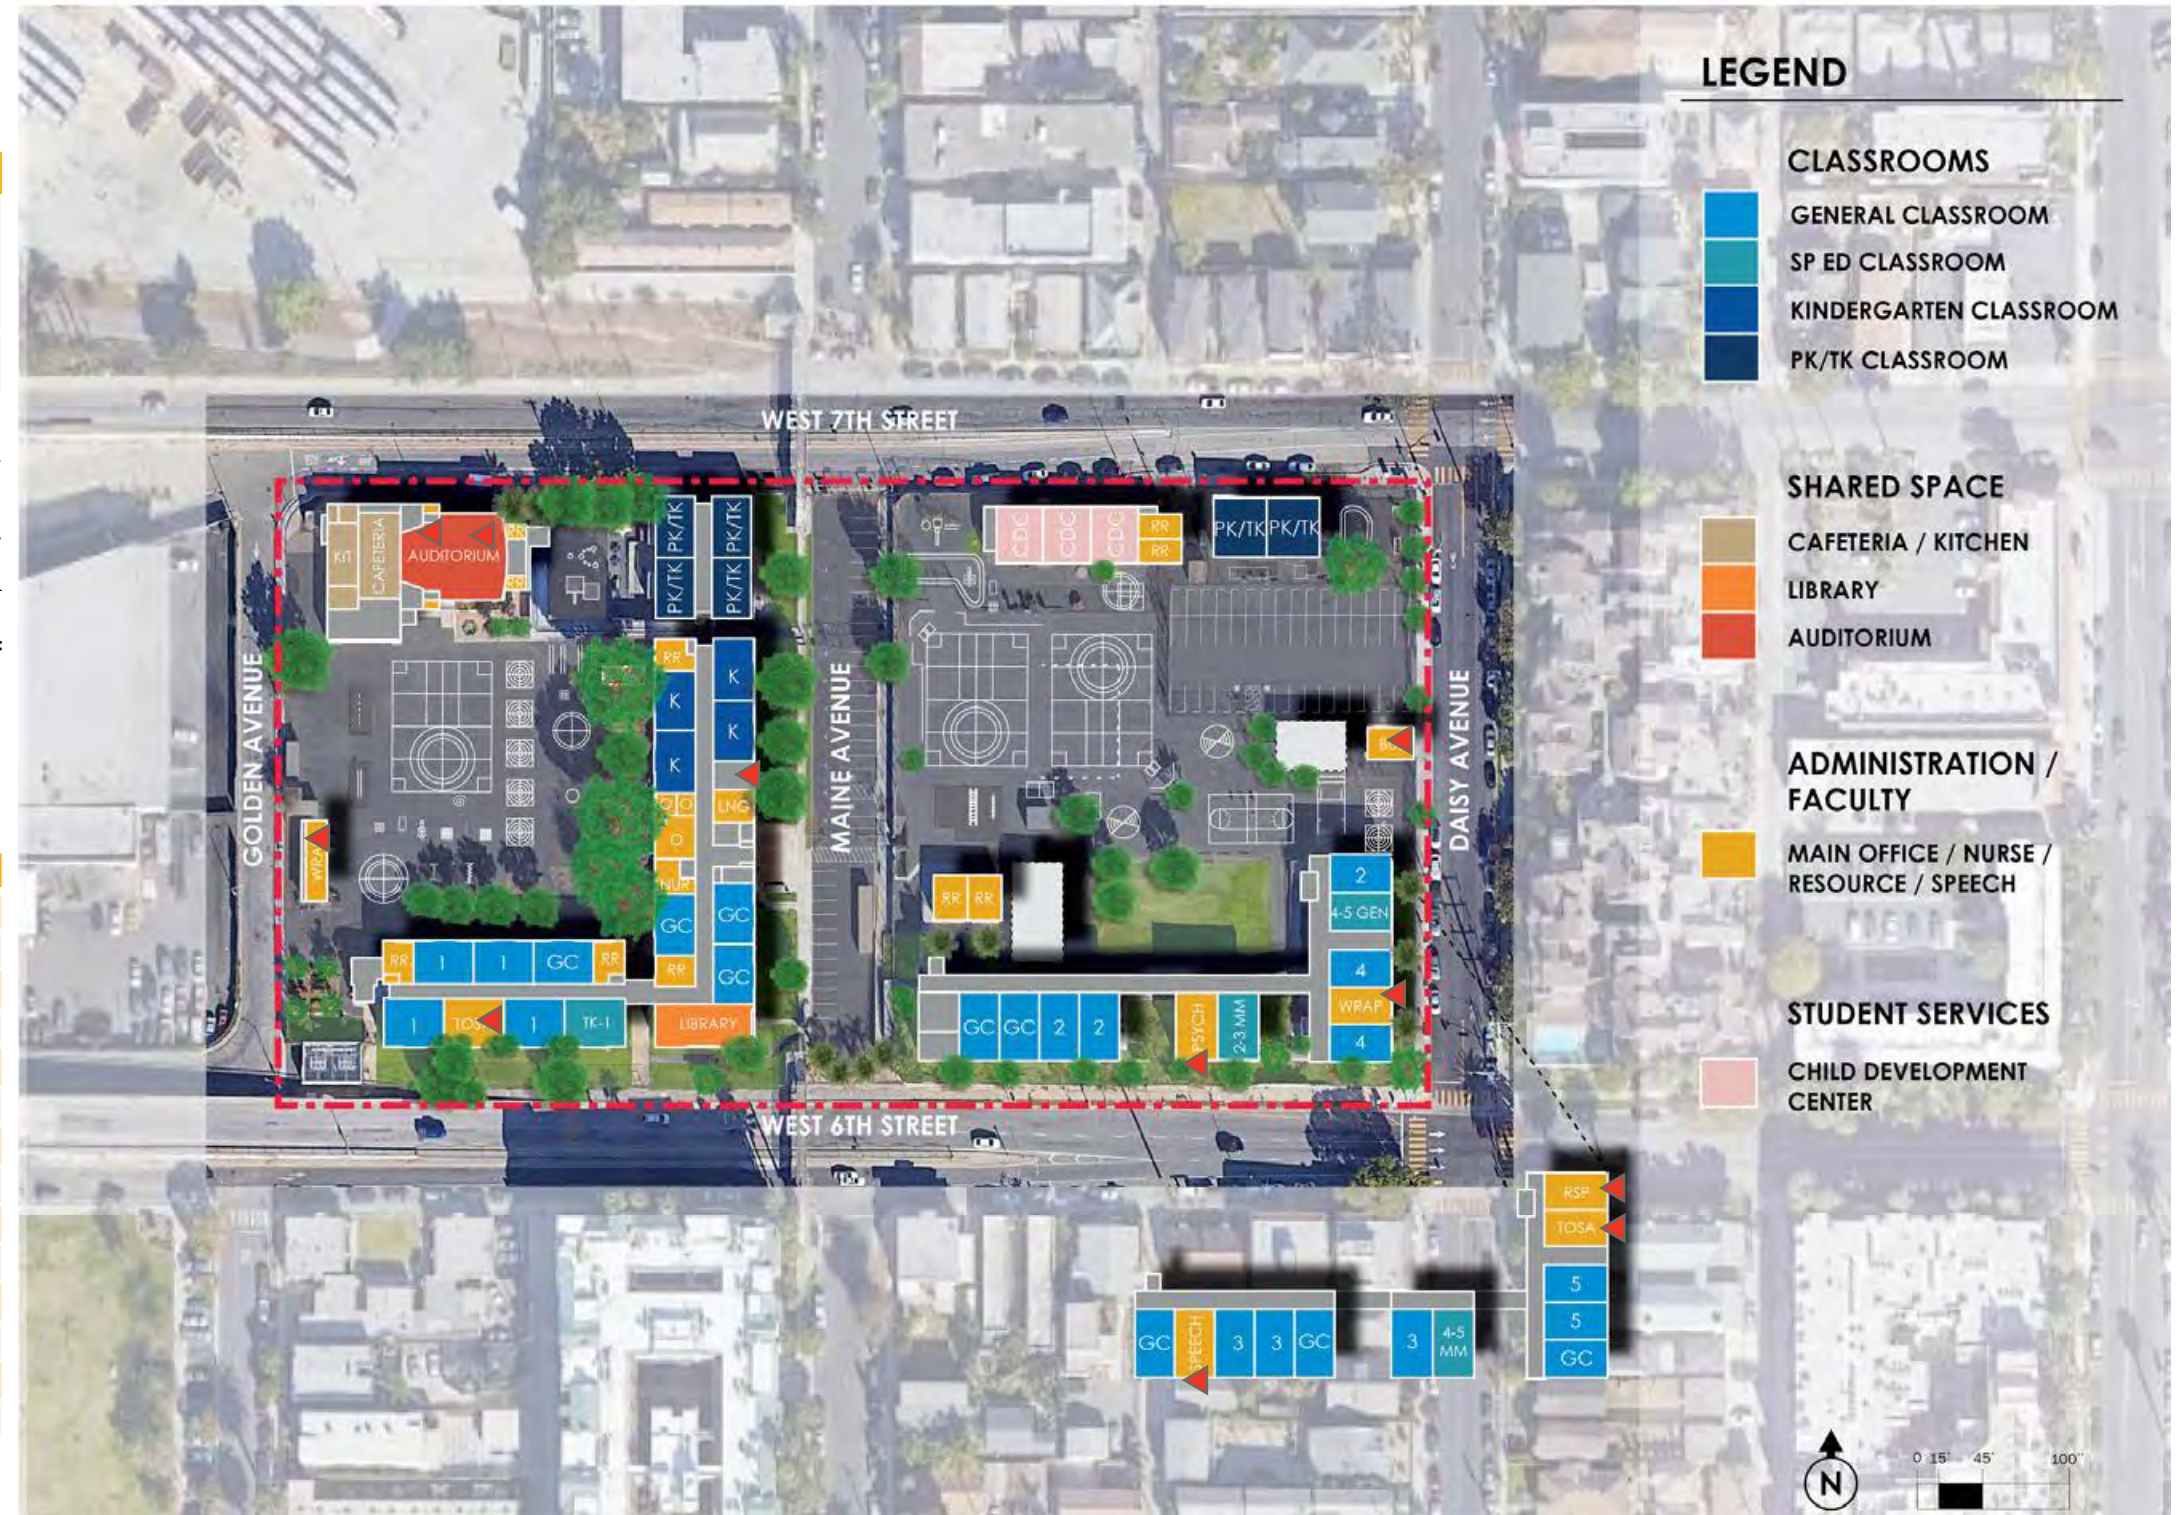
At 732 square feet (including the Dry Storage area), the Edison Elementary School kitchen is small and cramped. This space is inadequate for the 2021-2022 Enrollment and service model. The food service areas at Edison Elementary School do not meet current ADA or EHS requirements. The kitchen lacks sufficient dedicated dry storage (which shares the space with the supervisor's office area). Dry storage is supplemented with a remote, exterior storage container. The existing exhaust hood is not UL Listed, has inadequate ventilation as required by UMC code and does not comply with NFPA code with regard to fire suppression and wall sheathing. The layout space for landing chilled product and reheated product is also inadequate. The service line is accessed within the kitchen space. Due to the size constraints of the kitchen, the service aisles for both the staff and the students are undersized and do not meet ADA requirements. Refrigeration is accommodated by (8) units within the kitchen space and supplemented with overflow refrigerated equipment in the cafeteria. Exposed wood in the kitchen is a potential harbinger for pests and/or vermin and is not allowed per EHS code. The wood fabricated employee storage cabinet and the guillotine style door near the disposer is not EHS code compliant. The air curtains in both the kitchen and cafeteria are wired to be switch activated. Per EHS code, air curtains should be plunger activated to avoid the possibility of shutting them off while service is in process. Codes require a UL Listed Type I exhaust hood with a UL 300 Fire Suppression System. A non-combustible wall finish is required behind the cooking equipment. Wall flashing is also required behind (which includes below) all wet areas including but not limited to sinks and disposers. There is no employee hand sink or dedicated food preparation sink within the kitchen space. This site would benefit from a prototype design to address EHS and DSA code compliance issues and provide an equipment package to meet current and future CNS needs.

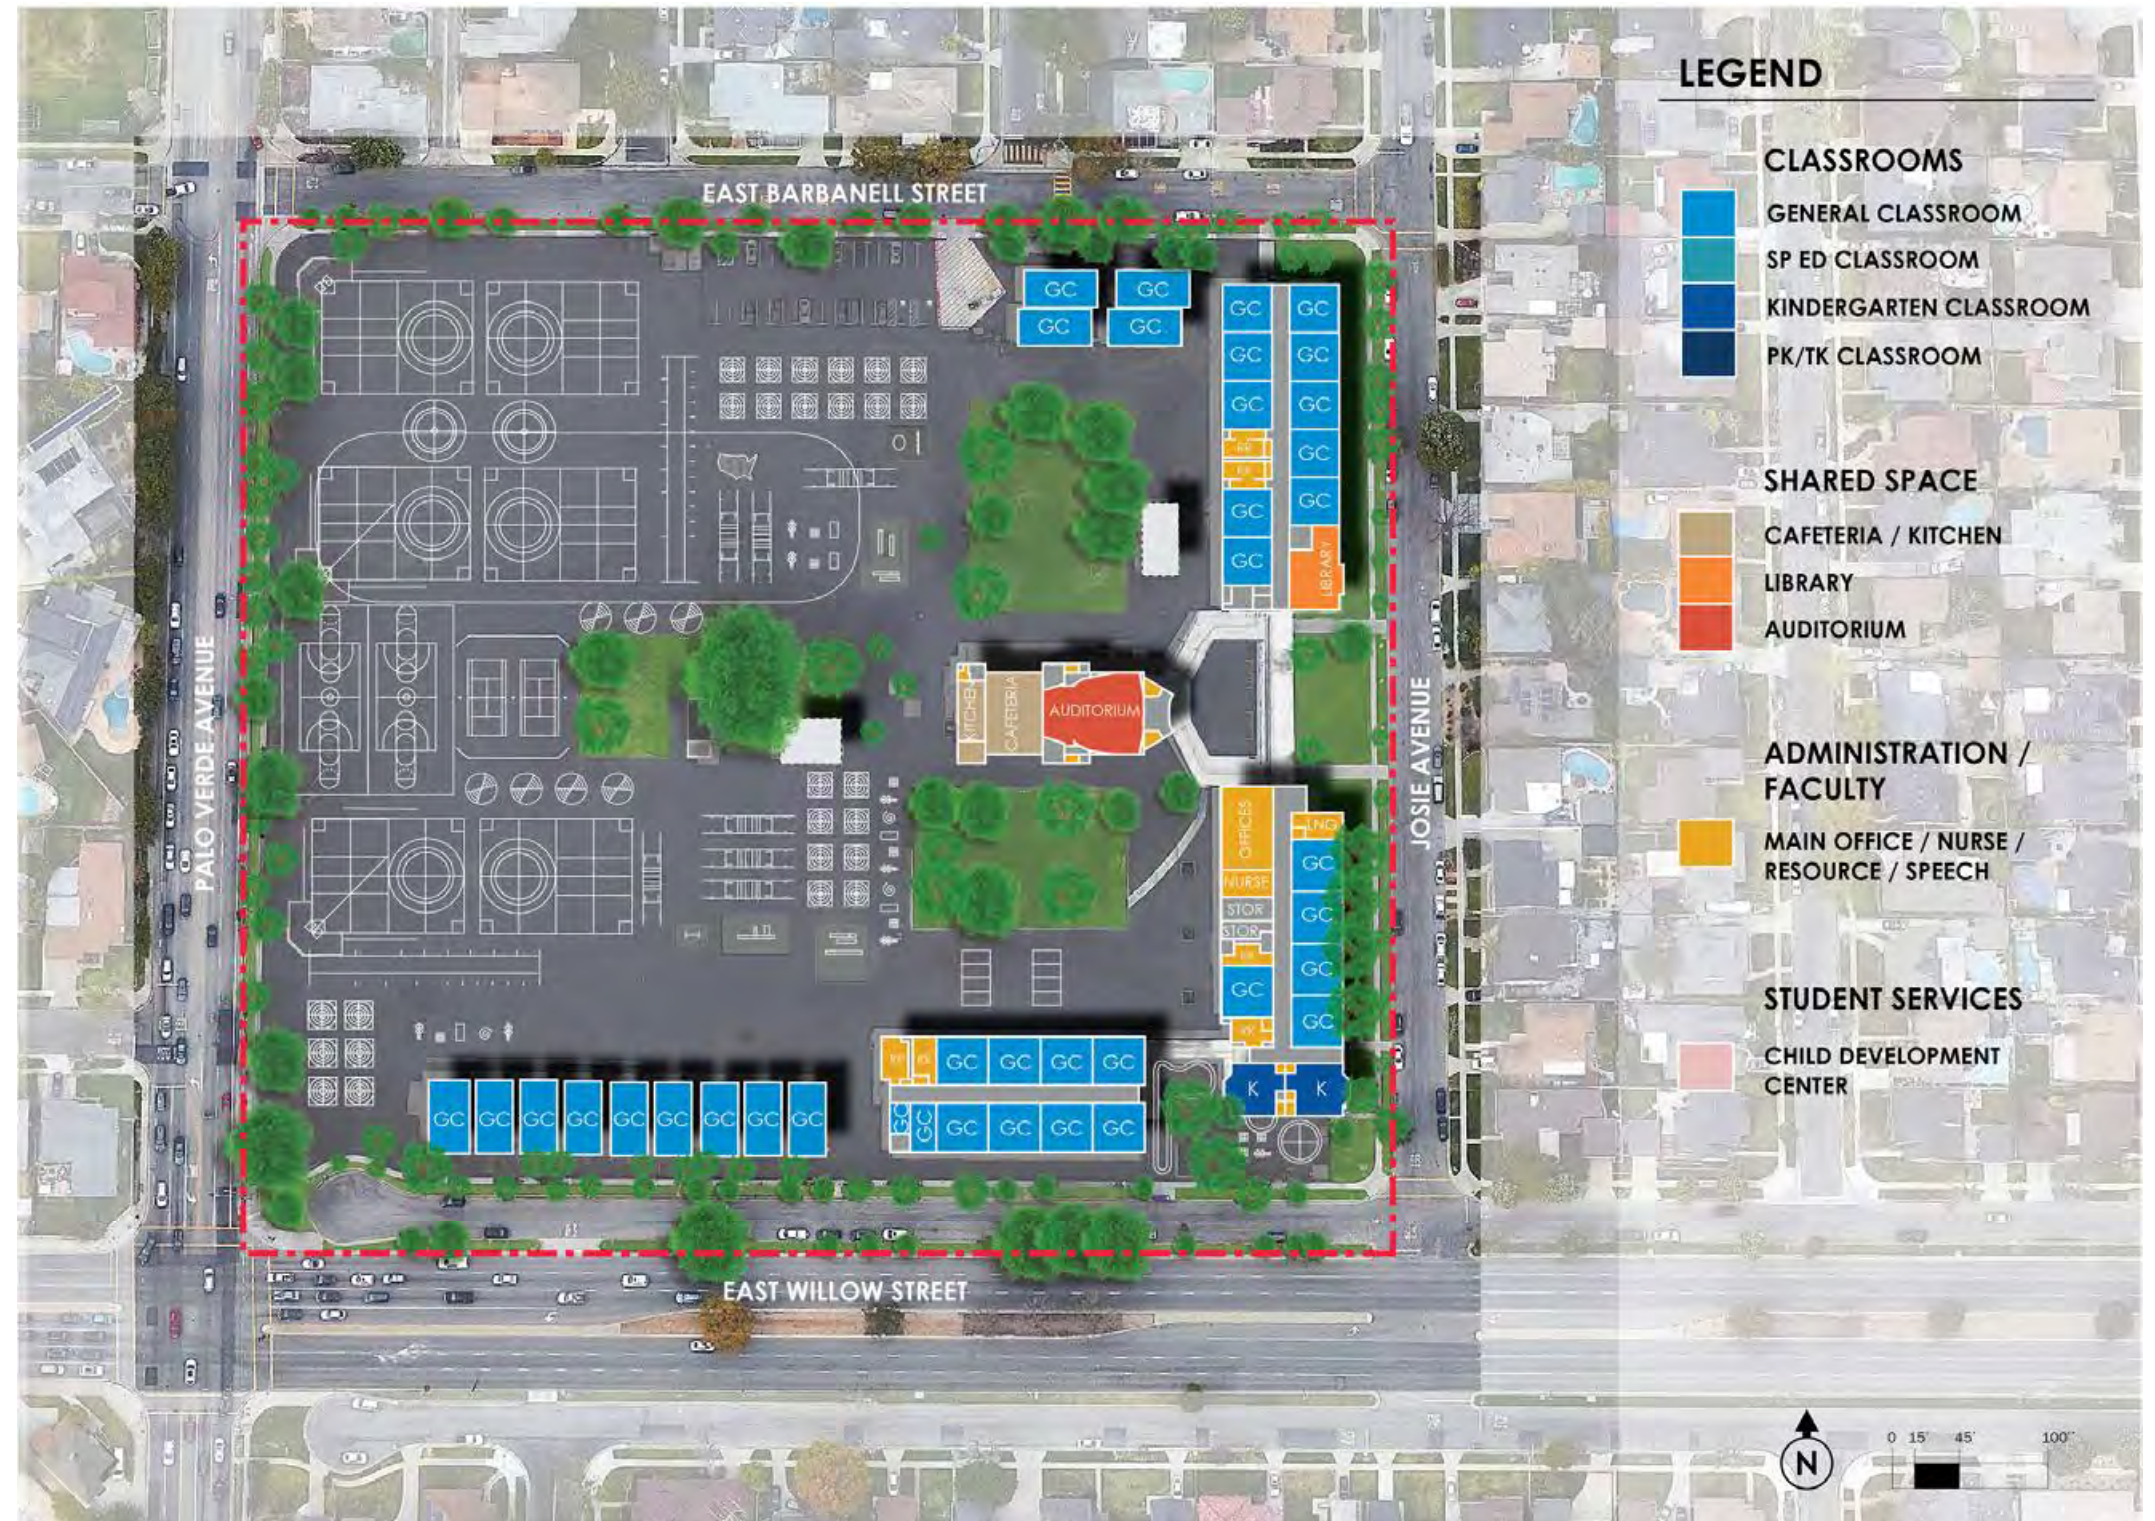
Emerson Parkside Academy School – Nutrition Services Plan 2022-2032

At 729 square feet (including the Dry Storage area), the Emerson Elementary School kitchen is undersized. The service line is accessed within the kitchen space. Though recently renovated as part of the LBUSD HVAC Construction project, the layout remained the same. Due to the size constraints of the kitchen, the service aisles for both the staff and the students are undersized and do not meet ADA requirements. Refrigeration is accommodated by a walk-in cooler and freezer. These units were locked at the time of site visit and therefore cannot be evaluated. The walk-ins are supplemented with (2) self-contained refrigerators and a milk cooler within the kitchen space and an additional milk cooler in the cafeteria. The air curtains in both the kitchen and cafeteria are full width and plunger activated. There is an employee hand sink and a dedicated food preparation sink within the kitchen space. This site would benefit from a prototype design to address EHS and DSA code compliance issues and provide an equipment package to meet current and future CNS needs.

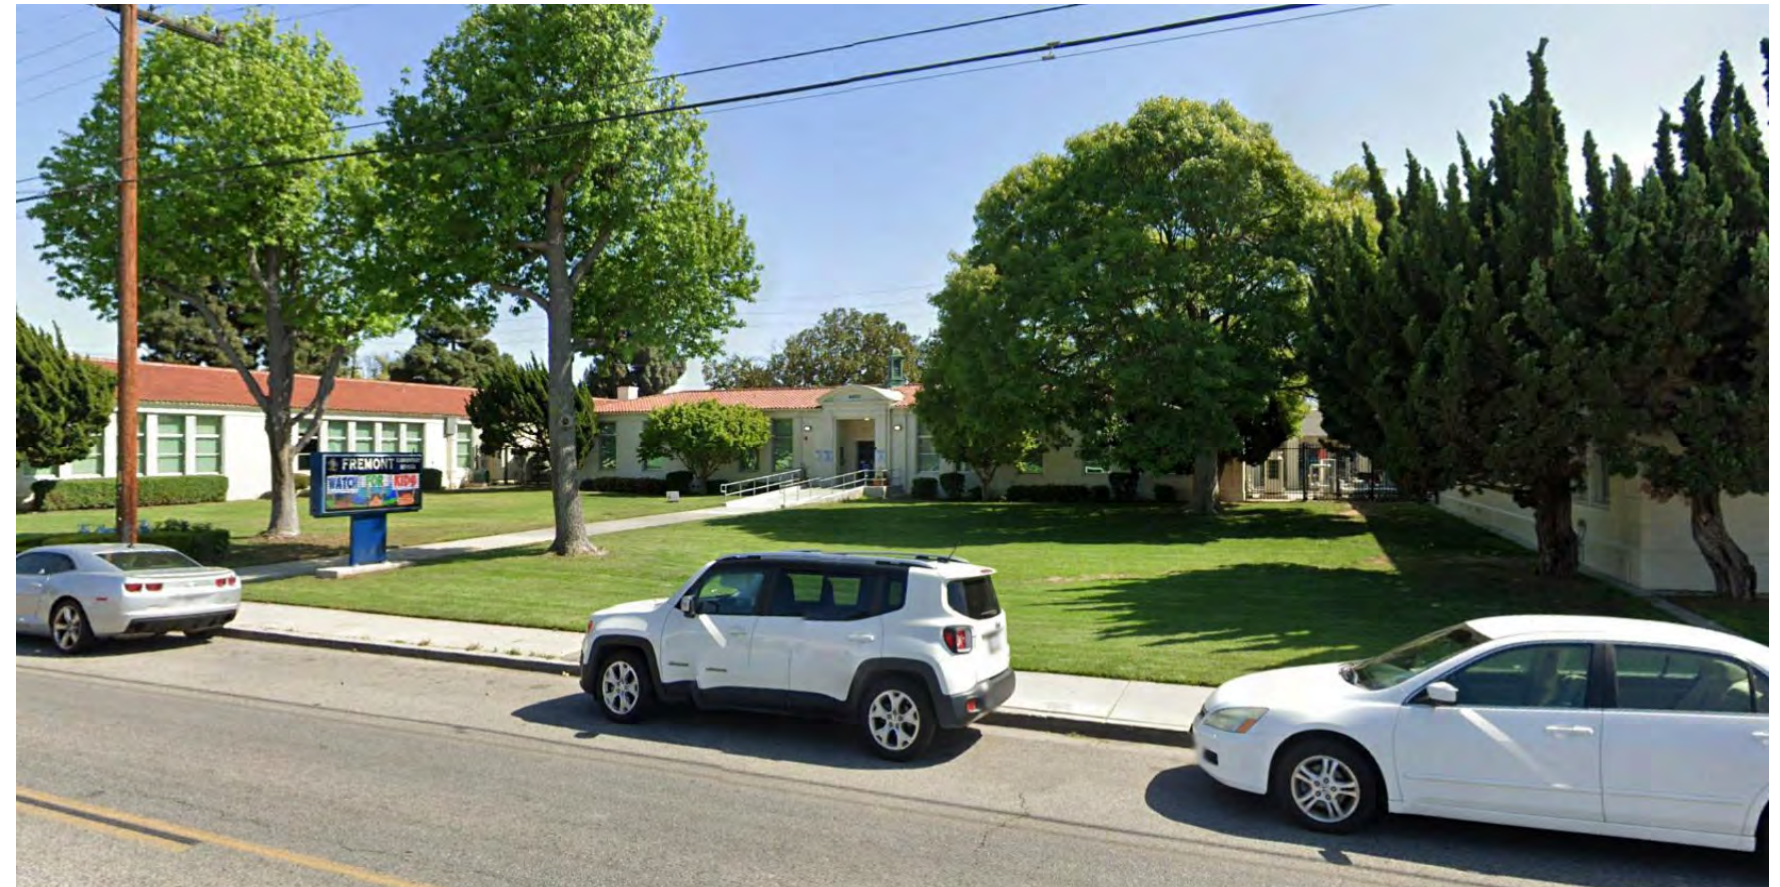
John C. Fremont Elementary School – Existing Campus

- (A) Inadequate secured parking from play area
- (B) ADA compliant parking to front door

- (E) Visibility of outdoor Kinder play from street
- (F) Lack of lawn/turf area at main play area
- (G) Lack of shade trees and canopies at play area
- (H) Difficult to read ground games / lack light-colored surfaces
- (J) Significant large areas of blacktop without use of reflective paints to reduce heat island and improve quality of play

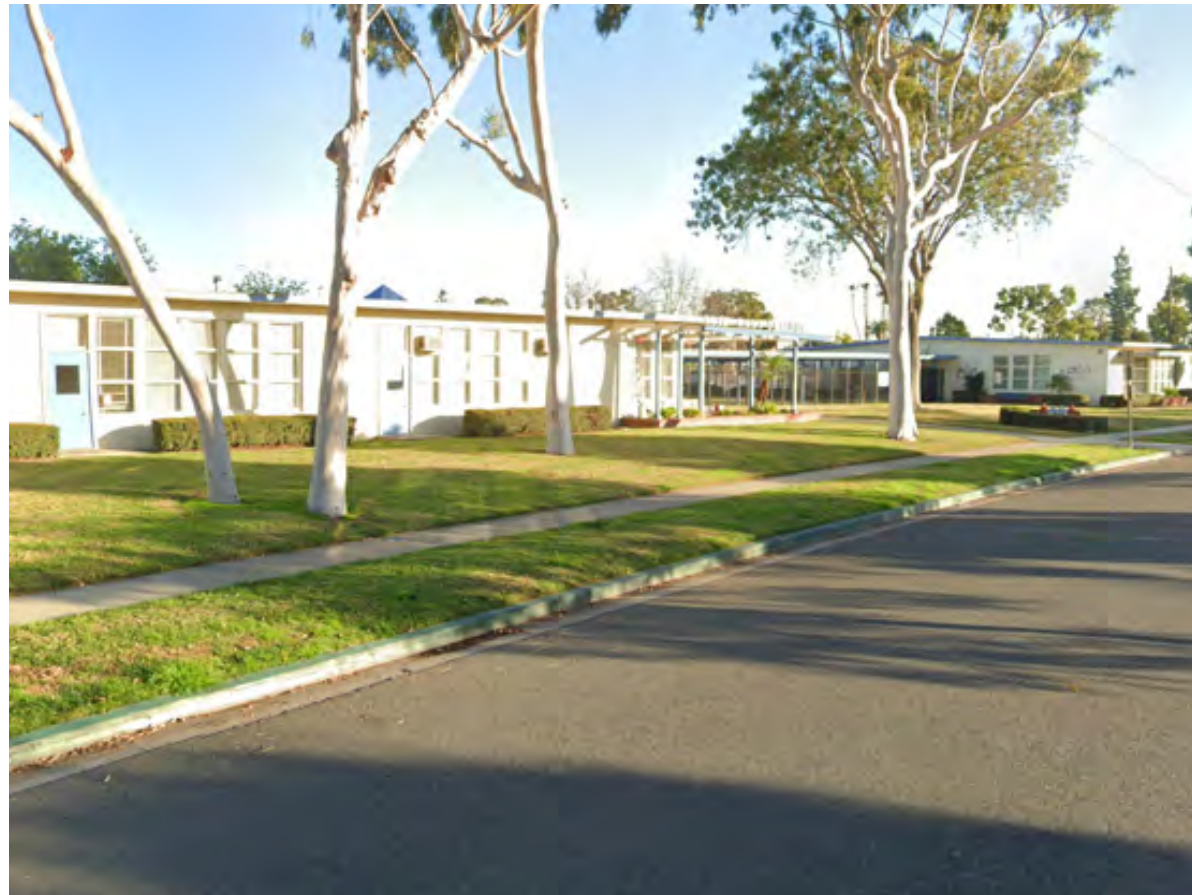
Minnie Gant Elementary School – Existing Campus

- D** Visibility of outdoor Kinder play from street
- E** Lack of adequate shade trees and canopies at play area
- F** Difficult to read ground games / lack light-colored surfaces
- G** Significant large areas of blacktop without use of reflective paints to reduce heat island and improve quality of play
