LBUSD 2022 Facility Master Plan

Long Beach Unified School District
Appendices

July 2022

A Facility Reports: Elementary Schools

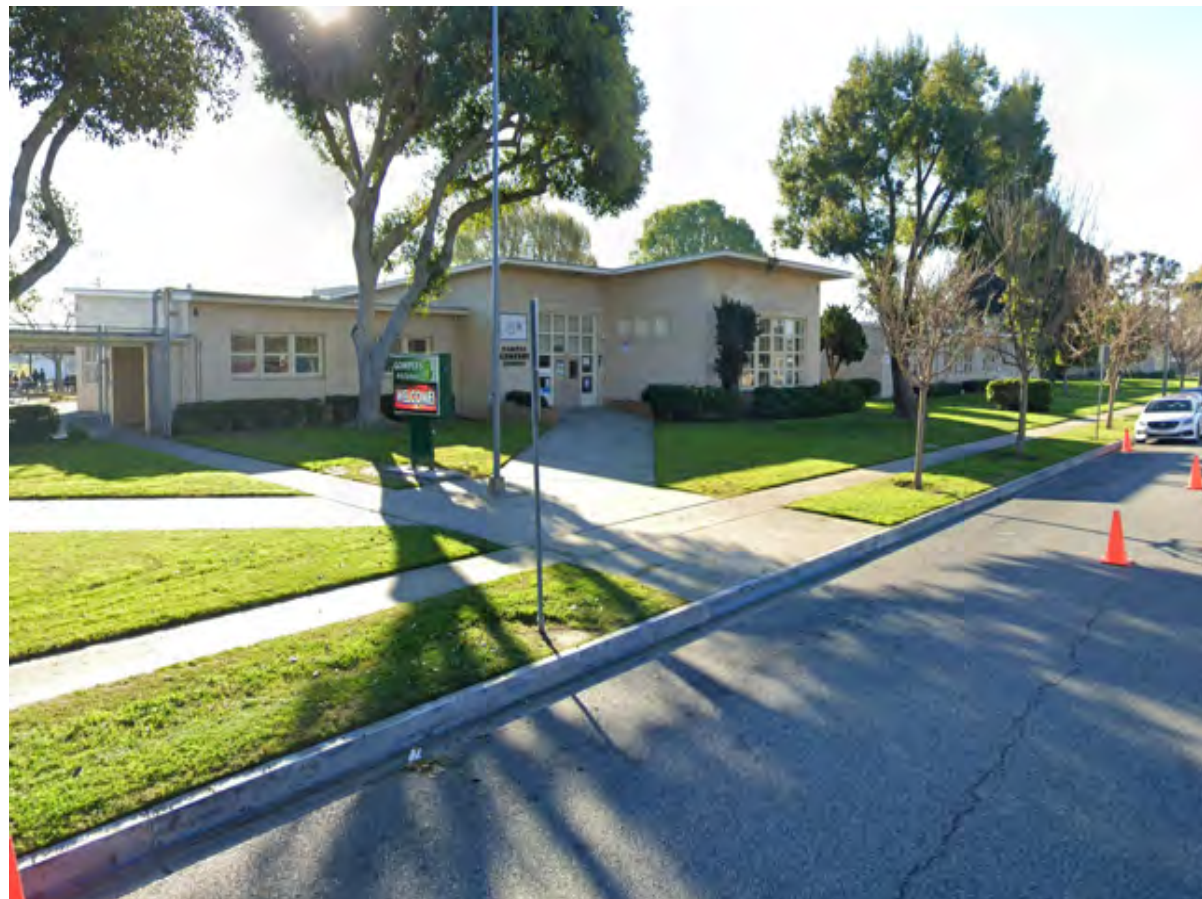
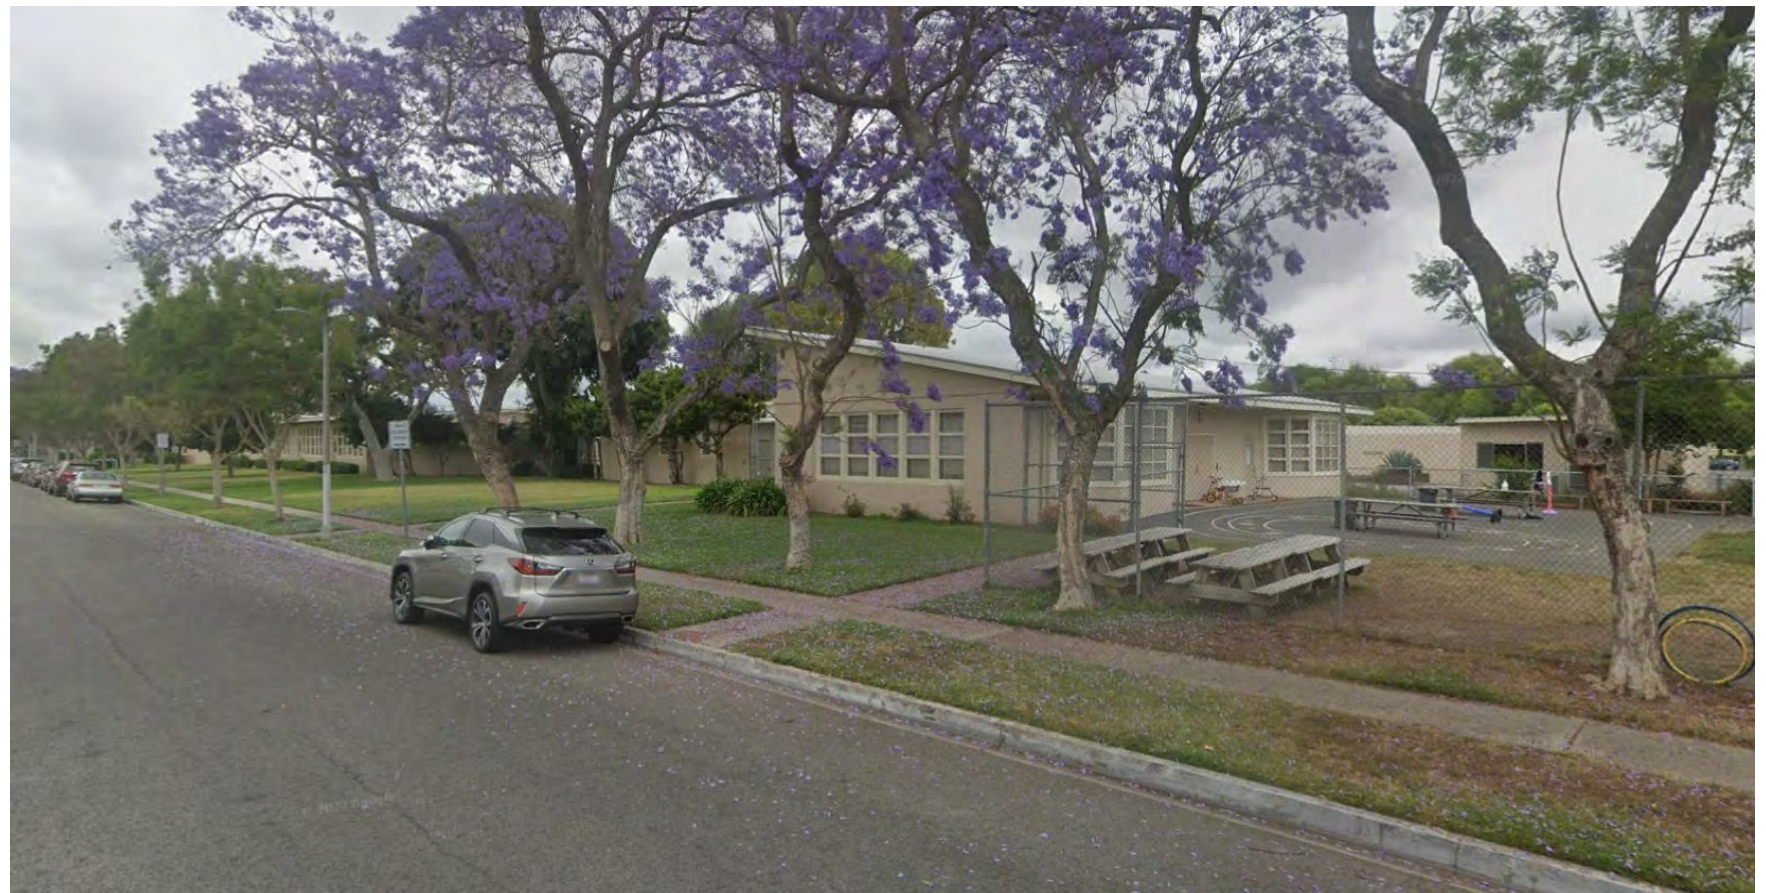
Samuel Gompers Elementary School – Existing Campus

- F** Visibility of outdoor Kinder play from street
- G** Lack of adequate lawn/turf area at main play area
- H** Lack of shade trees and canopies at play area
- J** Significant large areas of blacktop without use of reflective paints to reduce heat island and improve quality of play

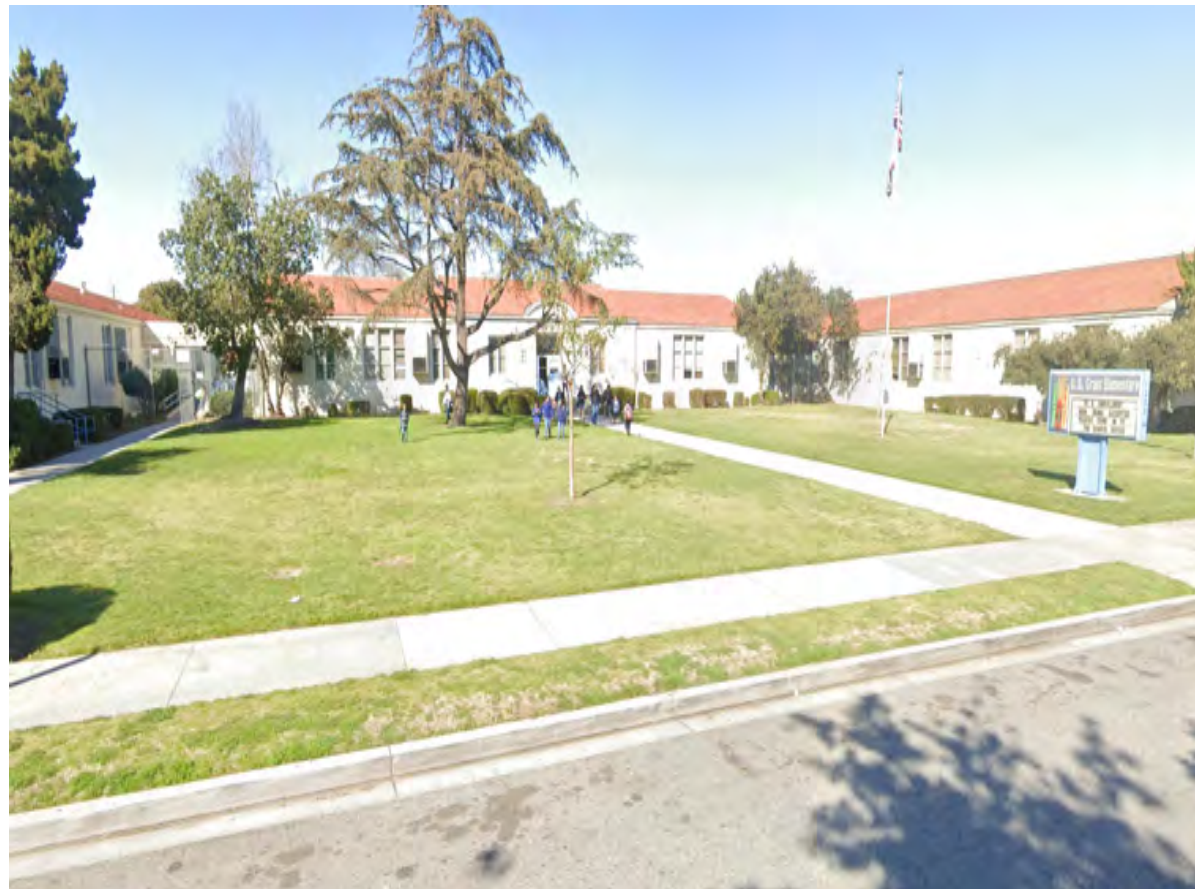
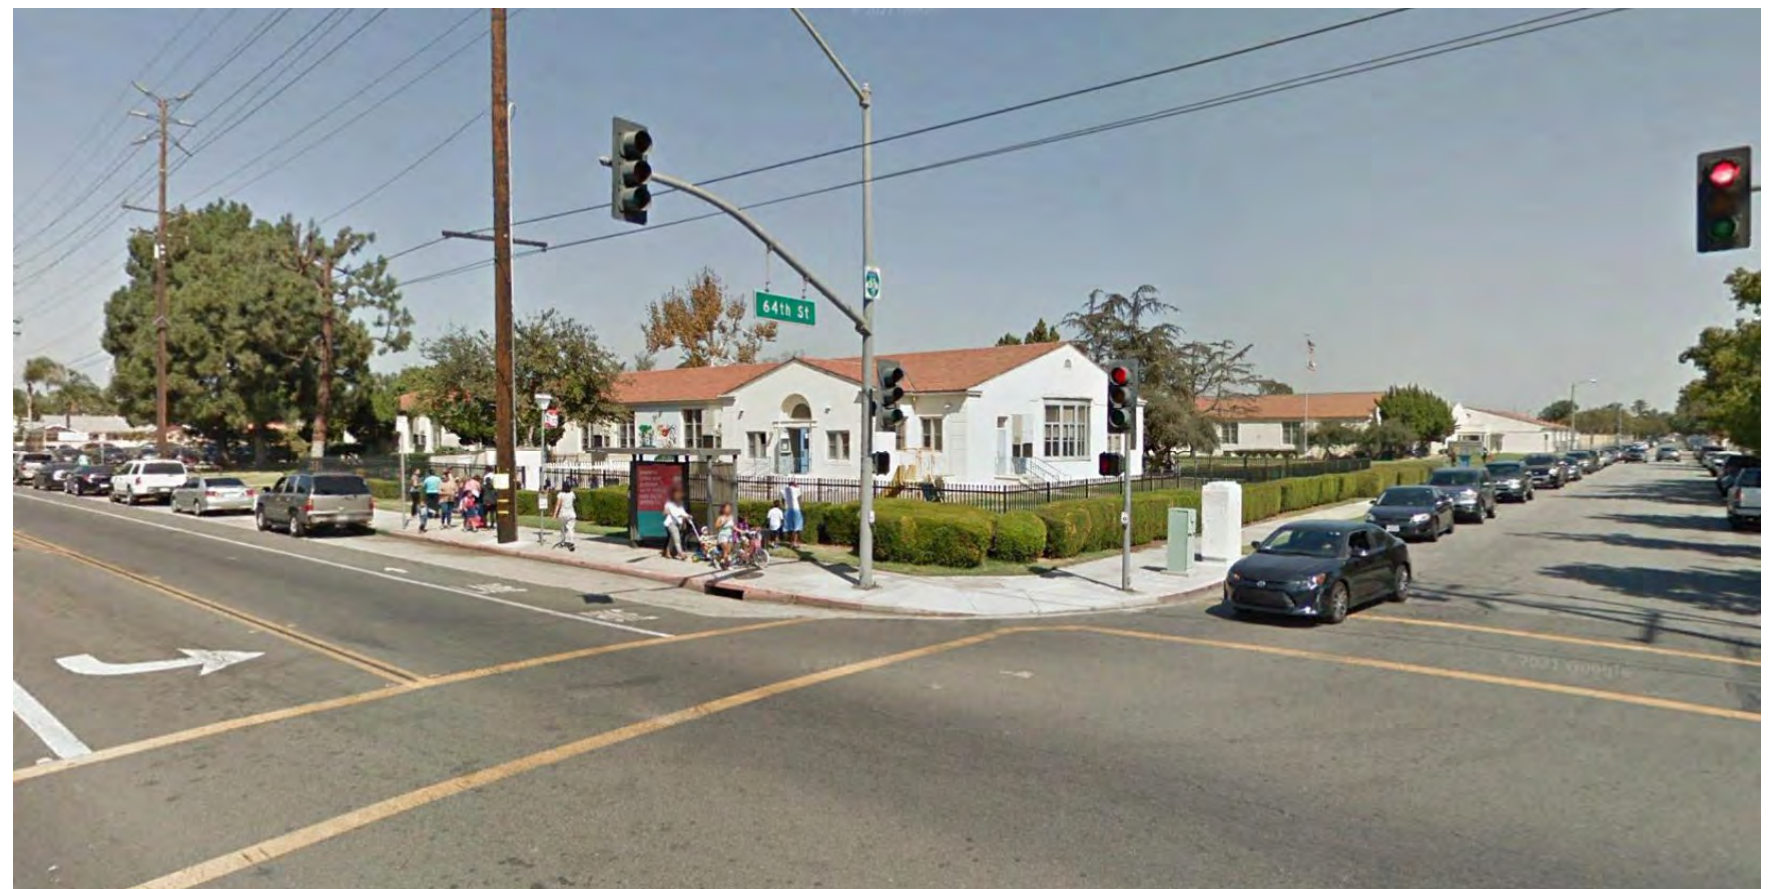
Ulysses S. Grant Elementary School – Existing Campus

- E** Visibility of outdoor Kinder play from street
- F** Lack of adequate lawn/turf area at main play area
- G** Lack of shade trees and canopies at main play area
- H** Significant large areas of blacktop without use of reflective paints to reduce heat island and improve quality of play

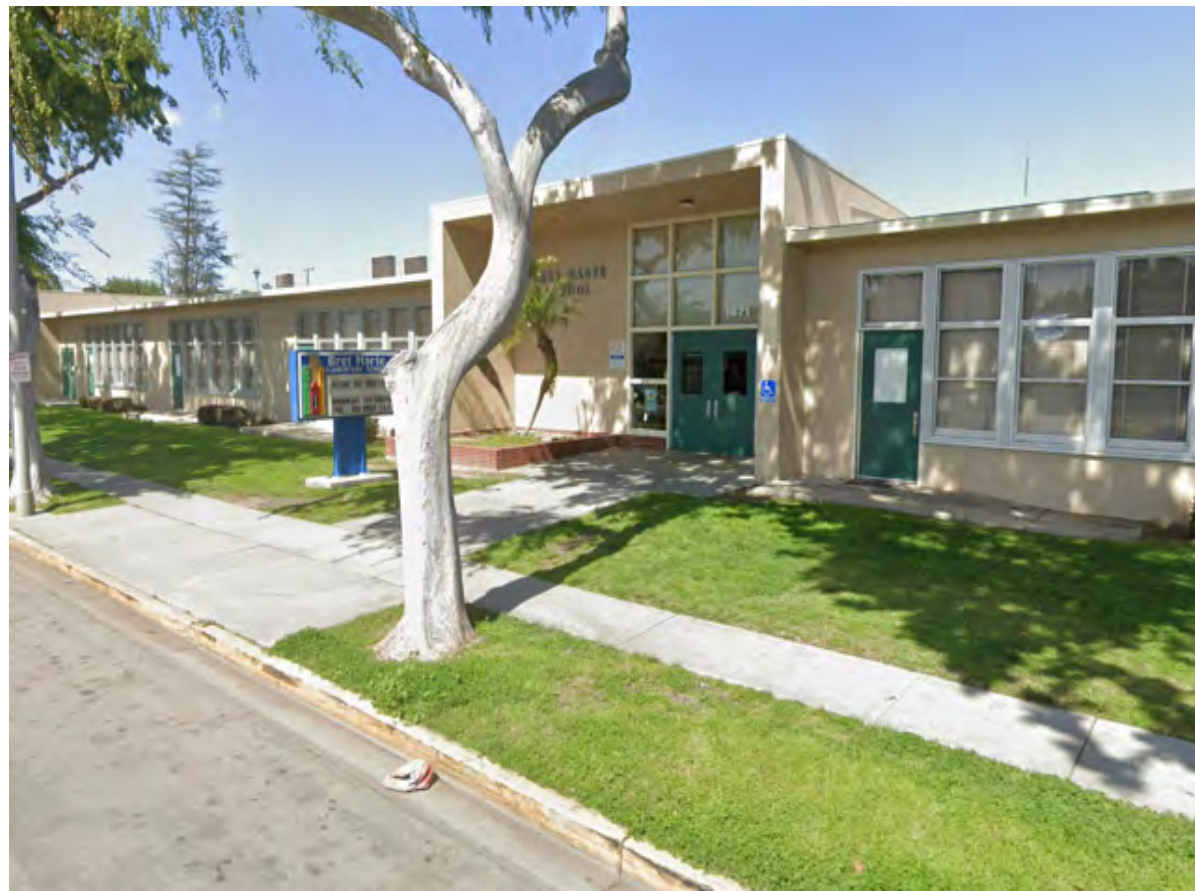
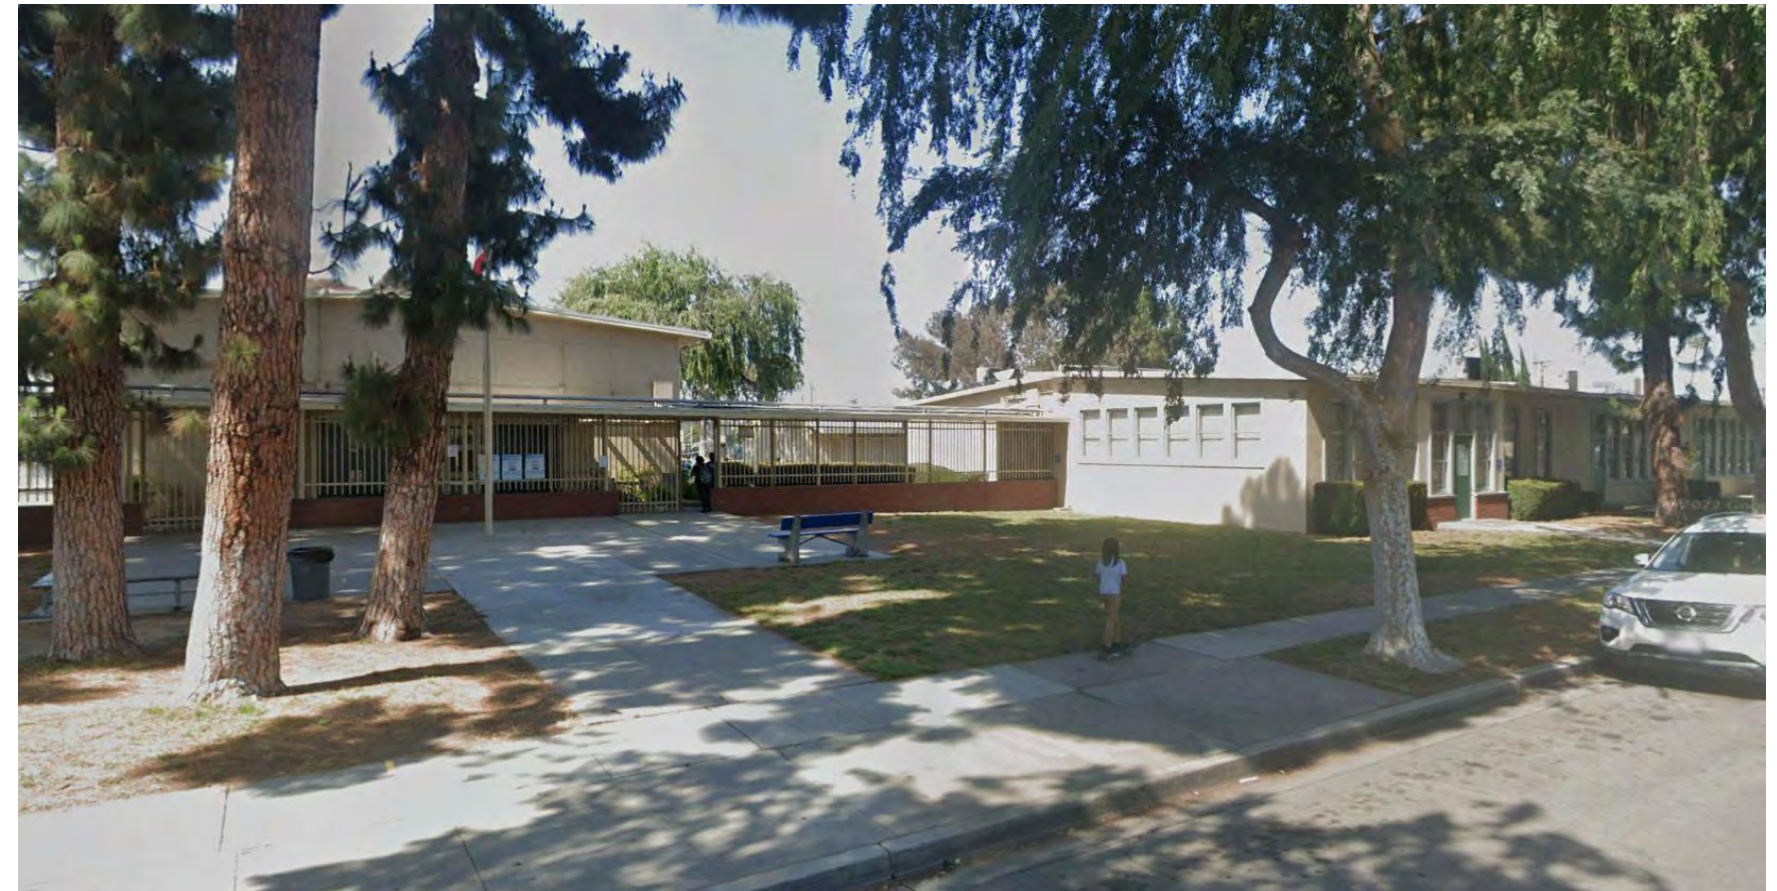
Bret Harte Elementary School – Existing Campus

- F** Visibility of outdoor PK/Kinder play from street
- G** Lack of adequate lawn/turf area at main play area
- H** Lack of shade trees and canopies at main play area
- J** Significant large areas of blacktop without use of reflective paints to reduce heat island and improve quality of play

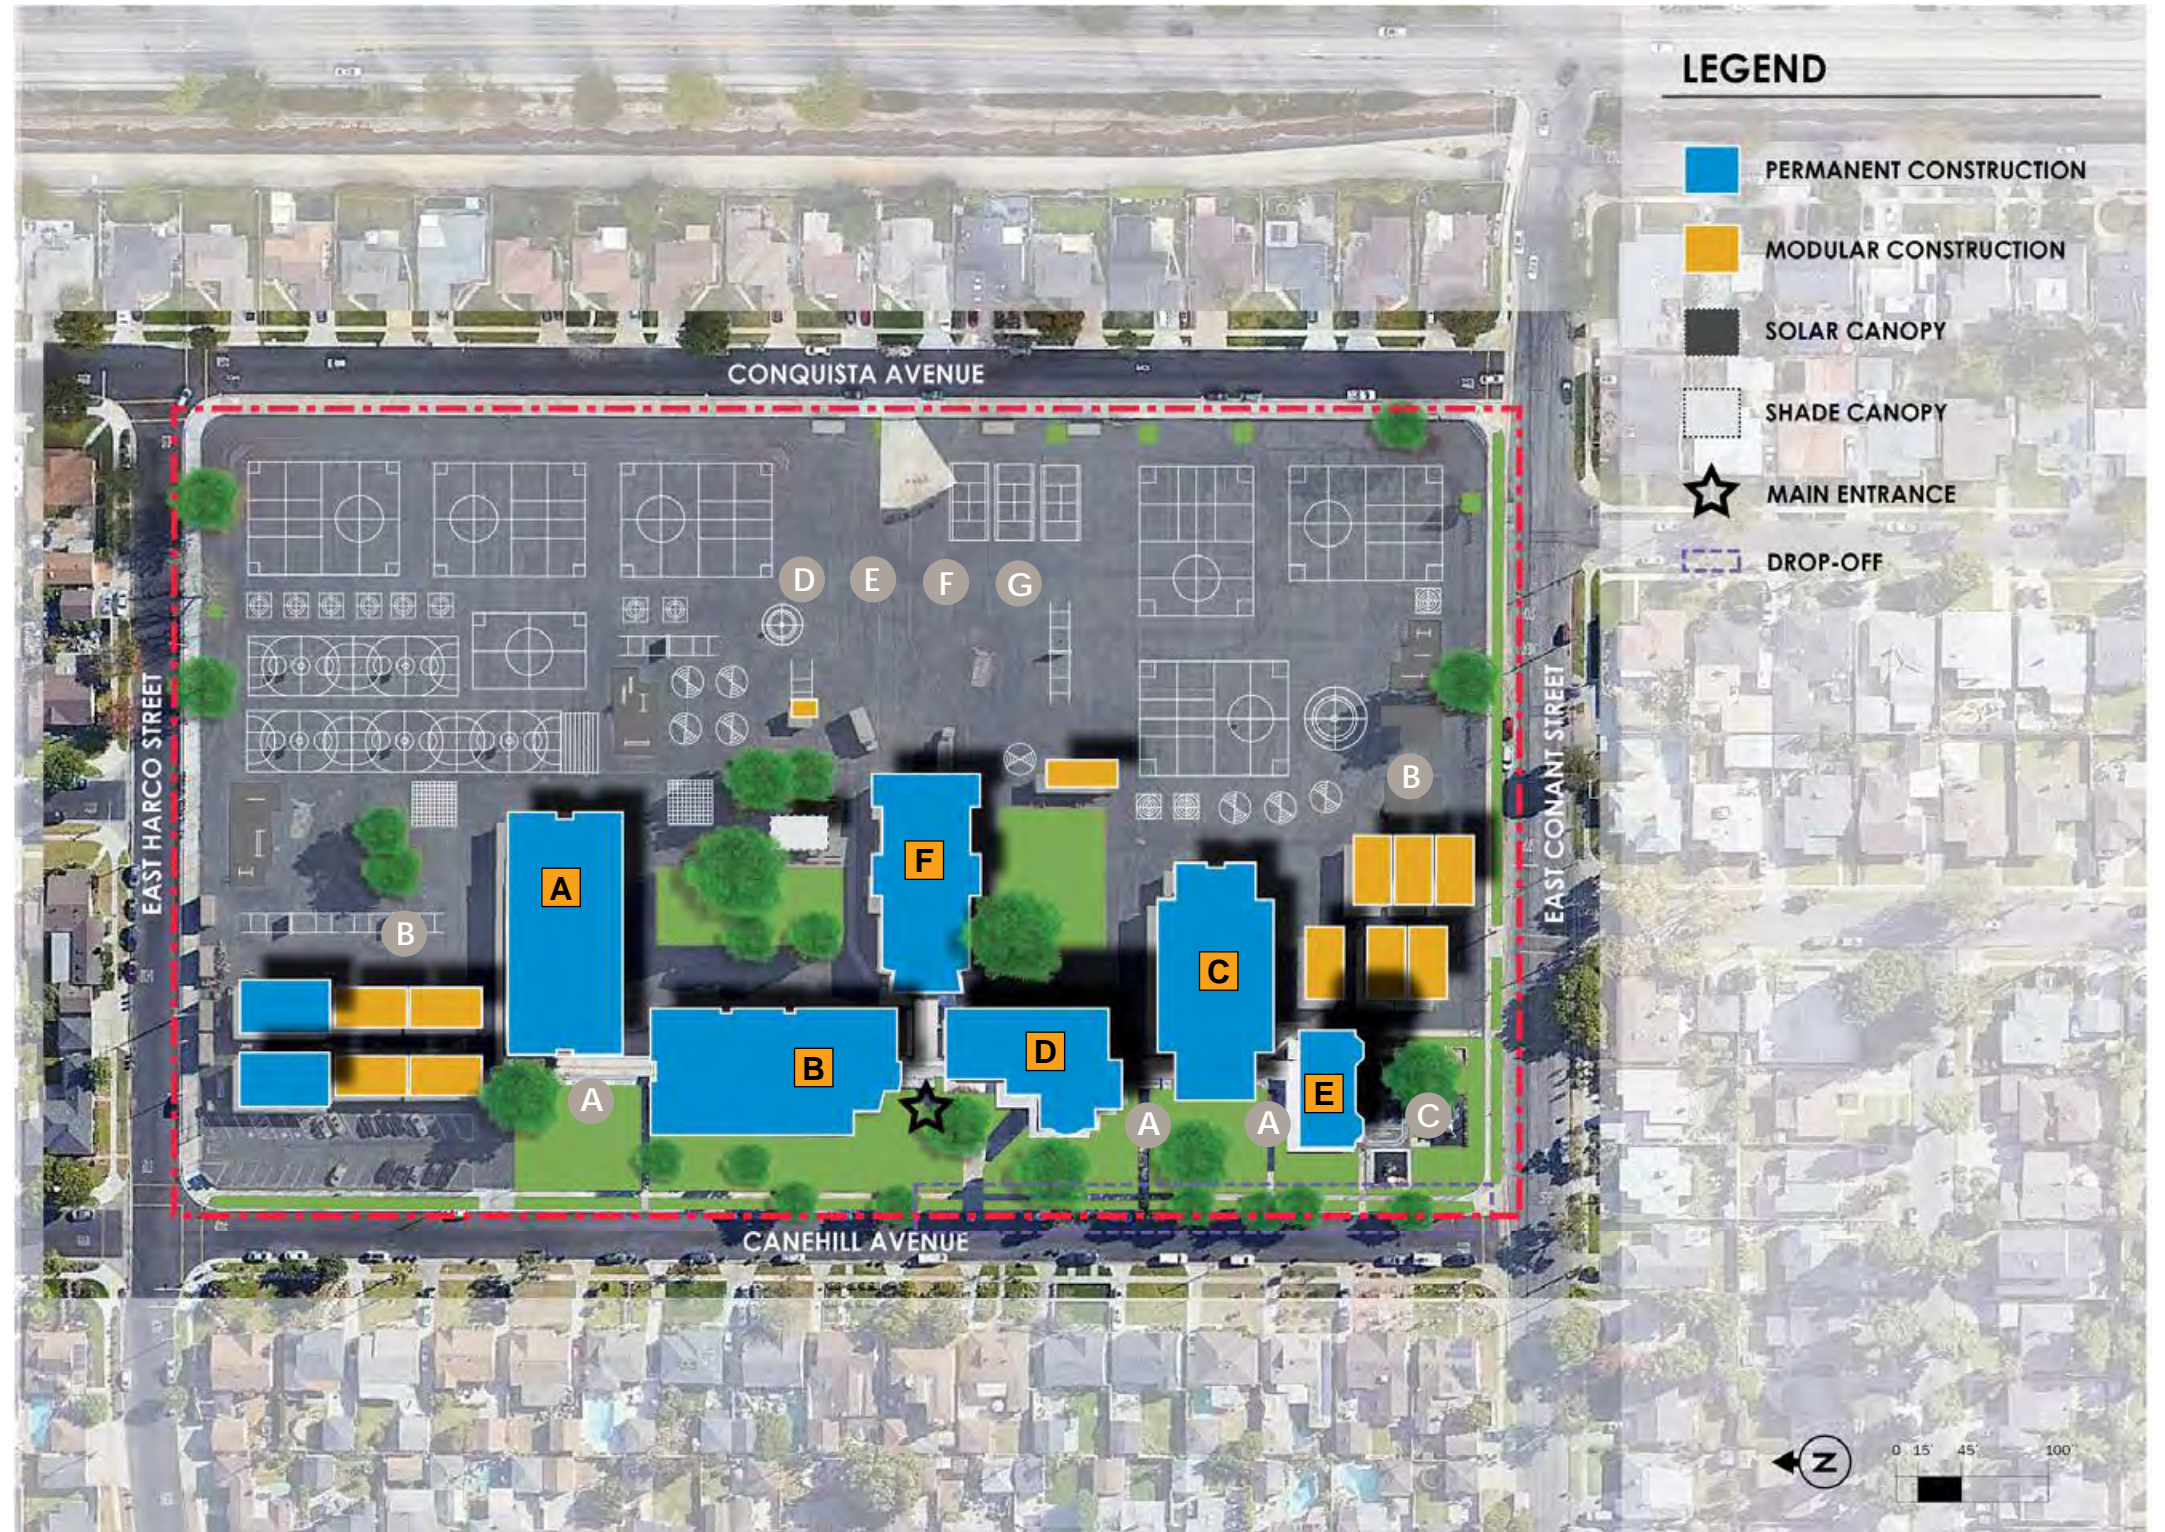
F Difficult to read ground games / lack light-colored surfaces

G Significant large areas of blacktop without use of reflective paints to reduce heat island and improve quality of play

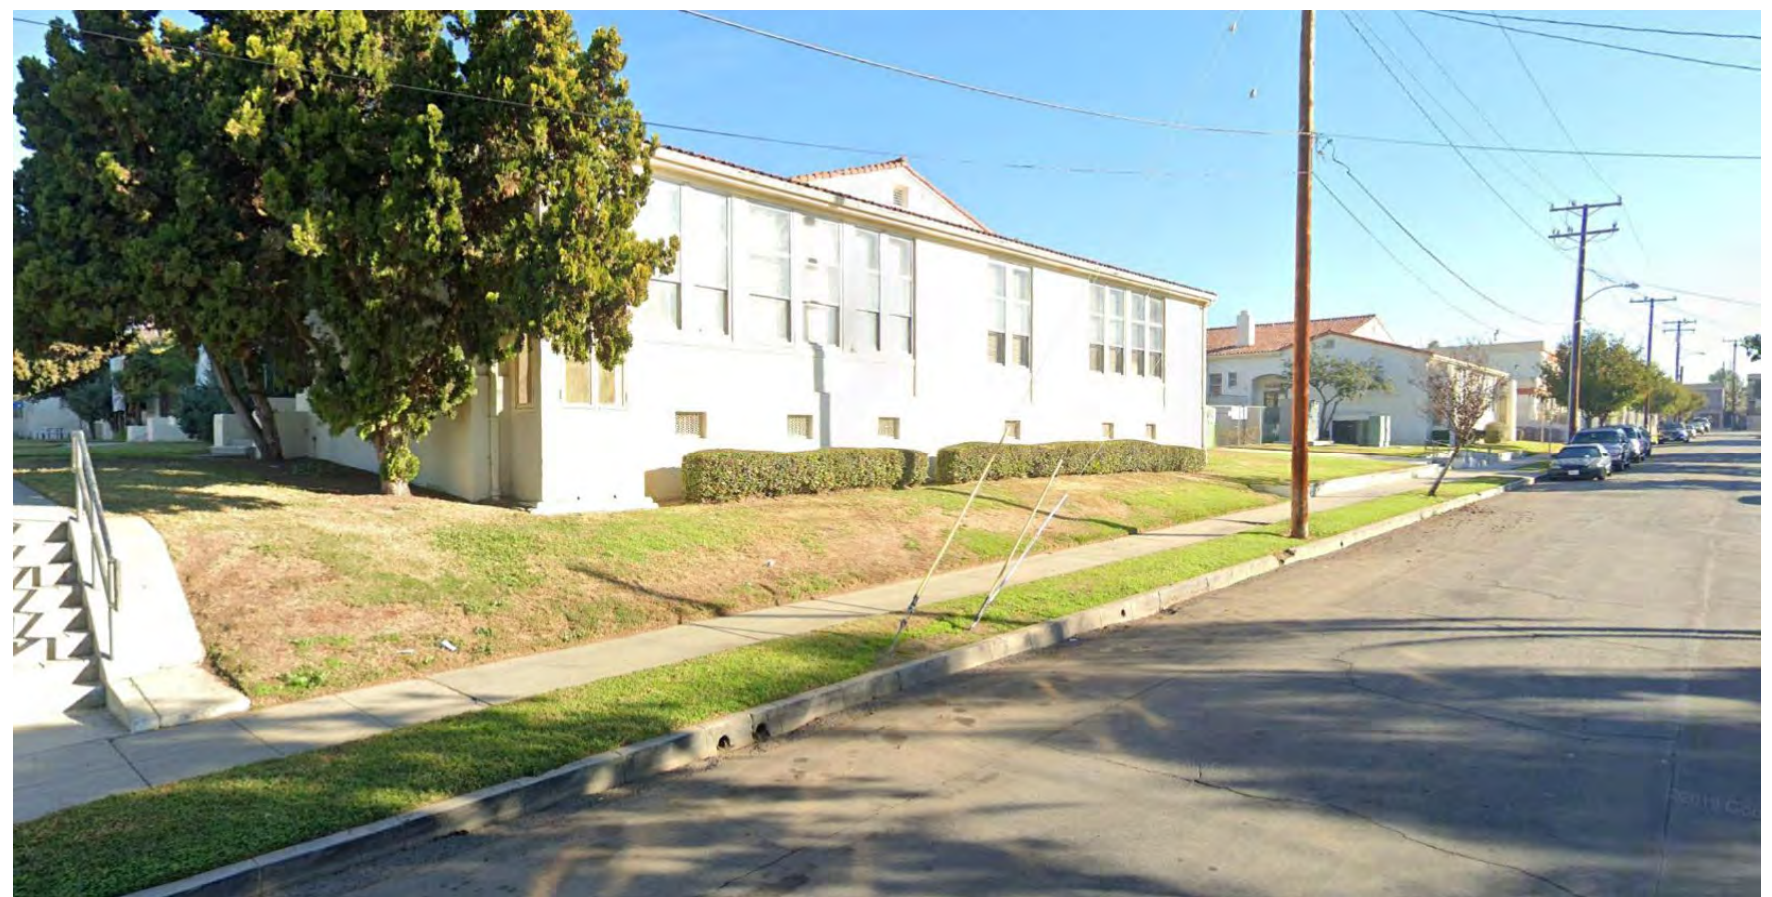
Nieto Herrera Elementary School – Existing Campus

- A** Inadequate parking count and lack of parking for visitors
- B** ADA compliance to front door

- F** Visibility of outdoor Kinder play from street
- G** Significant large areas of blacktop without use of reflective paints to reduce heat island and improve quality of play

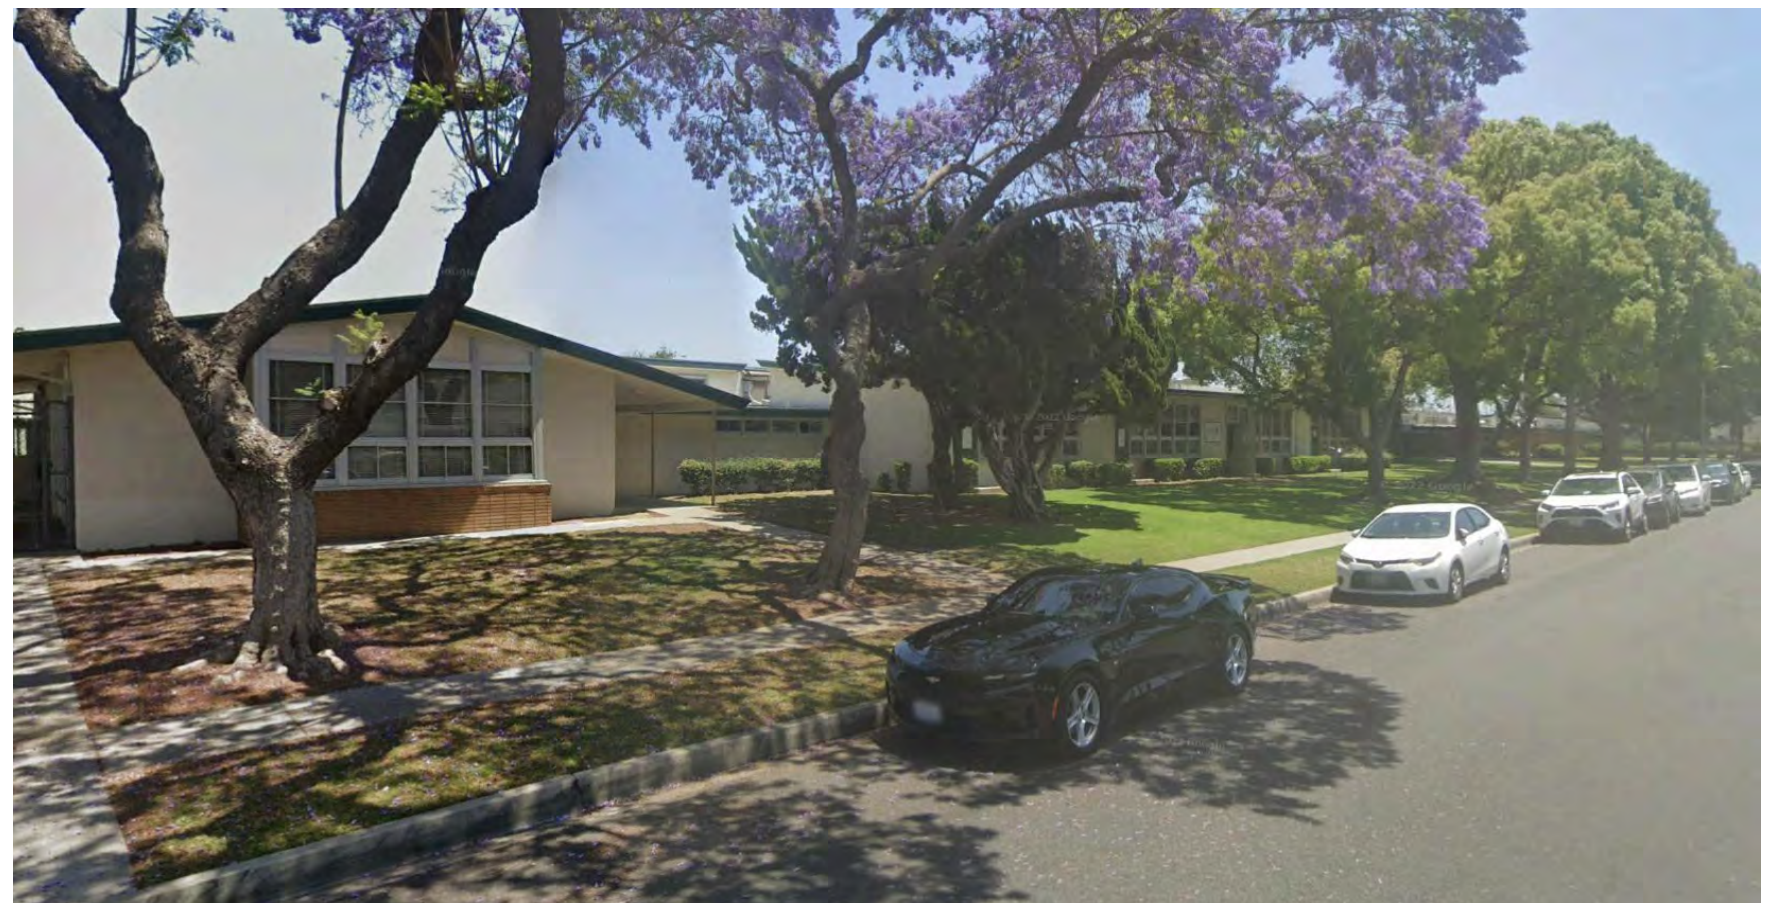
Oliver Wendell Holmes Elementary School – Existing Campus

K Lack of shade trees at play area

L Significant large areas of blacktop without use of reflective paints to reduce heat island and improve quality of play

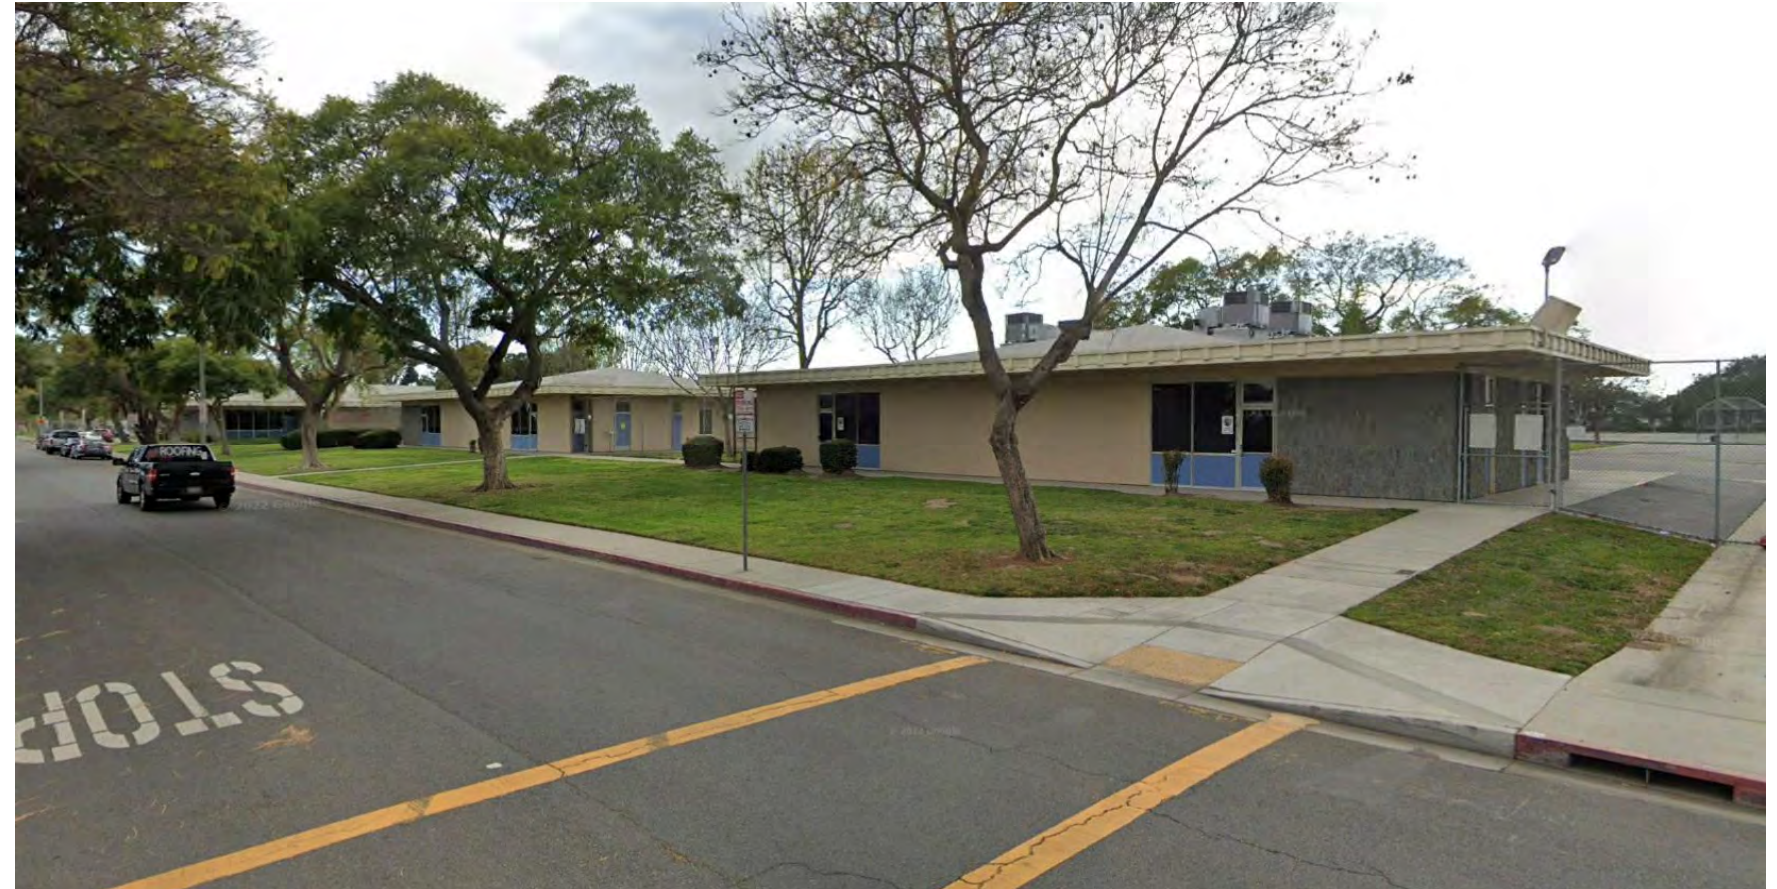
Elizabeth Hudson Elementary School – Existing Campus

- A** Significant large areas of blacktop without use of reflective paints to reduce heat island and improve quality of play

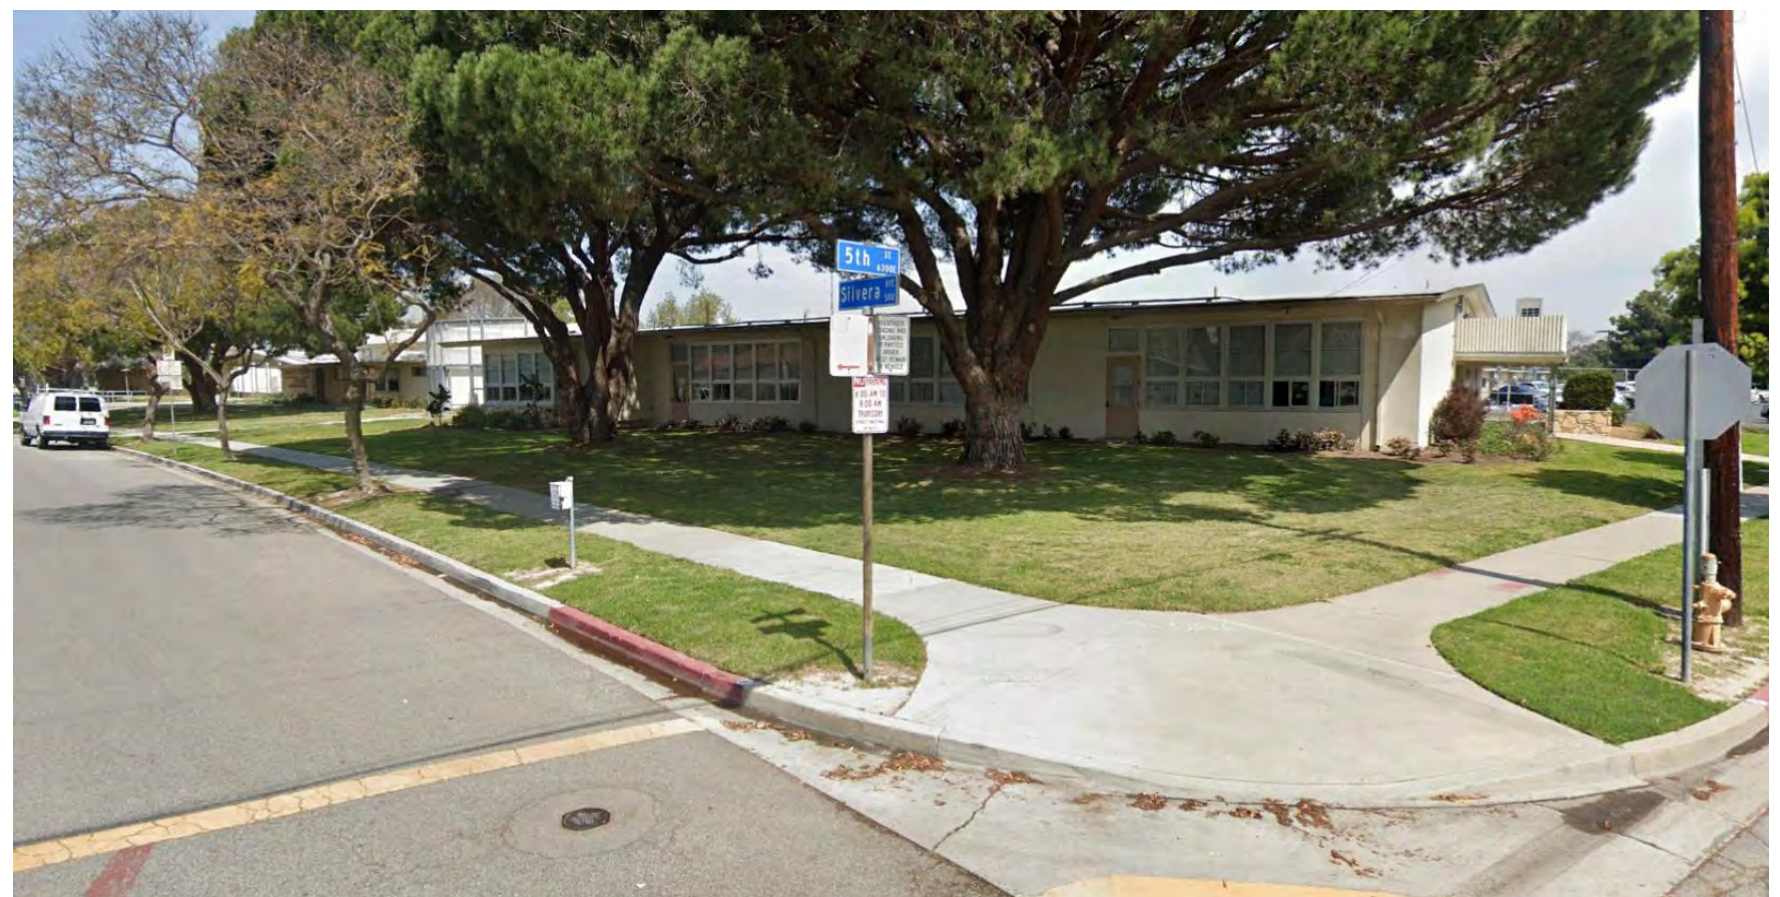
Charles F. Kettering Elementary School – Existing Campus

C Lack of shade trees at play area

D Significant large areas of blacktop without use of reflective paints to reduce heat island and improve quality of play

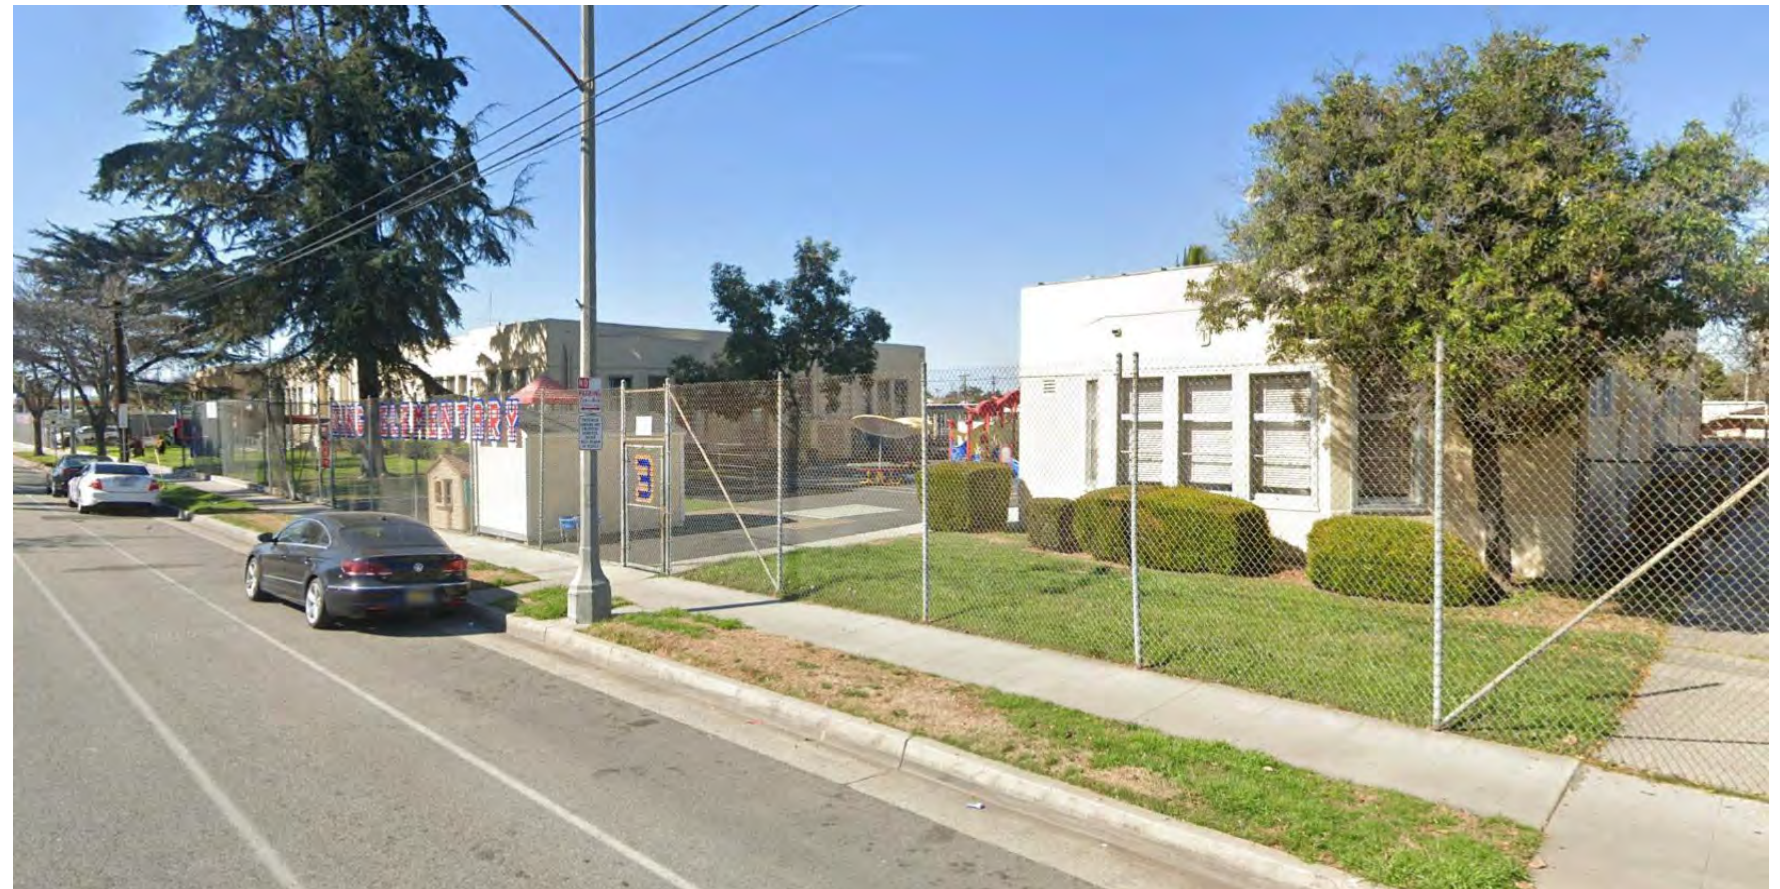
Starr King Elementary School – Existing Campus

- E** Visibility of outdoor Kinder play from street
- F** Lack of lawn/turf area at main play area
- G** Lack of adequate apparatus play zone for younger learners
- H** Lack of shade trees at play area
- J** Difficult to read ground games / lack light-colored surfaces
- K** Significant large areas of blacktop without use of reflective paints to reduce heat island and improve quality of play

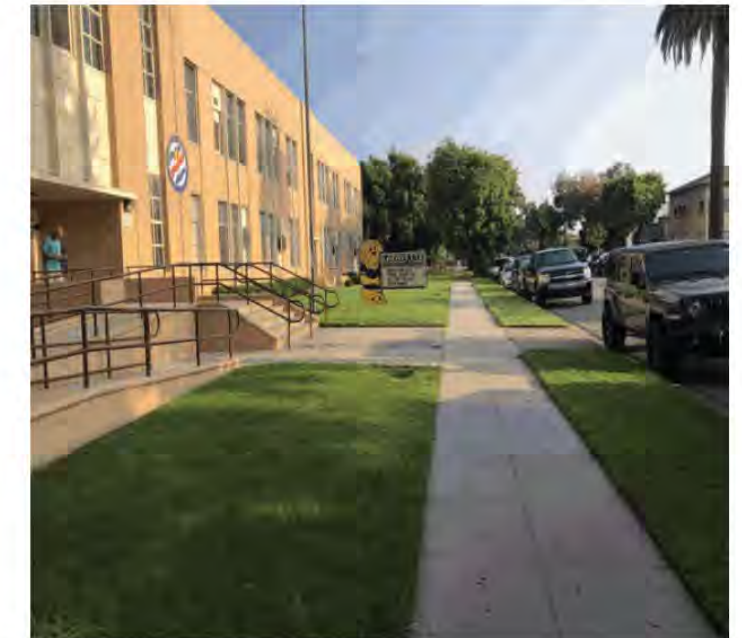
FACILITY CONDITION ASSESSMENT

Disciplines	5 Year DCI Score
Architectural	91
Plumbing	97
Mechanical	72
Fire Protection	91
Electrical	78
Communications	89
Safety and Security	100
Structural	94
5-YR FCI Score, buildings only:	
	88
Civil	100
5-YR FCI Score including Civil:	
	90

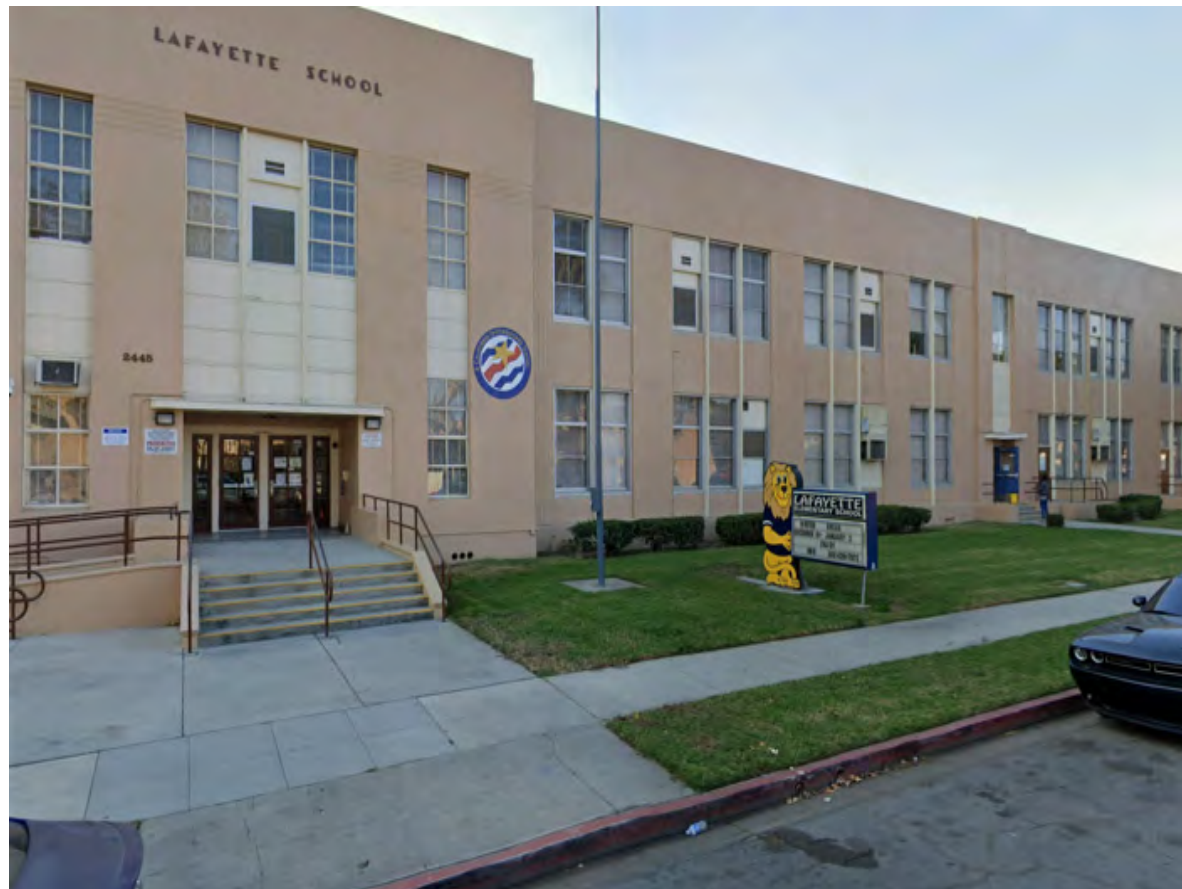
Lafayette Elementary School – Existing Campus

H Lack of shade trees at play area

J Significant large areas of blacktop without use of reflective paints to reduce heat island and improve quality of play
