LBUSD 2022 Facility Master Plan

Long Beach Unified School District
Appendices

July 2022

A Facility Reports: Elementary Schools

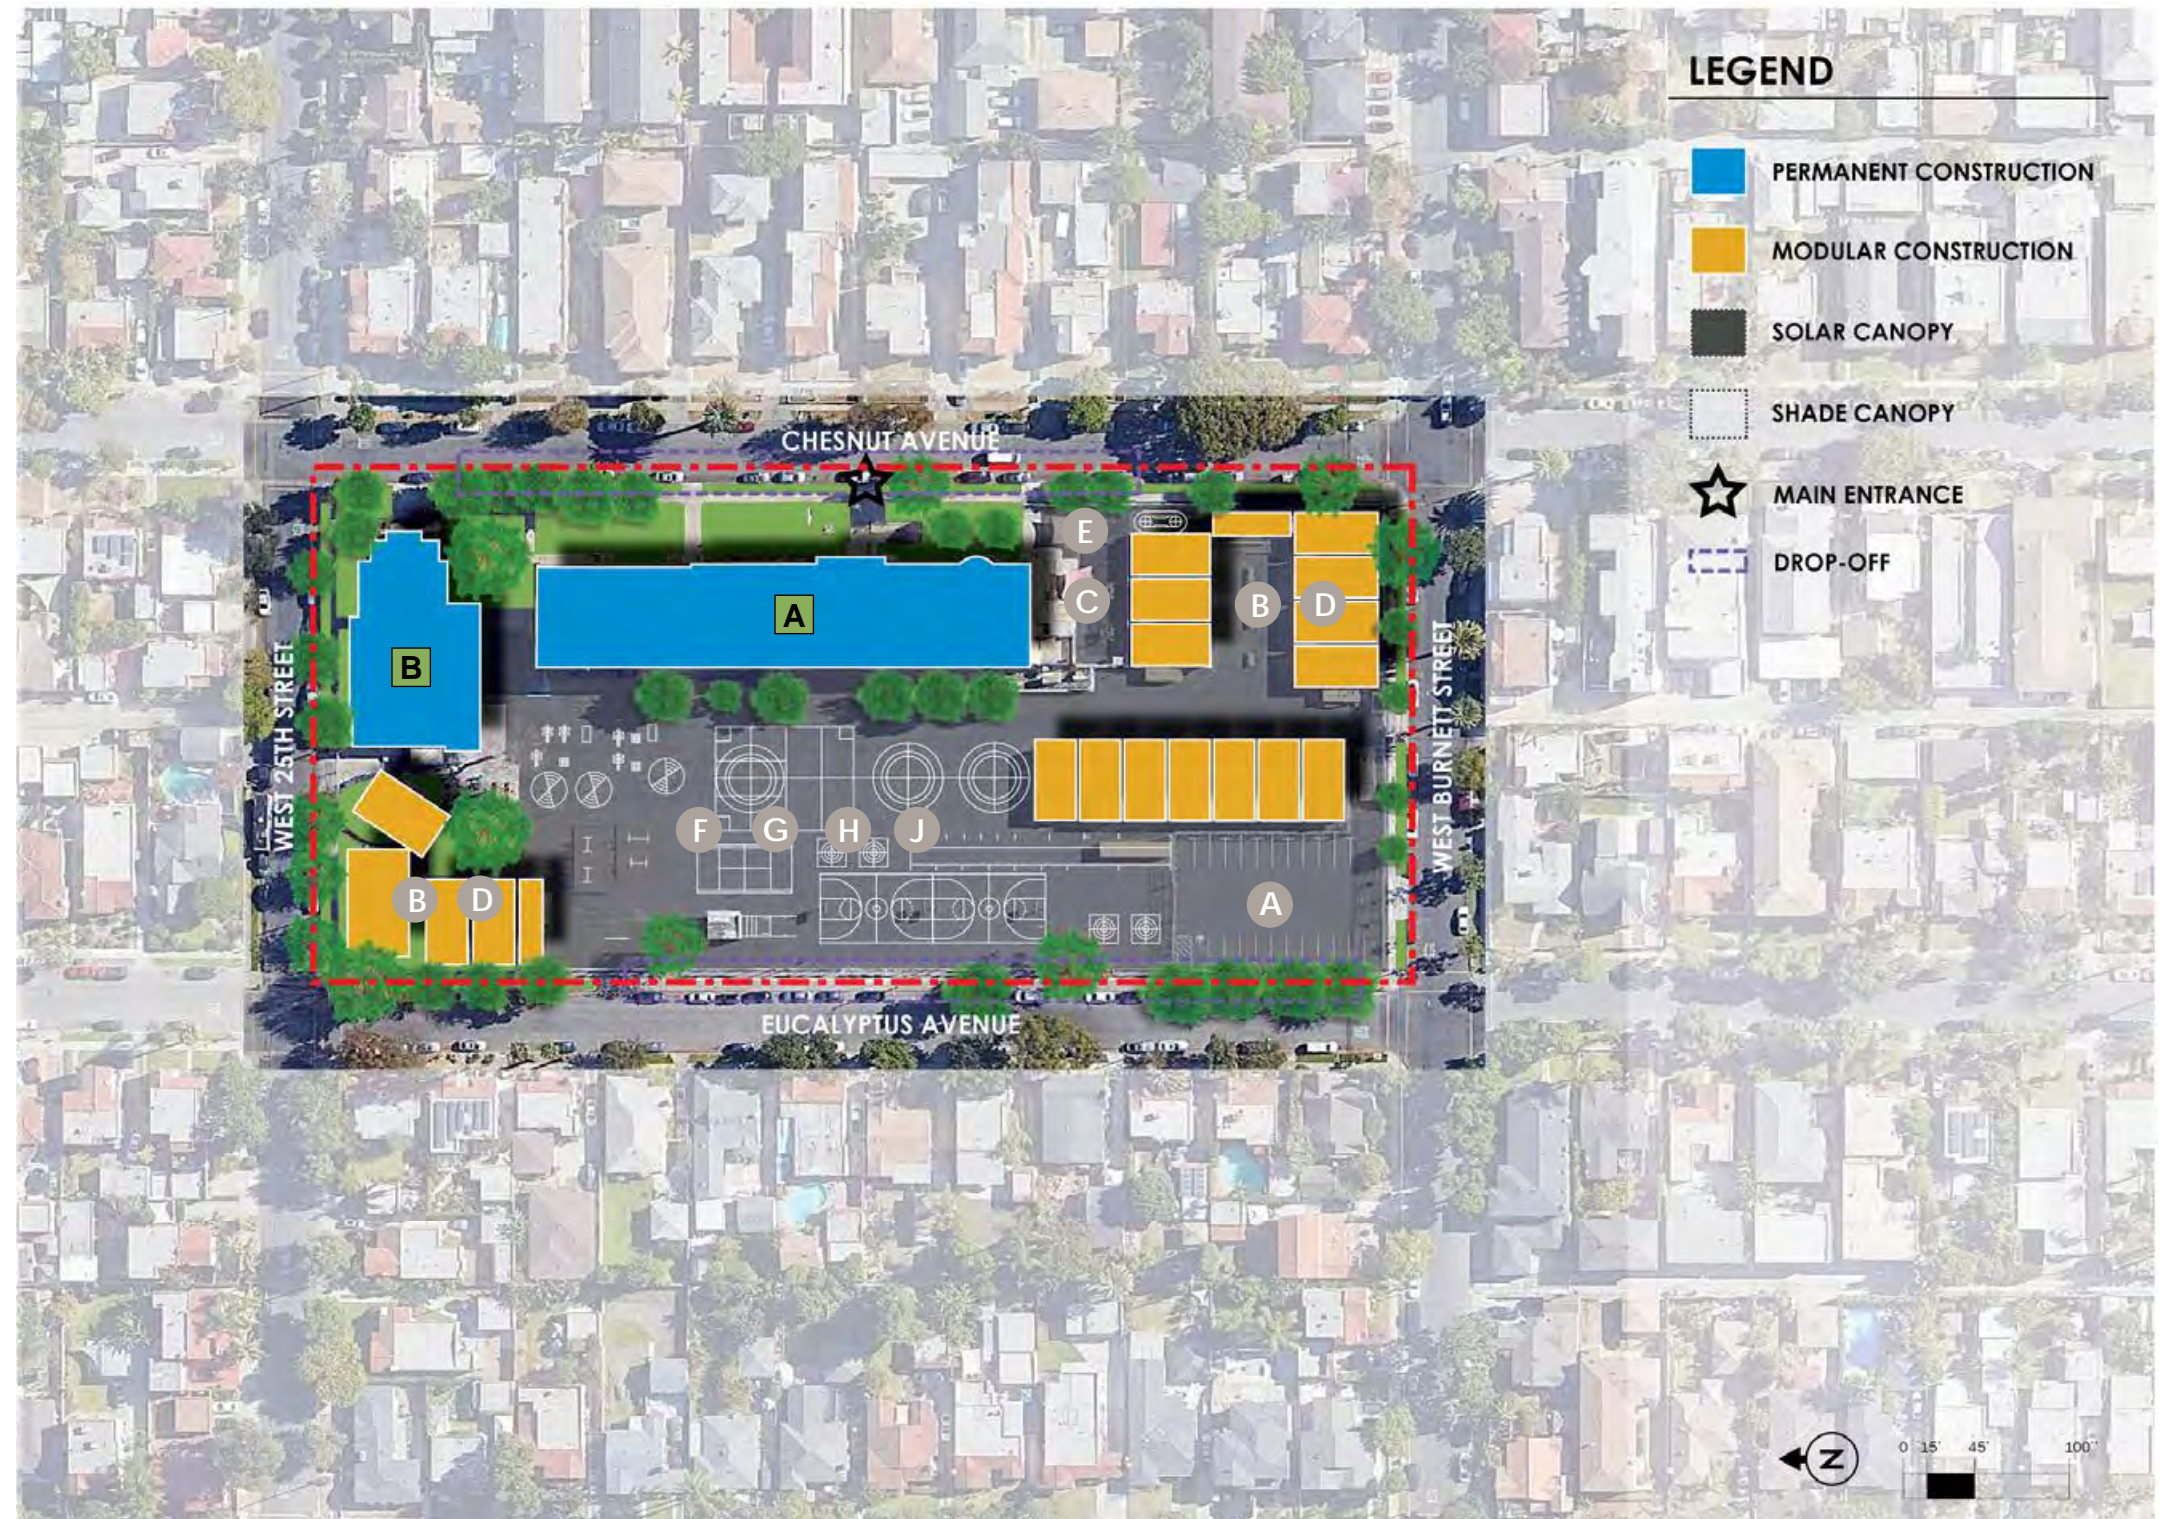
Lafayette Elementary School – Existing Space Utilization

Category	Existing	Planning Capacity
Administration	2,971 SF	3,312 SF
Auditorium	1,676 SF	5,191 SF
Library	993 SF	2,685 SF
Nutrition Services		
Cafeteria	1,288 SF	3,043 SF
Food Service	915 SF	1,700 SF
Lunch Shelter	----	2,684 SF
Site		
Playground	1.86 Acres	2.0 Acres
Parking	24 Stalls	68 Stalls

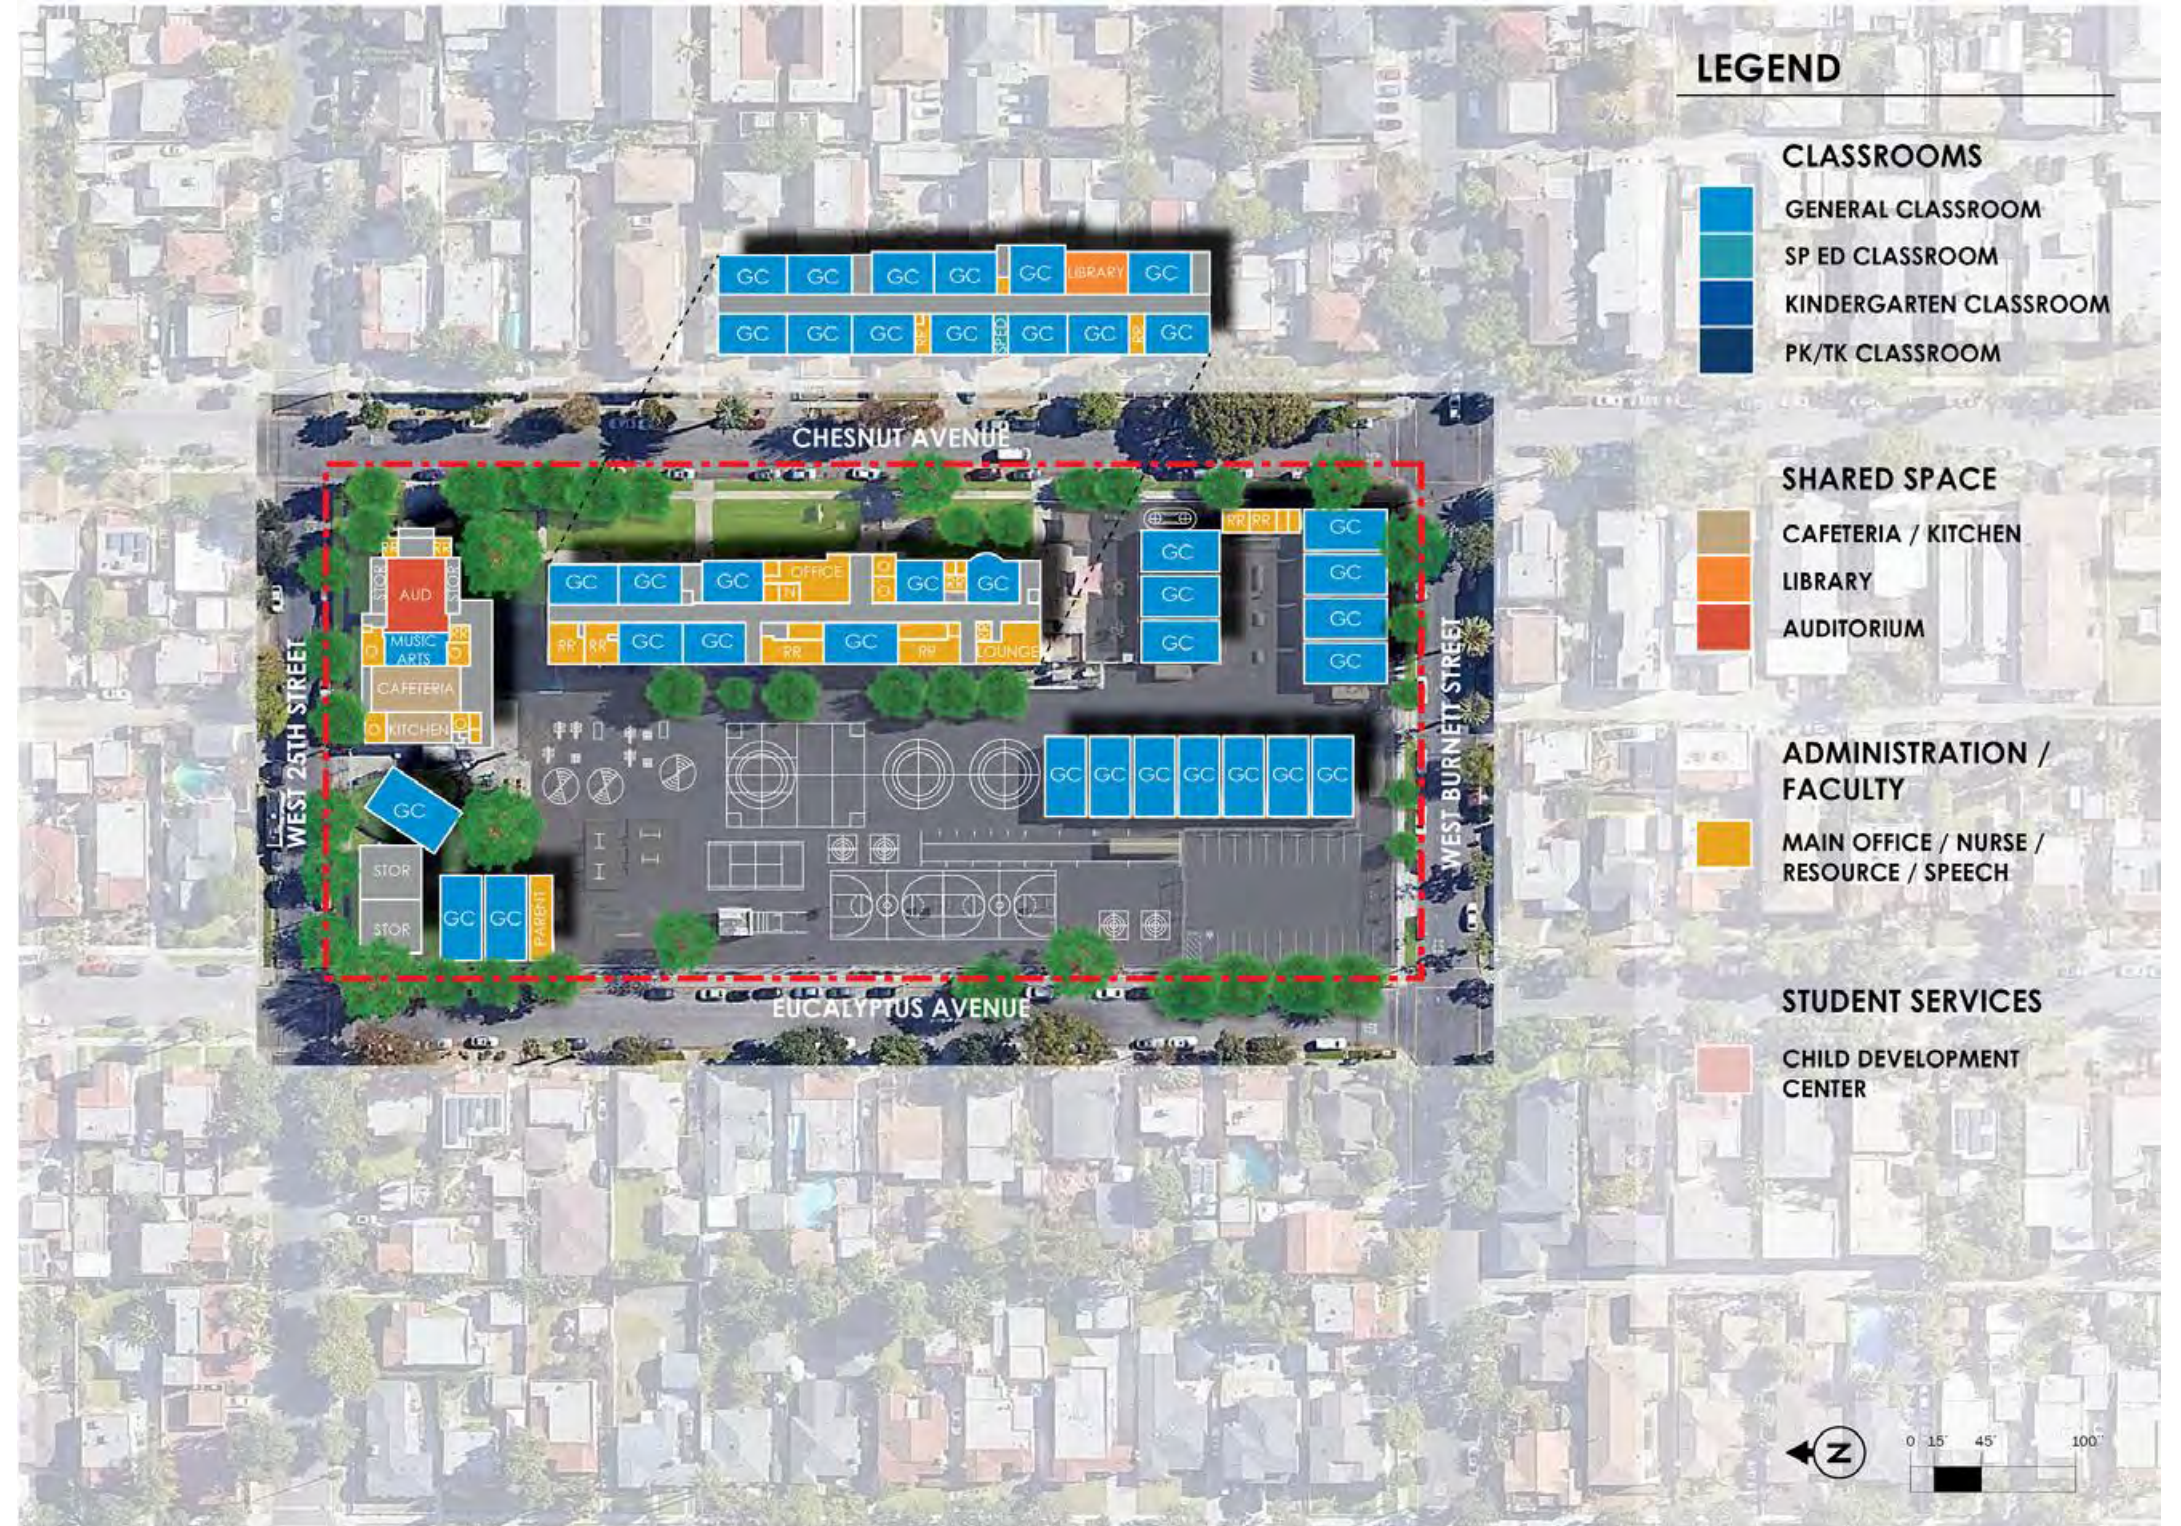
Lafayette Elementary School – Nutrition Services Plan 2022-2032

"TO FIT" DESIGN

- EXISTING BUILDING FOOTPRINT MODERNIZATION
- NEW BUILDING FOOTPRINT

Though recently renovated as part of the LBusD HVAC Construction project, the food service areas at Lafayette Elementary School do not meet current ADA or EHS requirements. The kitchen lacks sufficient dedicated dry storage (which shares the space with the supervisor's office area). Dry storage is supplemented with a remote, exterior storage container. The layout space for landing chilled product and reheated product is also inadequate. The service line is accessed within the cafeteria. Due to the size constraints of the kitchen, the aiseways for the staff are undersized and do not meet ADA requirements. Refrigeration is accommodated by a walk-in cooler, walk-in freezer and (2) self-contained units within the kitchen space and supplemented with (3) milk coolers in the cafeteria. There are (2) full width air curtains in the cafeteria that are either switch operated or were non-operational at the time of site visit. Per EHS code, air curtains should be plunger activated to avoid the possibility of shutting them off while service is in process. Though fairly new, the hood must have certain overhang clearances to be deemed code compliant, however this hood does not meet these requirements. ADA requires that exposed 'P' traps below hand sinks be insulated. The interiors of the walk-in cooler and the walk-in freezer are clad in FRP. This is not only against EHS code, it also leads to delamination and increases the potential for mold. This site would benefit from a prototype design to address EHS and DSA code compliance issues and provide an equipment package to meet current and future CNS needs.

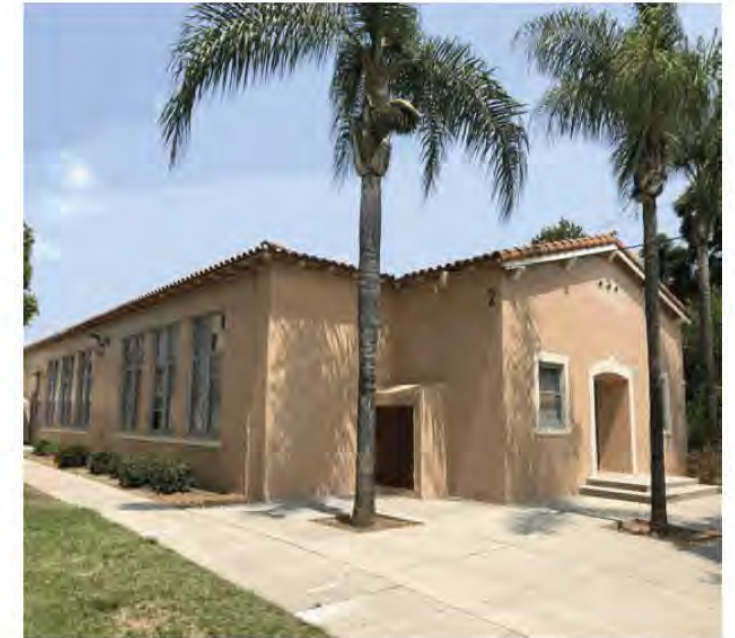
FACILITY CONDITION ASSESSMENT

Disciplines	5 Year DCI Score
Architectural	94
Plumbing	100
Mechanical	94
Fire Protection	100
Electrical	95
Communications	100
Safety and Security	100
Structural	100
5-YR FCI Score, buildings only: 96	
Civil	100
5-YR FCI Score including Civil: 97

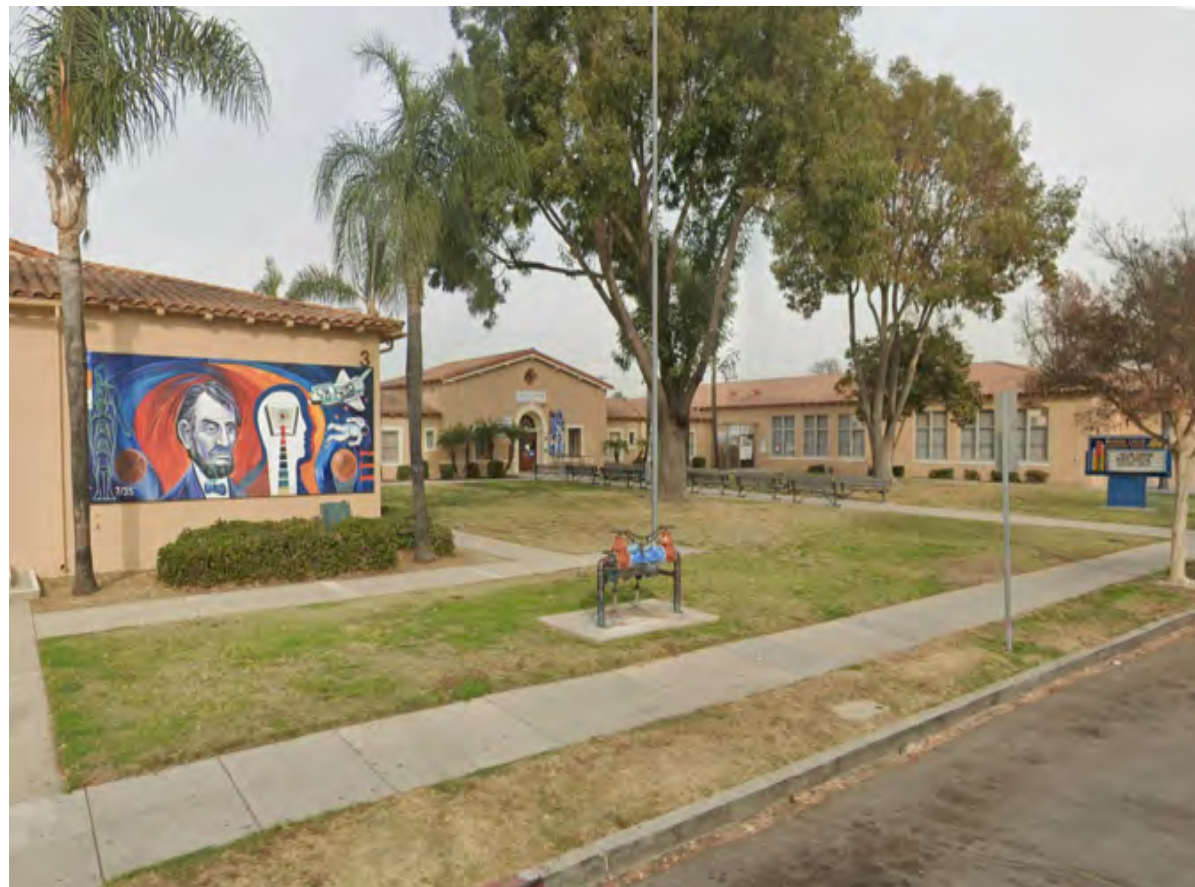
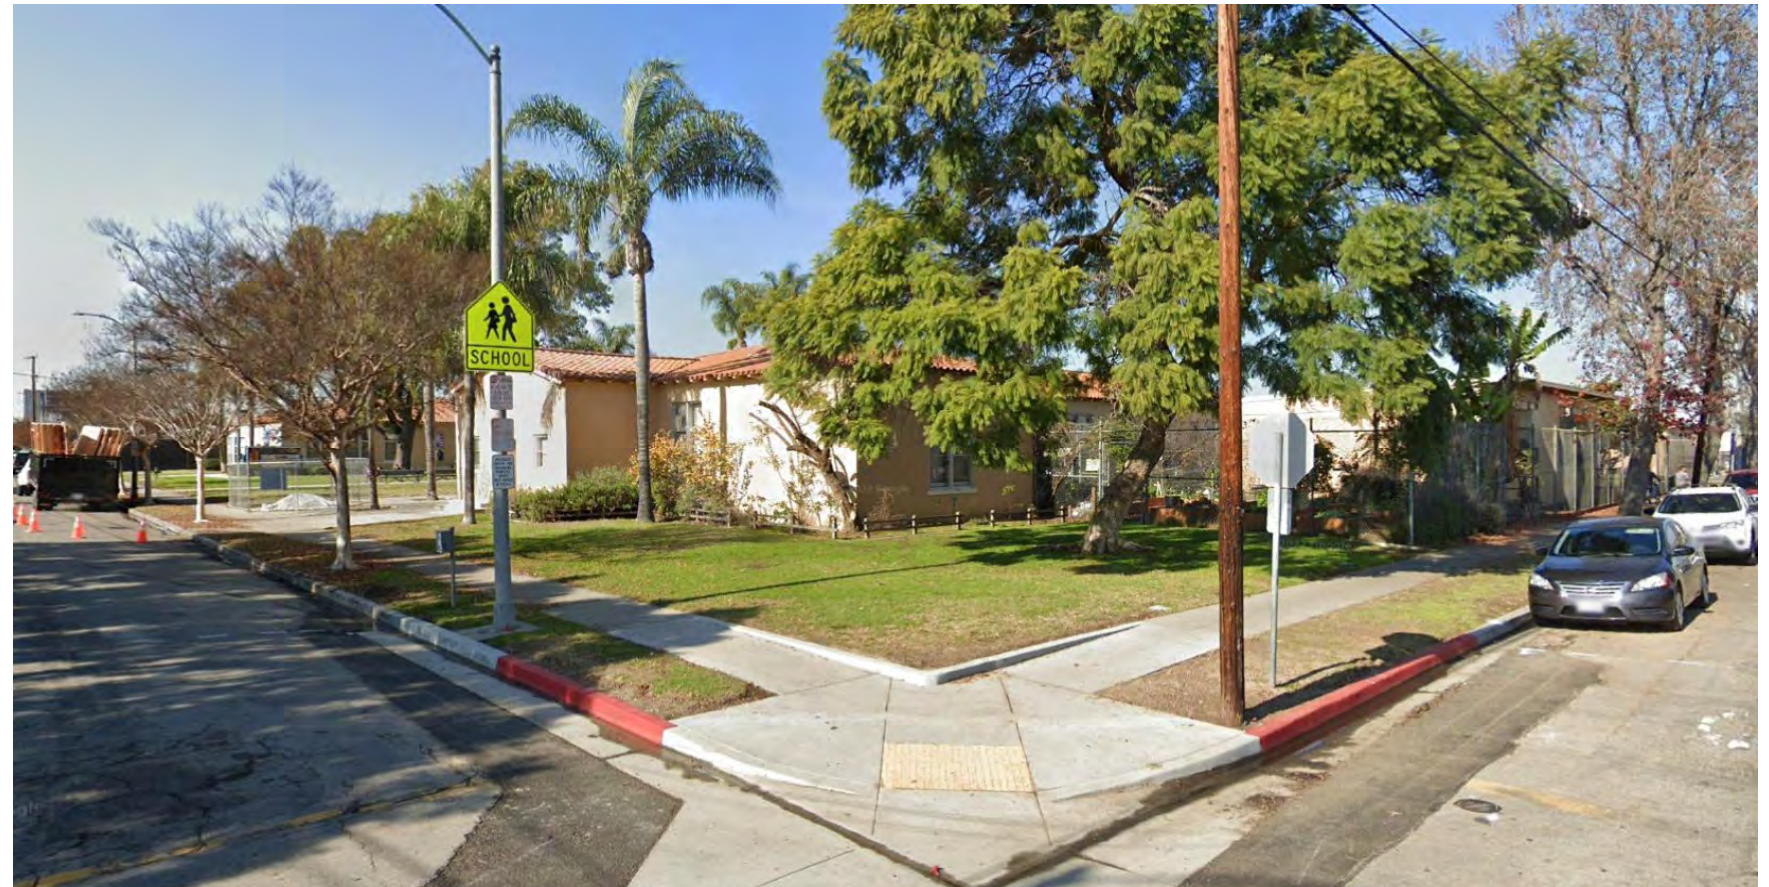
Abraham Lincoln Elementary School – Existing Campus

F Significant large areas of blacktop without use of reflective paints to reduce heat island and improve quality of play

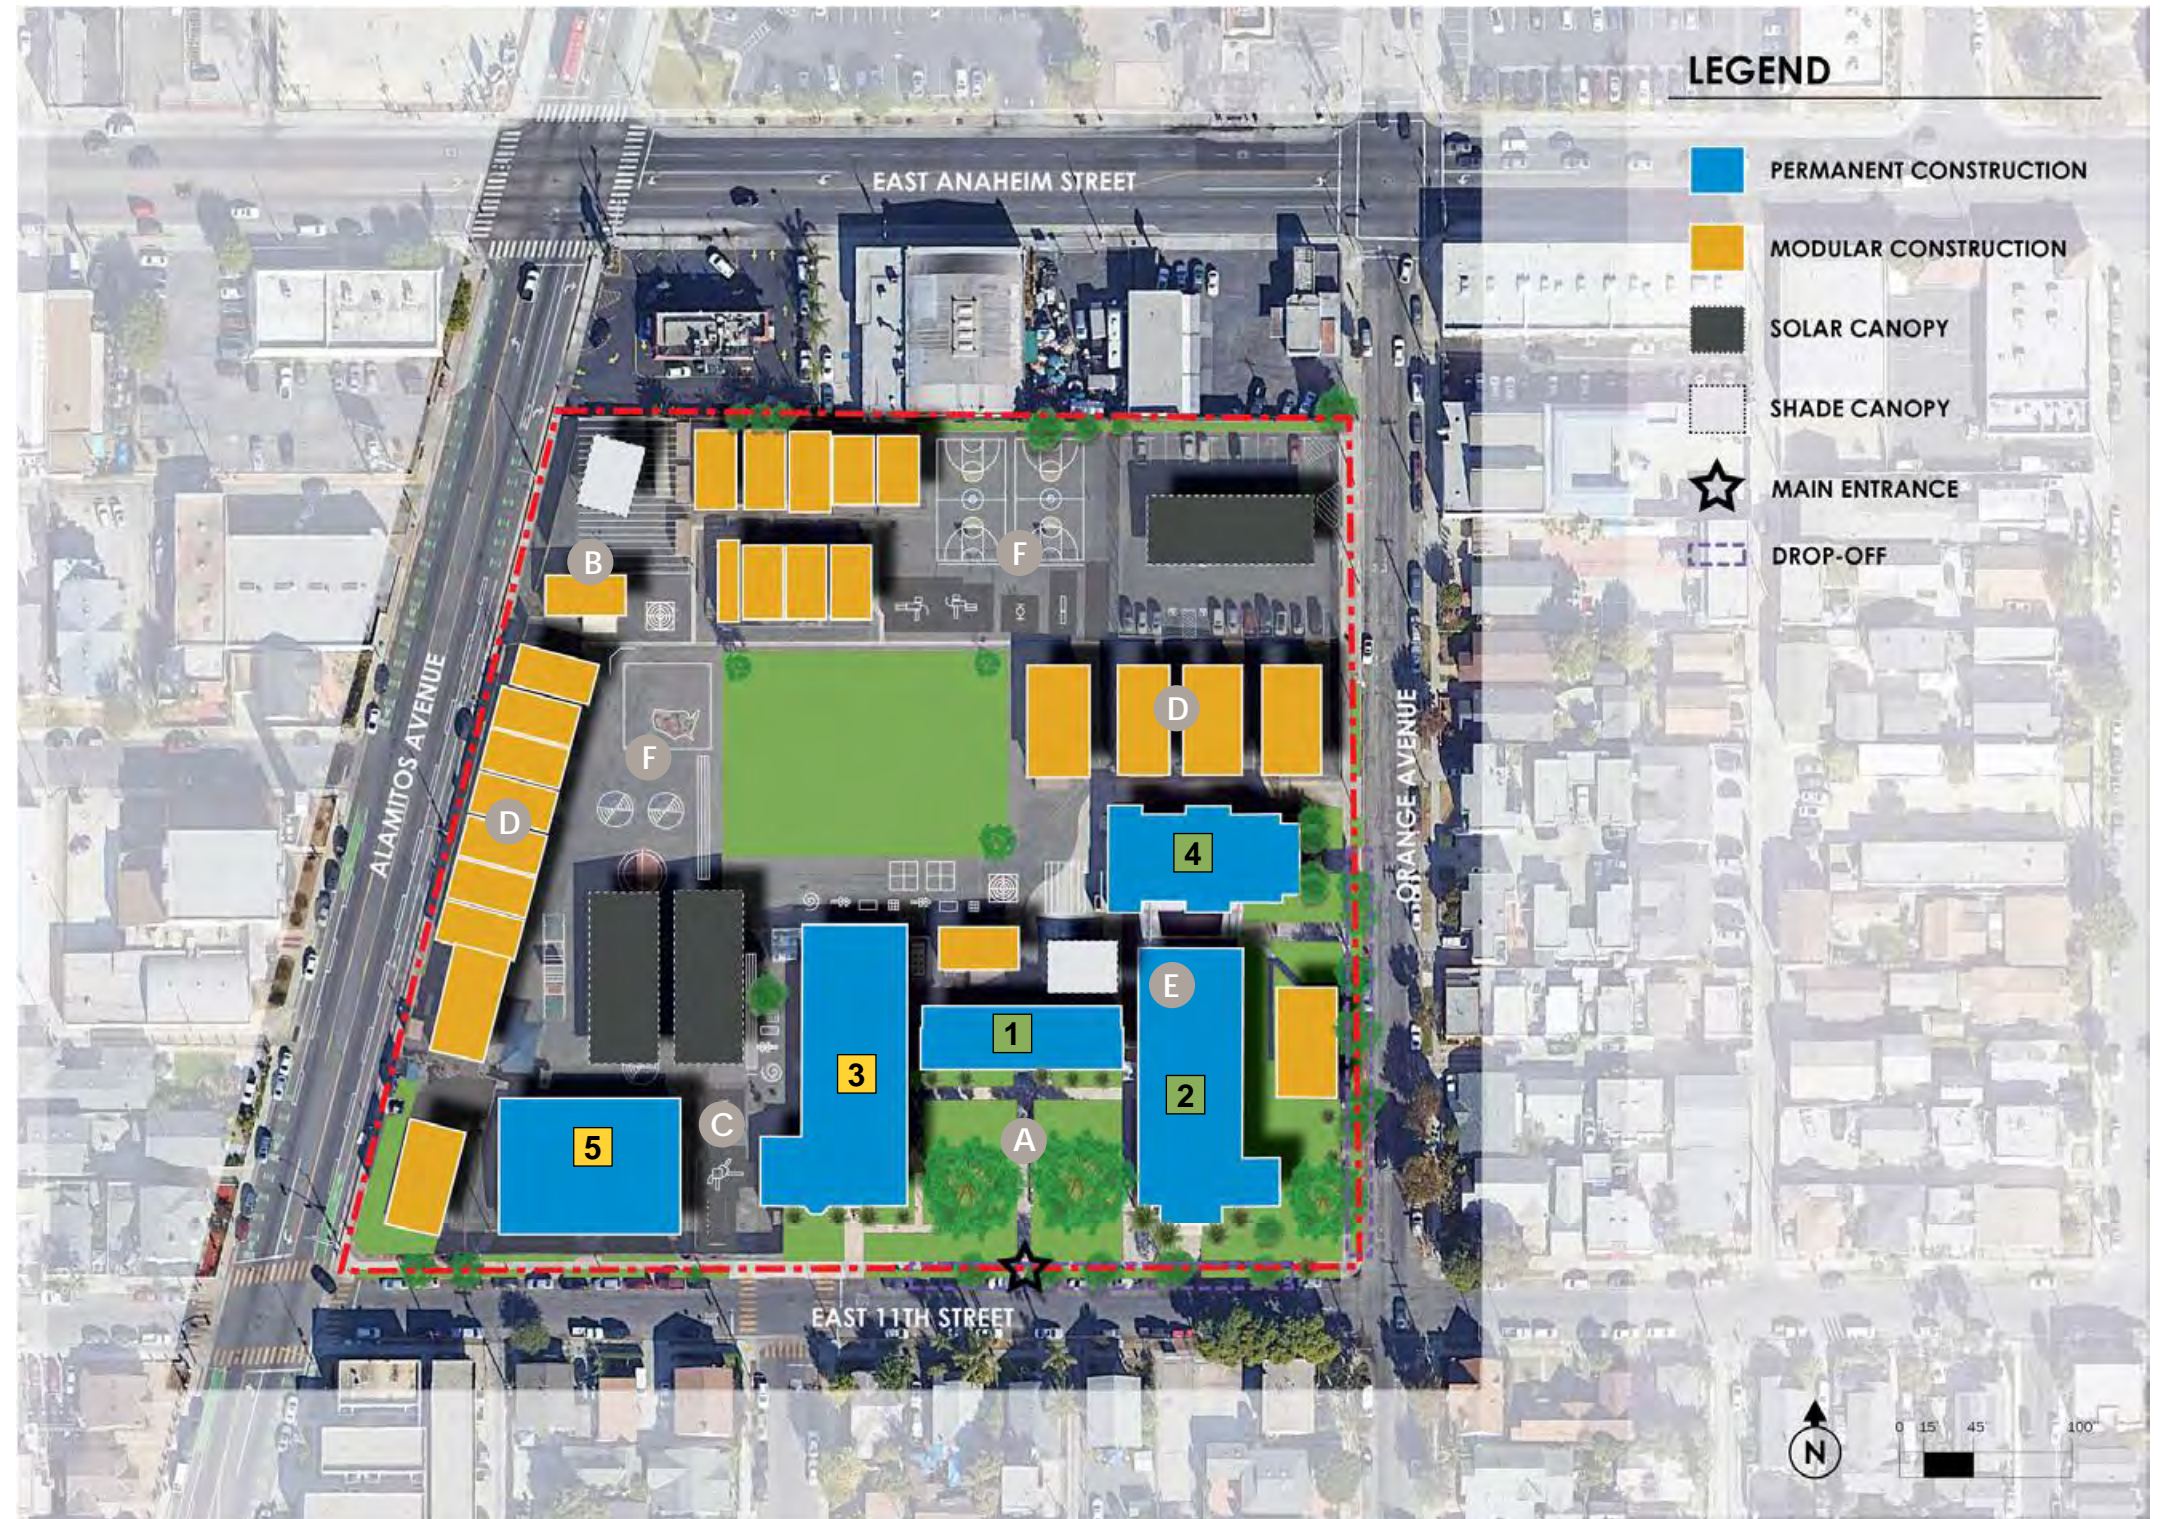
Abraham Lincoln Elementary School – Existing Space Utilization

Category	Existing	Planning Capacity
Administration	2,732 SF	3,108 SF
Auditorium	2,651 SF	4,872 SF
Library	1,355 SF	2,520 SF
Nutrition Services		
Cafeteria	1,358 SF	2,856 SF
Food Service	897 SF	1,596 SF
Lunch Shelter	860 SF	2,520 SF
Site		
Playground	2.3 Acres	2.0 Acres
Parking	58 Stalls	63 Stalls

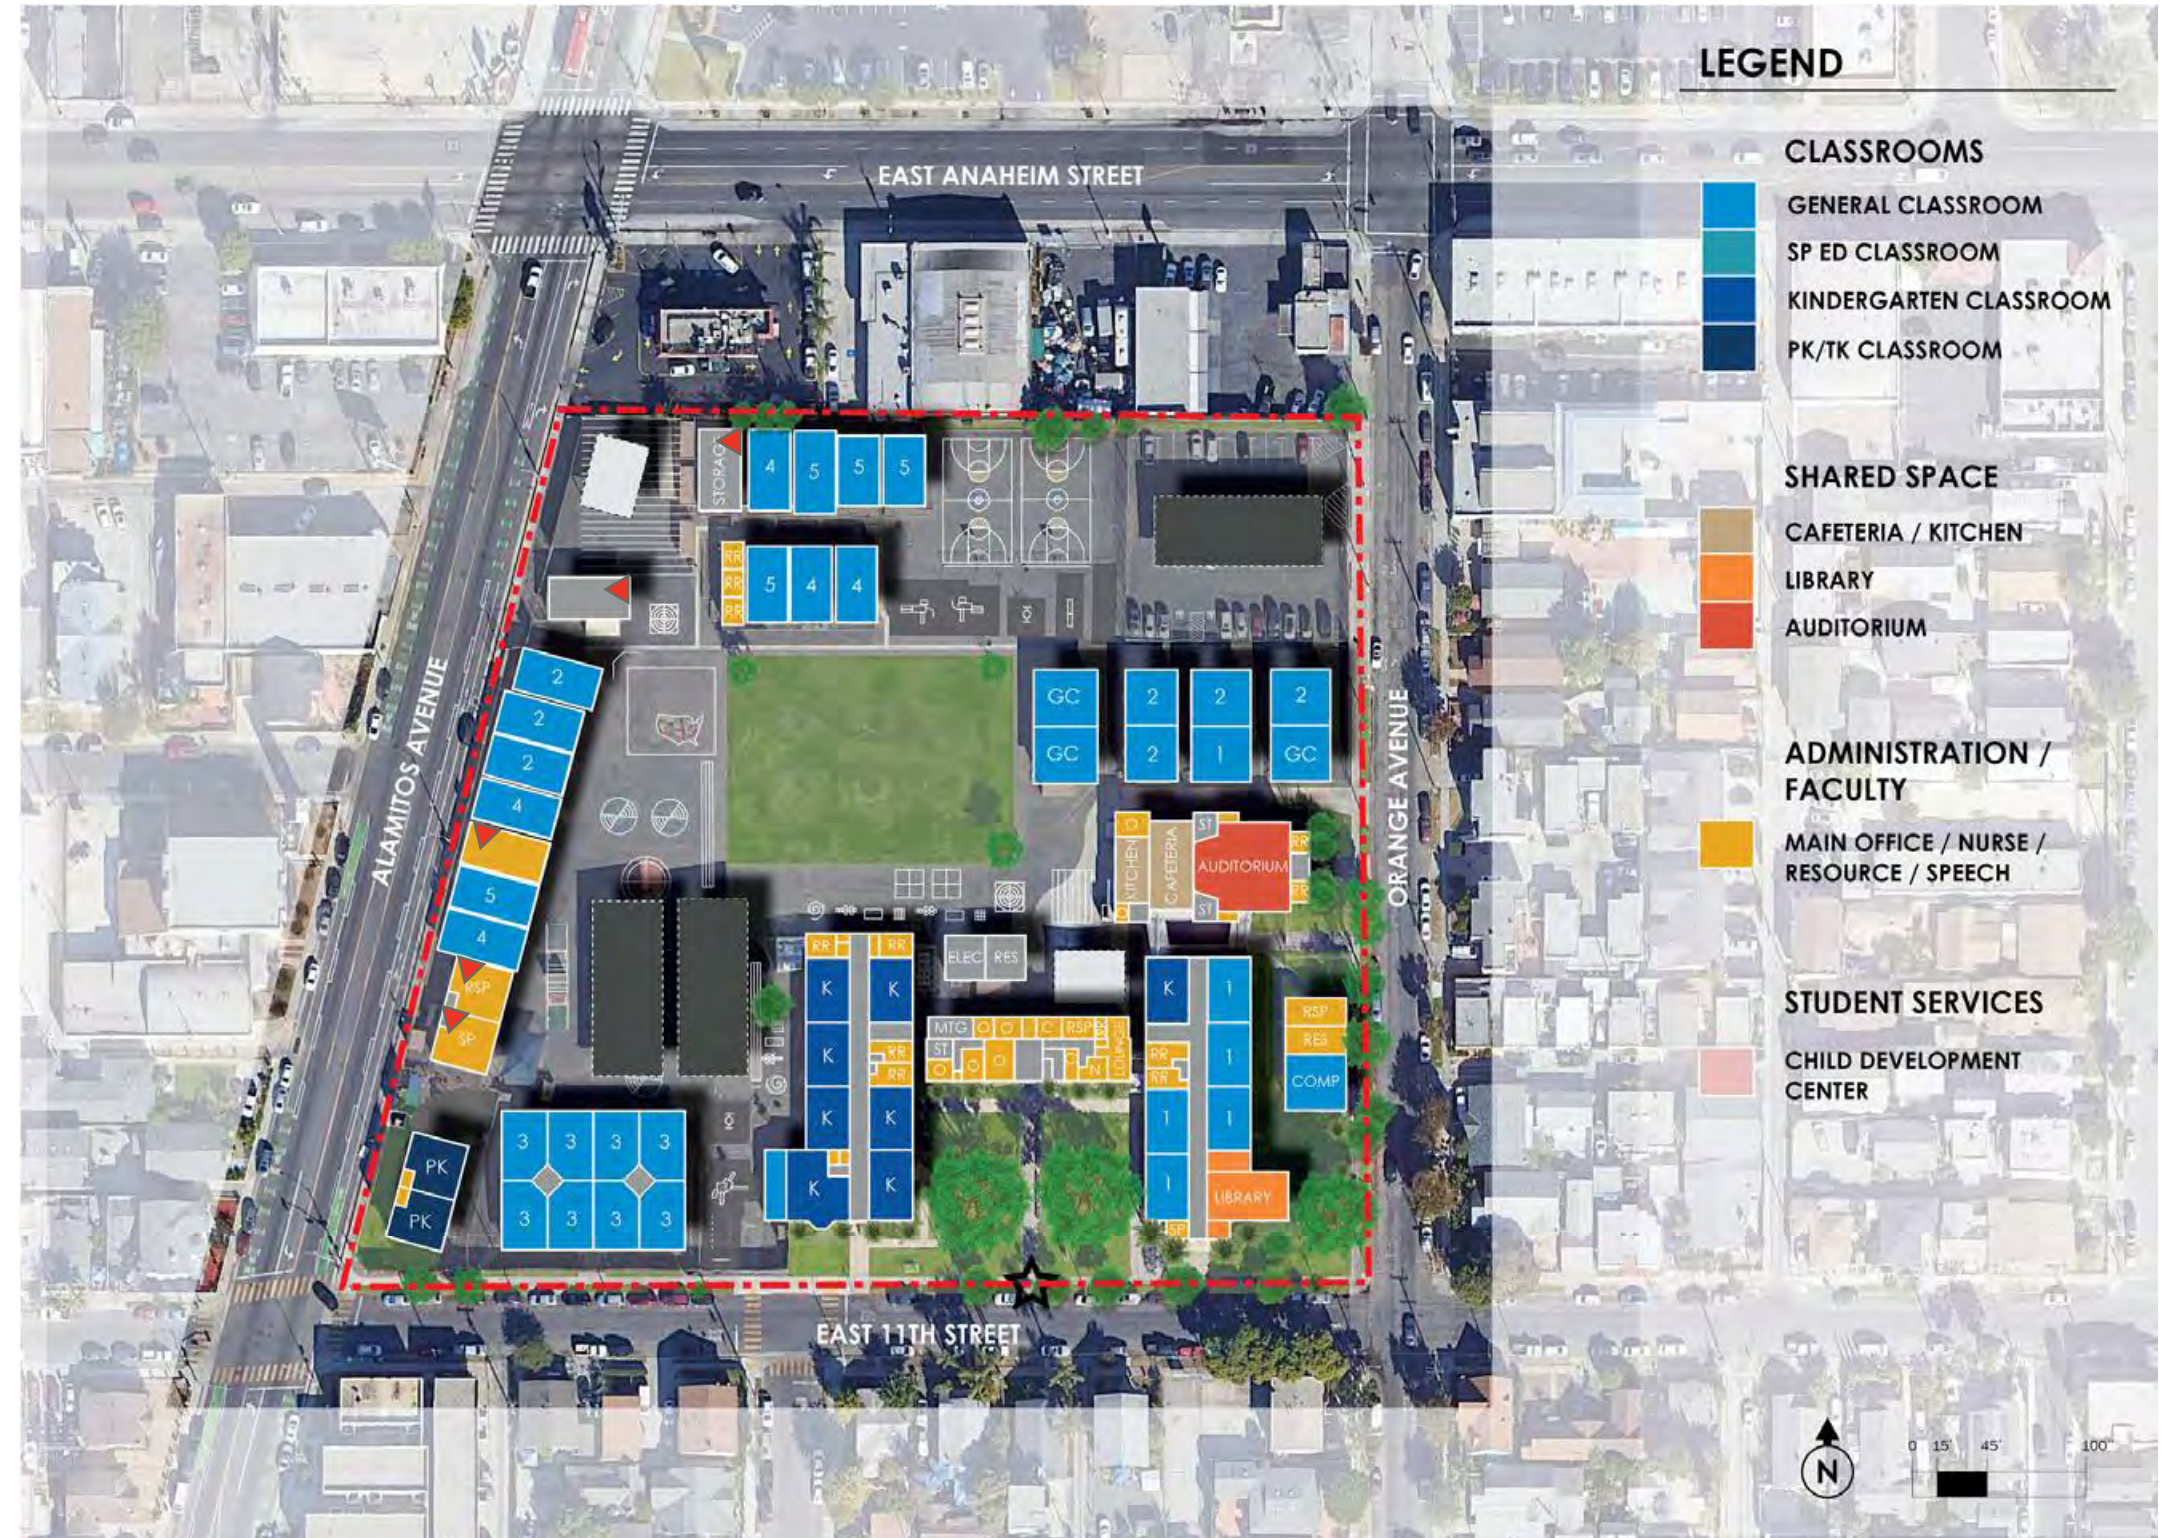
Abraham Lincoln Elementary School – Nutrition Services Plan 2022-2032

The Lincoln Elementary School kitchen is small and cramped. This space is inadequate for the 2021-2022 Enrollment and service model. Though recently renovated as part of the LBUSD HVAC Construction project, the food service areas at Lincoln Elementary School do not meet current ADA or EHS requirements. The kitchen lacks sufficient dedicated dry storage (which shares the space with the supervisor’s office area). Dry storage is supplemented with a remote, exterior storage container. There is no exterior ramp for the storage container which necessitates a step up to access the interior. The layout space for landing chilled product and reheated product is also inadequate. The service line is accessed within the kitchen space. Due to the size constraints of the kitchen, the service aisles for both the staff and the students are undersized and do not meet ADA requirements. Refrigeration is accommodated by (6) units within the kitchen space and supplemented with overflow refrigerated equipment in the cafeteria. Exposed wood in the kitchen is a potential harbinger for pests and/or vermin and is not allowed per EHS code. The laminate clad wood service counter, the wood stanchions on the food guards and the wood guillotine style door near the disposer are not EHS code compliant. There are (2) double exit doors in the cafeteria that do not have EHS required, full width, plunger activated air curtains. Wall flashing is required behind (which includes below) all wet areas including but not limited to sinks and disposers. There is no employee hand sink or dedicated food preparation sink within the kitchen space. This site would benefit from a prototype design to address EHS and DSA code compliance issues and provide an equipment package to meet current and future CNS needs.

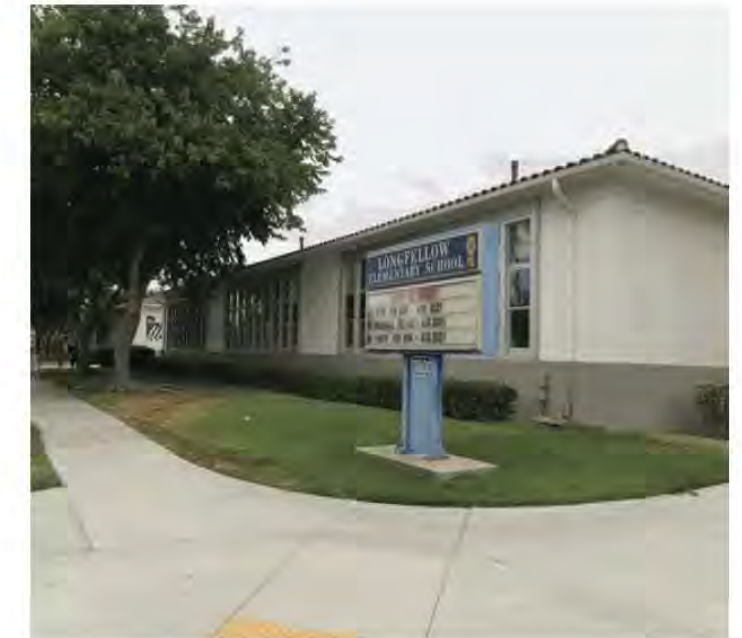
FACILITY CONDITION ASSESSMENT

Disciplines	5 Year DCI Score
Architectural	99
Plumbing	99
Mechanical	97
Fire Protection	99
Electrical	97
Communications	98
Safety and Security	100
Structural	99
5-YR FCI Score, buildings only:	
	98
Civil	100
5-YR FCI Score including Civil:	
	99

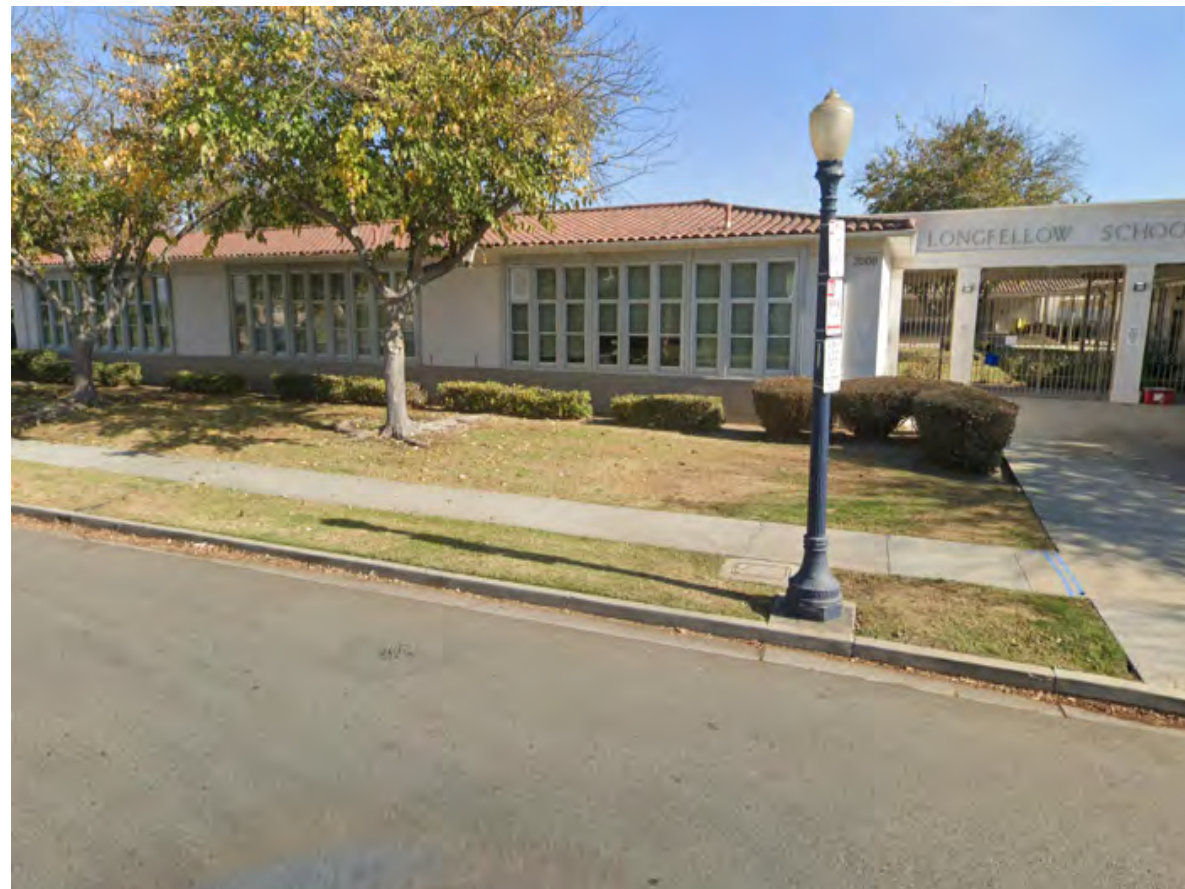
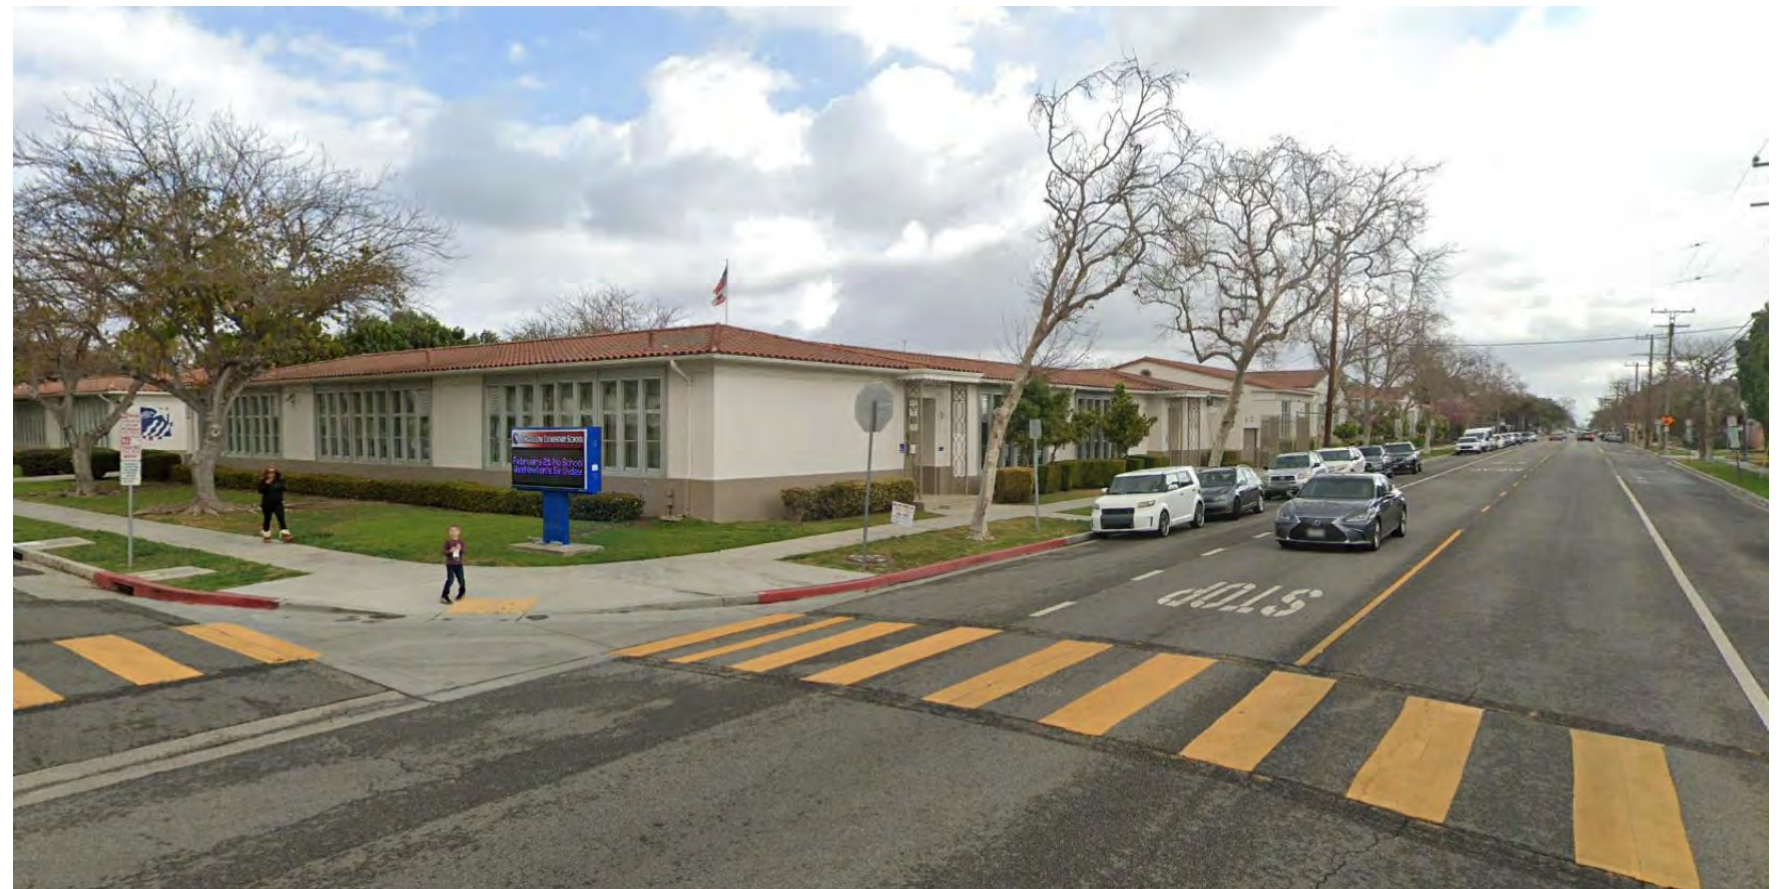
Henry W. Longfellow Elementary School – Existing Campus

- C** Visibility of outdoor Kinder play from street
- D** Lack of shade trees at play area
- E** Significant large areas of blacktop without use of reflective paints to reduce heat island and improve quality of play
