LBUSD 2022 Facility Master Plan

Long Beach Unified School District
Appendices

July 2022

A Facility Reports: Elementary Schools

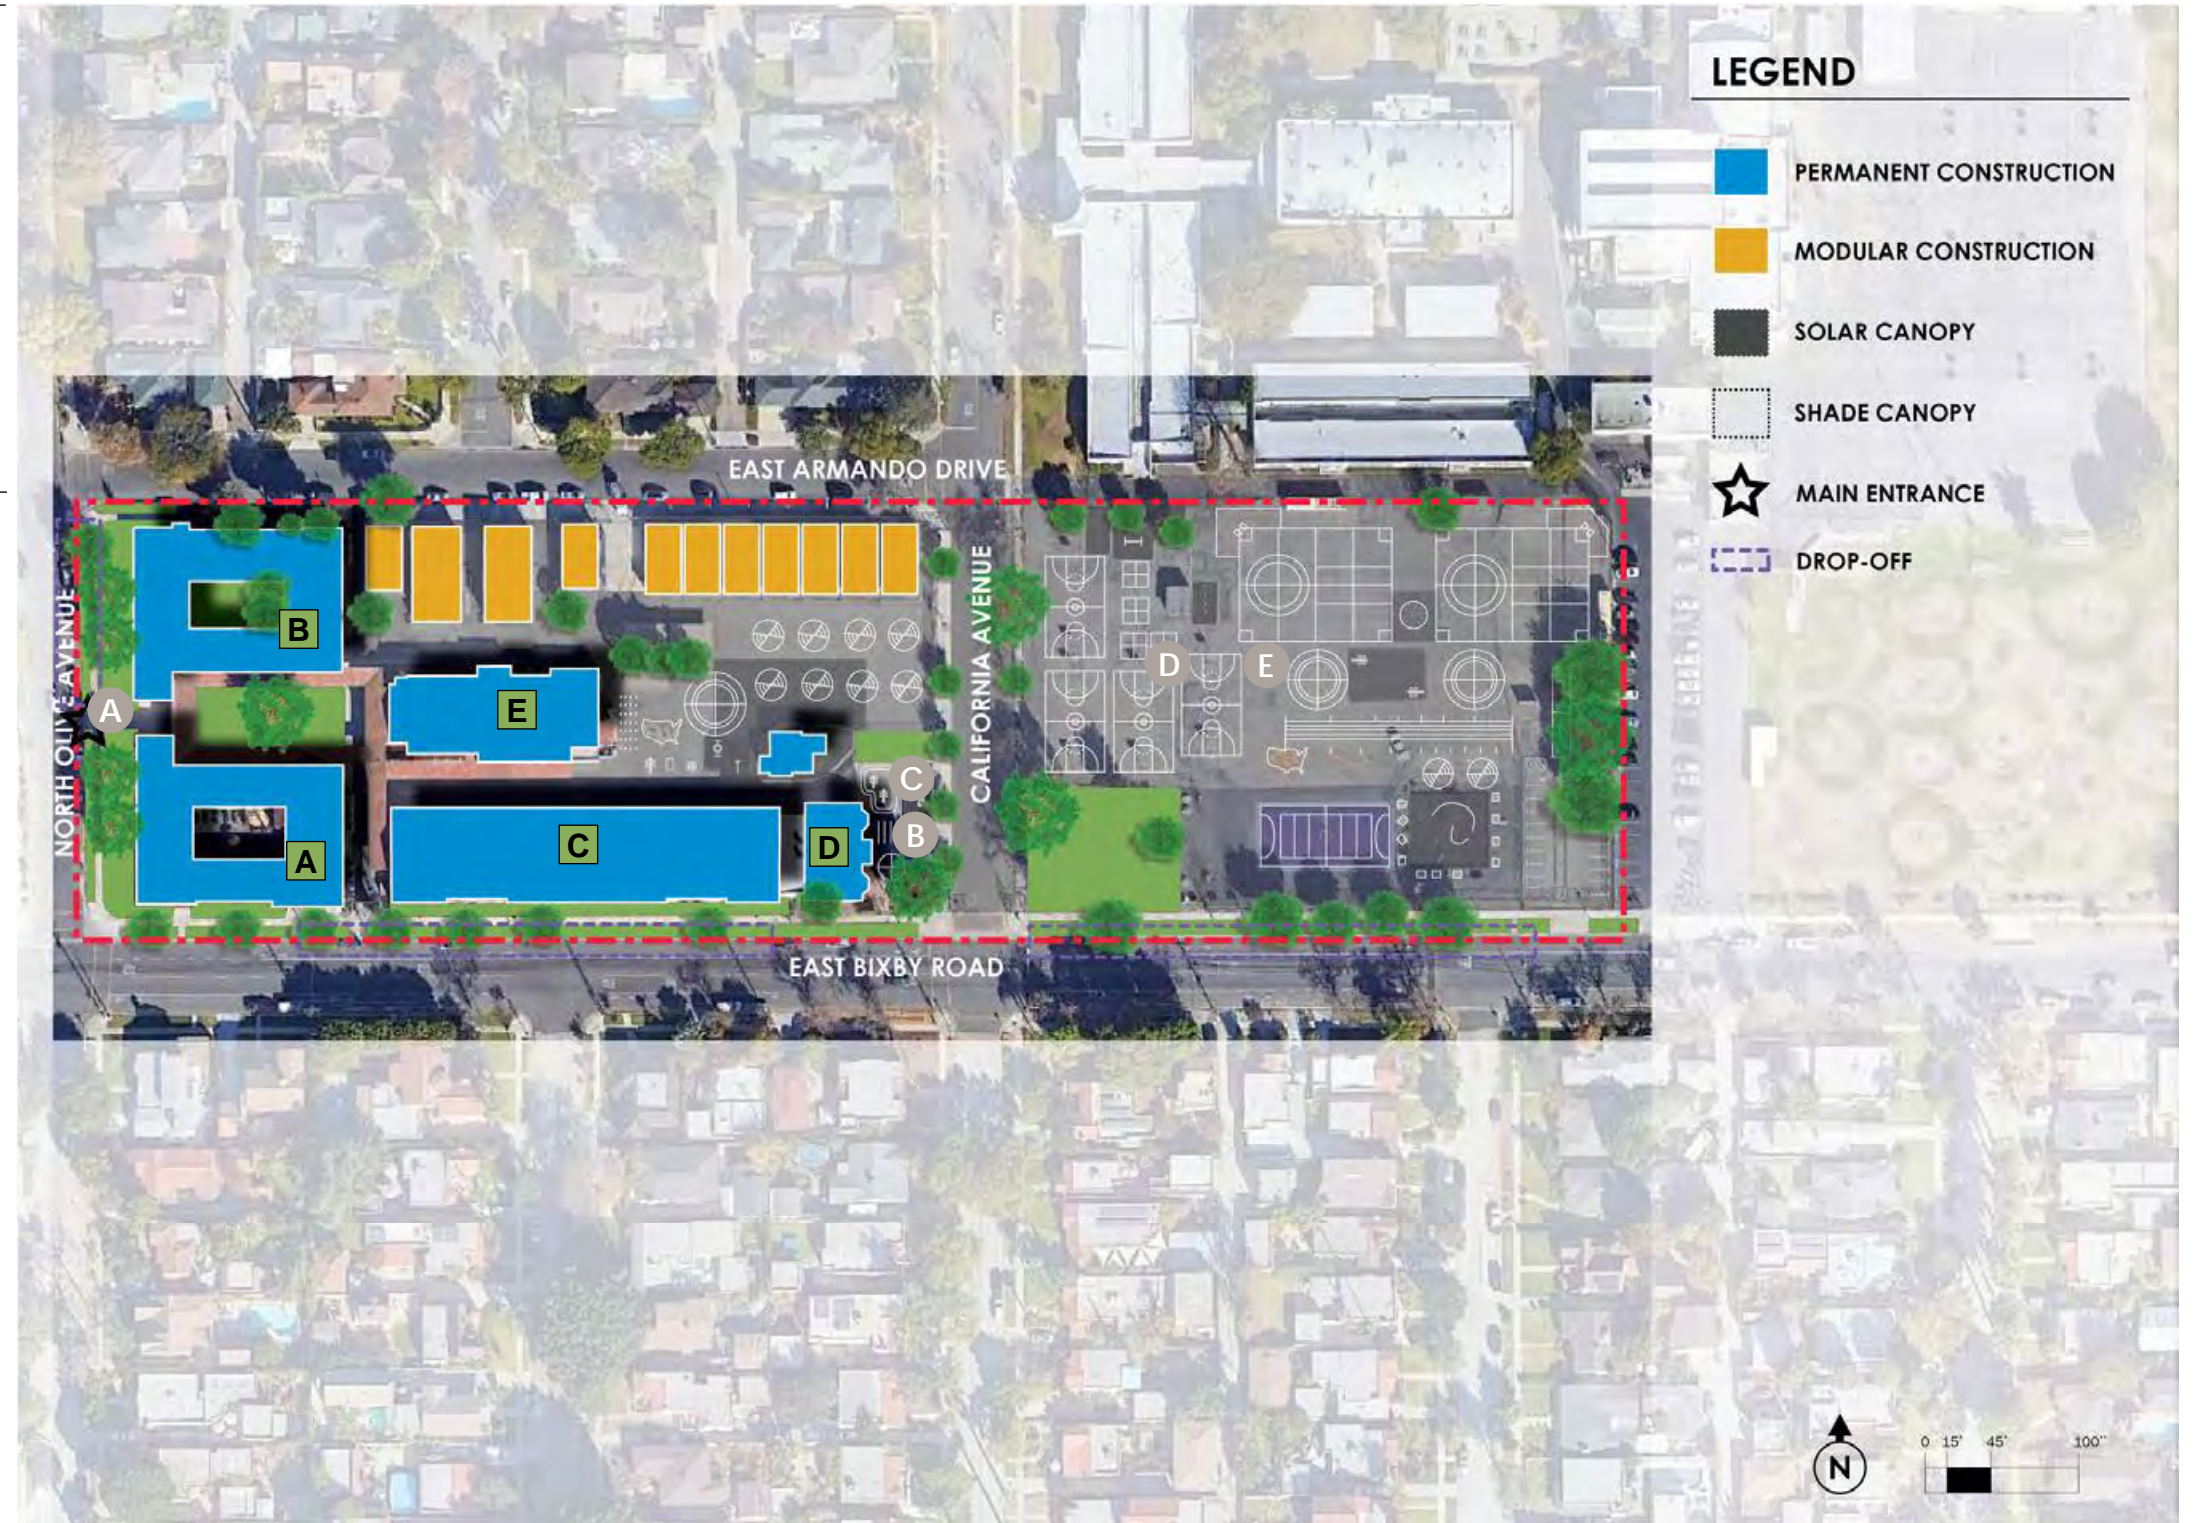
Henry W. Longfellow Elementary School – Existing Space Utilization

Category	Existing	Planning Capacity
Administration	1,261 SF	2,799 SF
Auditorium	3,379 SF	5,318 SF
Library	1,440 SF	3,079 SF
Nutrition Services		
Cafeteria	1,856 SF	3,172 SF
Food Service	781 SF	2,425 SF
Lunch Shelter	----	2,799 SF
Site		
Playground	3.4 Acres	2.0 Acres
Parking	21 Stalls	73 Stalls

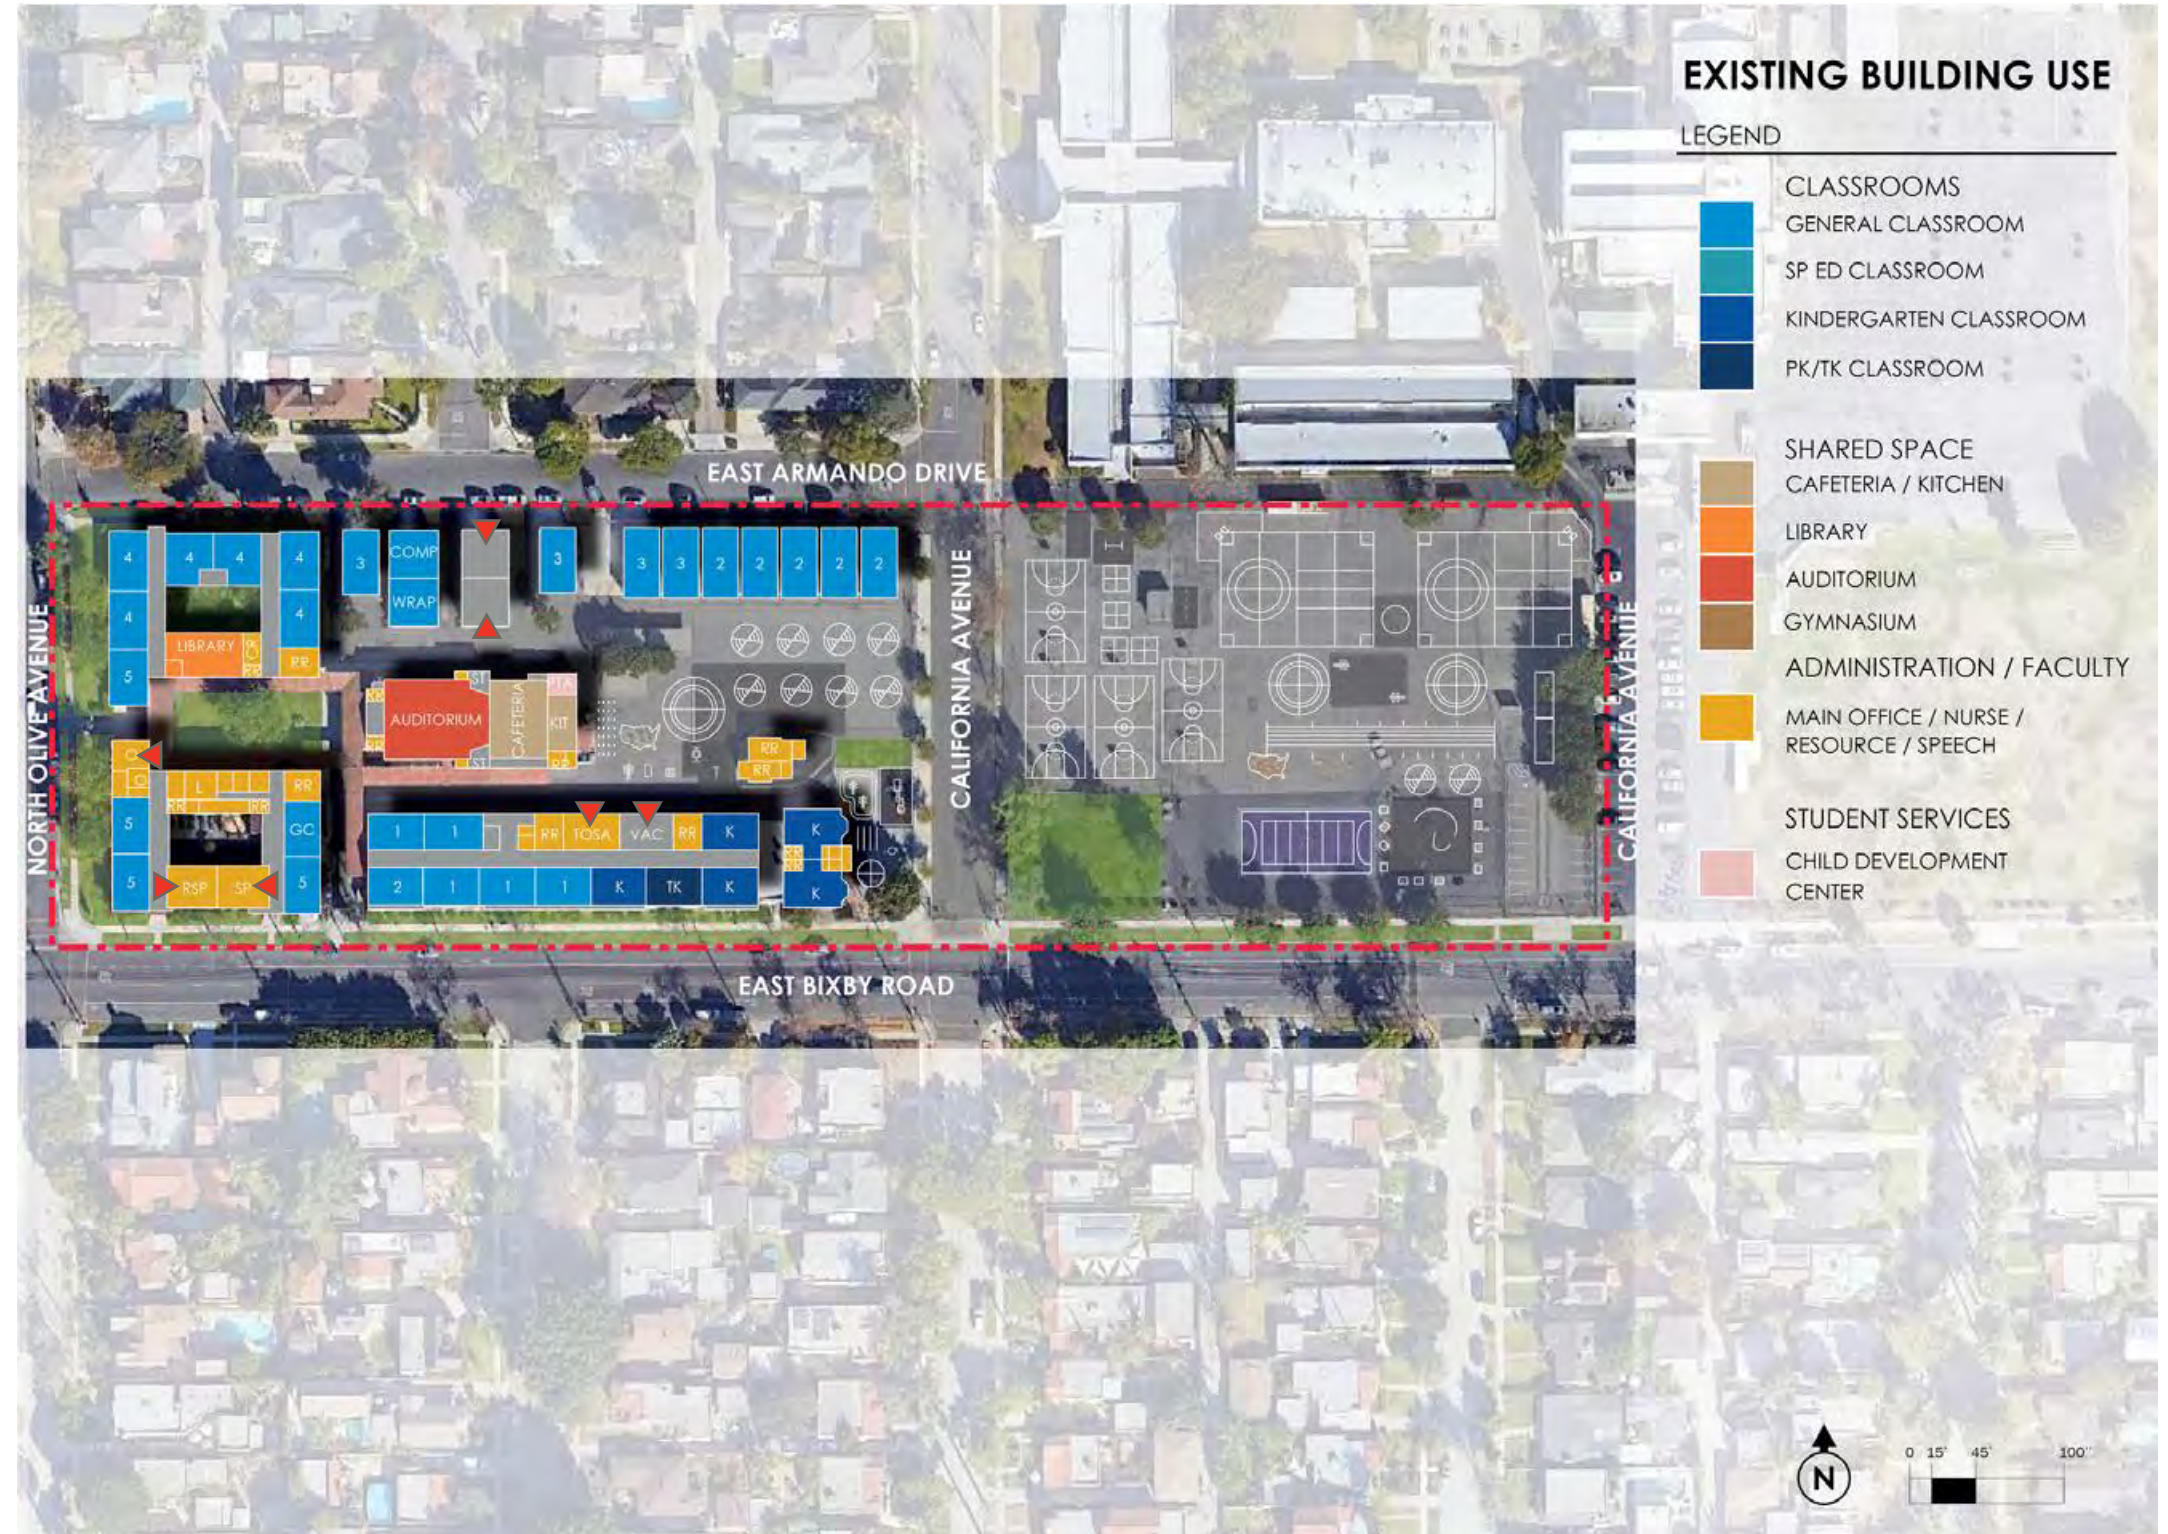
Henry W. Longfellow Elementary School– Nutrition Services Plan 2022-2032

Though recently renovated as part of the LBUSD HVAC Construction project, the food service areas at Lafayette Elementary School do not meet current ADA or EHS requirements. The kitchen lacks sufficient dedicated dry storage (which shares the space with the supervisor's office area). Dry storage is supplemented with a remote, exterior storage container. The layout space for landing chilled product and reheated product is also inadequate. The service line is accessed within the cafeteria. Due to the size constraints of the kitchen, the aisleways for the staff are undersized and do not meet ADA requirements. Refrigeration is accommodated by a walk-in cooler, walk-in freezer and (2) self-contained units within the kitchen space and supplemented with (3) milk coolers in the cafeteria. There are (2) full width air curtains in the cafeteria that are either switch operated or were non-operational at the time of site visit. Per EHS code, air curtains should be plunger activated to avoid the possibility of shutting them off while service is in process. Though fairly new, the hood must have certain overhang clearances to be deemed code compliant, however this hood does not meet these requirements. ADA requires that exposed 'P' traps below hand sinks be insulated. The interiors of the walk-in cooler and the walk-in freezer are clad in FRP. This is not only against EHS code, it also leads to delamination and increases the potential for mold. This site would benefit from a prototype design to address EHS and DSA code compliance issues and provide an equipment package to meet current and future CNS needs.

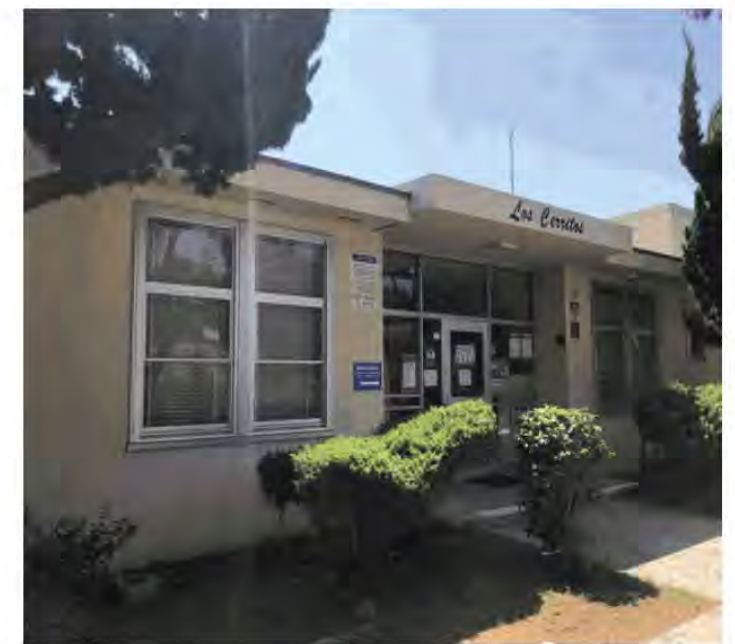
FACILITY CONDITION ASSESSMENT

Disciplines	5 Year DCI Score
Architectural	26
Plumbing	47
Mechanical	48
Fire Protection	100
Electrical	34
Communications	100
Safety and Security	54
Structural	81
5-YR FCI Score, buildings only:	
	46
Civil	100
5-YR FCI Score including Civil:	
	63

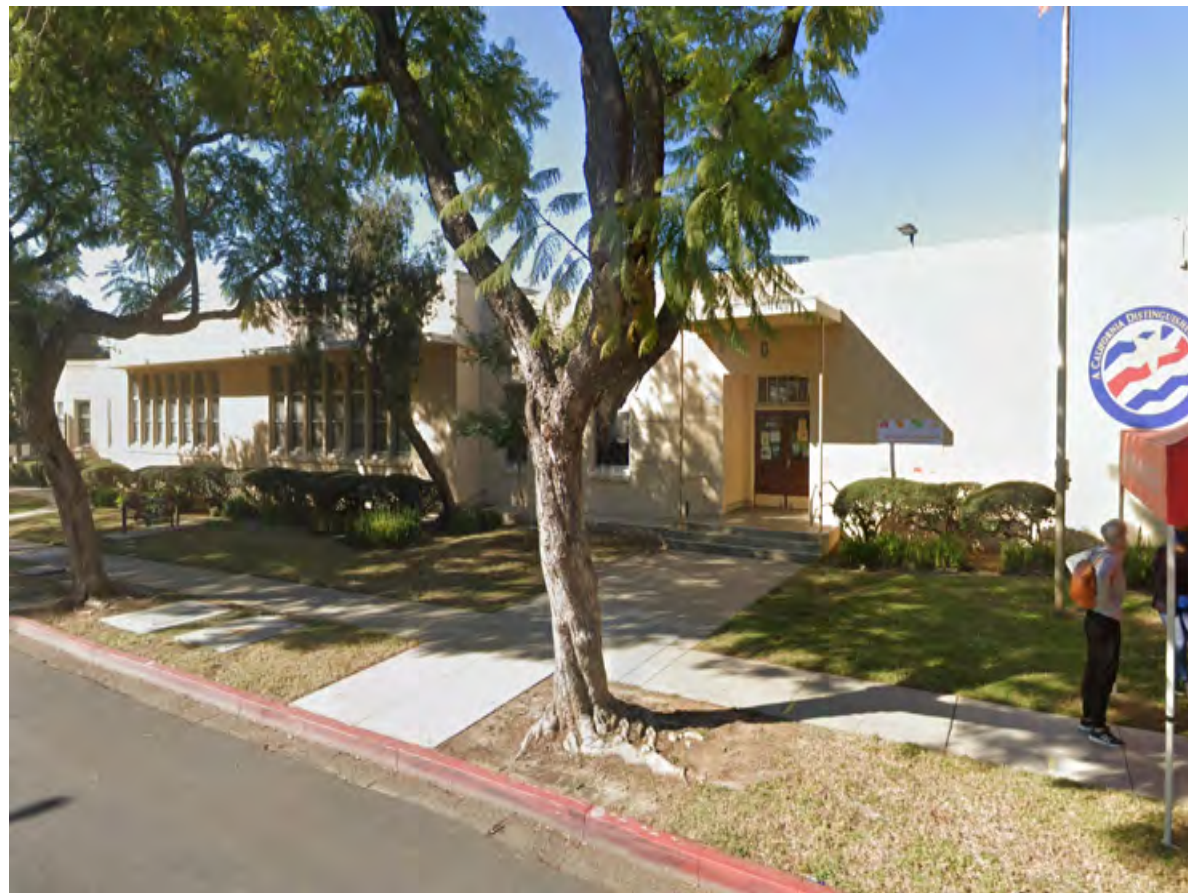
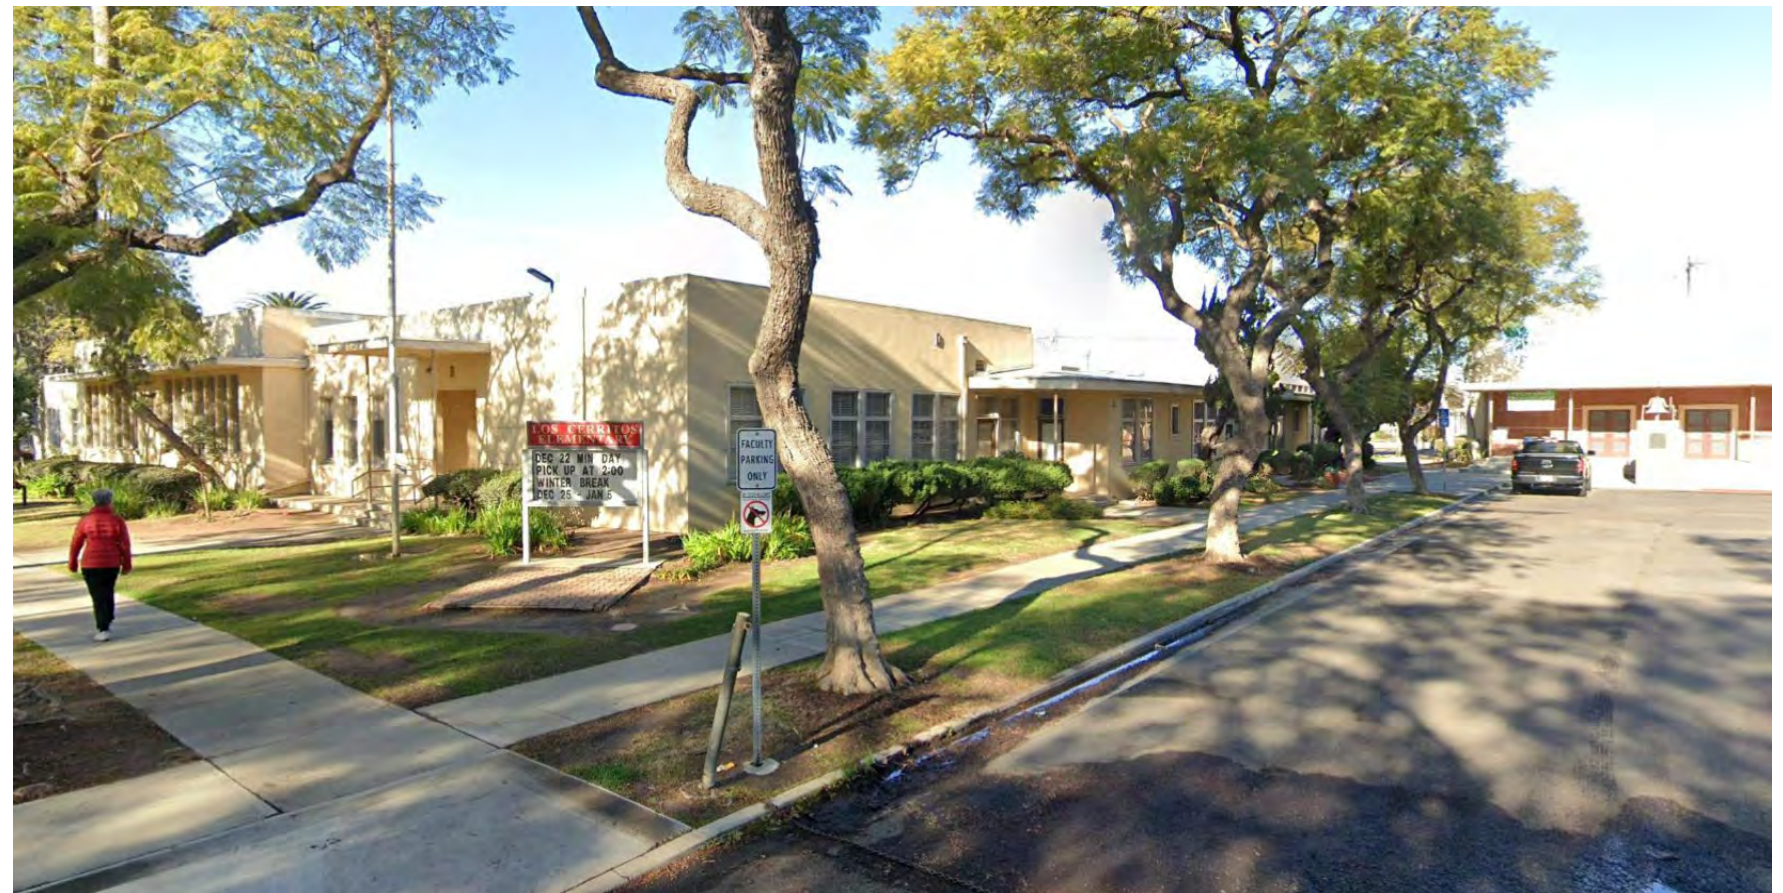
Los Cerritos Elementary School – Existing Campus

- C** Lack of lawn/turf area at main play area
- D** Lack of adequate apparatus play zone for younger learners
- E** Lack of shade trees at play area
- F** Significant large areas of blacktop without use of reflective paints to reduce heat island and improve quality of play

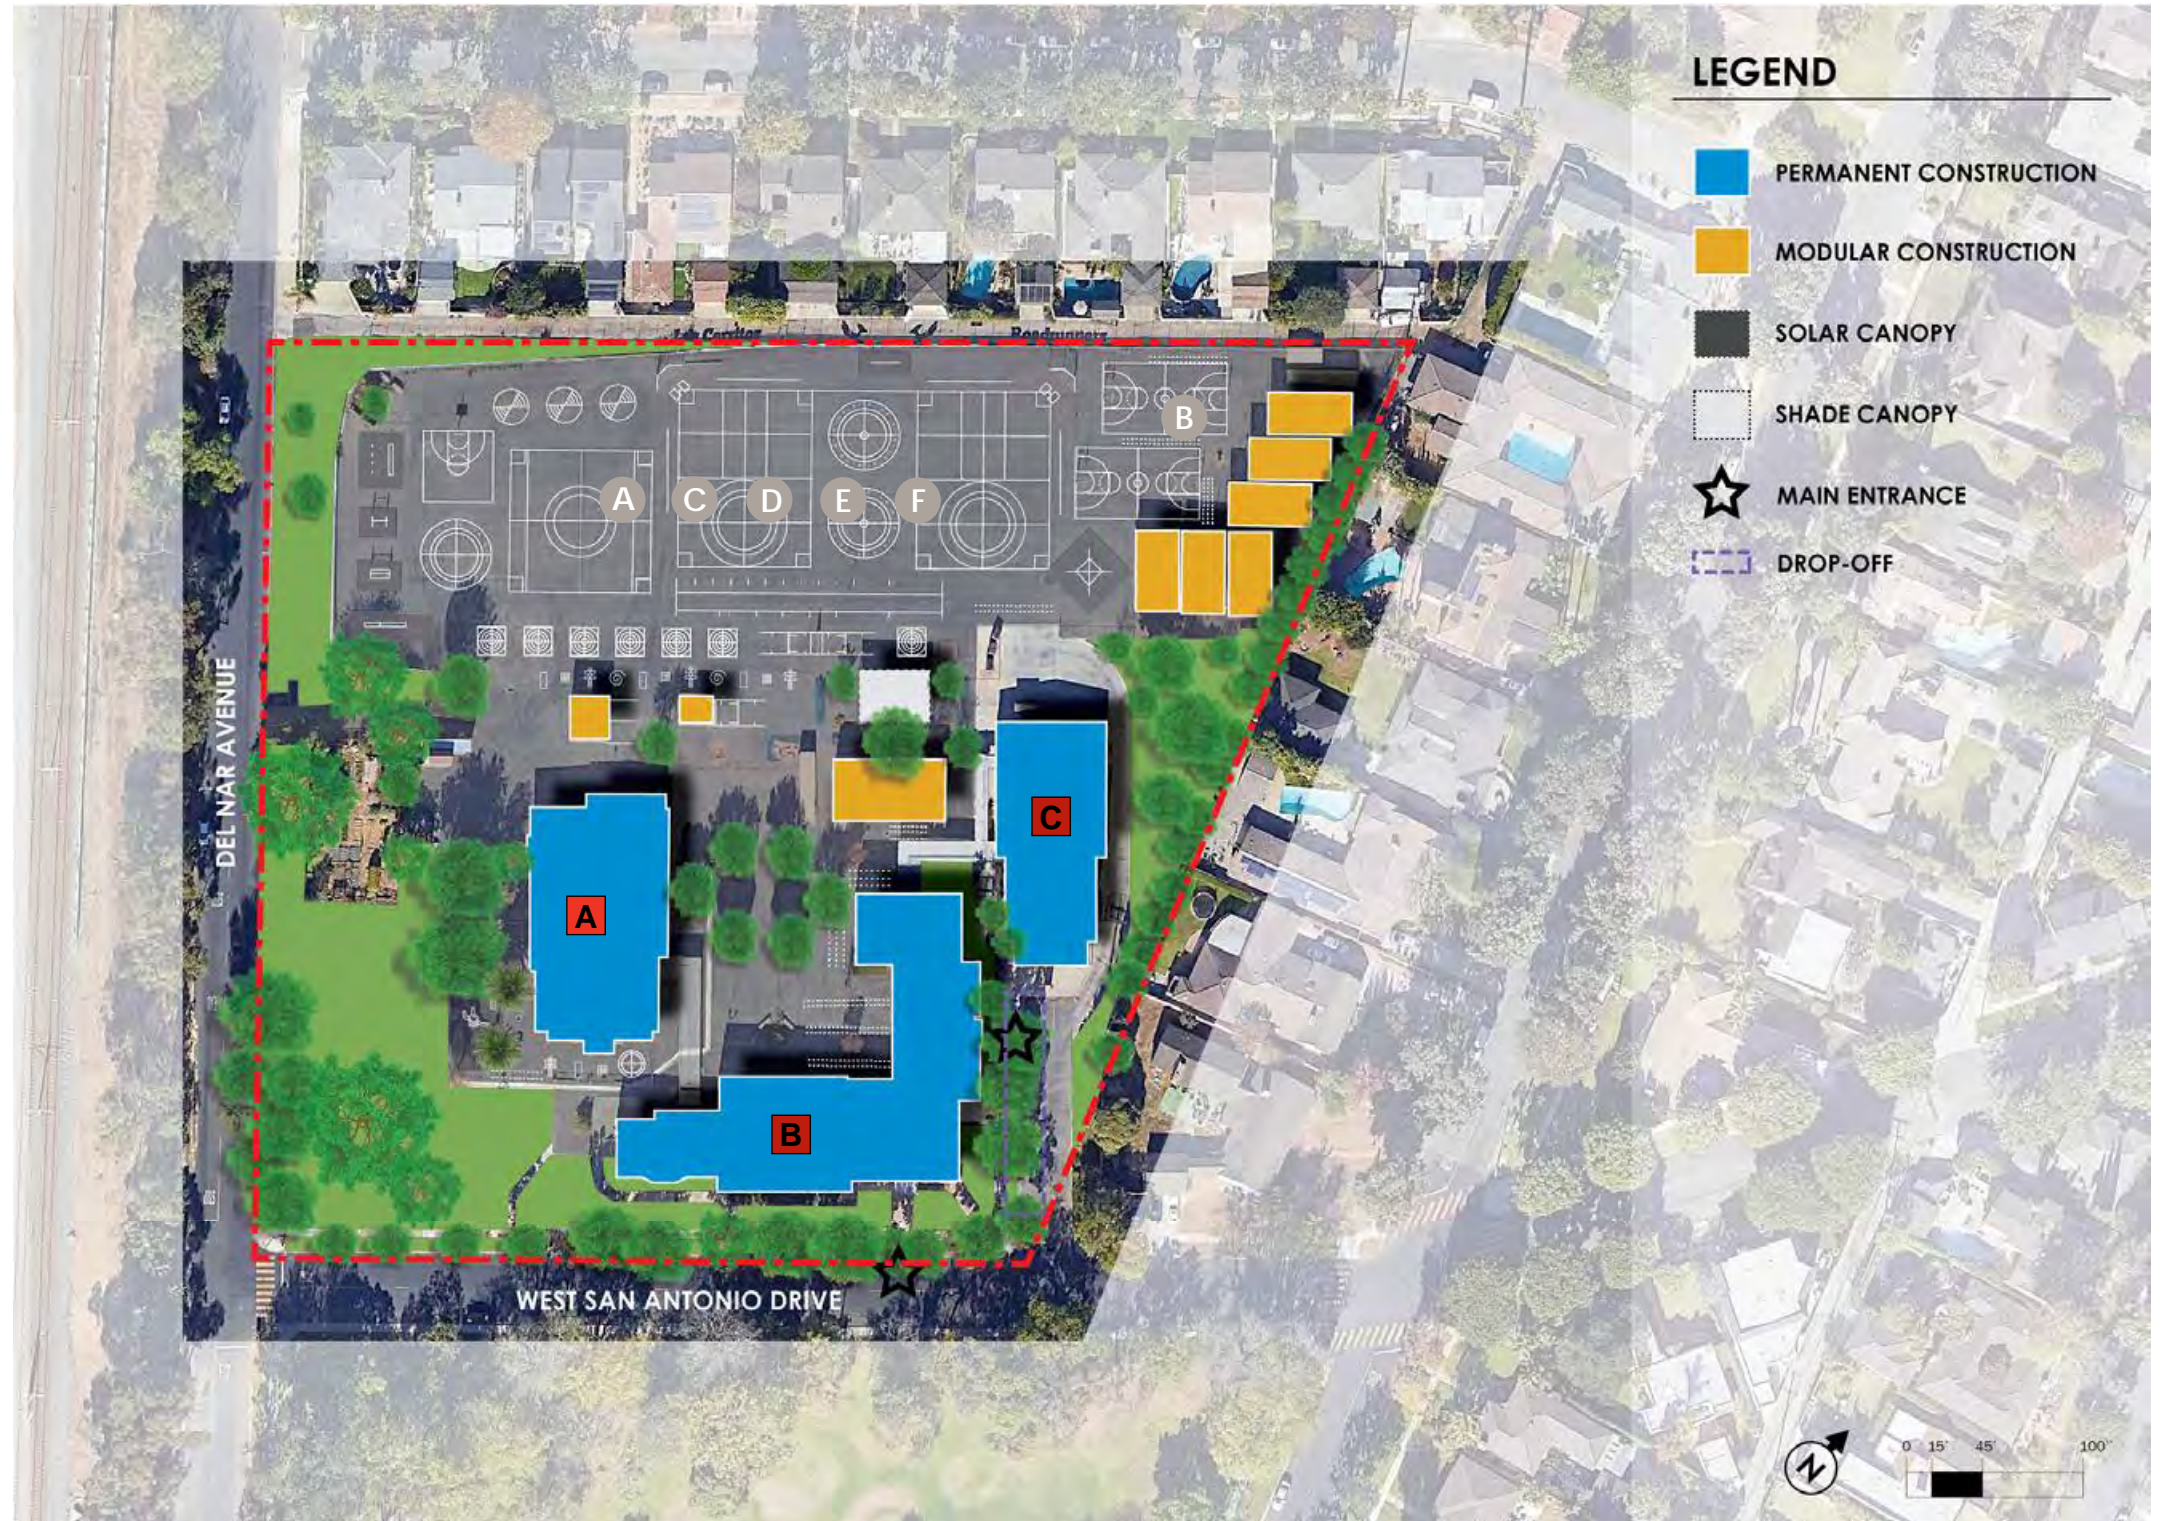
Los Cerritos Elementary School – Existing Space Utilization

Category	Existing	Planning Capacity
Administration	2,751 SF	2,370 SF
Auditorium	3,104 SF	2,891 SF
Library	1,365 SF	1,564 SF
Nutrition Services		
Cafeteria	1,223 SF	1,611 SF
Food Service	651 SF	1,234 SF
Lunch Shelter	820 SF	1,422 SF
Site		
Playground	2.9 Acres	1.4 Acres
Parking	3 Stalls	36 Stalls

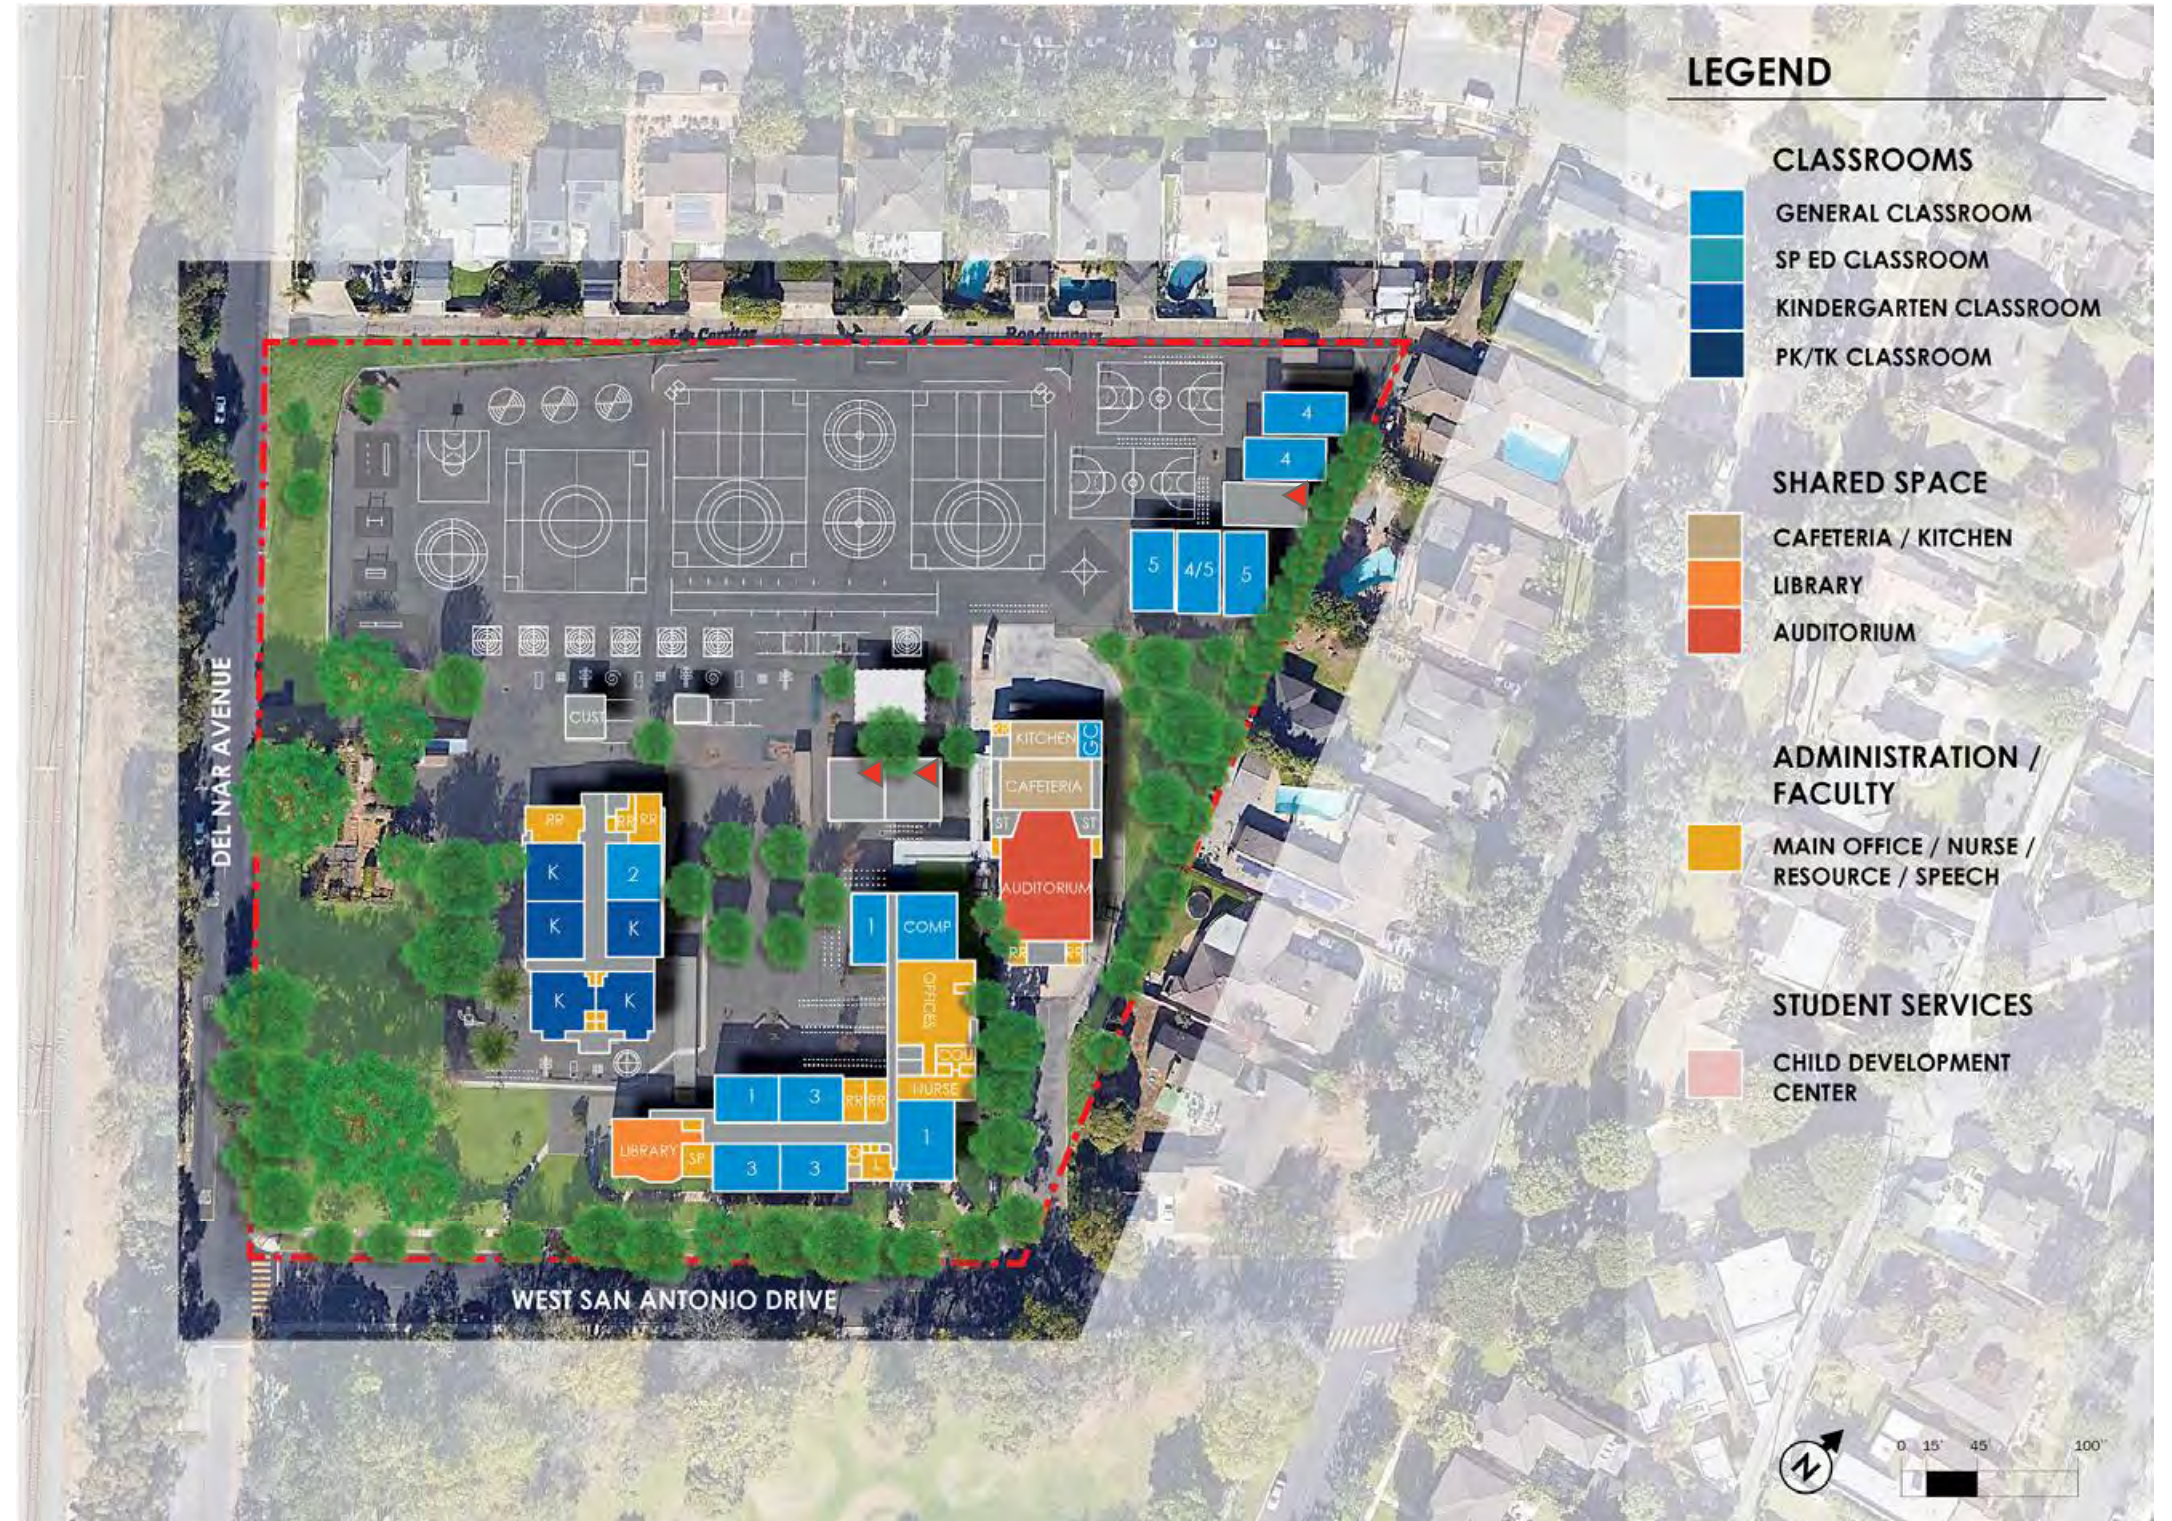
The Los Cerritos Elementary School kitchen is small and cramped. This space is inadequate for the 2021-2022 Enrollment and service model. The food service areas at Los Cerritos Elementary School do not meet current ADA or EHS requirements. The kitchen lacks sufficient dedicated dry storage (which shares the space with the supervisor's office area). The layout space for landing chilled product and reheated product is also inadequate. The service line is accessed within the kitchen space. Due to the size constraints of the kitchen, the service aisles for both the staff and the students are undersized and do not meet ADA requirements. Refrigeration is accommodated by (6) units within the kitchen space and supplemented with minimal overflow refrigerated equipment in the cafeteria. Exposed wood in the kitchen is a potential harbinger for pests and/or vermin and is not allowed per EHS code. The wood stanchions on the food guards; the wood window frames above the sink and the exposed wood guillotine style door near the disposer are not EHS code compliant. The air curtains in both the kitchen and cafeteria are wired to be switch activated. Per EHS code, air curtains should be plunger activated to avoid the possibility of shutting them off while service is in process. There is a double exit door in the cafeteria that do not have EHS required, full width, plunger activated air curtains. The exhaust hood is grossly undersized, non-UL Listed and has no fire suppression system. There is no employee hand sink or dedicated food preparation sink within the kitchen space. There is no ADA accessible entrance to either the kitchen or the cafeteria. This site would benefit from a prototype design to address EHS and DSA code compliance issues and provide an equipment package to meet current and future CNS needs.

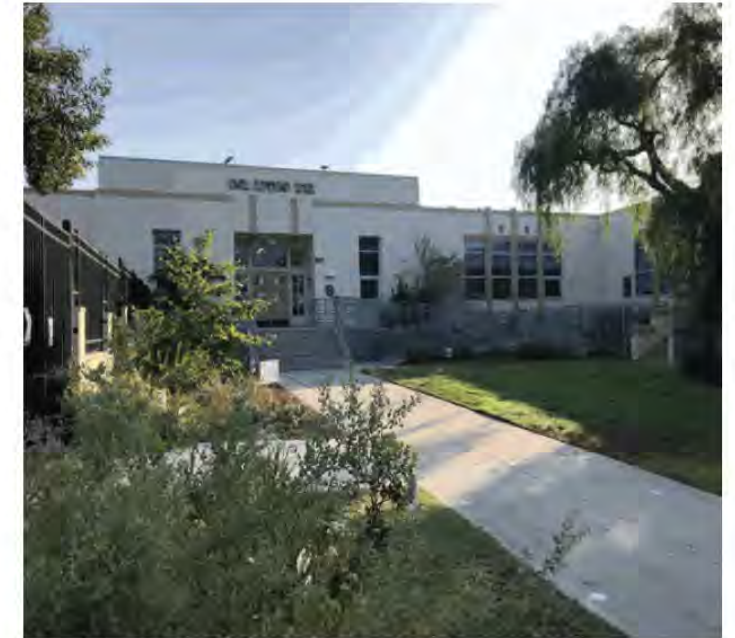
FACILITY CONDITION ASSESSMENT

Disciplines	5 Year DCI Score
Architectural	99
Plumbing	100
Mechanical	100
Fire Protection	100
Electrical	100
Communications	100
Safety and Security	100
Structural	97
5-YR FCI Score, buildings only:	99
Civil	100
5-YR FCI Score including Civil:	99

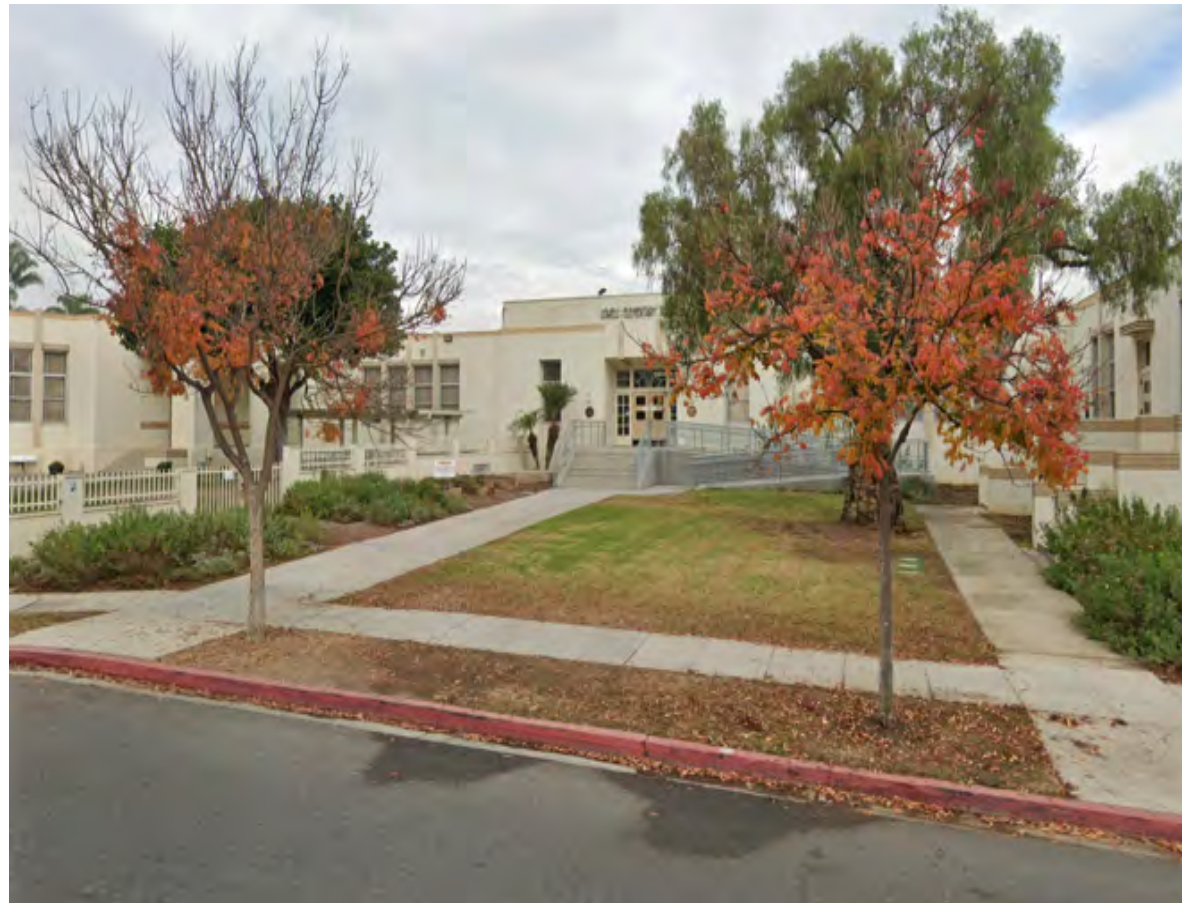
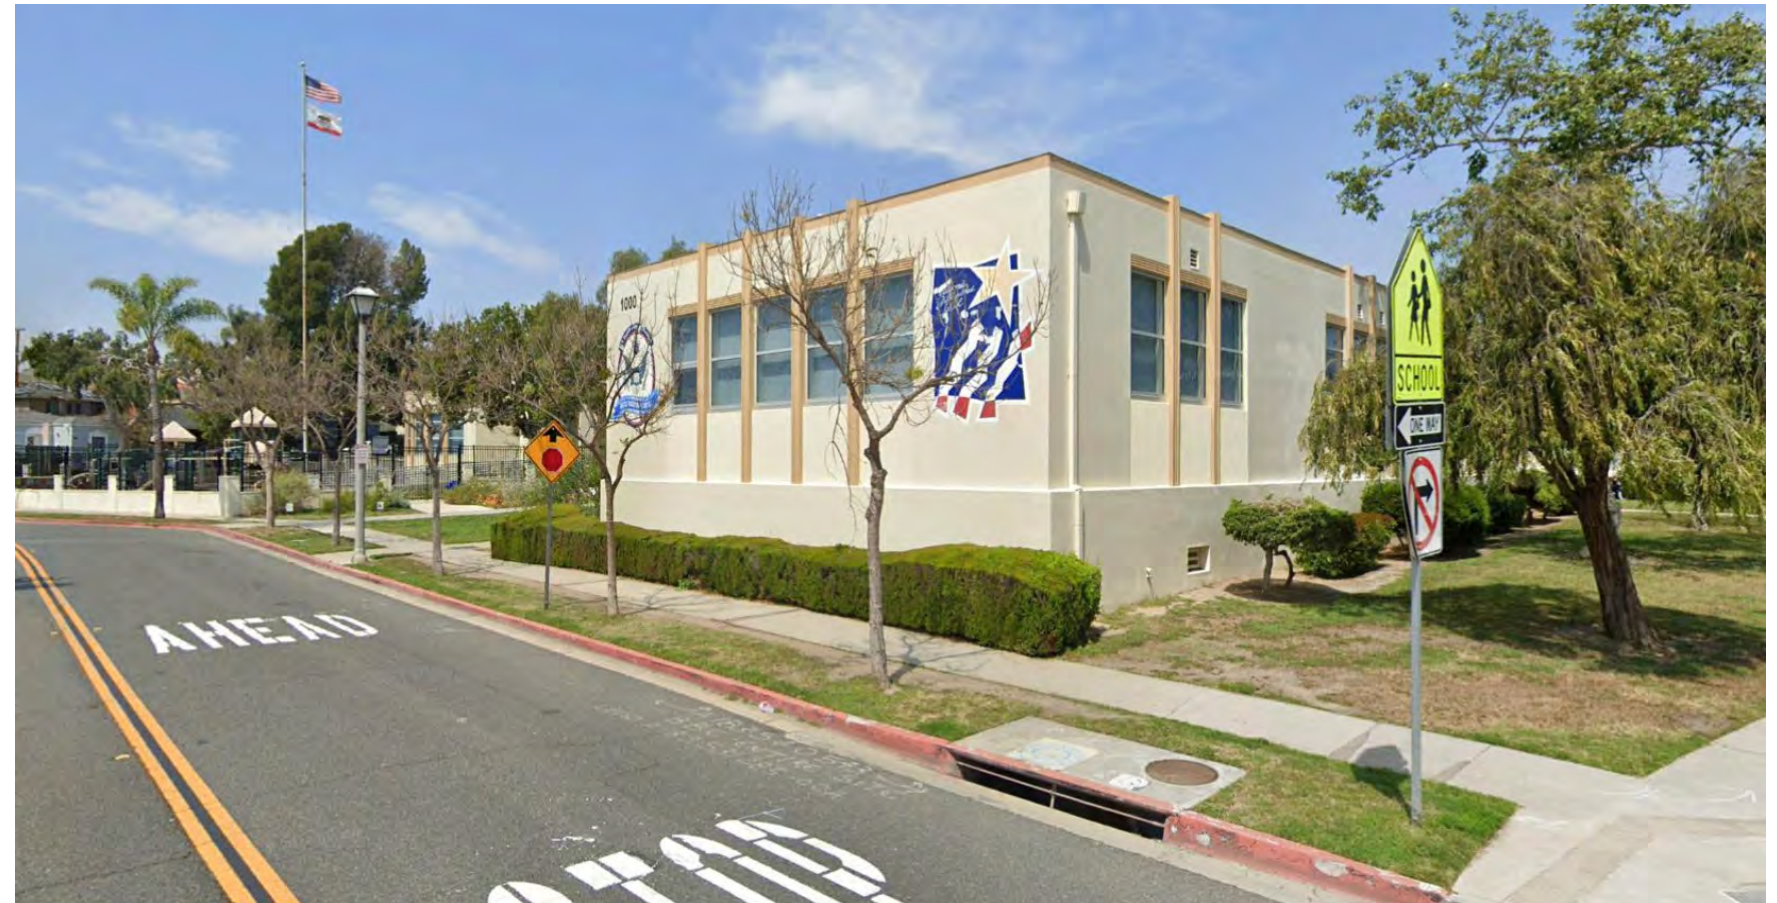
James R. Lowell Bayside Academy – Existing Campus

- D** Visibility and fencing height at outdoor Kinder play from street
- E** Lack of lawn/turf area at main play area
- F** Lack of shade trees at play area
- G** Significant large areas of blacktop without use of reflective paints to reduce heat island and improve quality of play
