LBUSD 2022 Facility Master Plan

Long Beach Unified School District
Appendices

July 2022

A Facility Reports: Elementary Schools

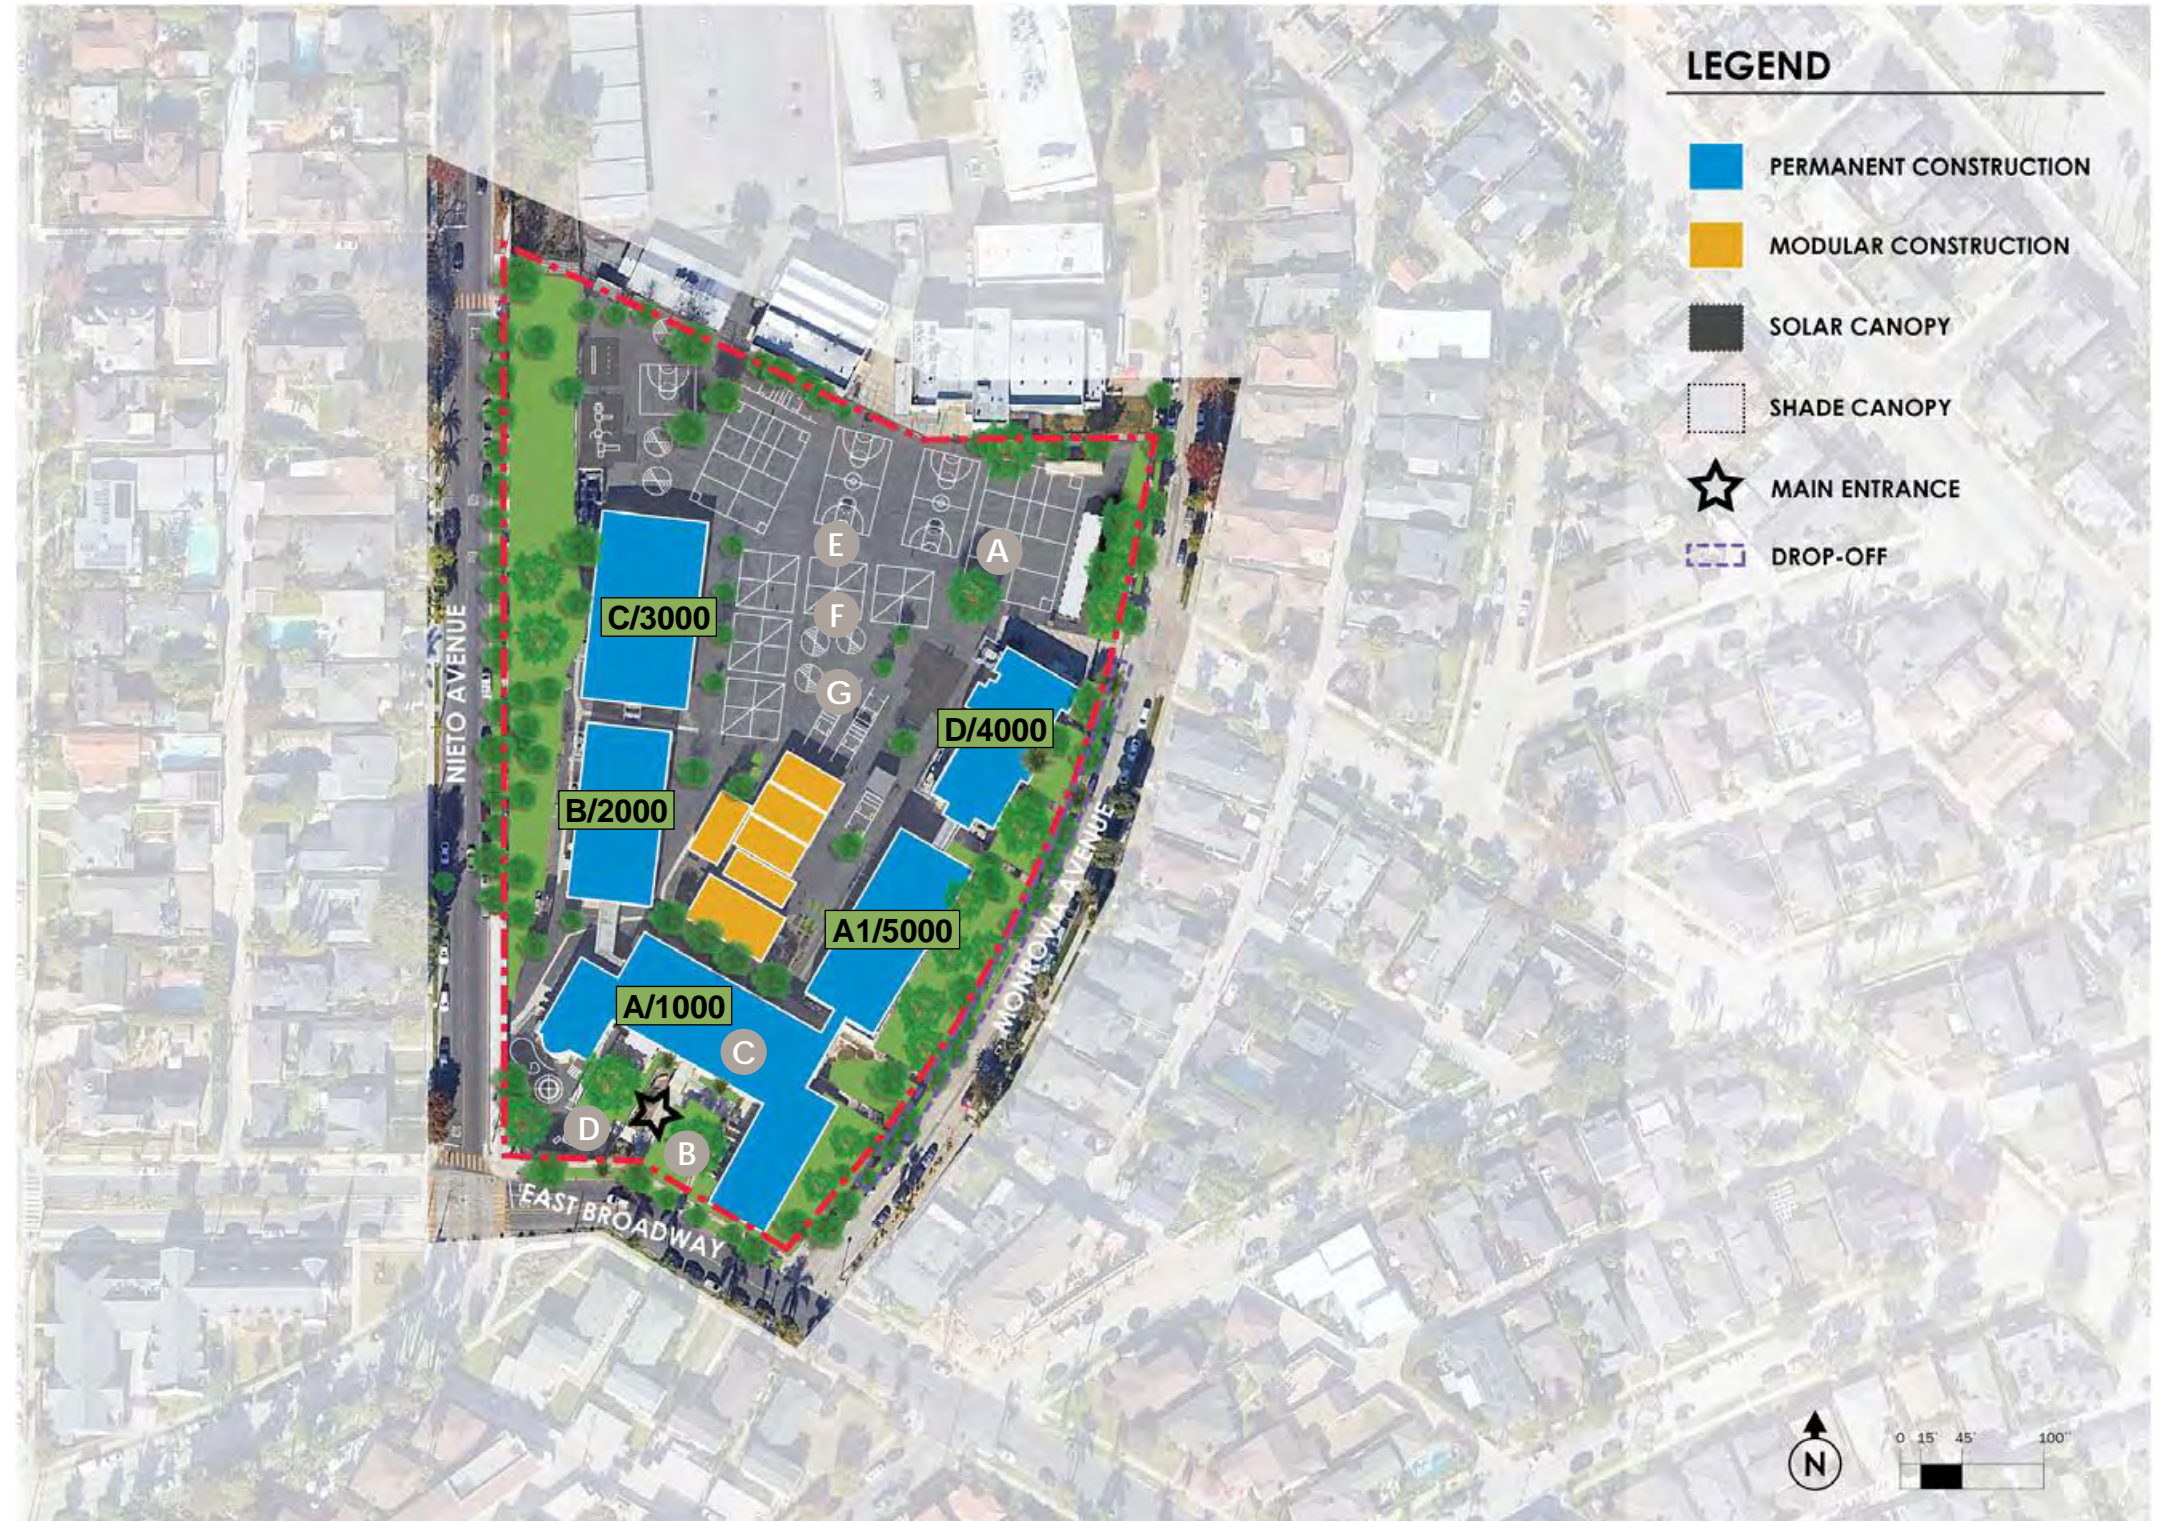
The Lowell Elementary School kitchen is small and cramped. Though recently renovated as part of the LBusD HVAC Construction project, the food service areas at Lowell Elementary School do not meet current ADA or EHS requirements. The kitchen lacks sufficient dedicated dry storage (which shares the space with the supervisor's office area). Chemicals are being stored in the dry storage room. Although not a compliance issue, it is also not considered best practices. The layout space for landing chilled product and reheated product is also inadequate. The service line is accessed within the kitchen space. Due to the size constraints of the kitchen, the service aisles for both the staff and the students are undersized and do not meet ADA requirements. Refrigeration is accommodated by (5) units within the kitchen space and supplemented with an additional unit in the cafeteria. There are (2) double exit doors in the cafeteria that do not have EHS required, full width, plunger activated air curtains. Wall flashing is required behind (which includes below) all wet areas including but not limited to sinks and disposers. There is no dedicated food preparation sink within the kitchen space. This site would benefit from a prototype design to address EHS and DSA code compliance issues and provide an equipment package to meet current and future CNS needs.

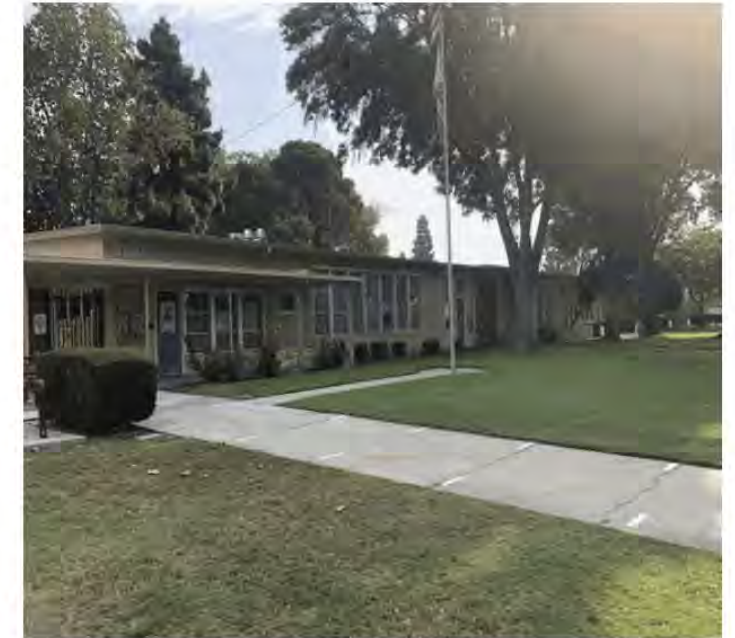
FACILITY CONDITION ASSESSMENT

Disciplines	5 Year DCI Score
Architectural	99
Plumbing	97
Mechanical	98
Fire Protection	99
Electrical	98
Communications	99
Safety and Security	100
Structural	98
5-YR FCI Score, buildings only: 98	
Civil	100
5-YR FCI Score including Civil: 99

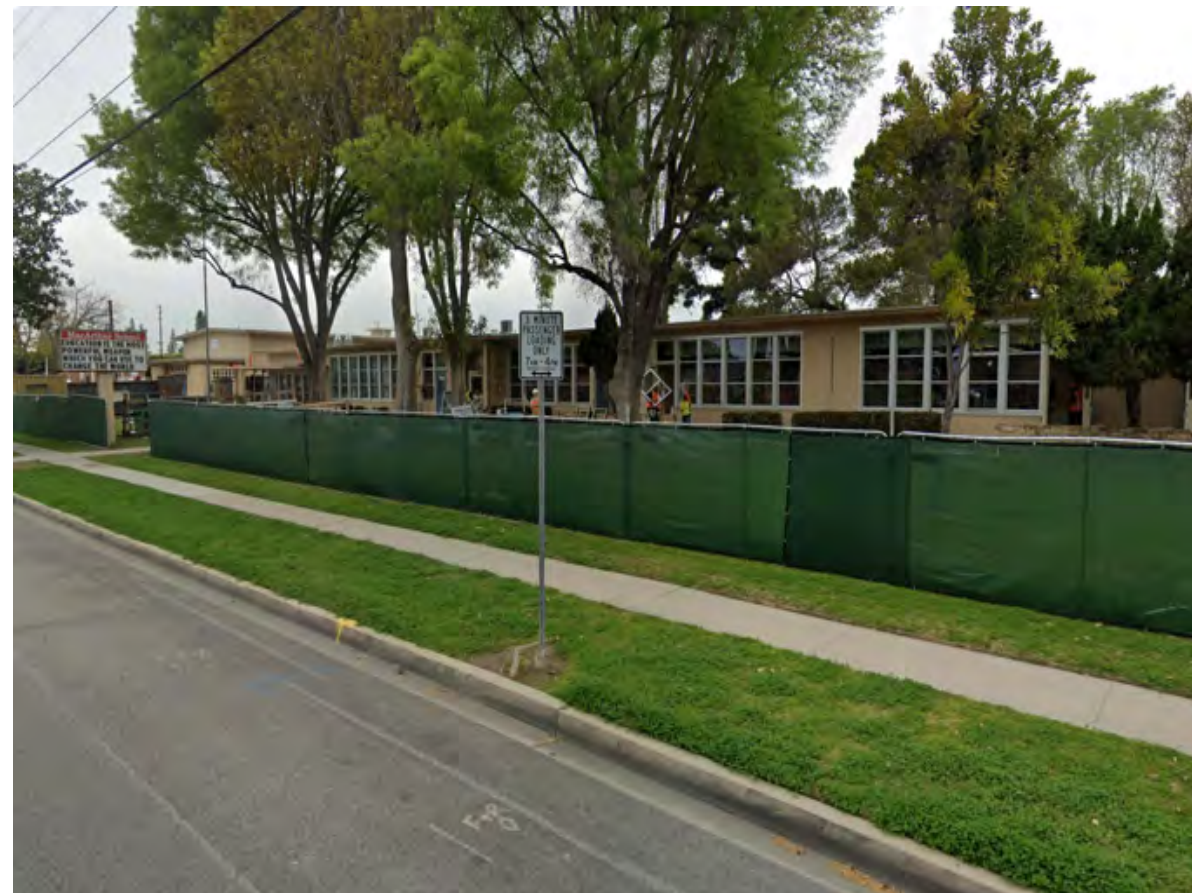
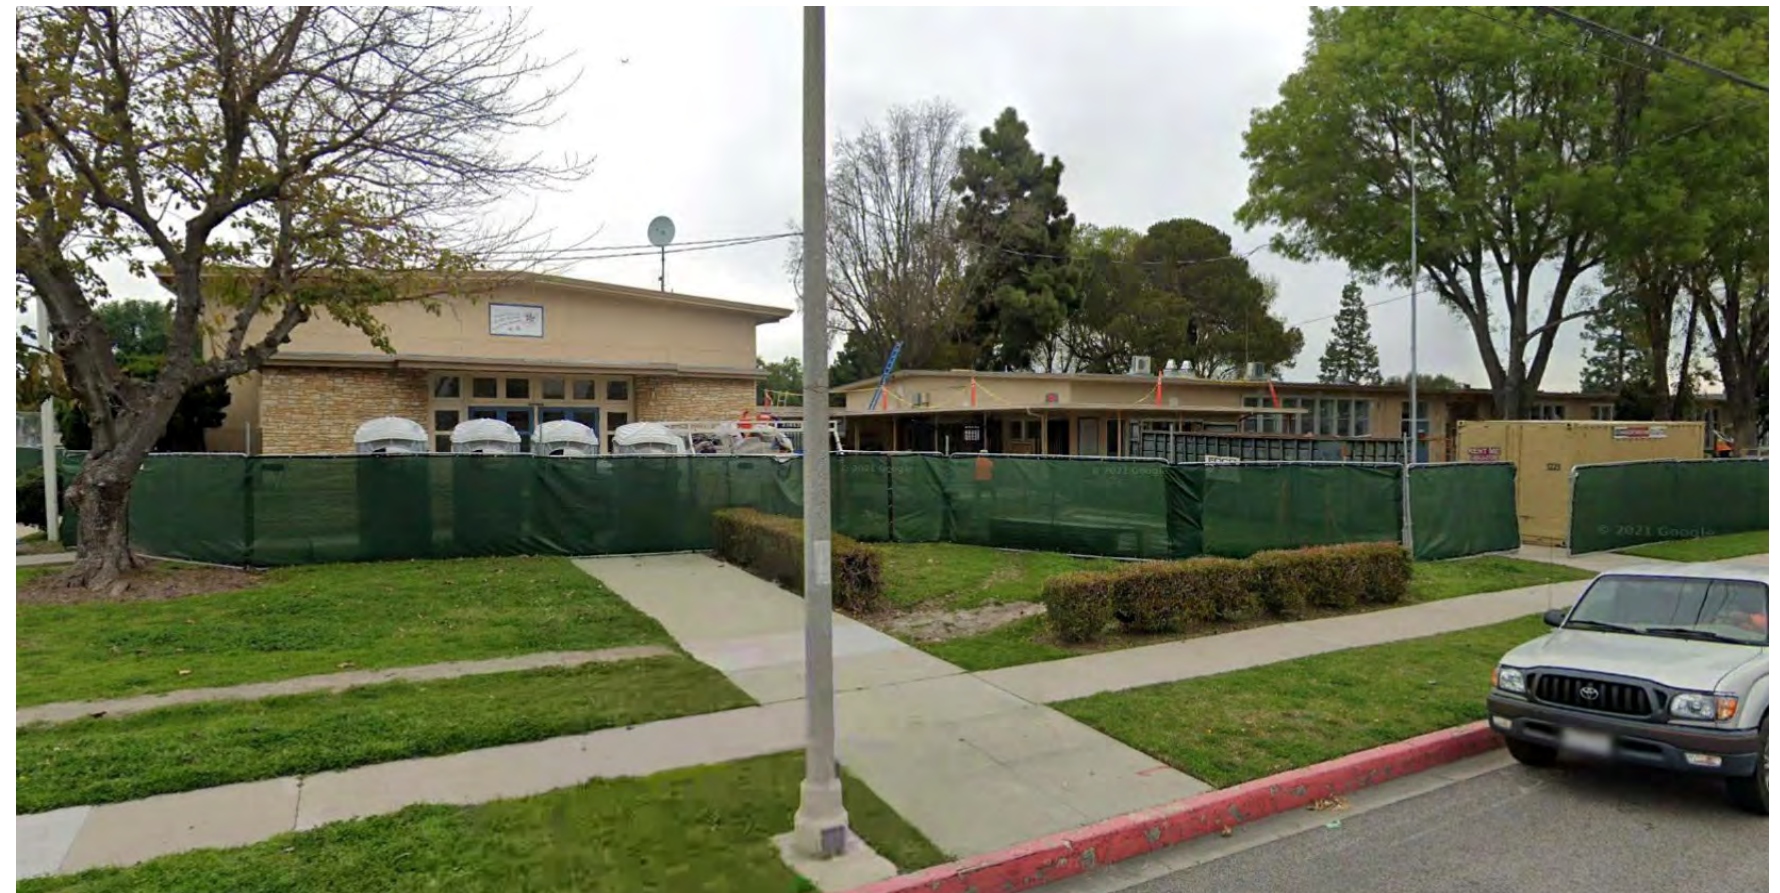
Douglas MacArthur Elementary School – Existing Campus

Facility Condition (by Bldg)

- B** Visibility of outdoor Kinder play from street
- C** Lack of lawn/turf area at main play area
- D** Lack of educational play equipment and natural elements at outdoor play area
- E** Lack of adequate apparatus play zone for younger learners
- F** Lack of shade trees at play area
- G** Significant large areas of blacktop without use of reflective paints to reduce heat island and improve quality of play

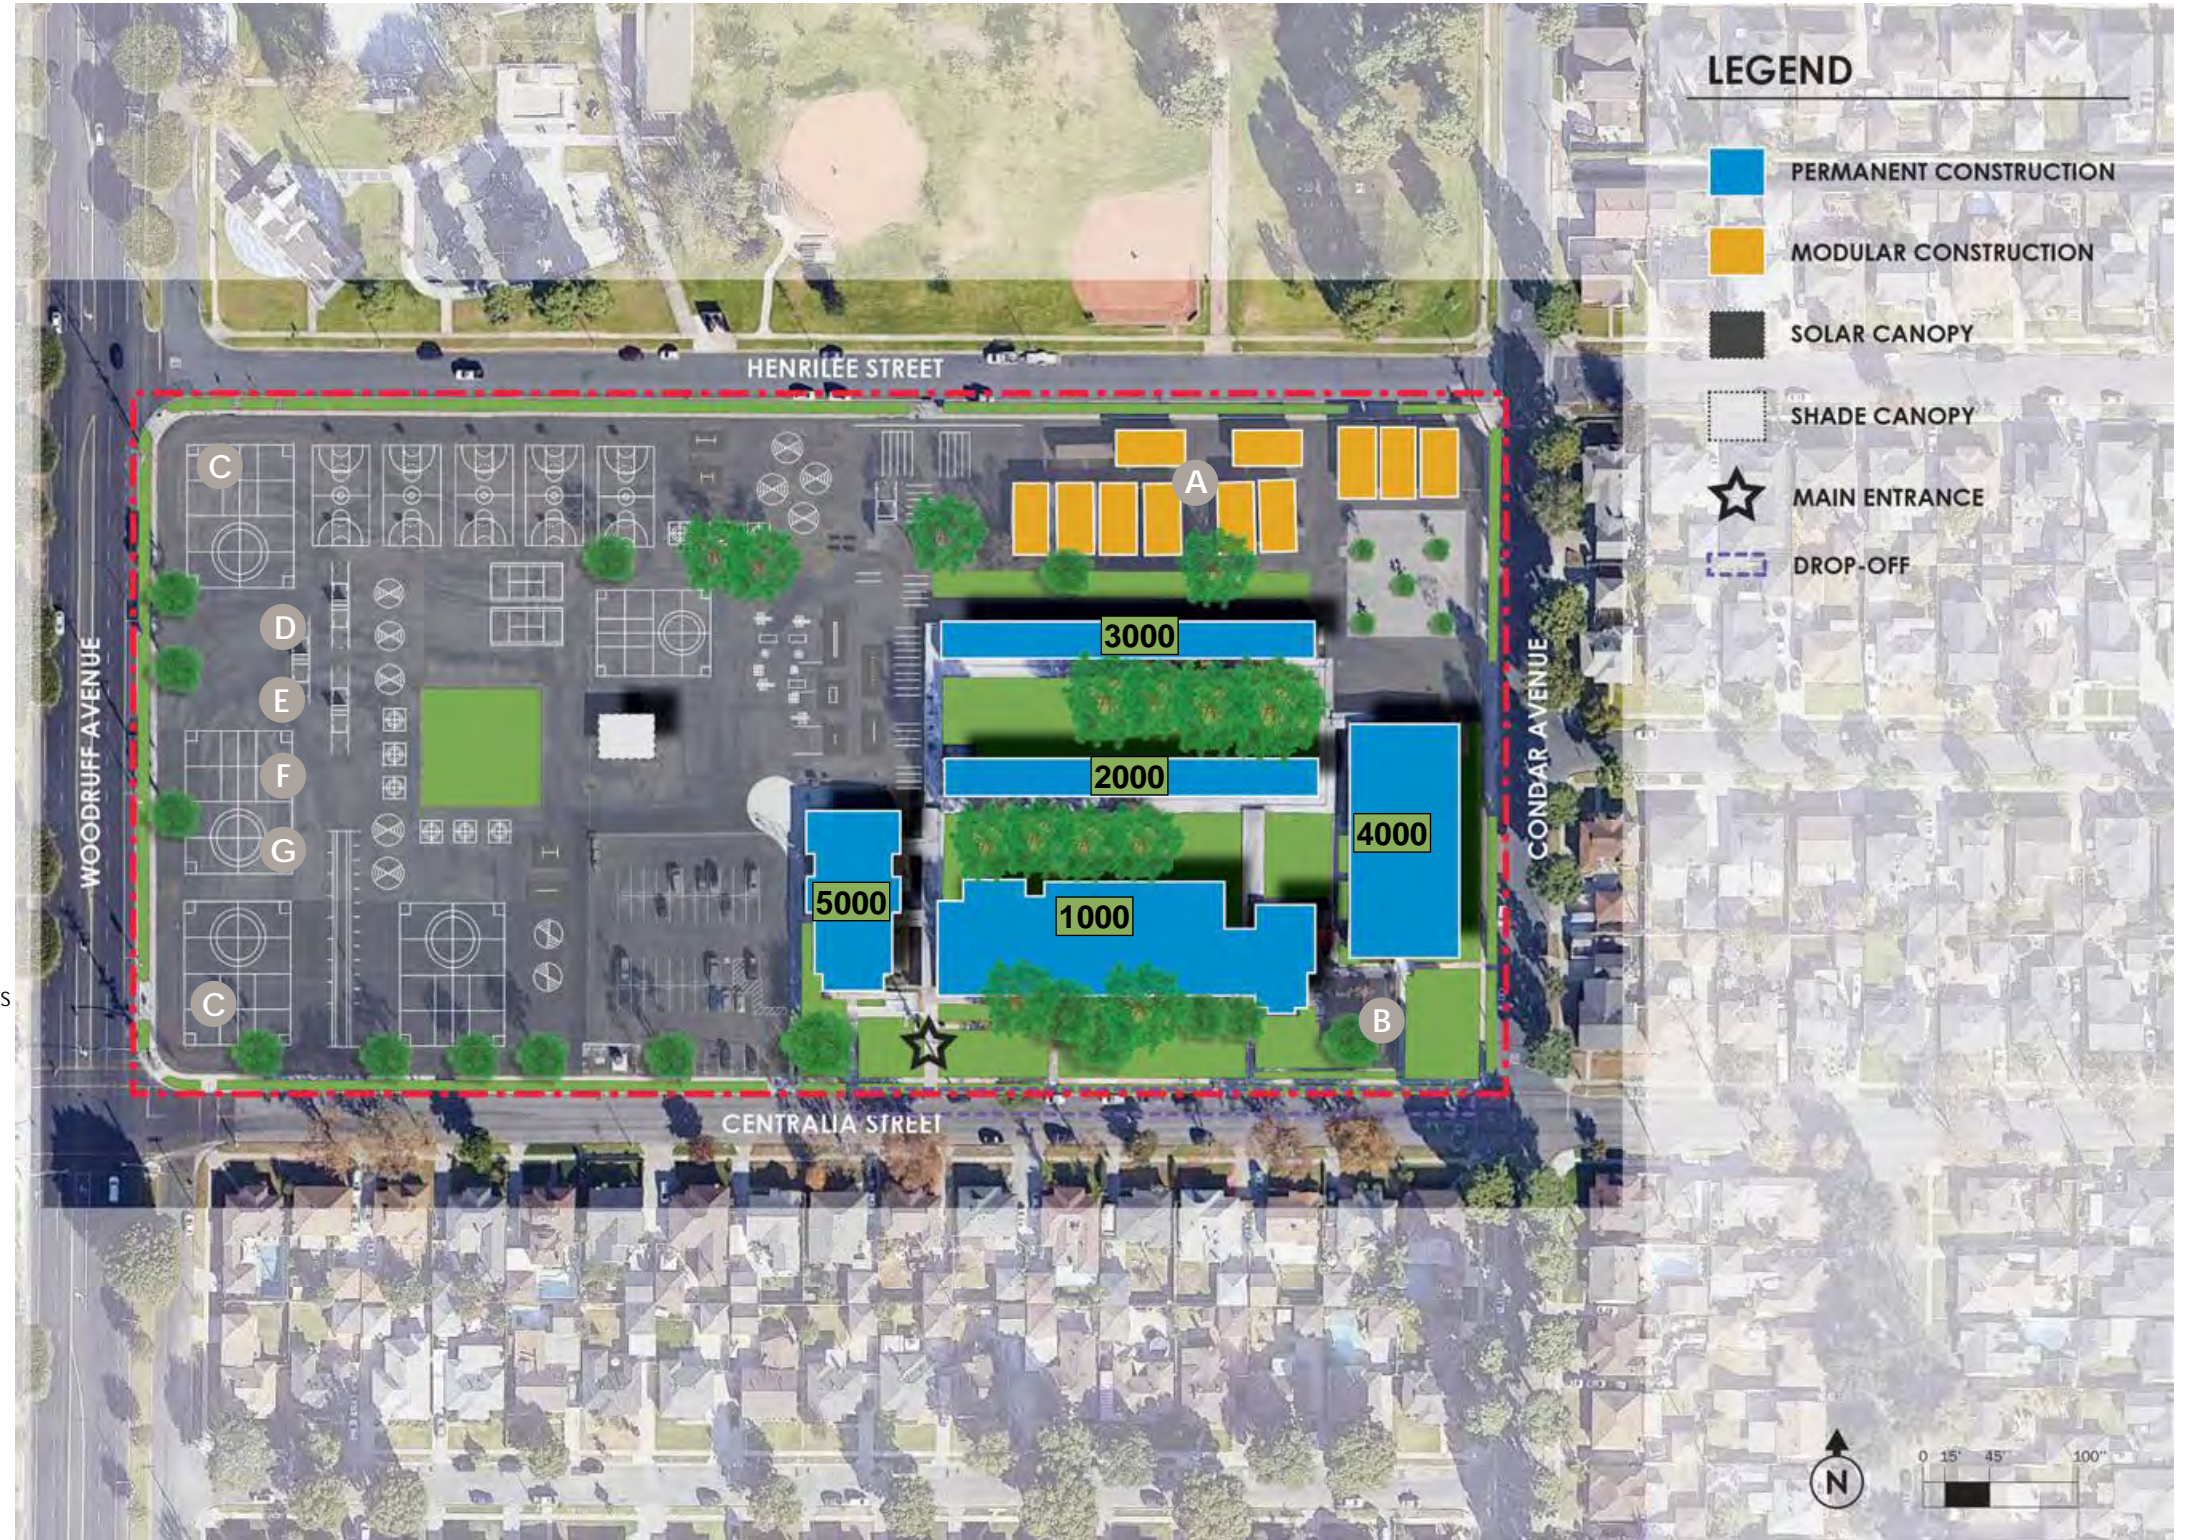
Douglas MacArthur Elementary School – Existing Space Utilization

Category	Existing	Planning Capacity
Administration	2,160 SF	1,505 SF
Auditorium	3,281 SF	1,836 SF
Library	1,596 SF	993 SF
Nutrition Services		
Cafeteria	1,236 SF	1,023 SF
Food Service	717 SF	783 SF
Lunch Shelter	820 SF	903 SF
Site		
Playground	4.9 Acres	1.4 Acres
Parking	50 Stalls	23 Stalls

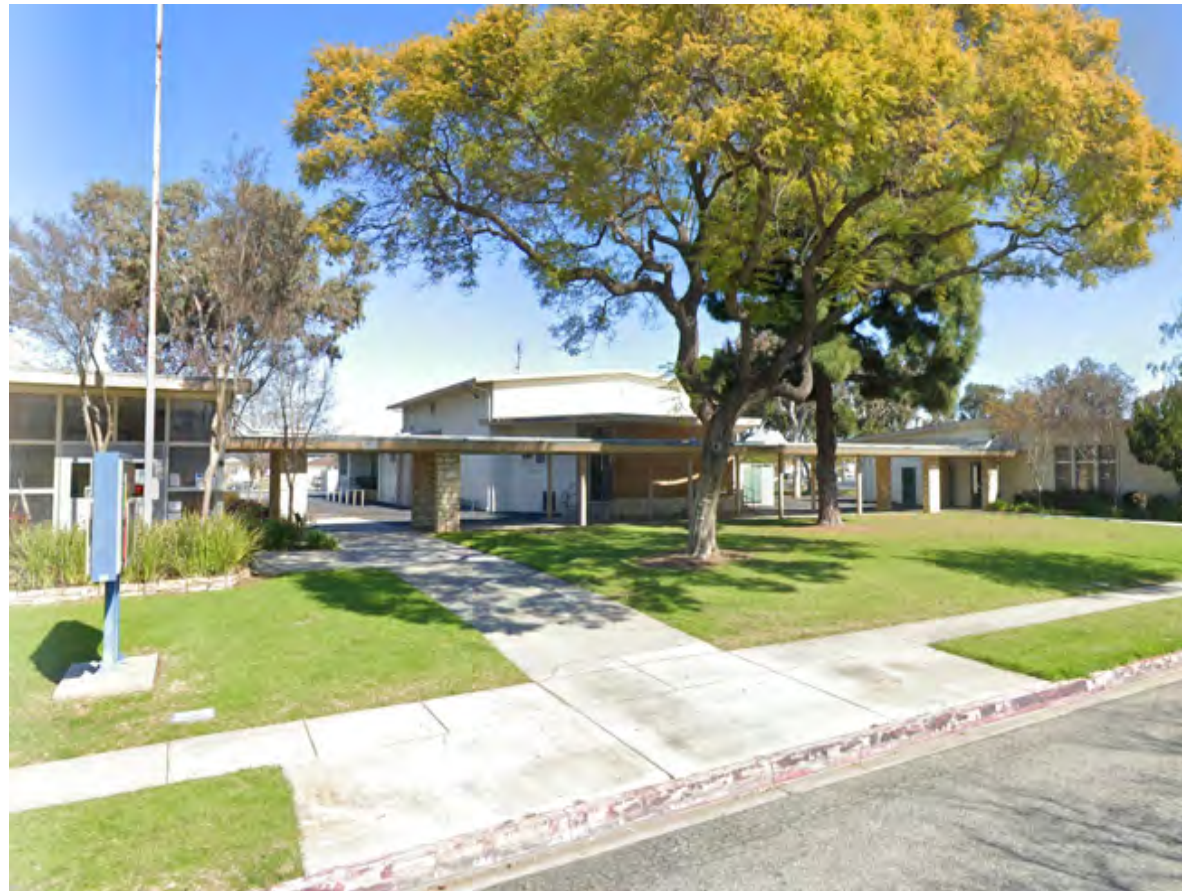
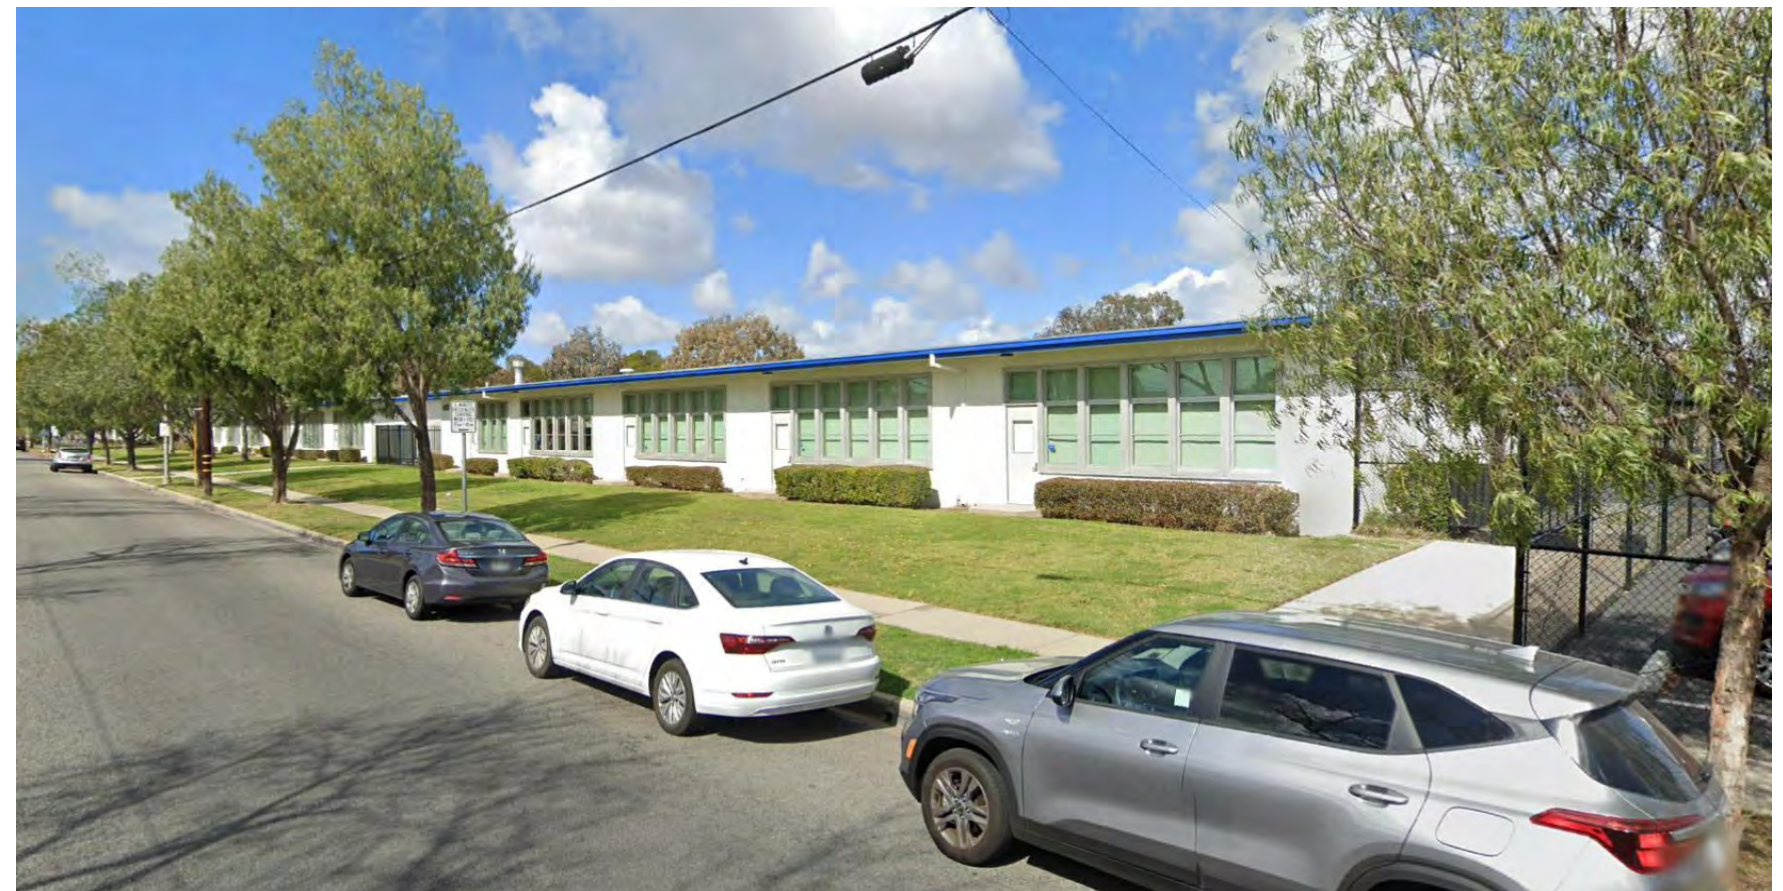
James Madison Elementary School – Existing Campus

Facility Condition (by Bldg)

- E** Visibility of outdoor Kinder play from street
- F** Lack of lawn/turf area at main play area
- G** Significant large areas of blacktop without use of reflective paints to reduce heat island and improve quality of play

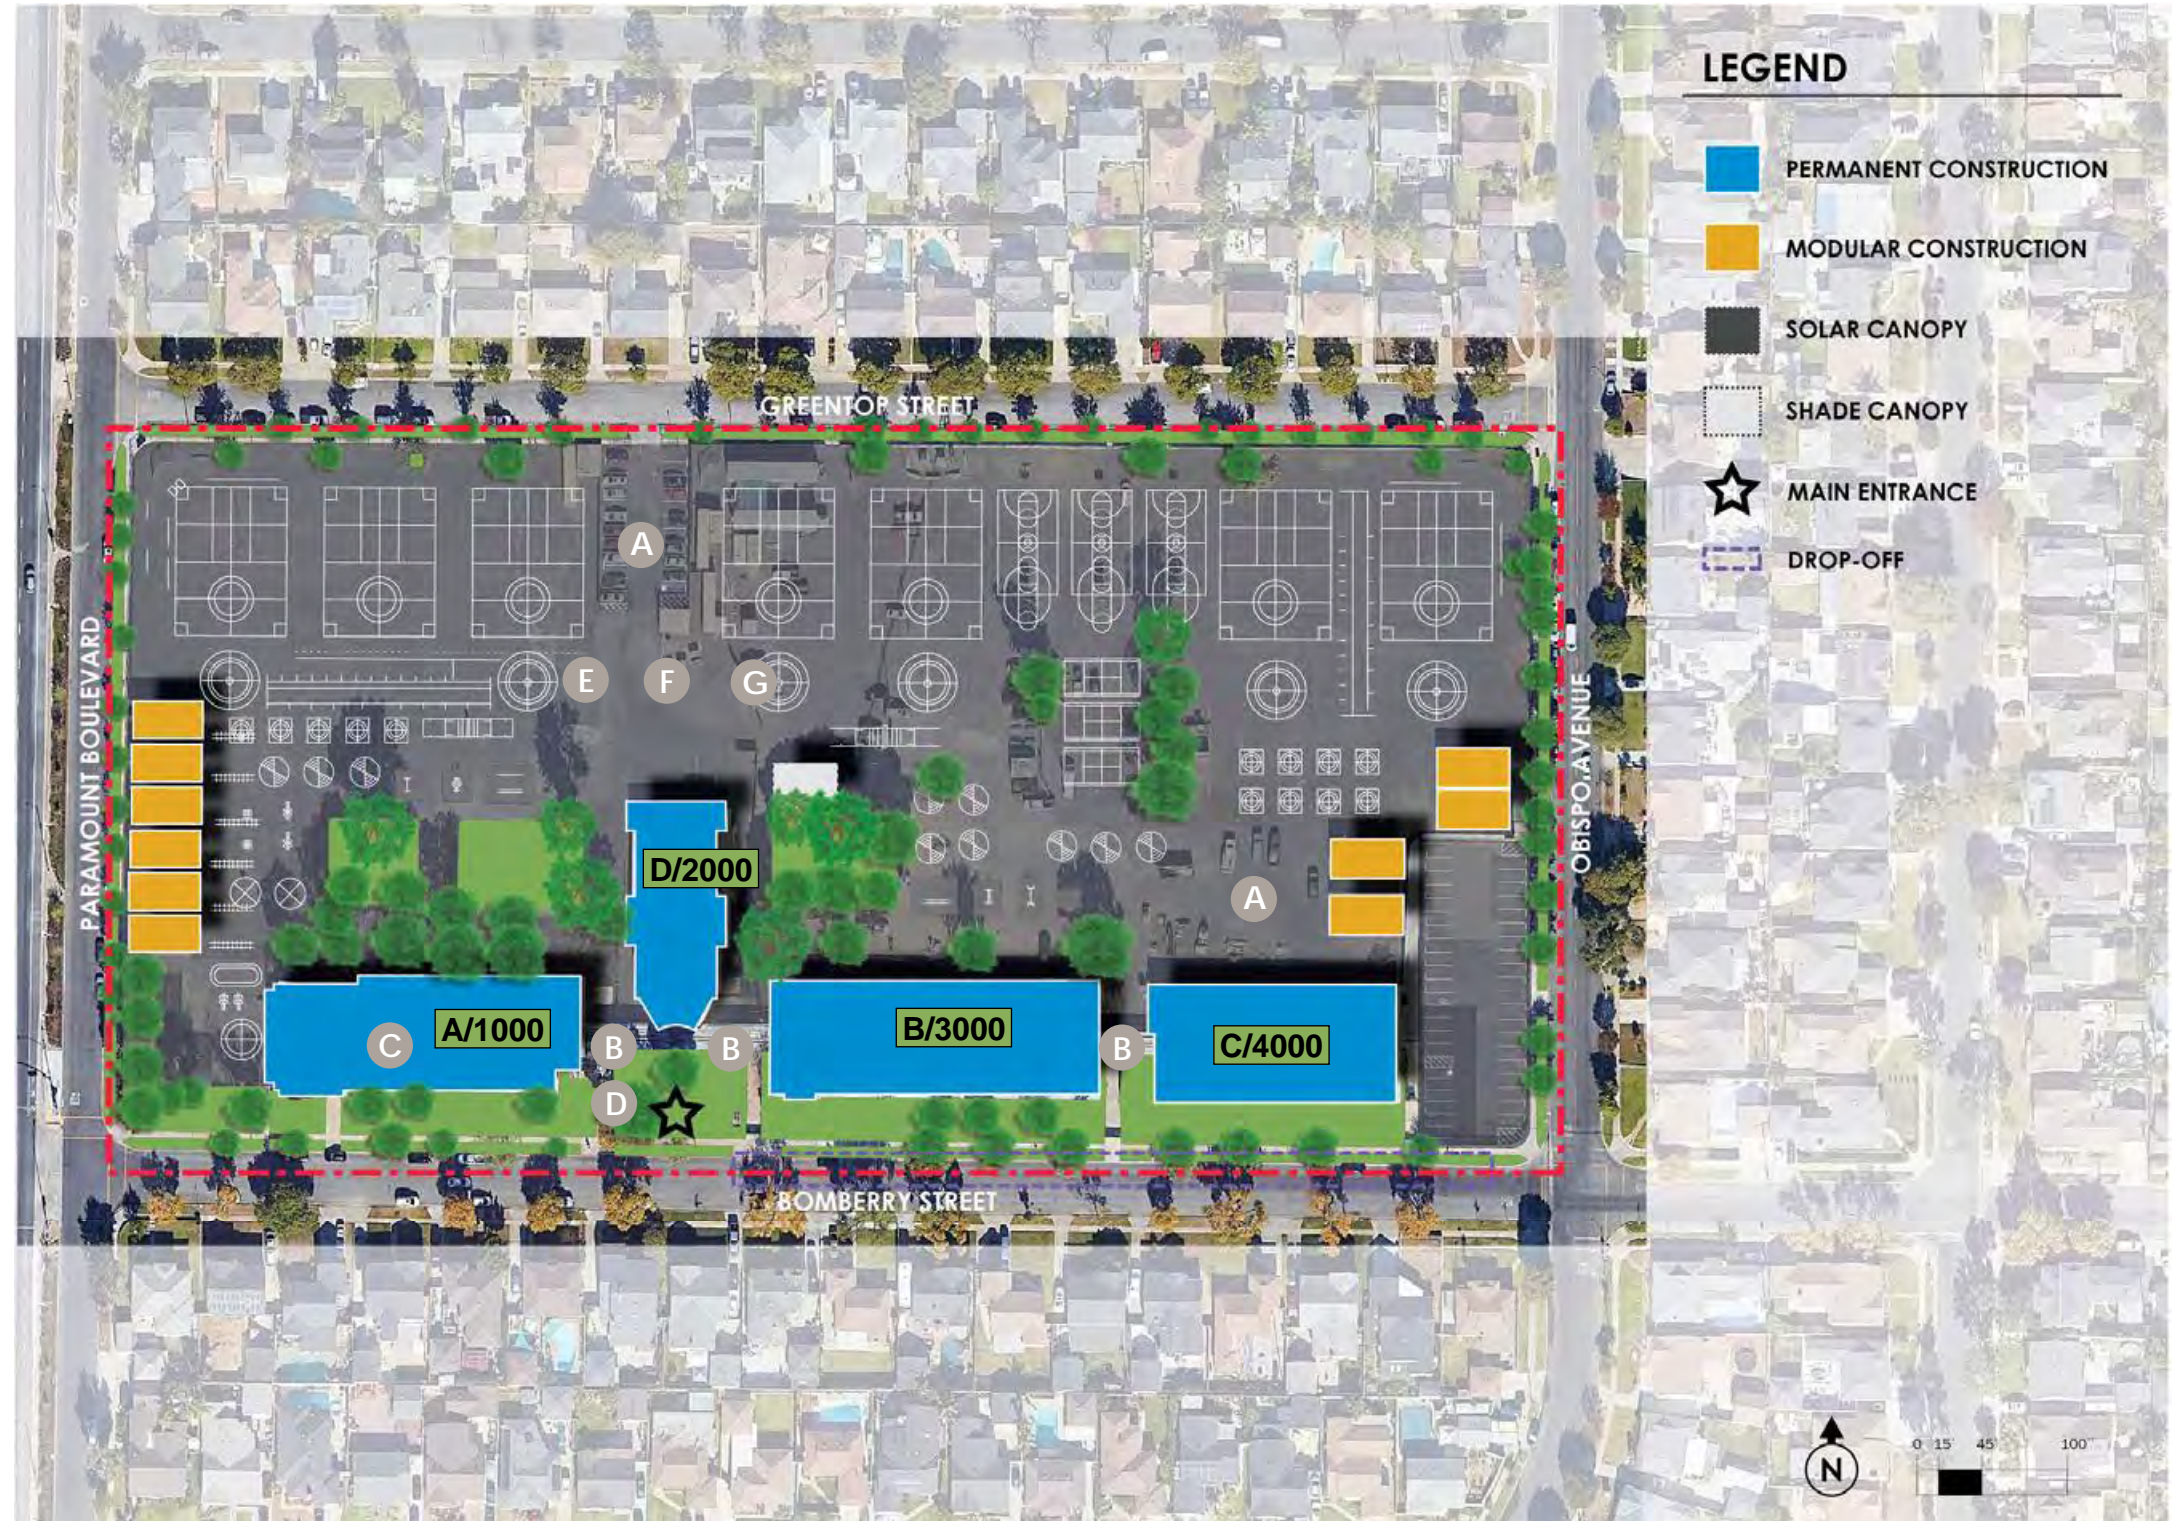
James Madison Elementary School – Existing Space Utilization

Category	Existing	Planning Capacity
Administration	1,694 SF	1,740 SF
Auditorium	3,751 SF	2,123 SF
Library	1,238 SF	1,148 SF
Nutrition Services		
Cafeteria	2,023 SF	1,183 SF
Food Service	716 SF	905 SF
Lunch Shelter	820 SF	1,044 SF
Site		
Playground	5.8 Acres	1.4 Acres
Parking	60 Stalls	27 Stalls

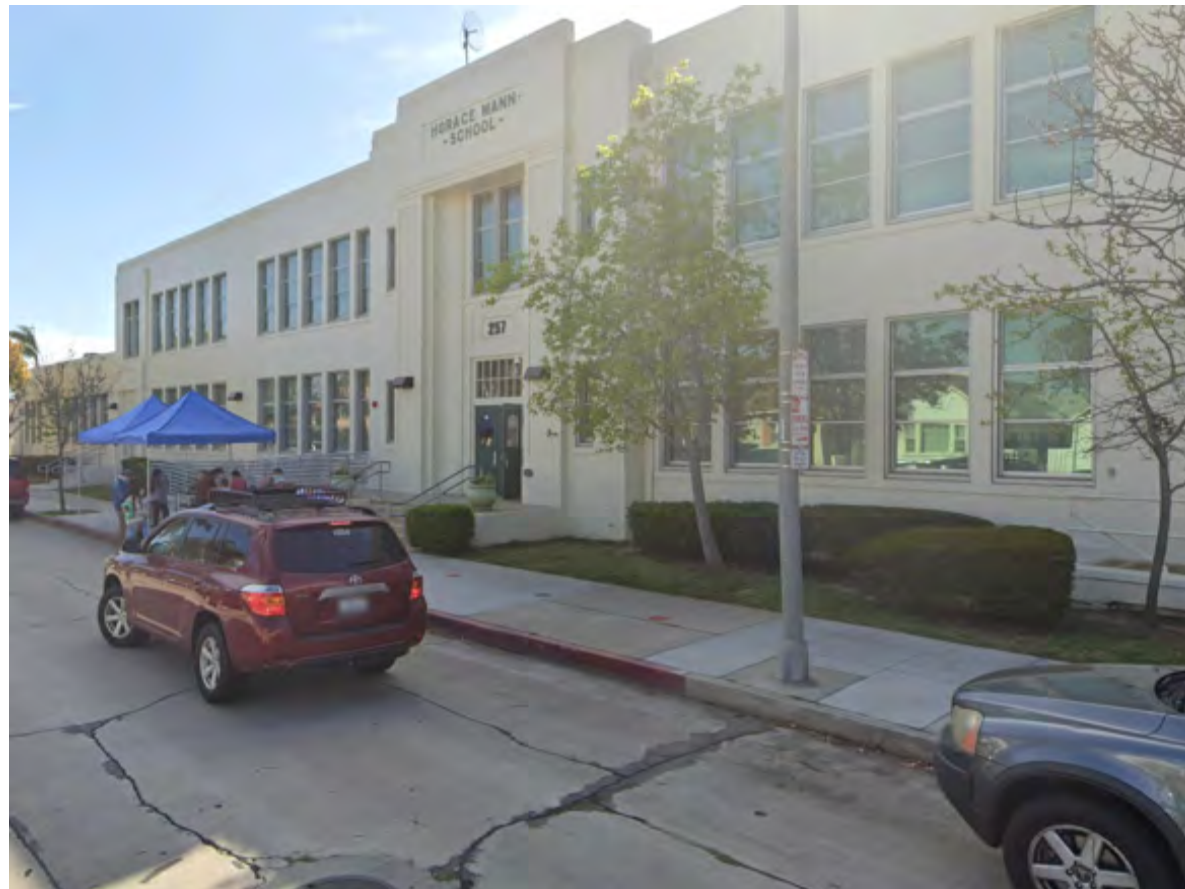
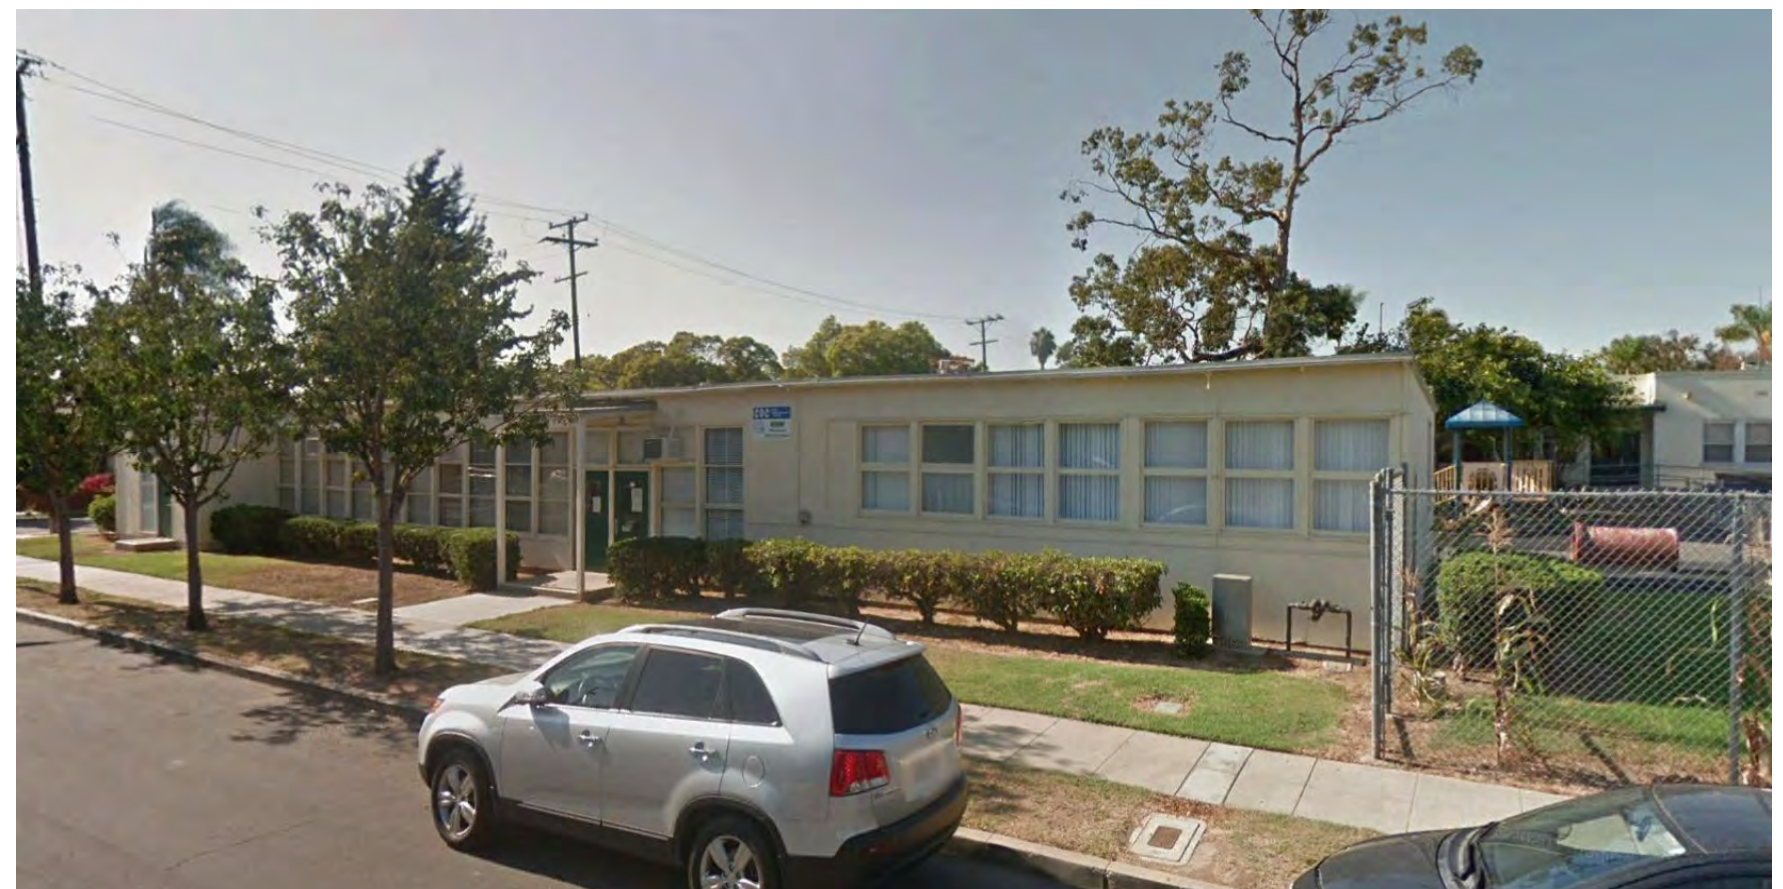
Horace Mann Elementary School – Existing Campus

Facility Condition (by Bldg)

F Lack of shade trees at play area

G Significant large areas of blacktop without use of reflective paints to reduce heat island and improve quality of play

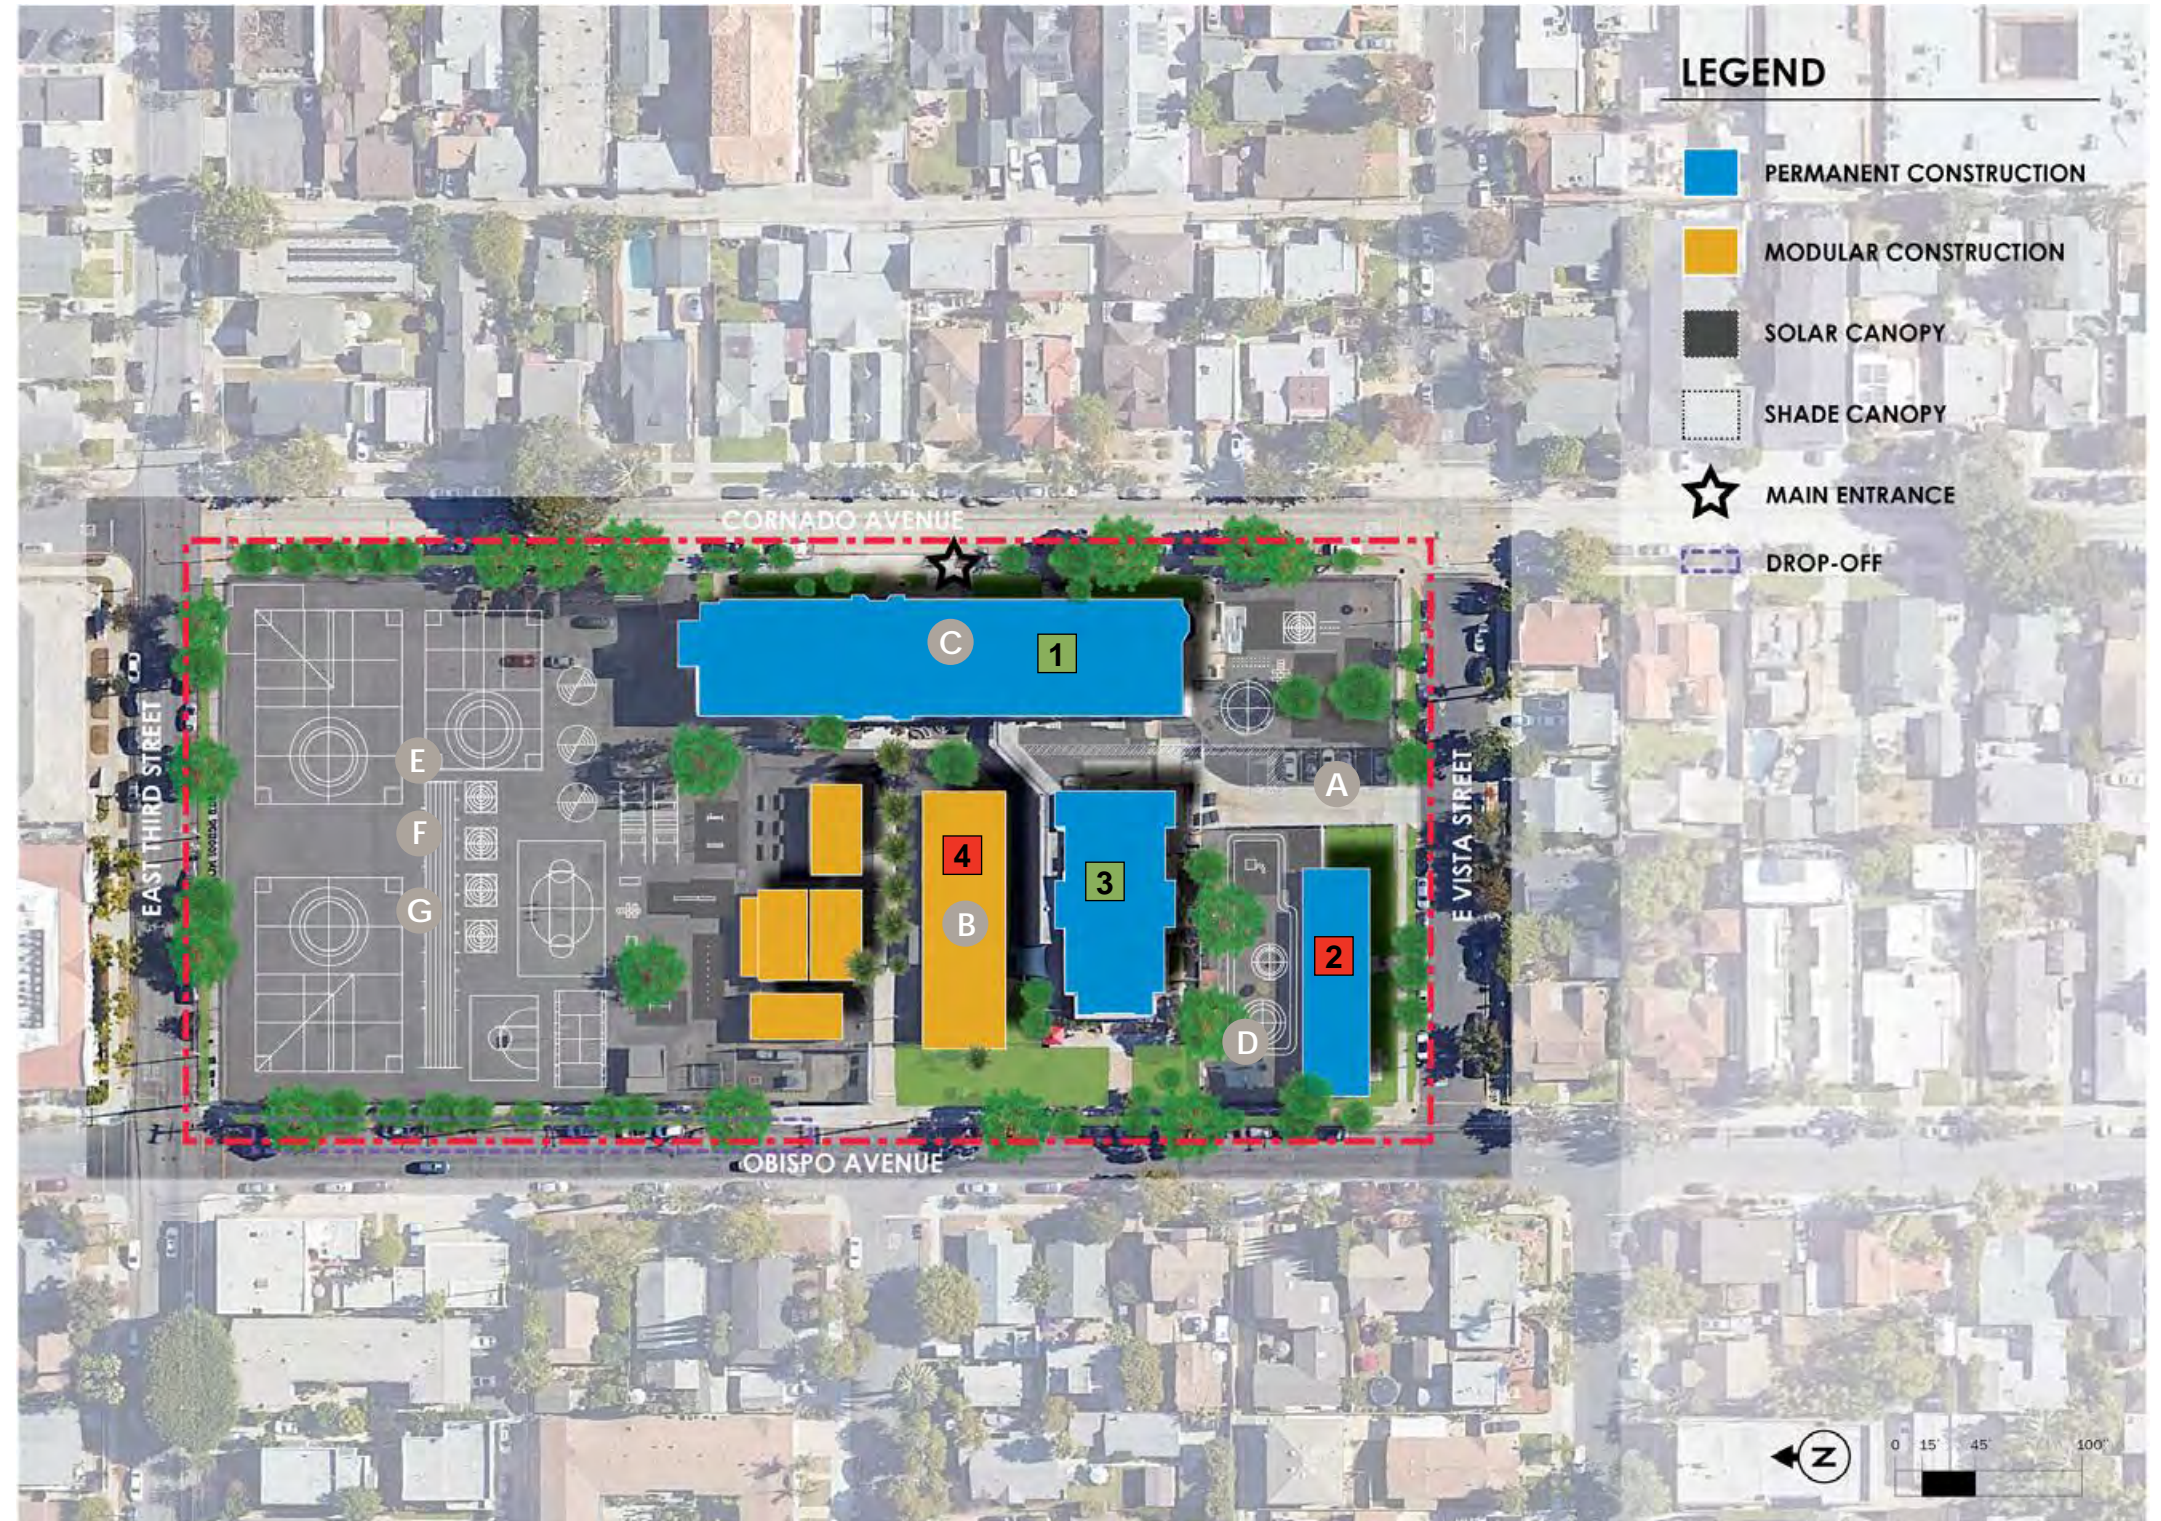
Horace Mann Elementary School – Existing Space Utilization

Category	Existing	Planning Capacity
Administration	2,675 SF	1,605 SF
Auditorium	3,316 SF	1,958 SF
Library	1,247 SF	1,059 SF
Nutrition Services		
Cafeteria	1,299 SF	1,091 SF
Food Service	724 SF	835 SF
Lunch Shelter	N/A	963 SF
Site		
Playground	2.2 Acres	1.4 Acres
Parking	12 Stalls	25 Stalls
