LBUSD 2022 Facility Master Plan

Long Beach Unified School District
Appendices

July 2022

A Facility Reports: Elementary Schools

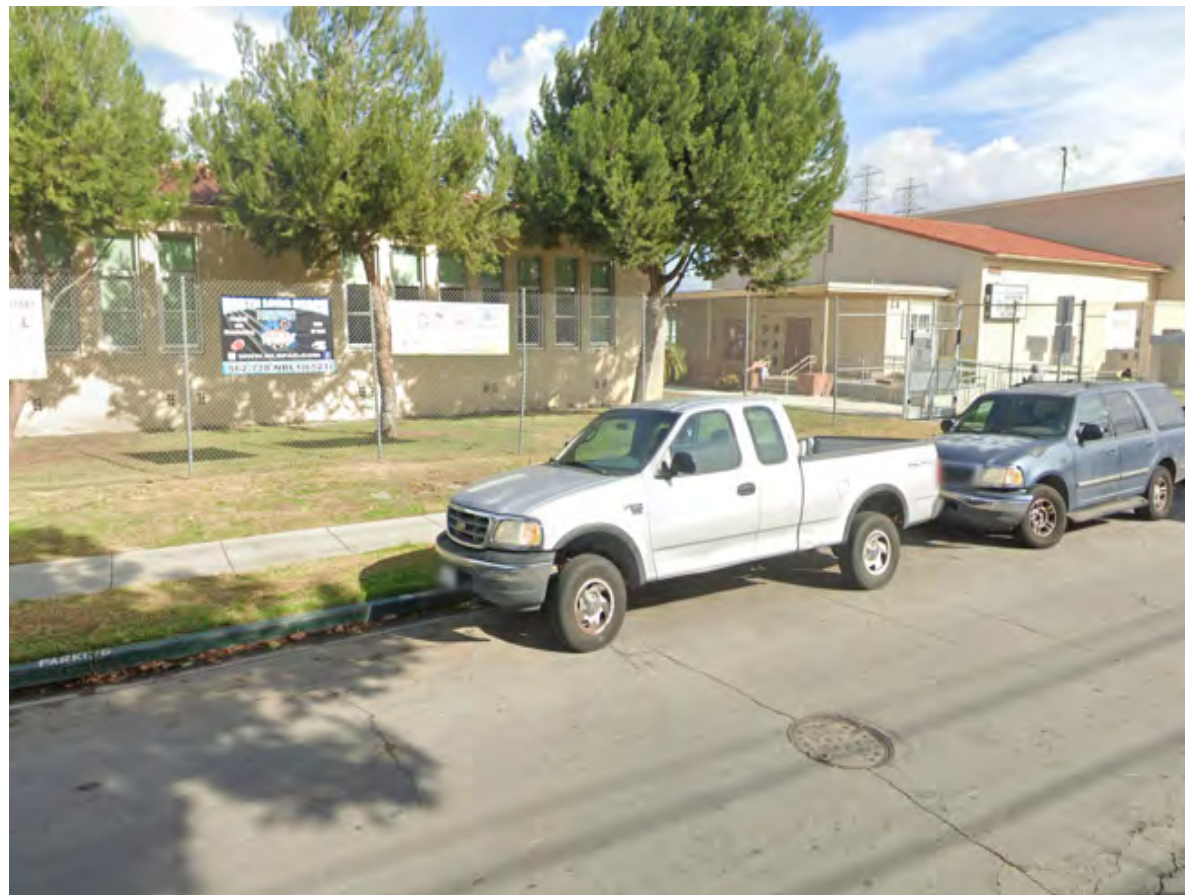
William McKinley Elementary School – Existing Campus

Facility Condition (by Bldg)

- C** Visibility of outdoor Kinder play from street
- D** Lack of lawn/turf area at main play area
- E** Lack of adequate apparatus play zone for younger learners
- F** Lack of shade trees at play area
- G** Significant large areas of blacktop without use of reflective paints to reduce heat island and improve quality of play

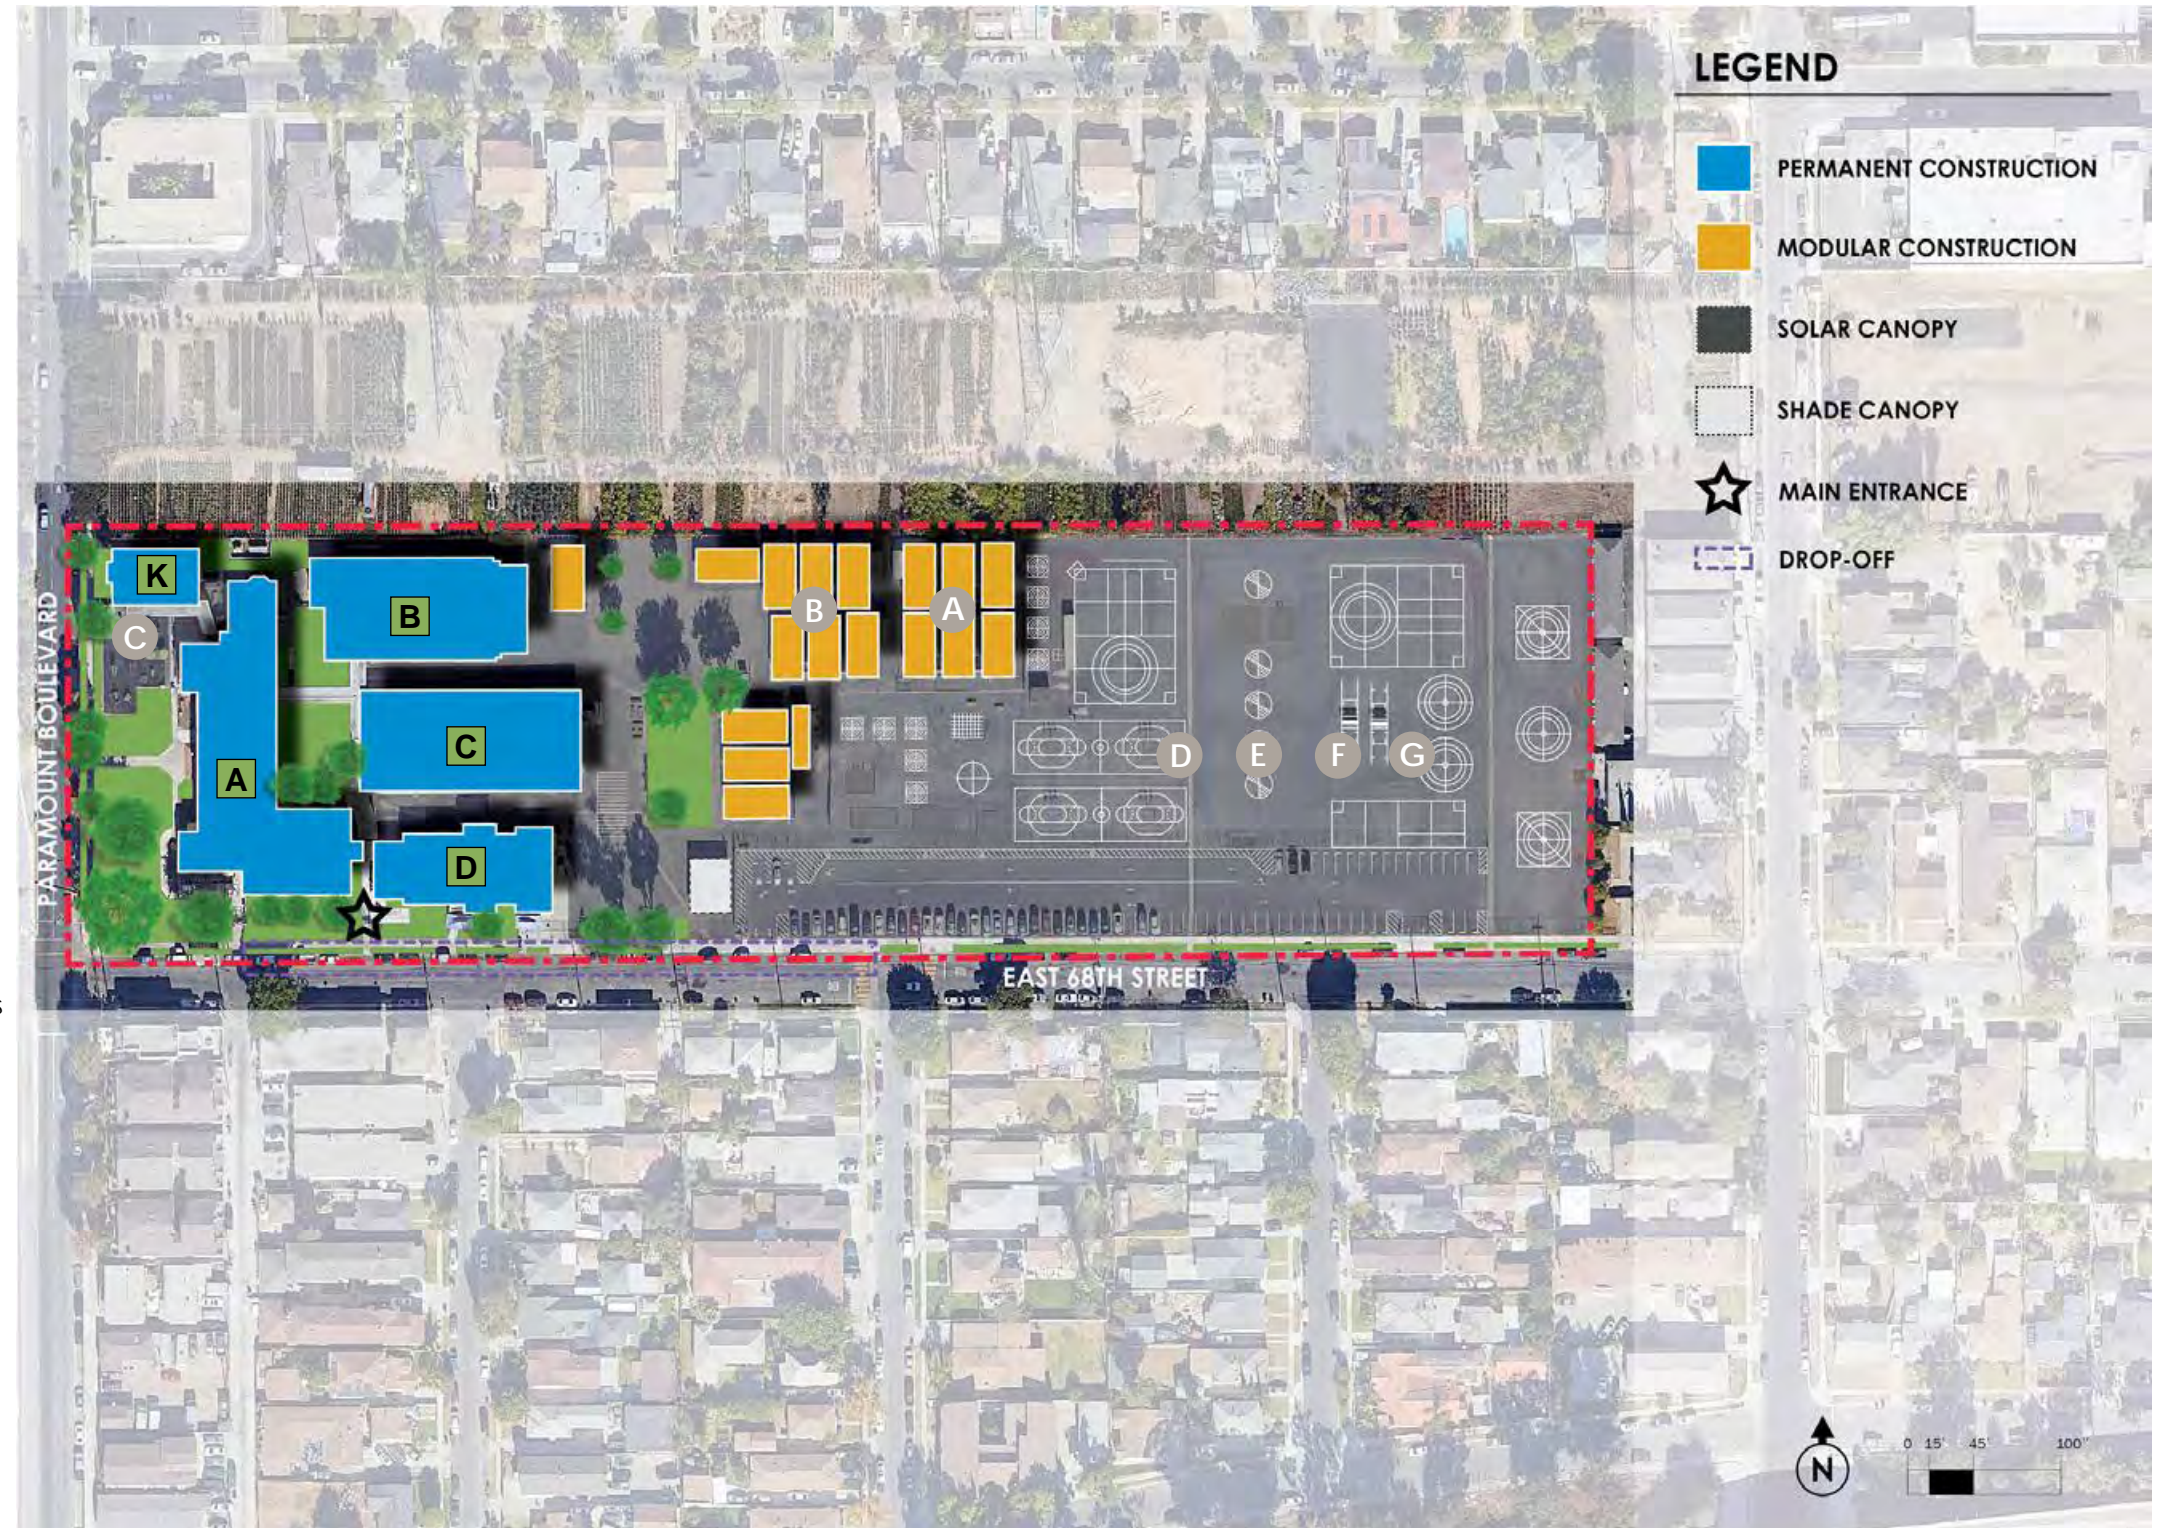
William McKinley Elementary School – Existing Space Utilization

Category	Existing	Planning Capacity
Administration	1,825 SF	2,590 SF
Auditorium	3,162 SF	3,160 SF
Library	2,663 SF	1,709 SF
Nutrition Services		
Cafeteria	1,262 SF	1,761 SF
Food Service	1,290 SF	1,347 SF
Lunch Shelter	820 SF	1,554 SF
Site		
Playground	4.8 Acres	1.4 Acres
Parking	78 Stalls	41 Stalls

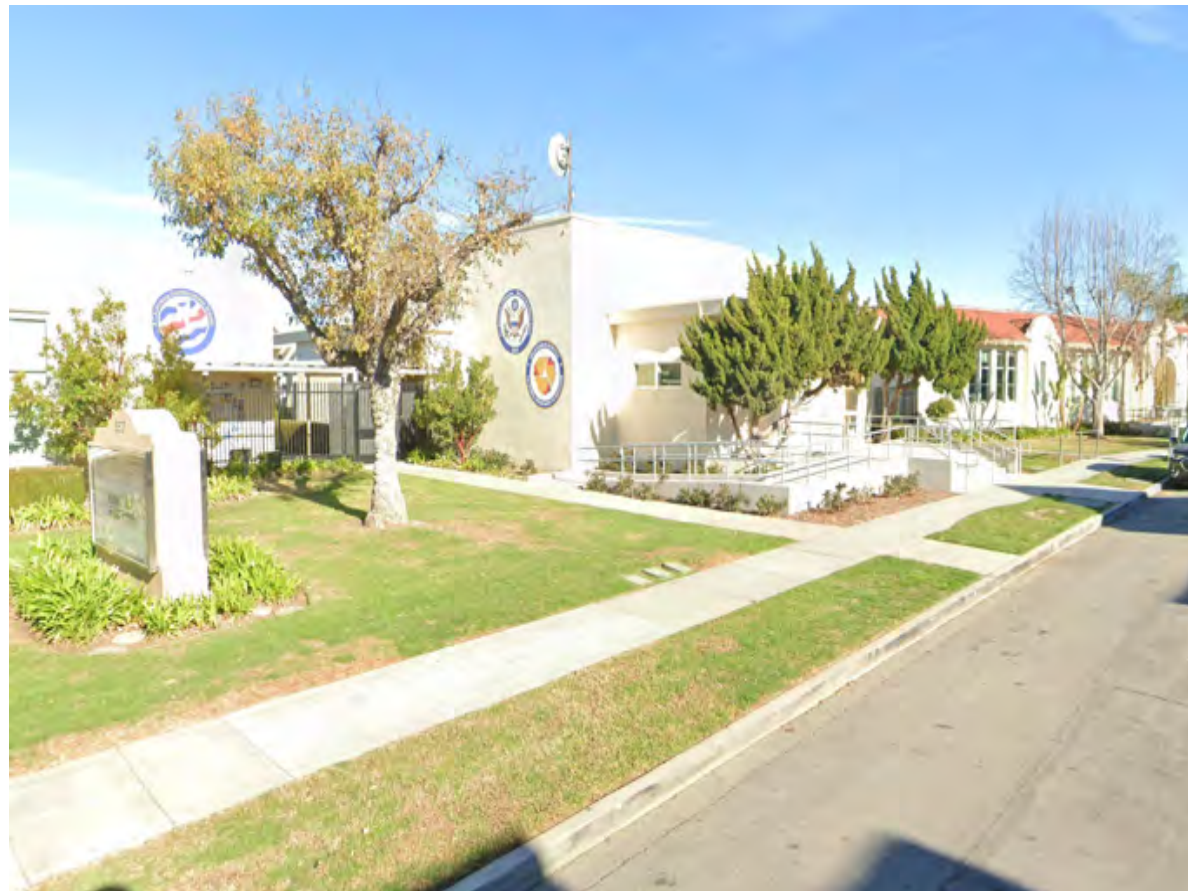
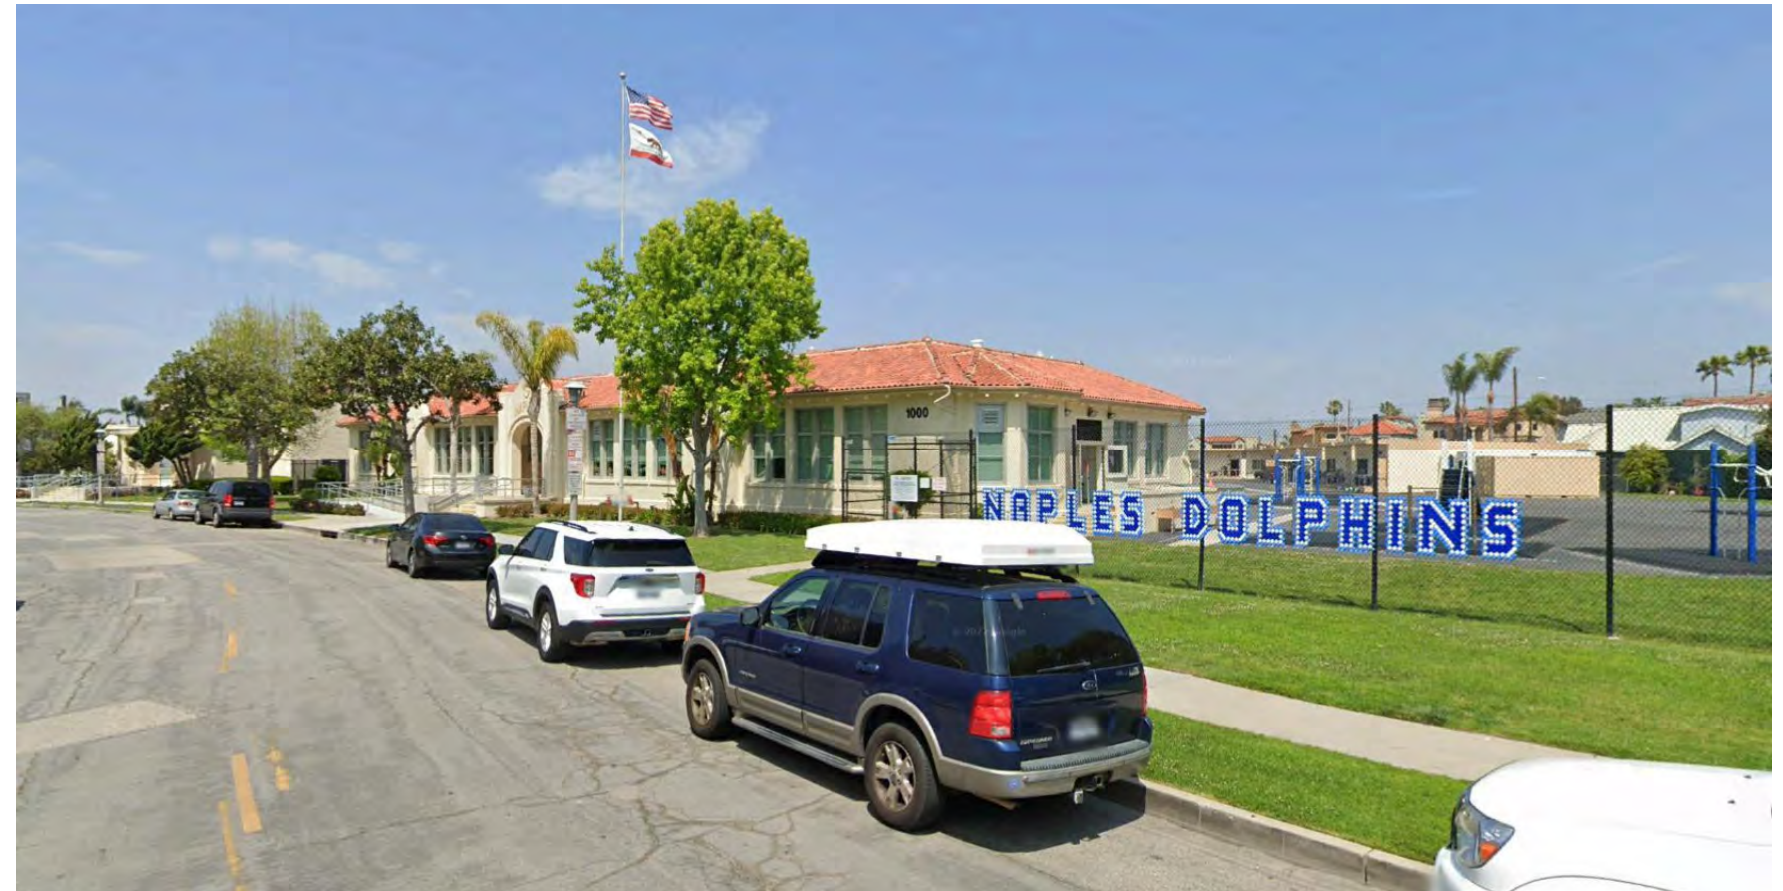
Naples Elementary School – Existing Campus

Facility Condition (by Bldg)

- C** Visibility of outdoor Kinder play from street
- D** Lack of lawn/turf area at main play area
- E** Lack of shade trees at play area
- F** Significant large areas of blacktop without use of reflective paints to reduce heat island and improve quality of play

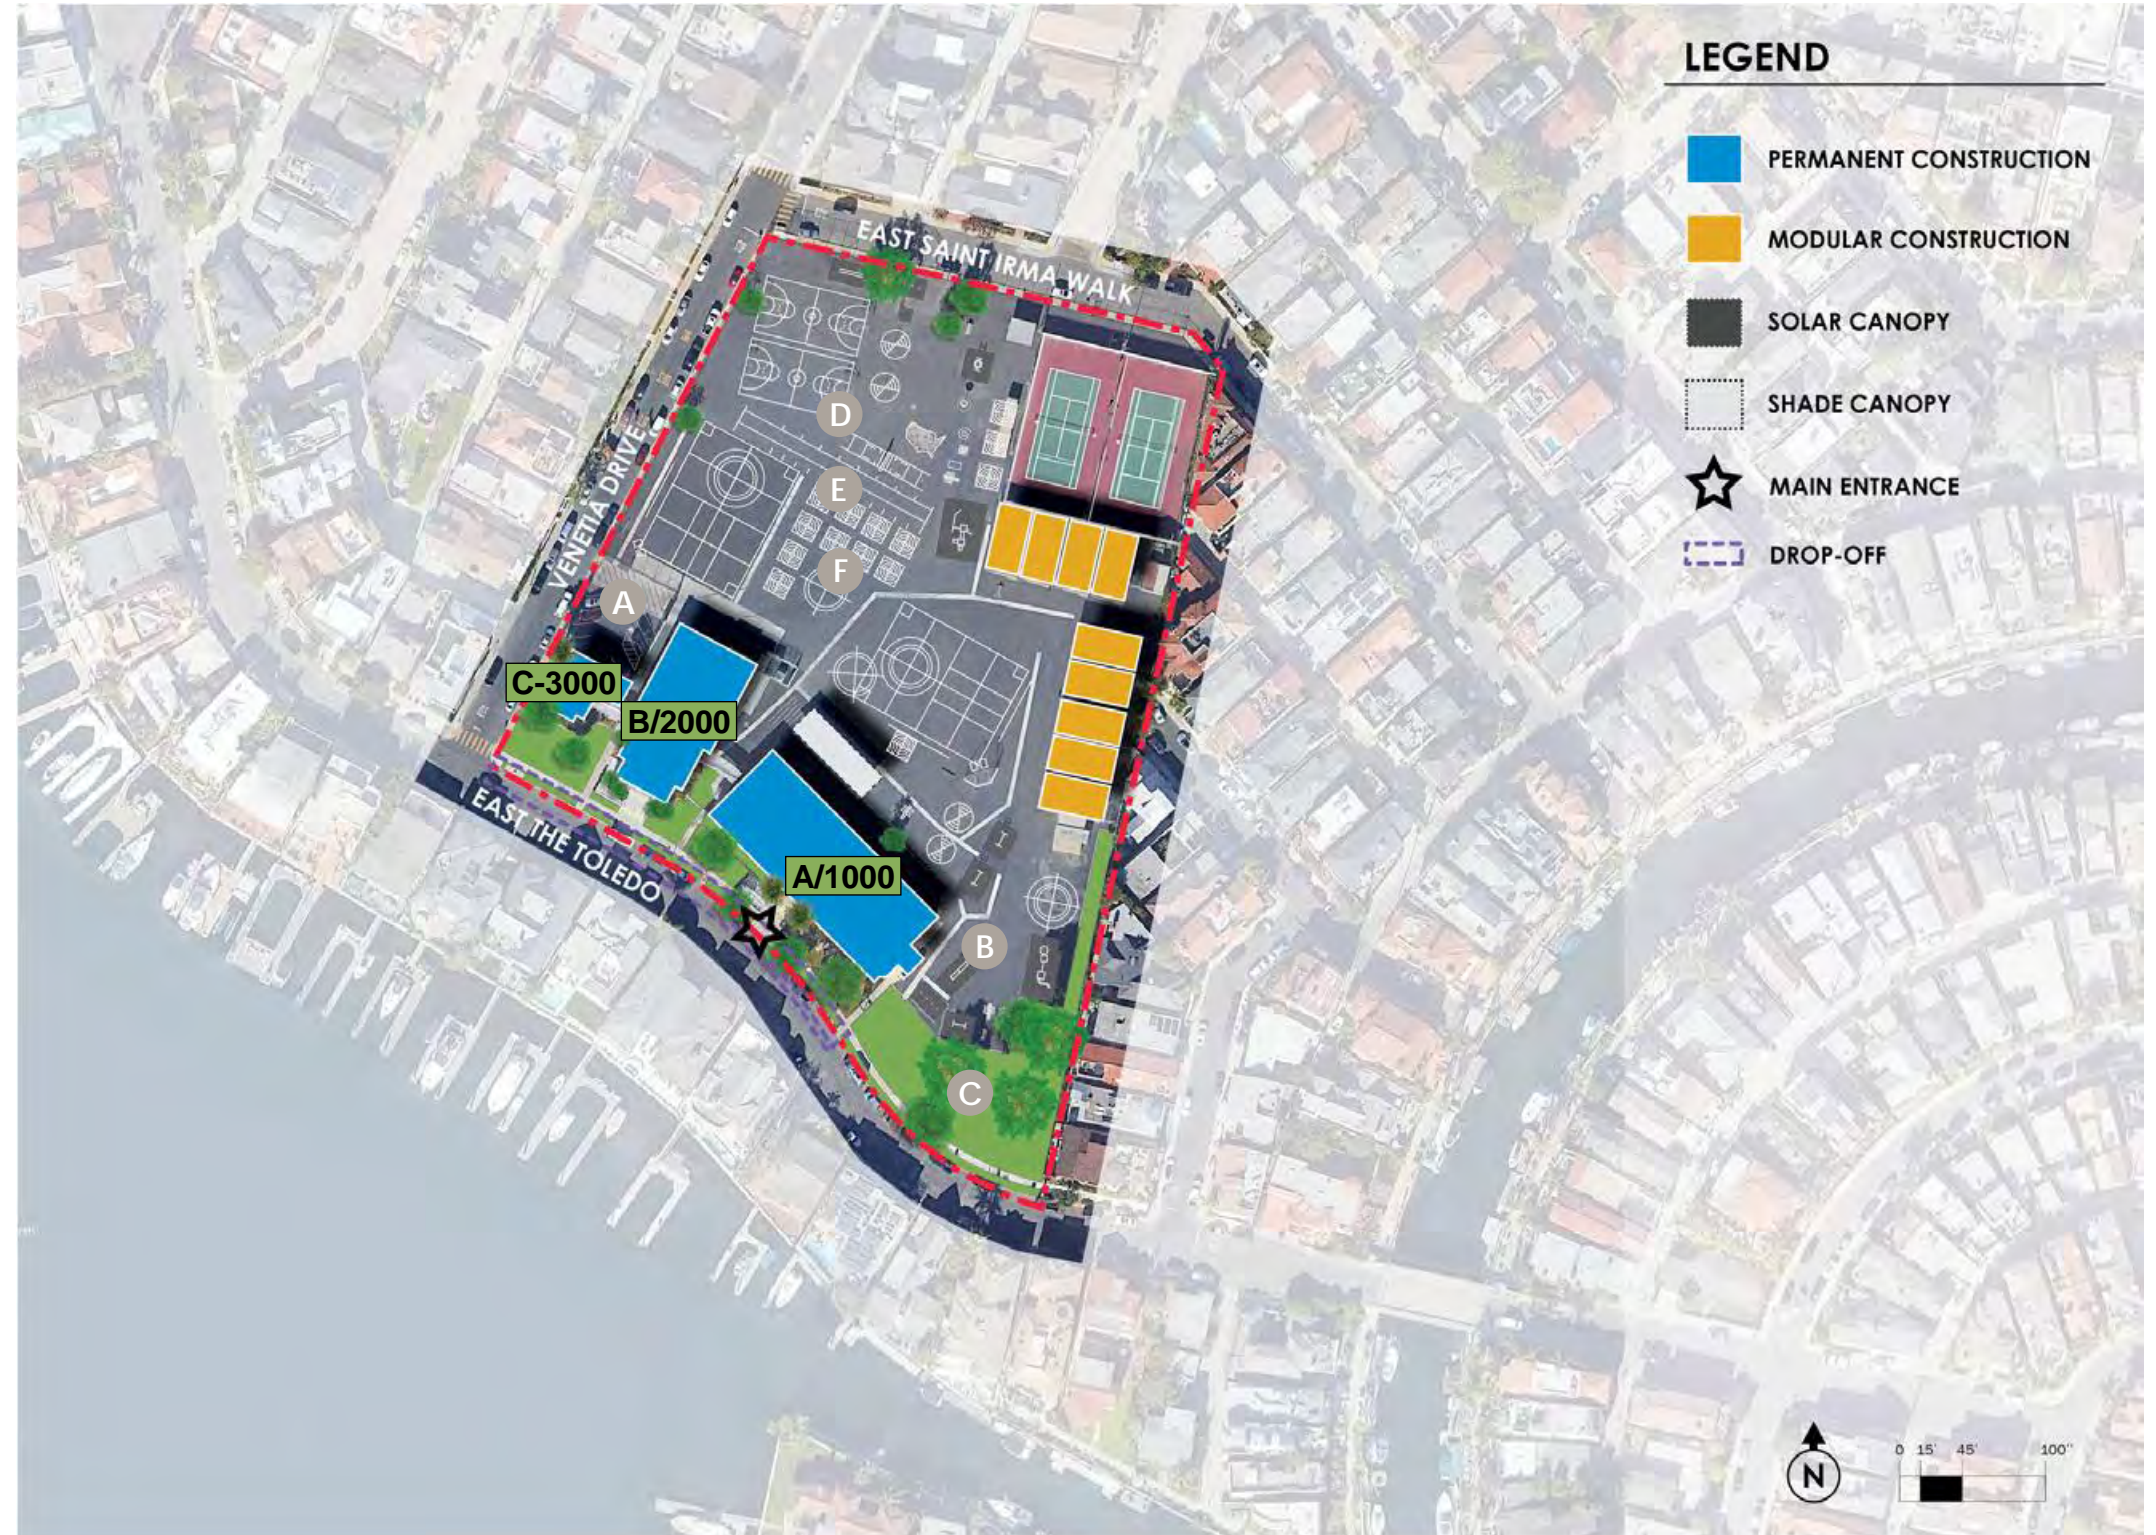
Naples Elementary School – Existing Space Utilization

Category	Existing	Planning Capacity
Administration	1,027 SF	1,445 SF
Auditorium	2,993 SF	1,763 SF
Library	1,474 SF	954 SF
Nutrition Services		
Cafeteria	1,262 SF	983 SF
Food Service	673 SF	751 SF
Lunch Shelter	1,640 SF	867 SF
Site		
Playground	2.1 Acres	1.4 Acres
Parking	6 Stalls	25 Stalls

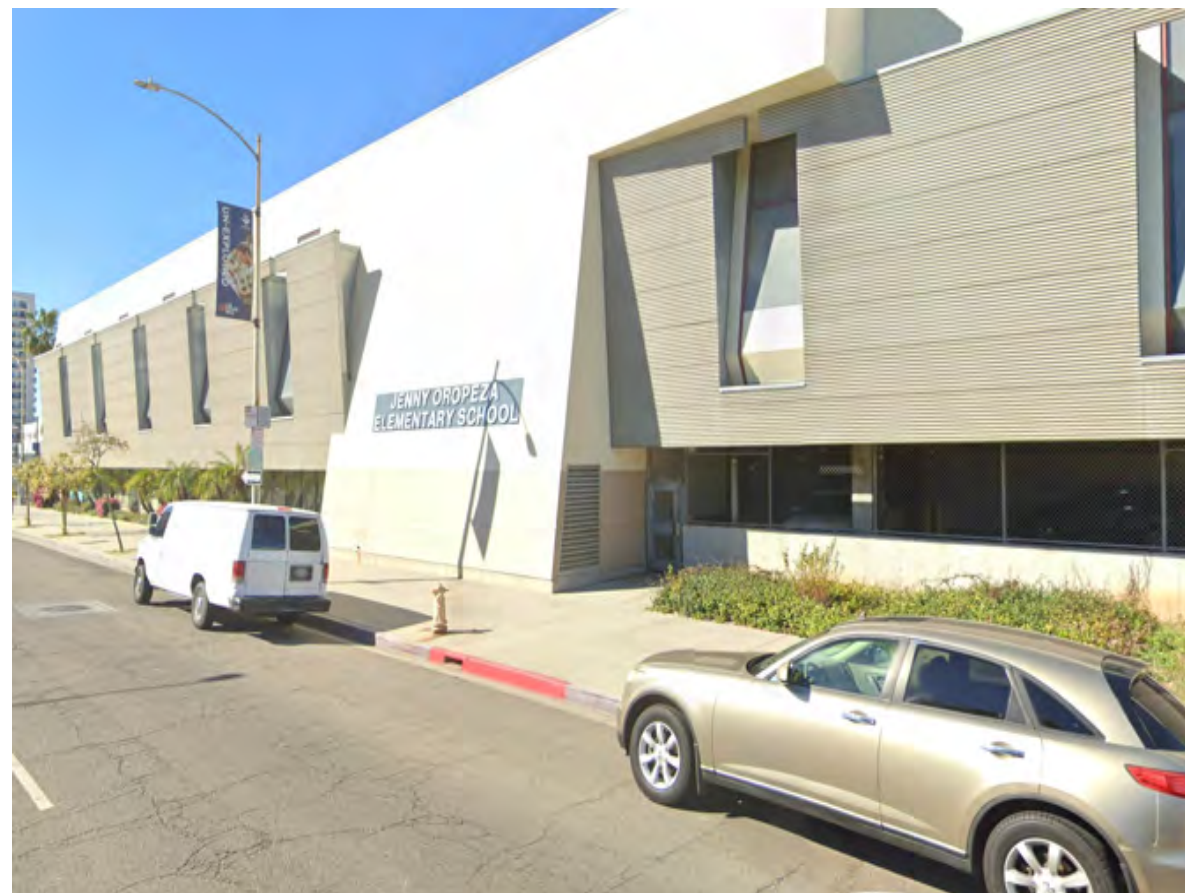
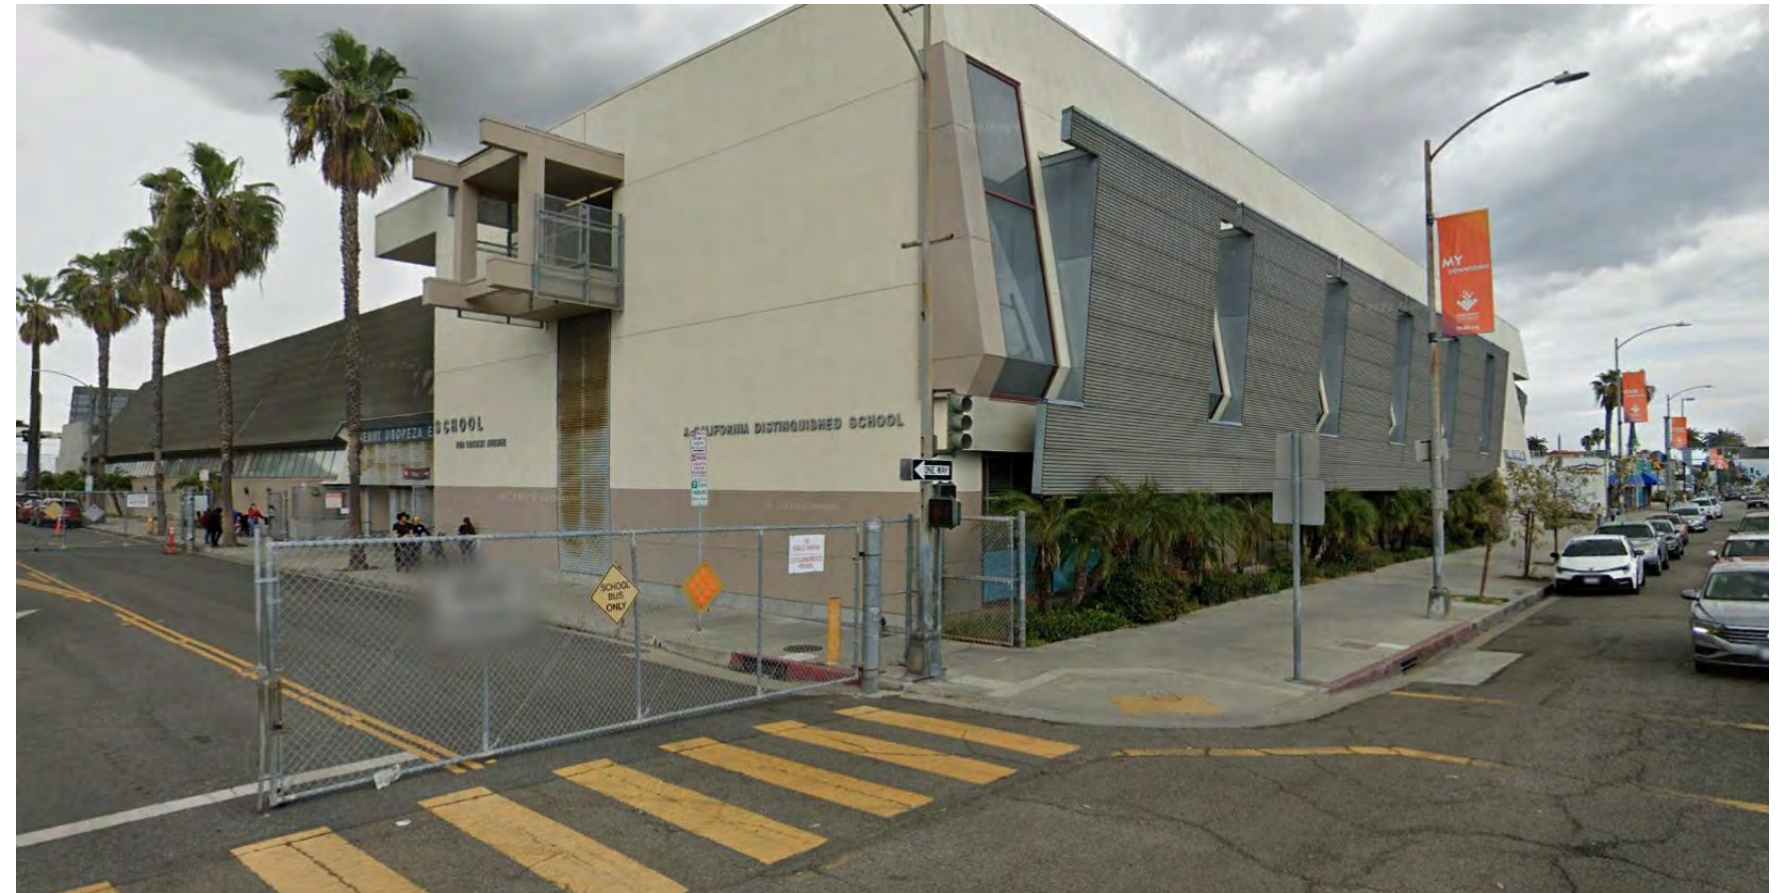
Jenny Oropeza Elementary School – Existing Campus

Facility Condition (by Bldg)

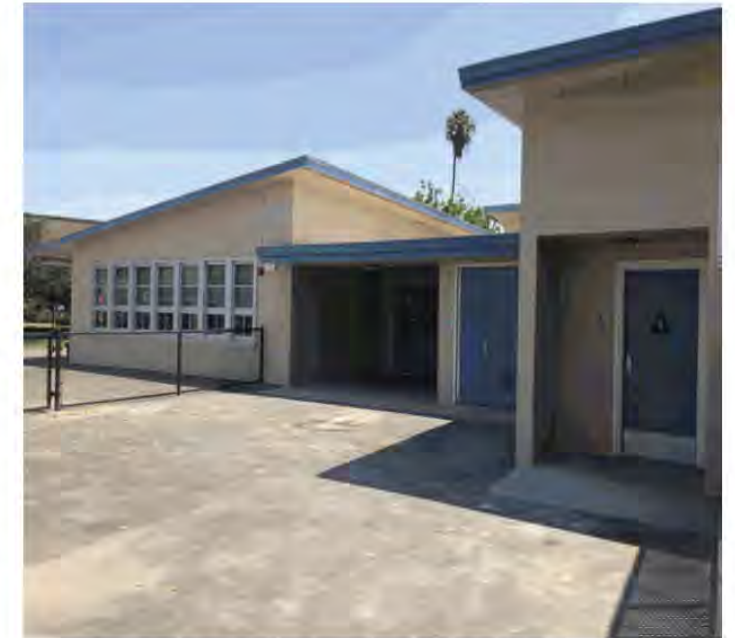
FACILITY CONDITION ASSESSMENT

Disciplines	5 Year DCI Score
Architectural	99
Plumbing	99
Mechanical	98
Fire Protection	99
Electrical	95
Communications	98
Safety and Security	100
Structural	99
5-YR FCI Score, buildings only: 98	
Civil	100
5-YR FCI Score including Civil: 99

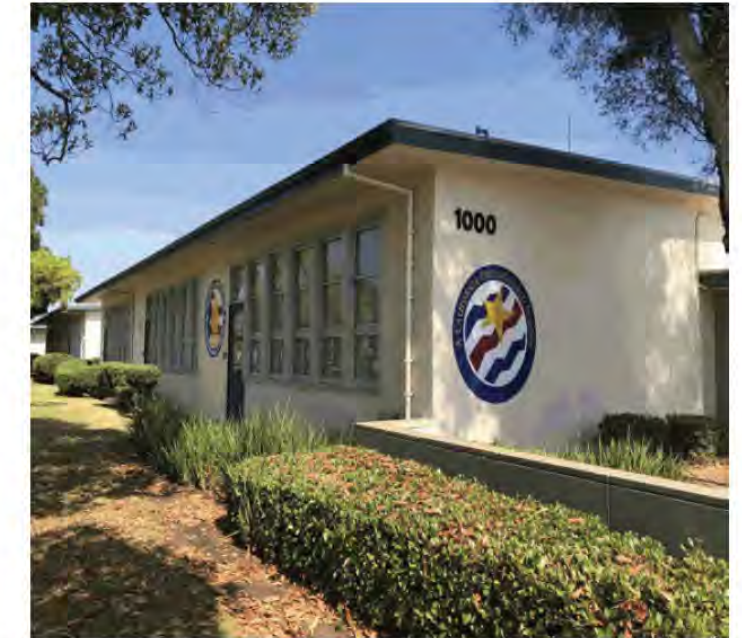
FACILITY CONDITION ASSESSMENT

Disciplines	5 Year DCI Score
Architectural	98
Plumbing	92
Mechanical	99
Fire Protection	99
Electrical	87
Communications	99
Safety and Security	100
Structural	99
5-YR FCI Score, buildings only: 97	
Civil	100
5-YR FCI Score including Civil: 98

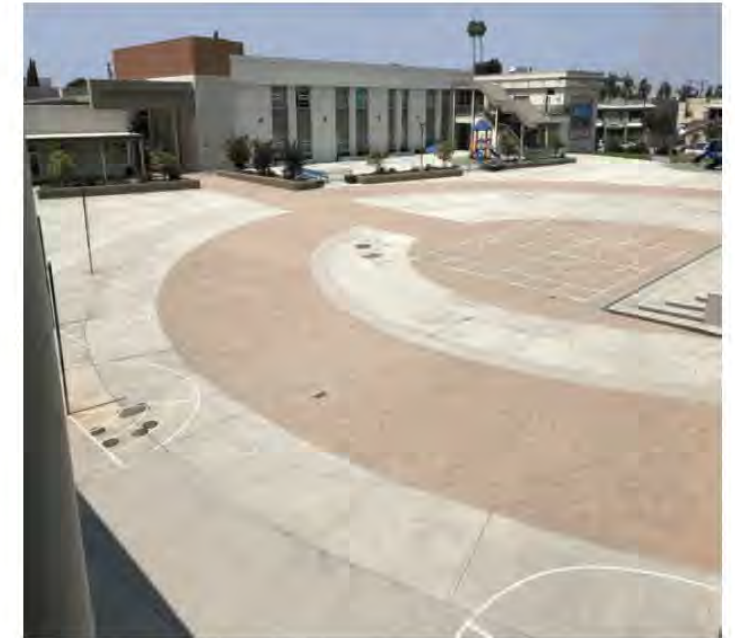
FACILITY CONDITION ASSESSMENT

Disciplines	5 Year DCI Score
Architectural	100
Plumbing	100
Mechanical	100
Fire Protection	100
Electrical	100
Communications	100
Safety and Security	100
Structural	100
5-YR FCI Score, buildings only:	100
Civil	100
5-YR FCI Score including Civil:	100

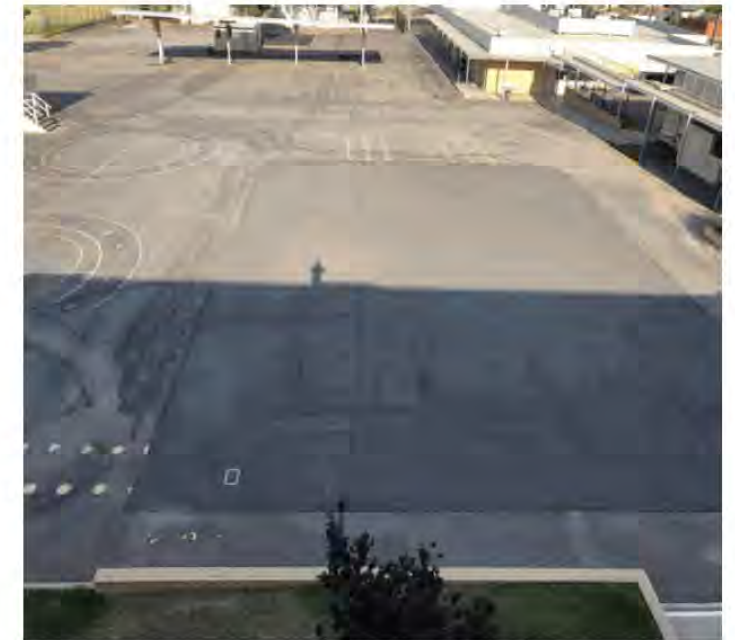
FACILITY CONDITION ASSESSMENT

Disciplines	5 Year DCI Score
Architectural	91
Plumbing	89
Mechanical	42
Fire Protection	93
Electrical	81
Communications	100
Safety and Security	71
Structural	100
5-YR FCI Score, buildings only:	84
Civil	100
5-YR FCI Score including Civil:	91

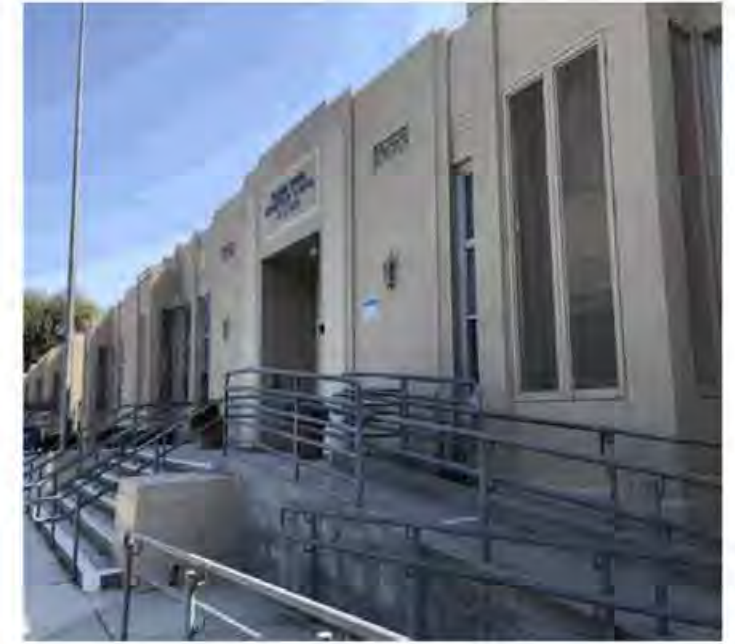
FACILITY CONDITION ASSESSMENT

Disciplines	5 Year DCI Score
Architectural	84
Plumbing	90
Mechanical	51
Fire Protection	100
Electrical	100
Communications	100
Safety and Security	100
Structural	100
5-YR FCI Score, buildings only:	86
Civil	100
5-YR FCI Score including Civil:	88

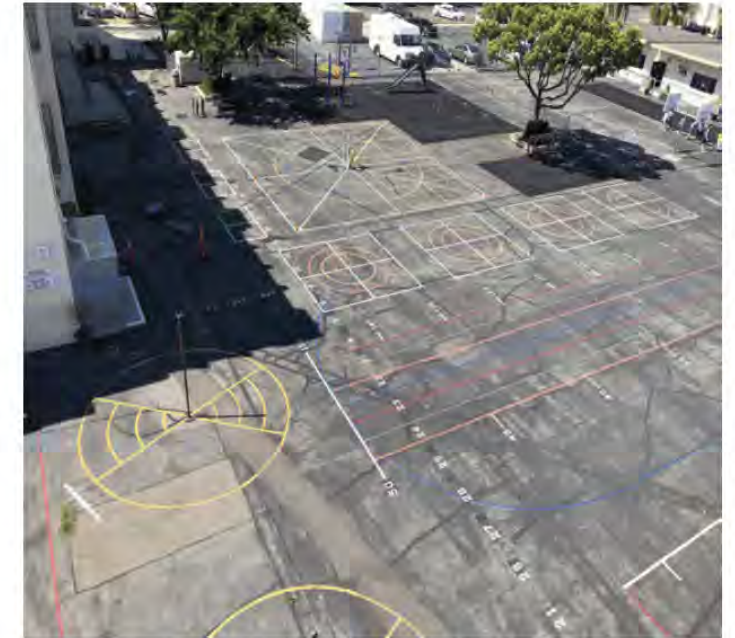
FACILITY CONDITION ASSESSMENT

Disciplines	5 Year DCI Score
Architectural	97
Plumbing	100
Mechanical	100
Fire Protection	100
Electrical	71
Communications	100
Safety and Security	100
Structural	100
5-YR FCI Score, buildings only: 95	
Civil	100
5-YR FCI Score including Civil: 96

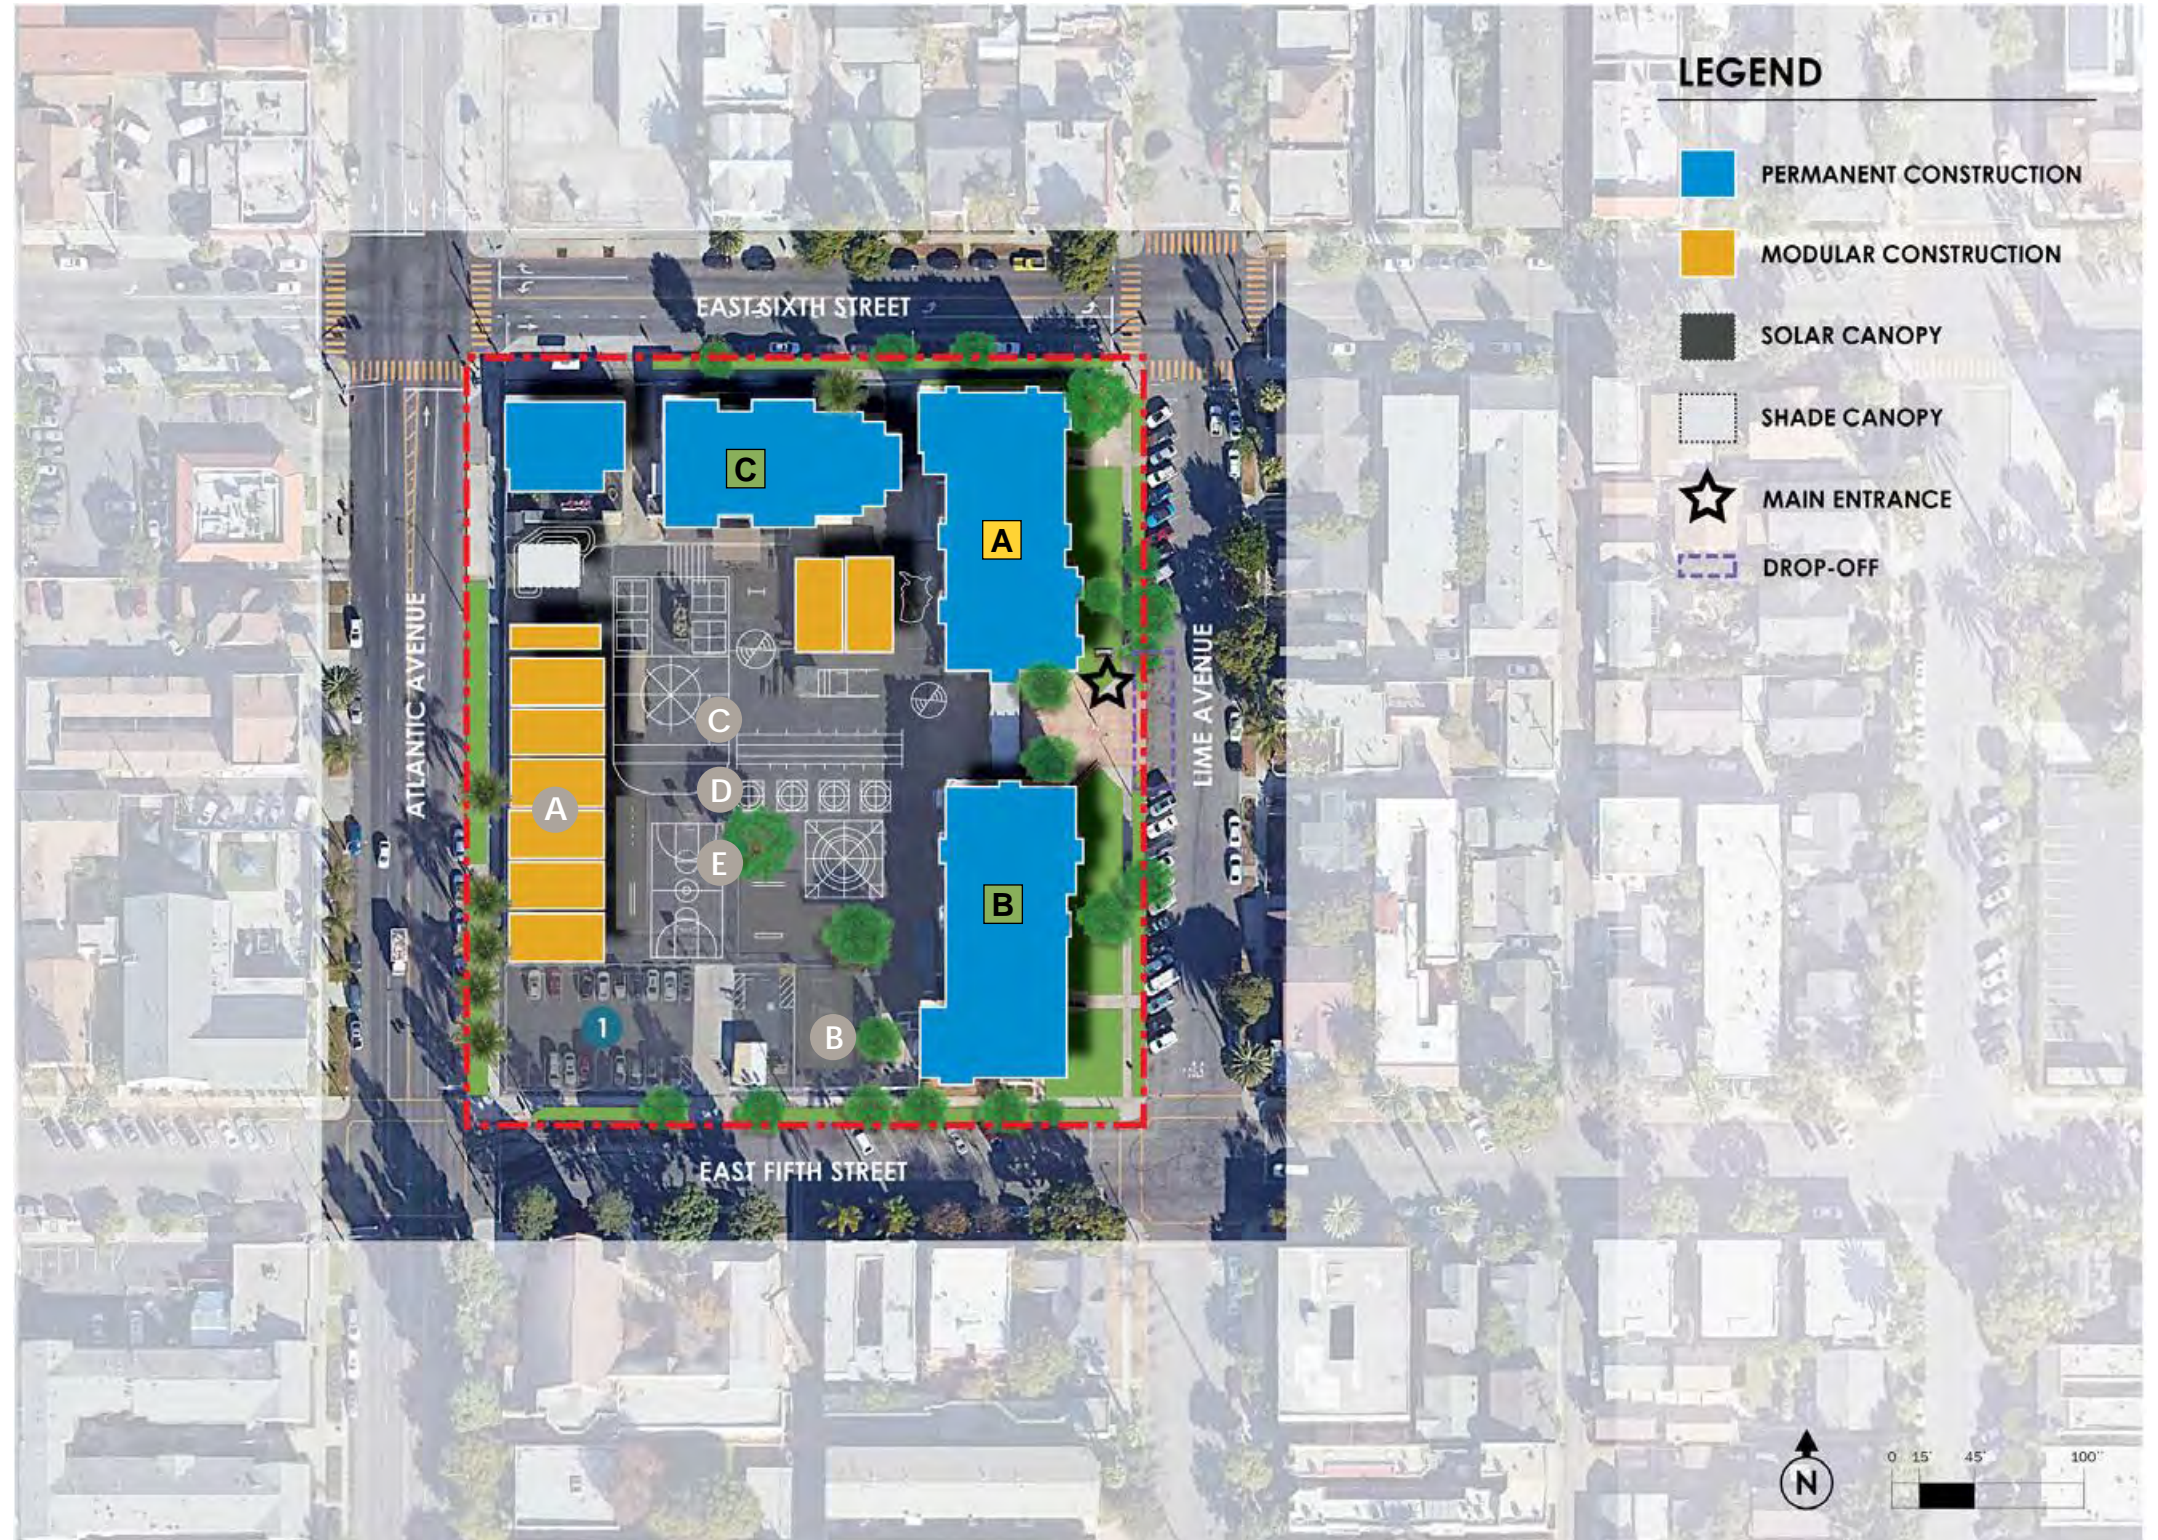
Robert Louis Stevenson Elementary School – Existing Campus

- B** Visibility of outdoor Kinder play from street
- C** Lack of lawn/turf area at main play area
- D** Lack of shade trees at play area
- E** Significant large areas of blacktop without use of reflective paints to reduce heat island and improve quality of play
