LBUSD 2022 Facility Master Plan

Long Beach Unified School District
Appendices

July 2022

A Facility Reports: Elementary Schools

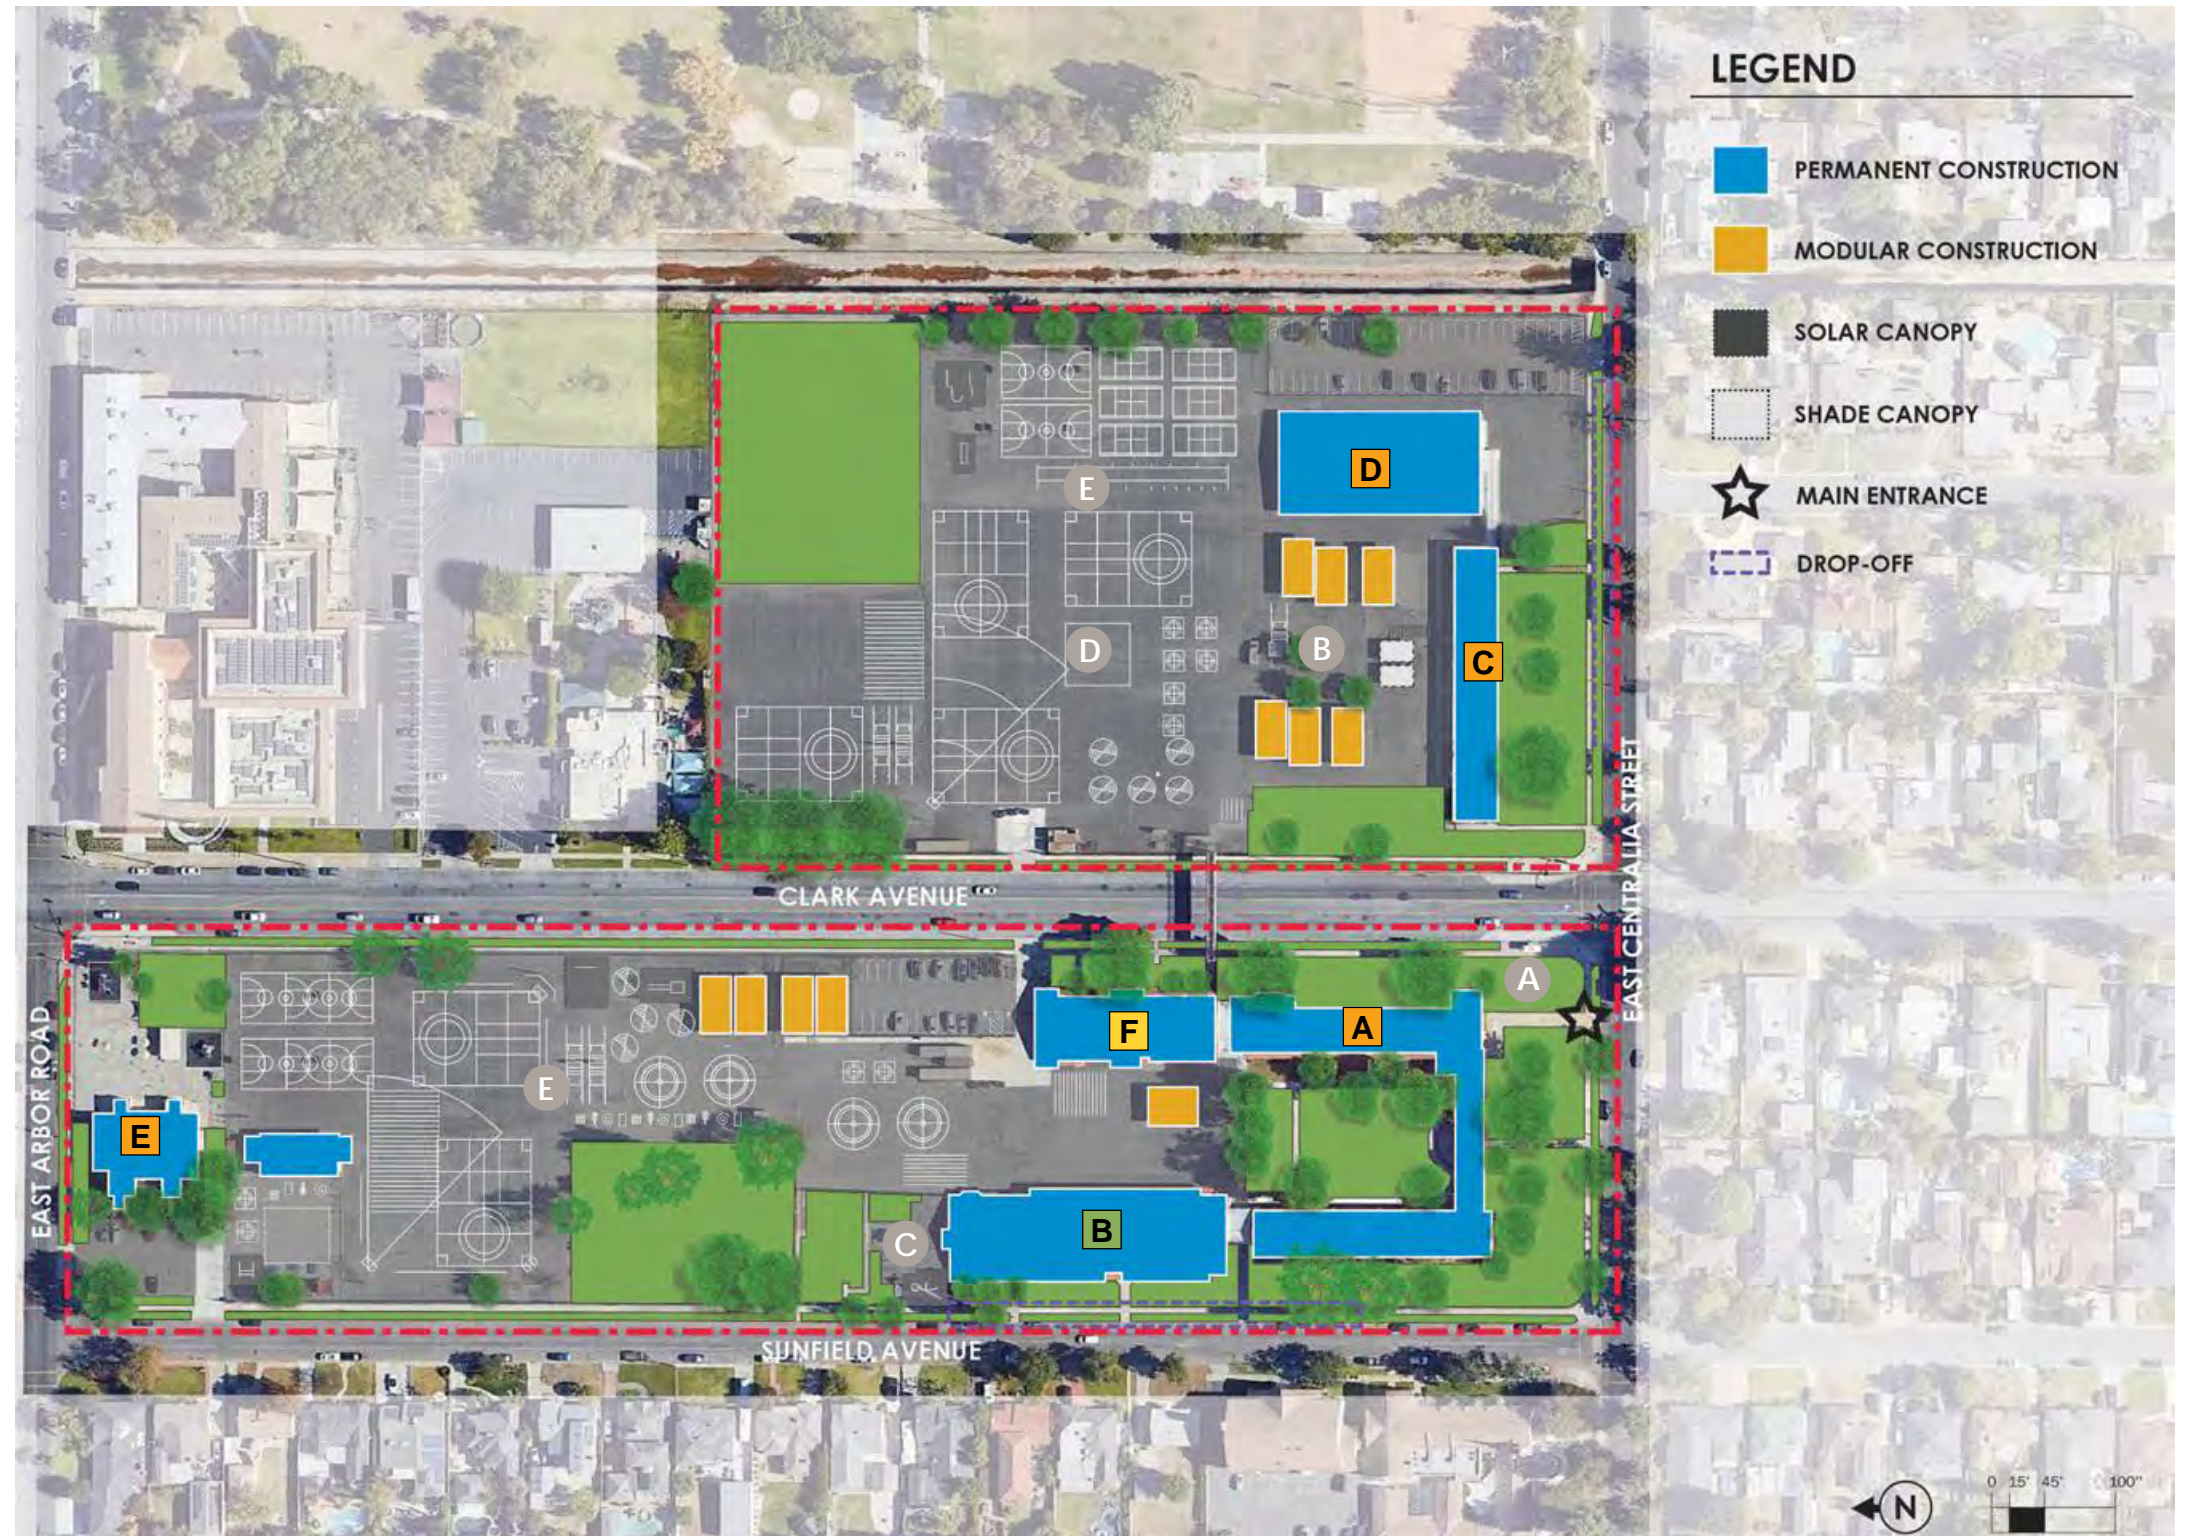
Mark Twain Elementary School – Existing Campus

D Lack of shade trees at play area

E Significant large areas of blacktop without use of reflective paints to reduce heat island and improve quality of play

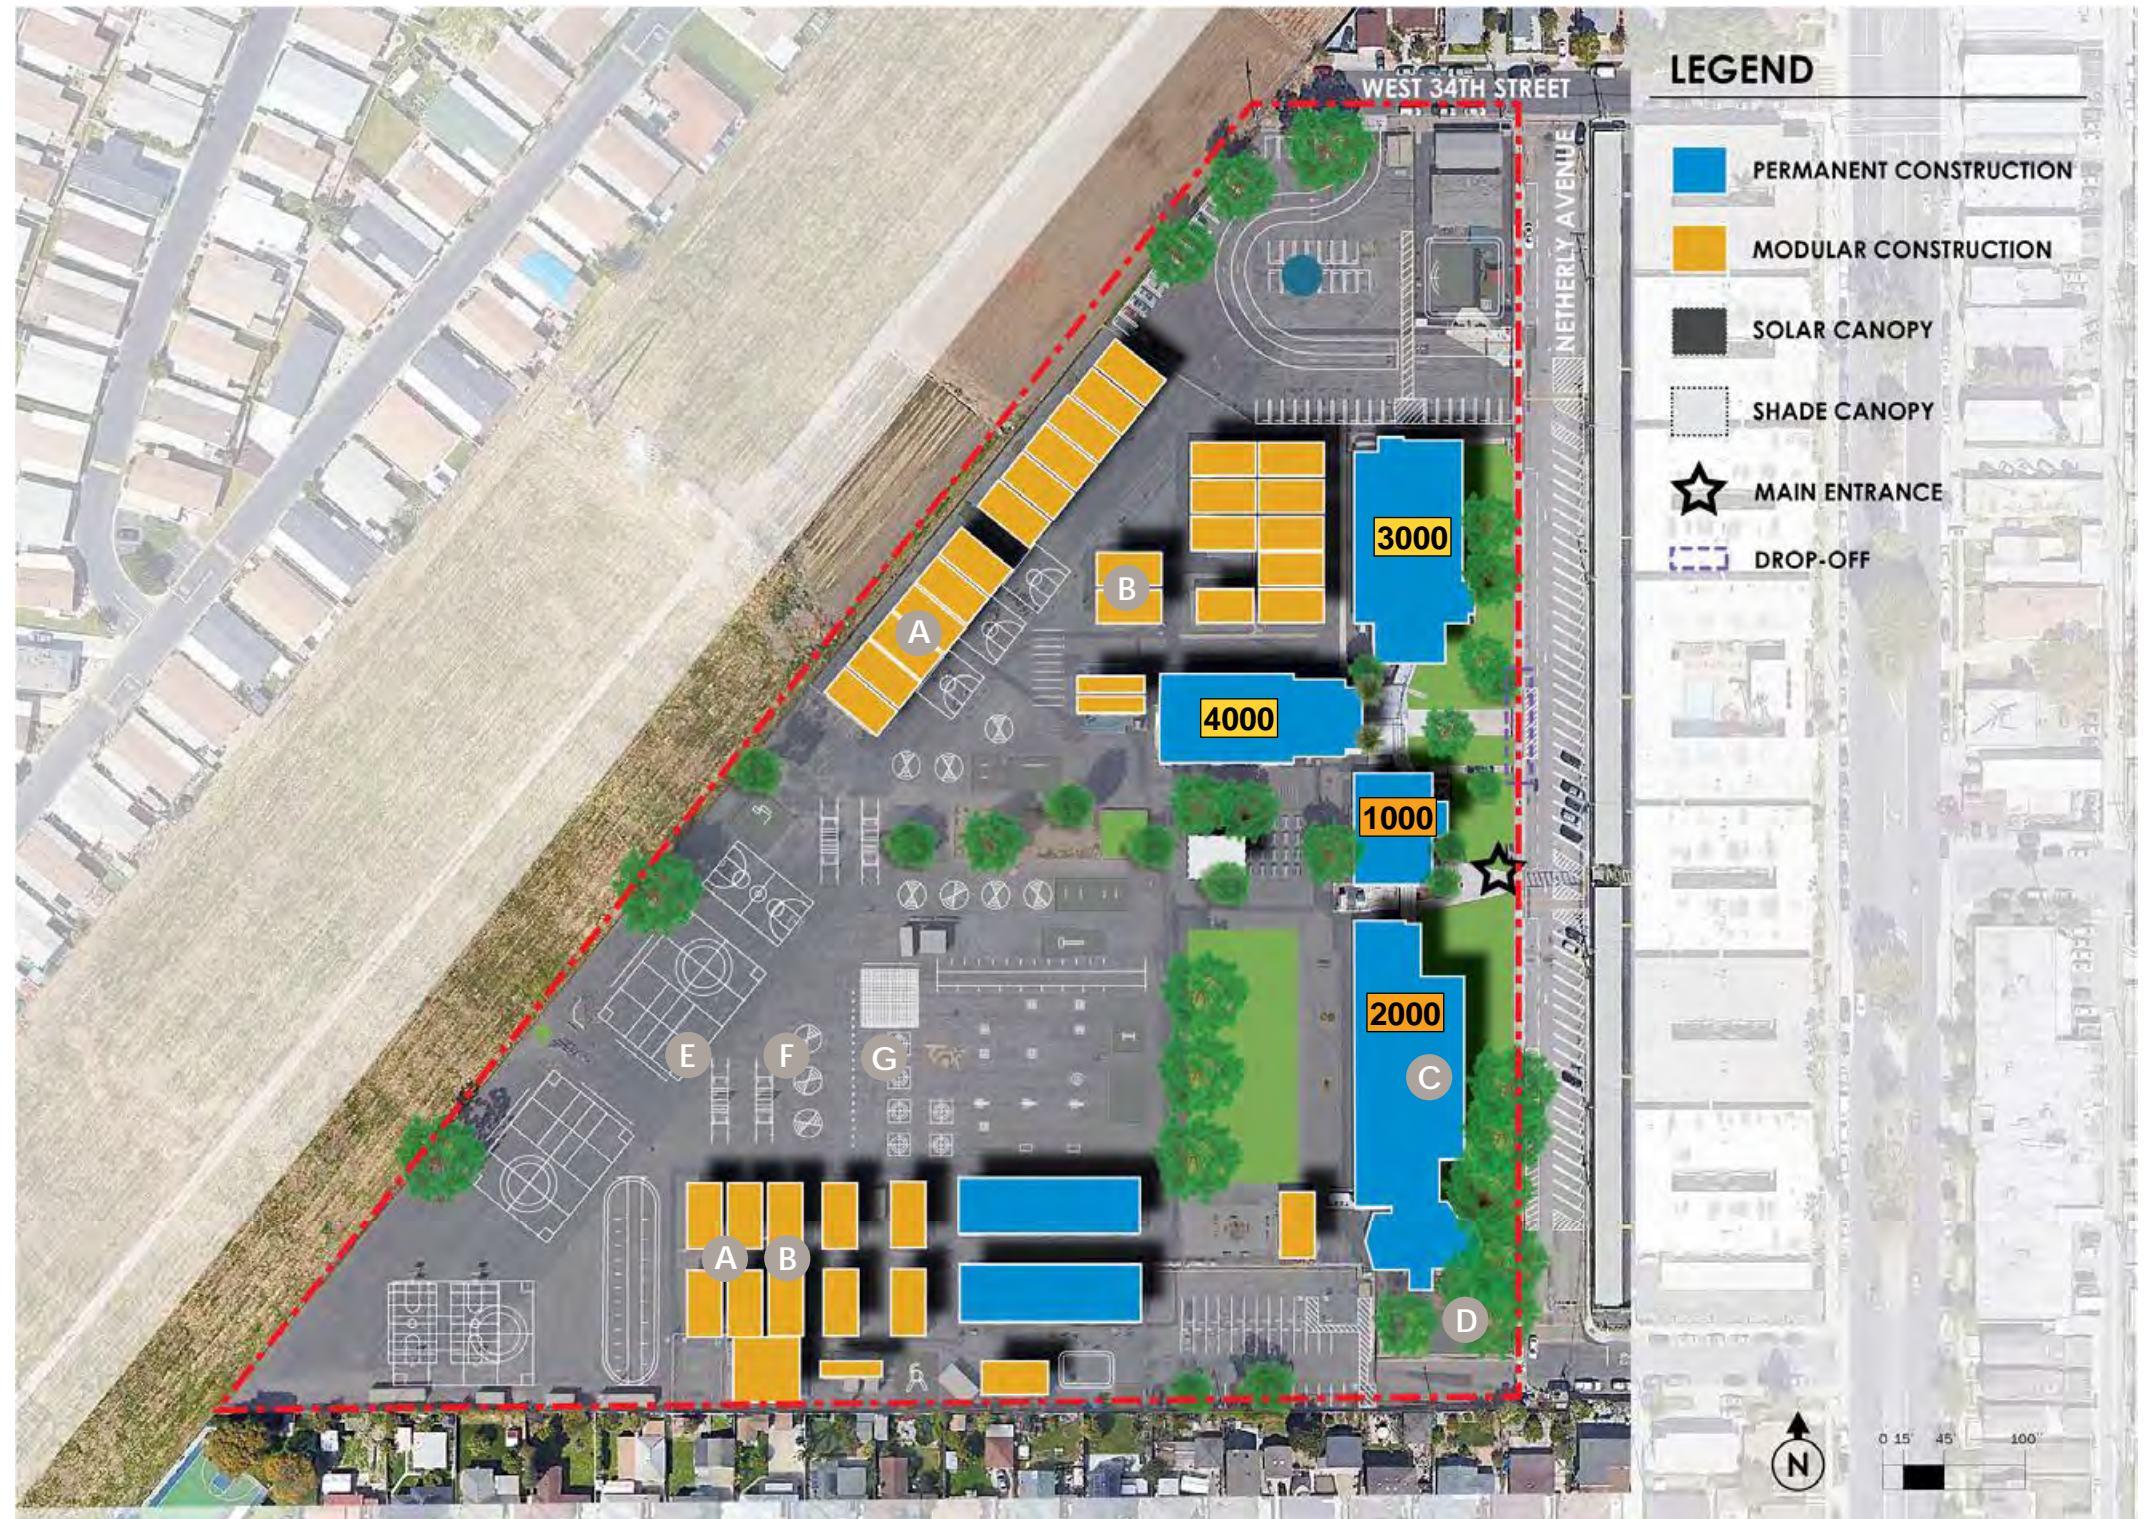
Daniel Webster Elementary School – Existing Campus

- D** Visibility of outdoor Kinder play from street
- E** Lack of lawn/turf area at main play area
- F** Lack of shade trees at play area
- G** Significant large areas of blacktop without use of reflective paints to reduce heat island and improve quality of play

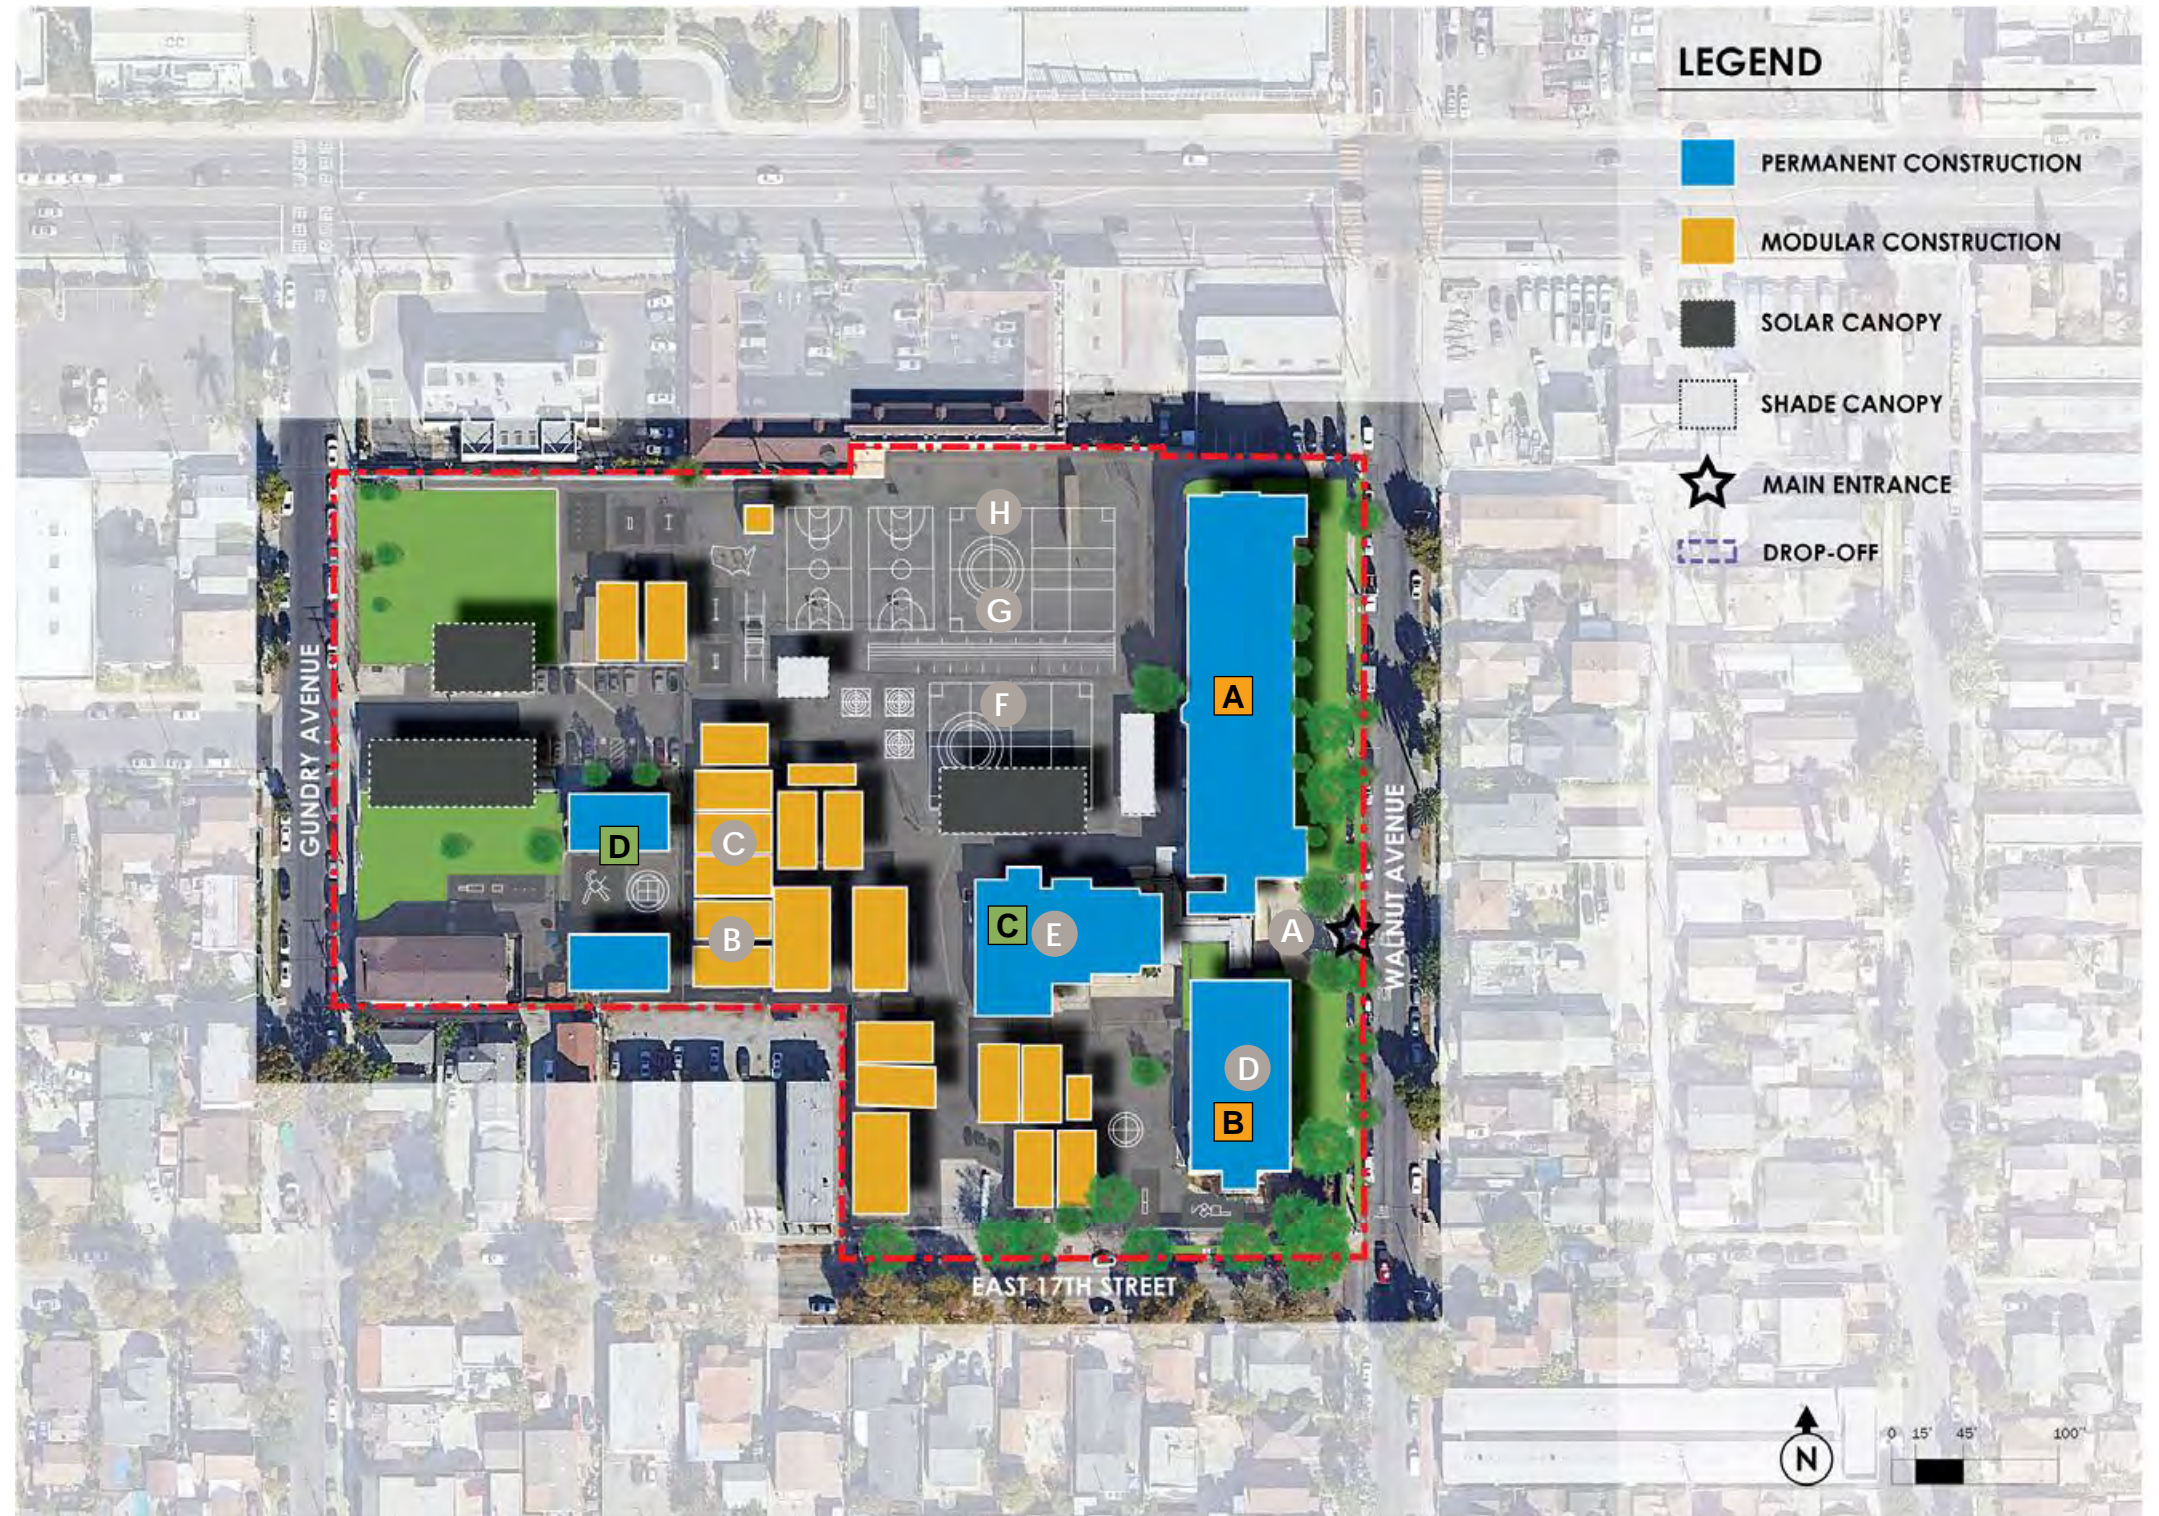
John G. Whittier Elementary School – Existing Campus

G Lack of shade trees at play area

H Significant large areas of blacktop without use of reflective paints to reduce heat island and improve quality of play

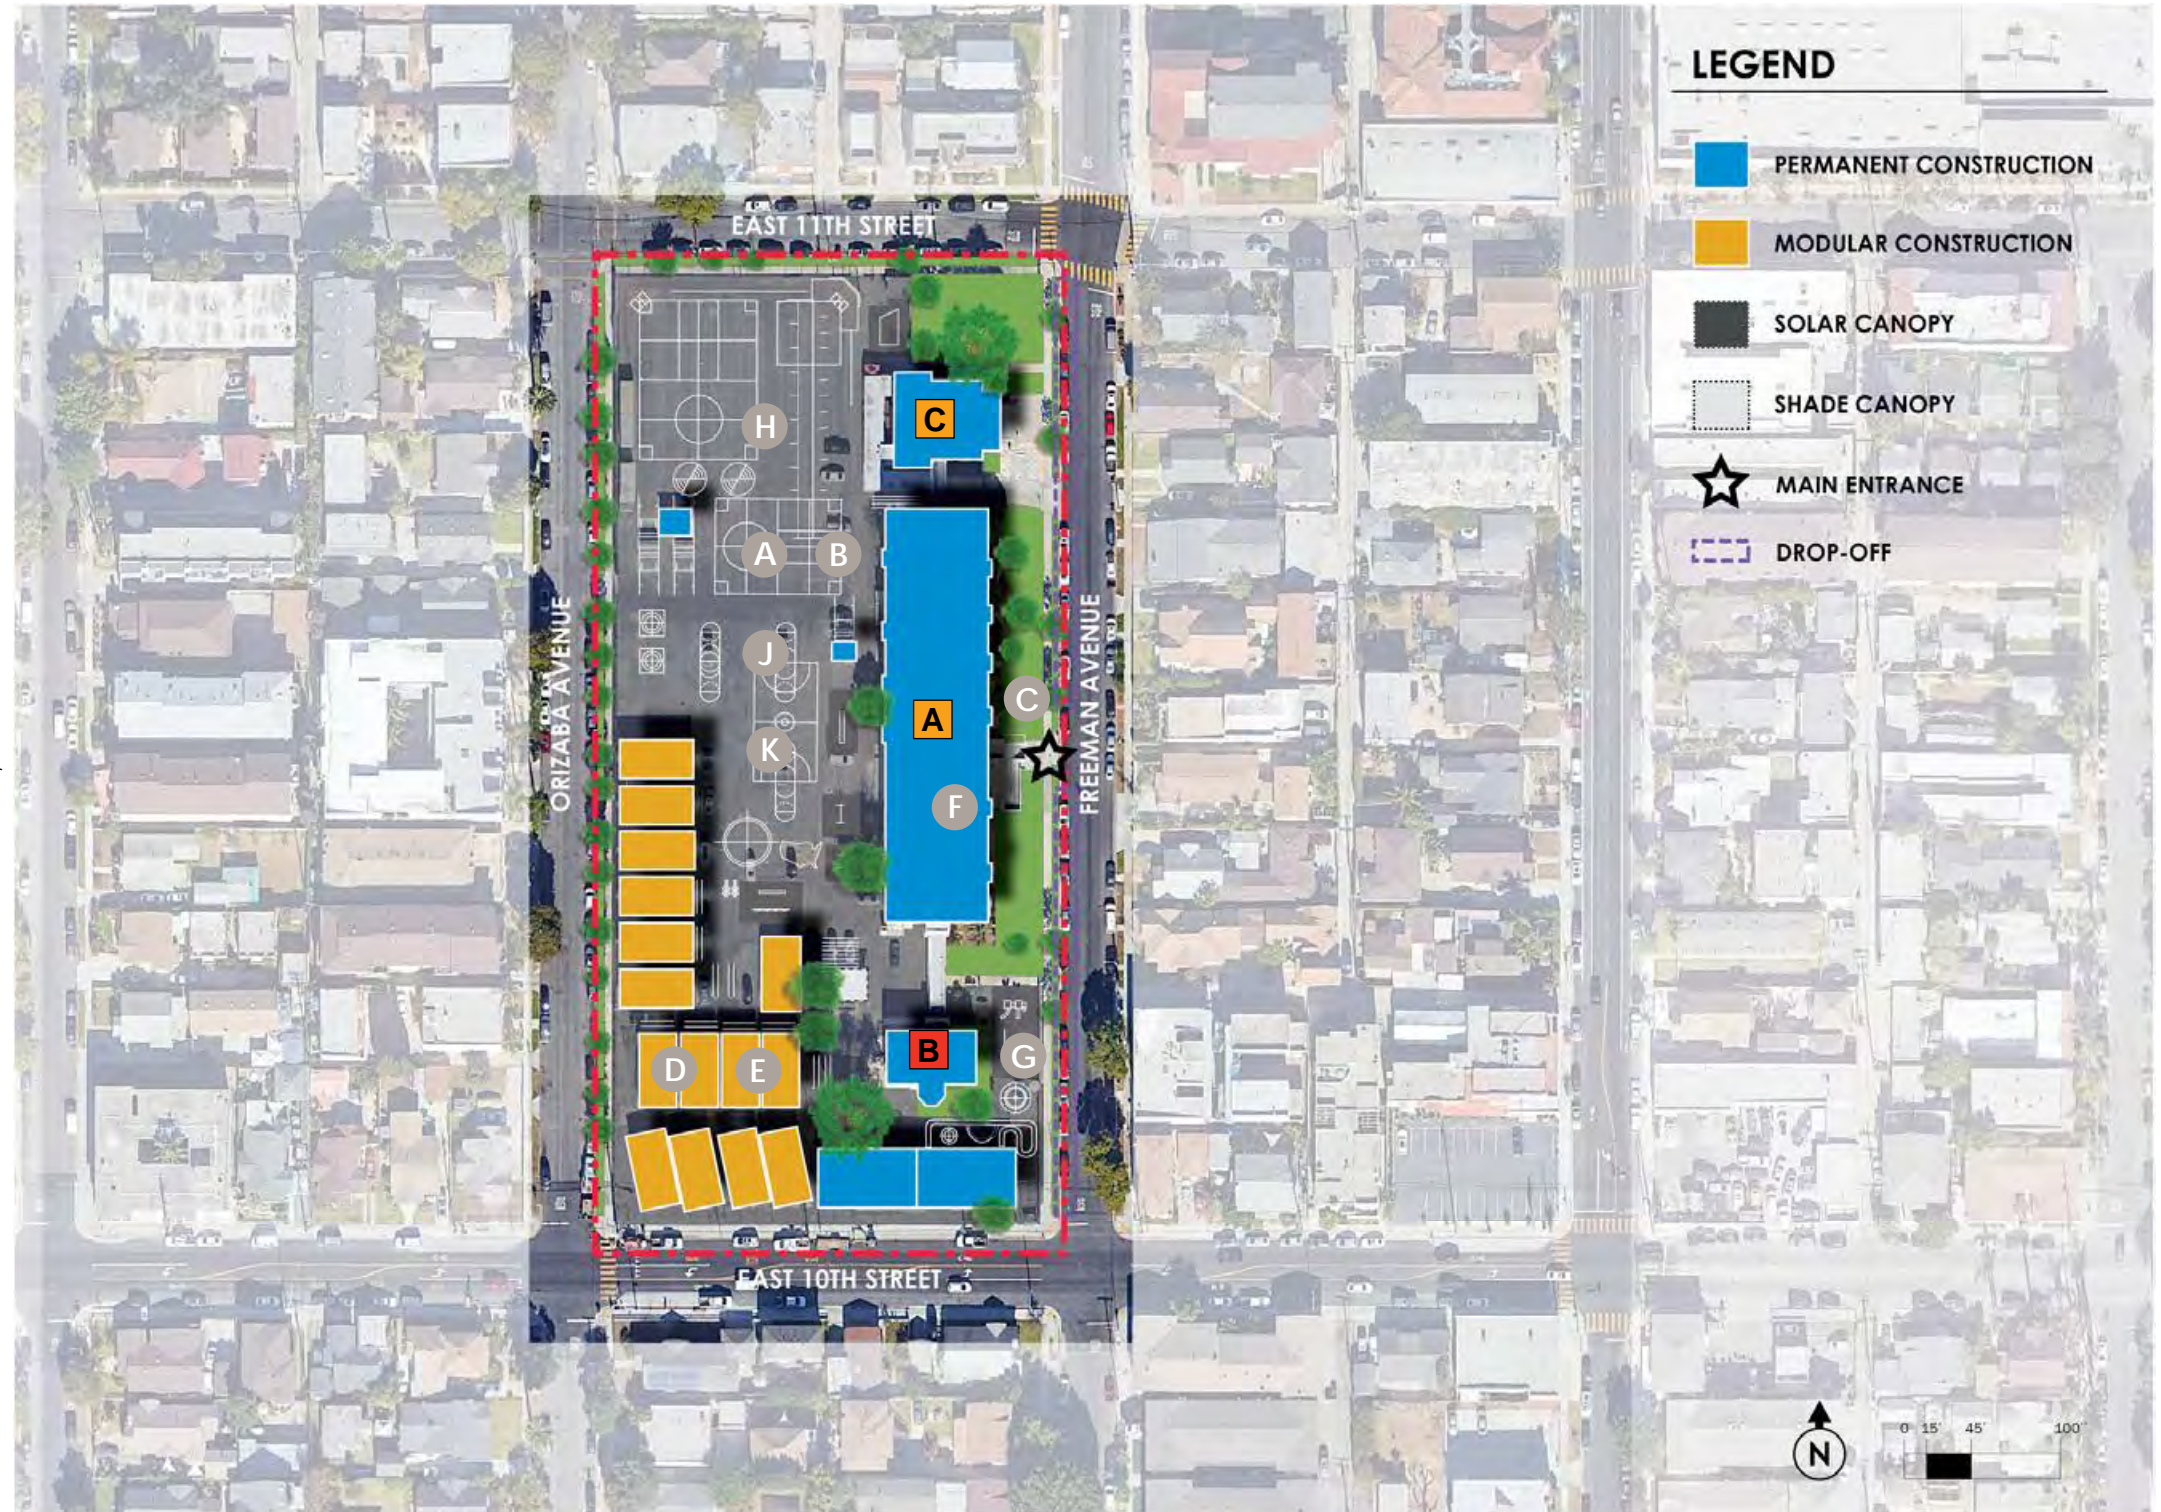
Frances Willard Elementary School – Existing Campus

- G** Visibility of outdoor Kinder play from street
- H** Lack of lawn/turf area at main play area
- J** Lack of shade trees at play area
- K** Significant large areas of blacktop without use of reflective paints to reduce heat island and improve quality of play

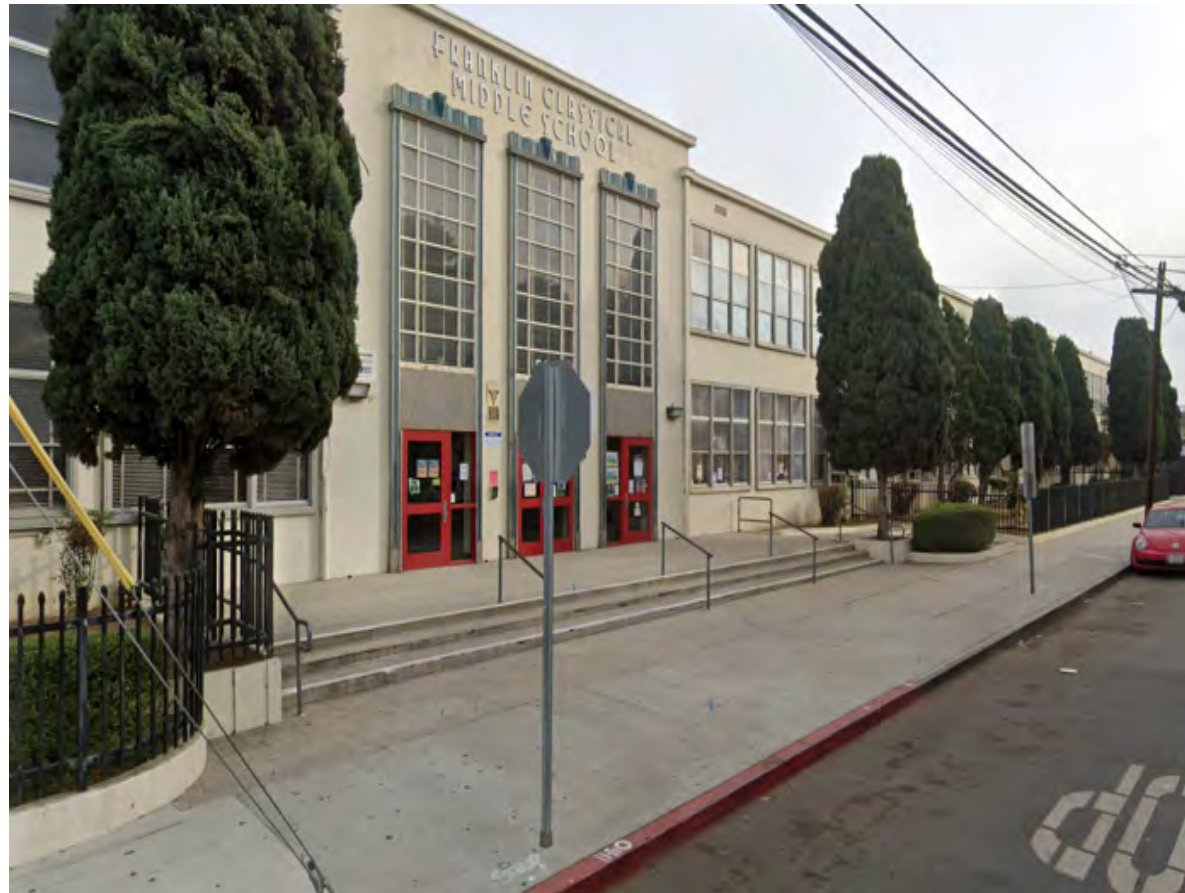
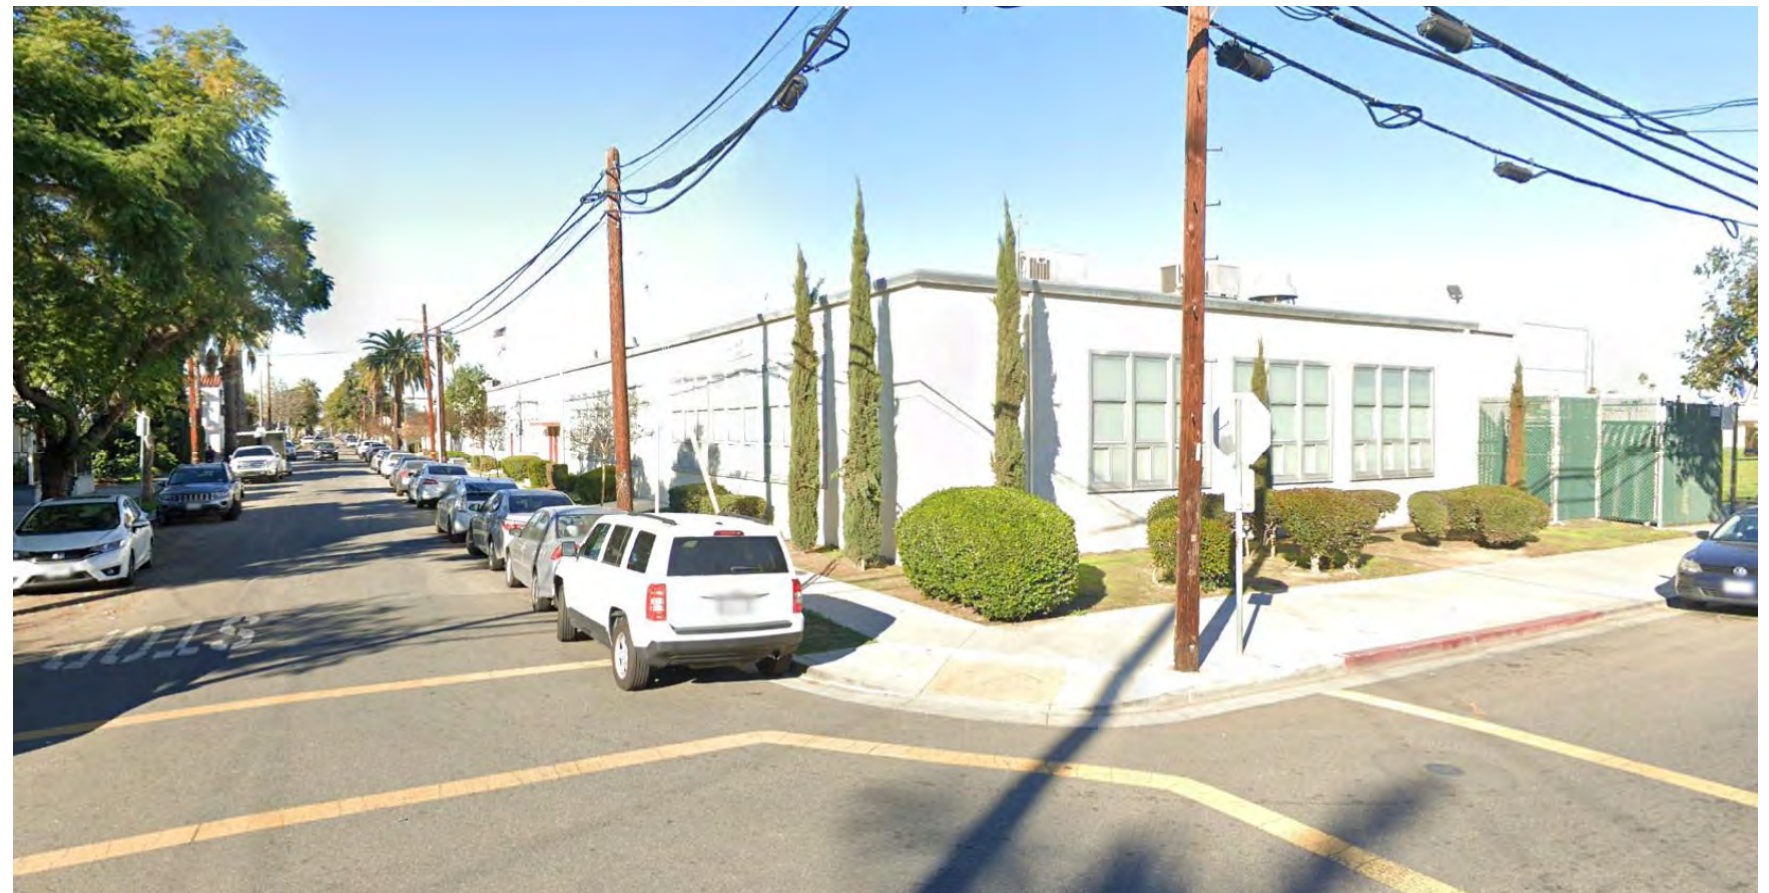
Benjamin Franklin Middle School – Existing Campus

- A** Significant large areas of blacktop without use of reflective paints to reduce heat island and improve quality of play

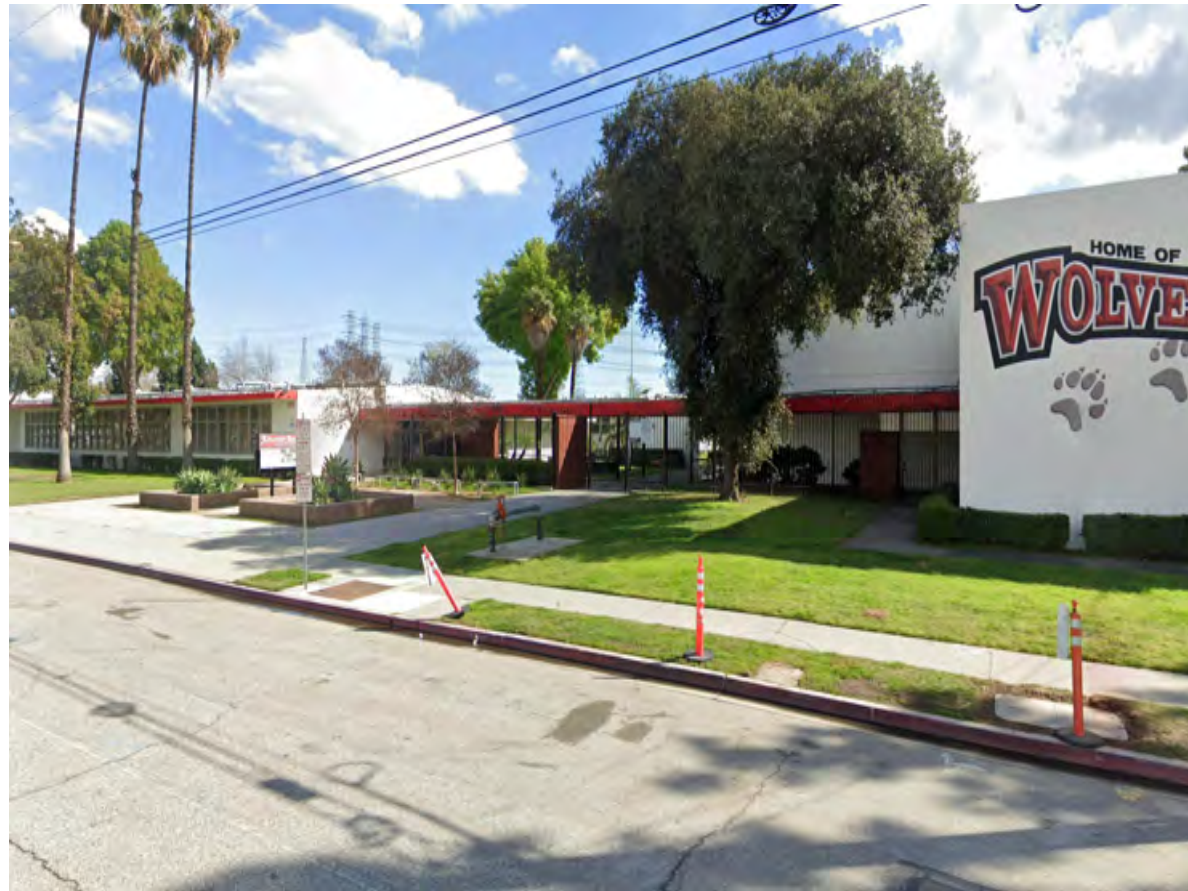
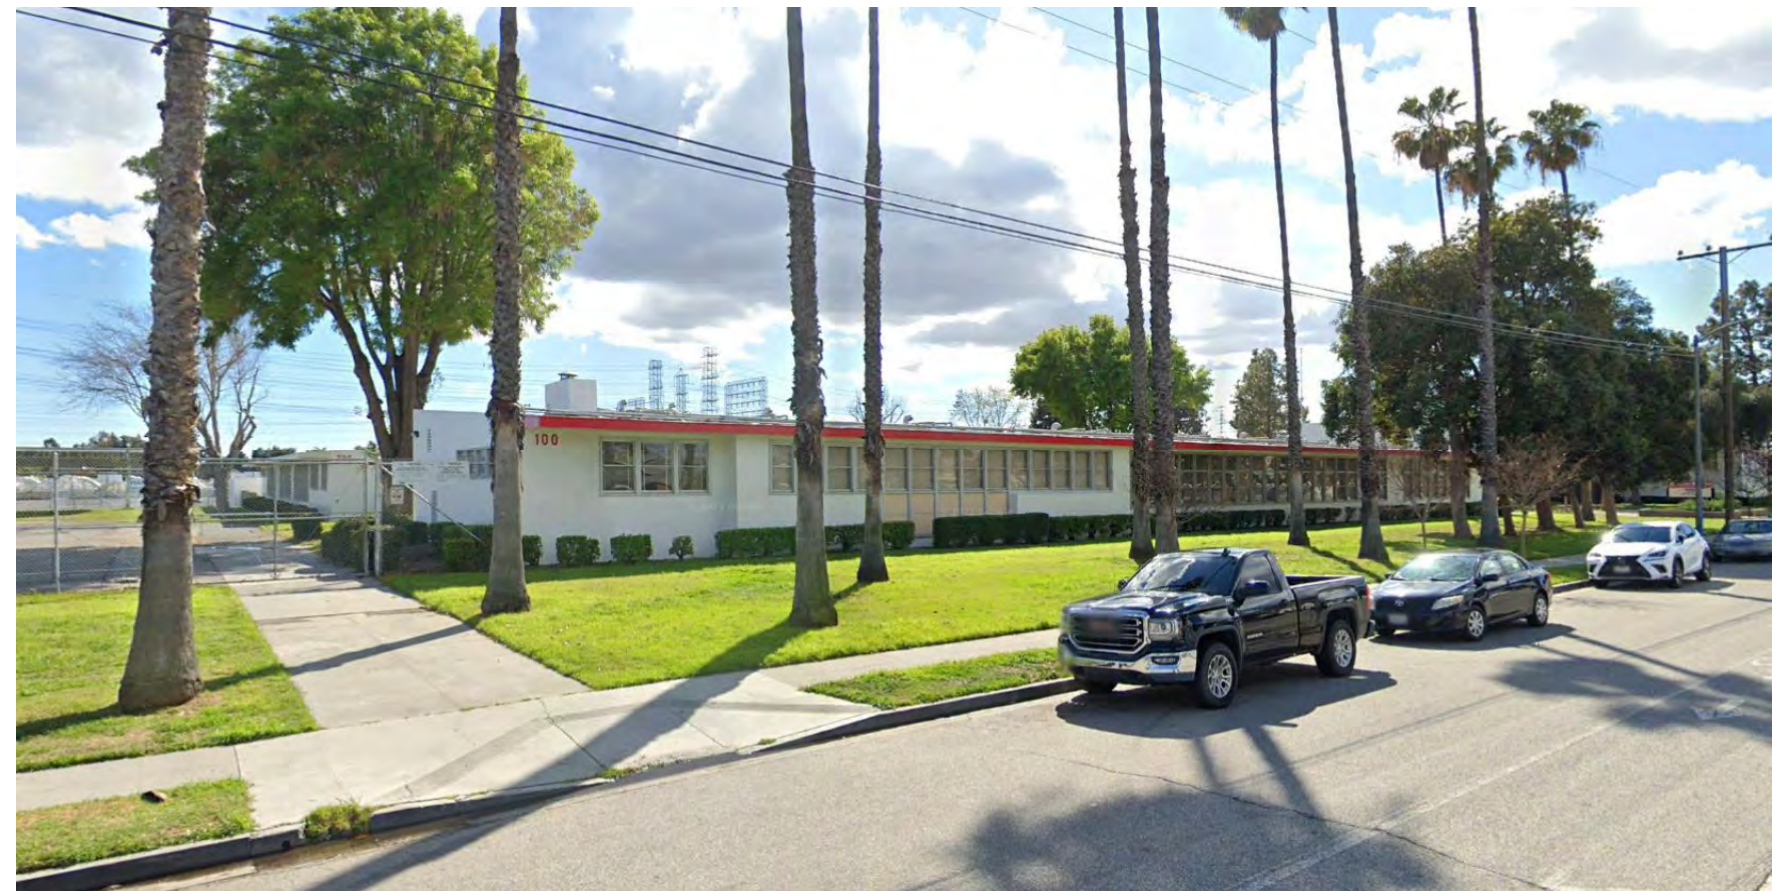
Alexander Hamilton Middle School – Existing Campus

- A Significant large areas of blacktop without use of reflective paints to reduce heat island and improve quality of play

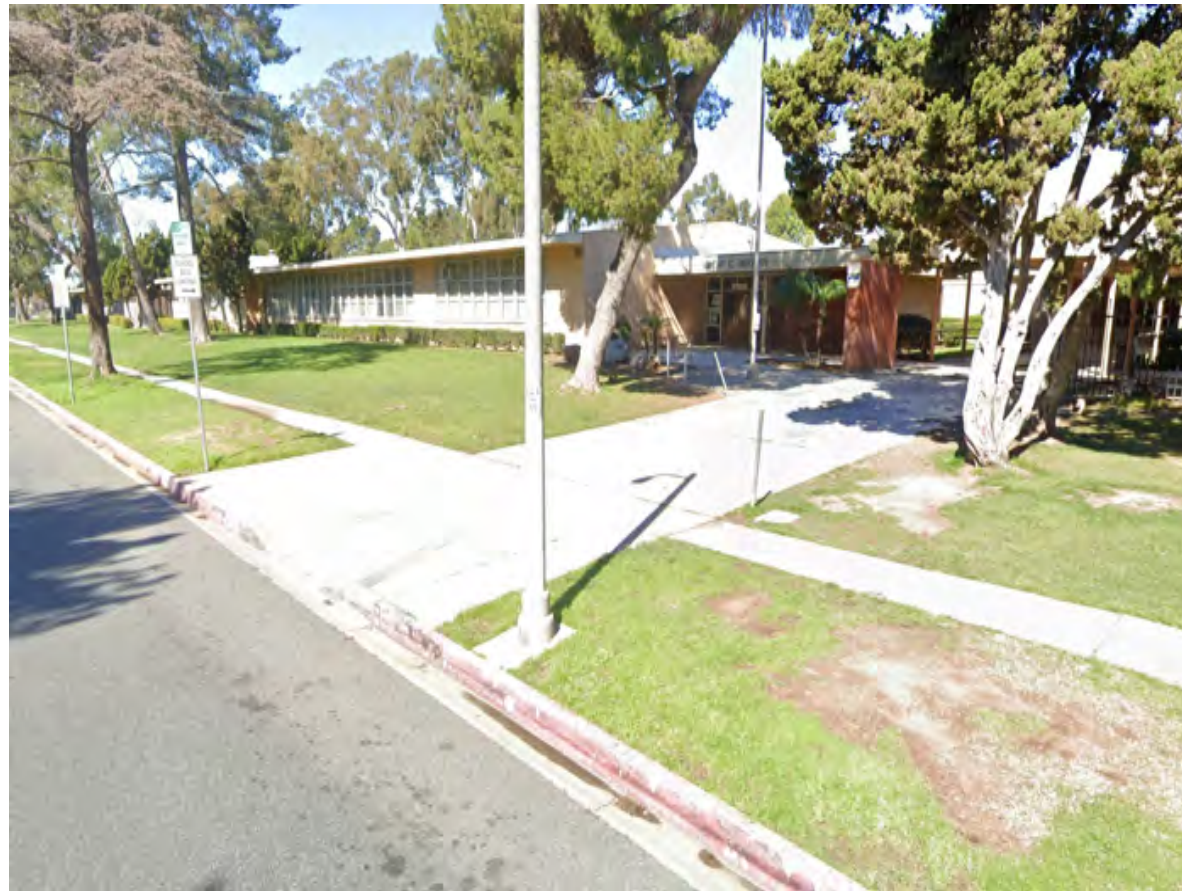
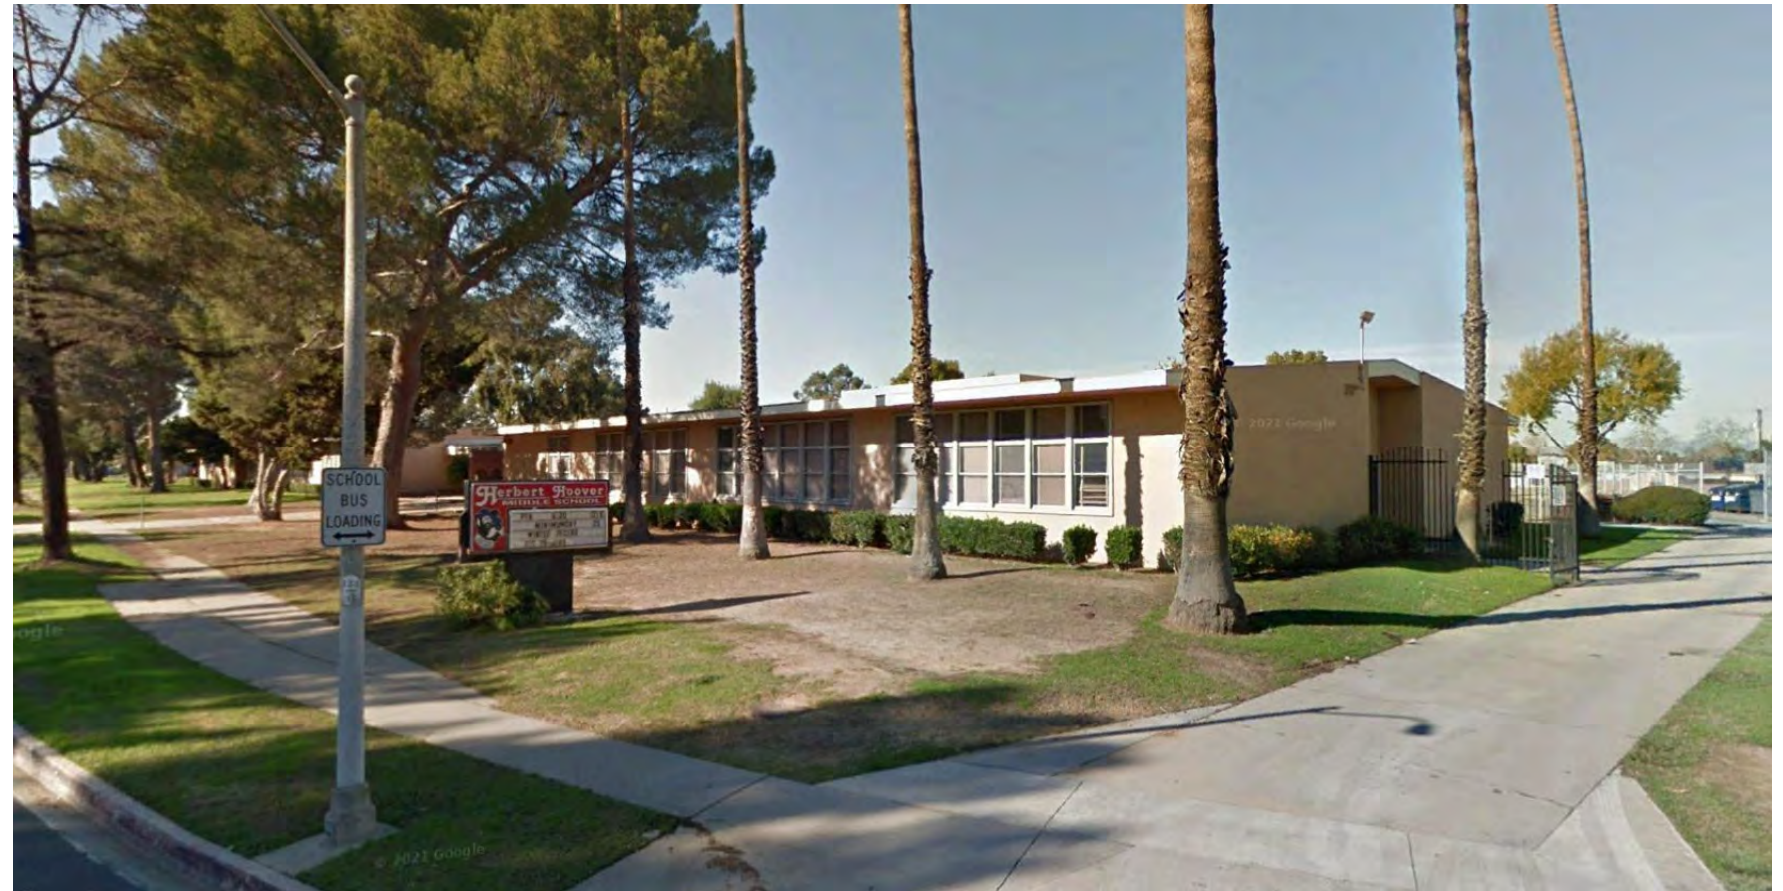
Herbert Hoover Middle School – Existing Campus

- A** Significant large areas of blacktop without use of reflective paints to reduce heat island and improve quality of play
