LBUSD 2022 Facility Master Plan

Long Beach Unified School District
Appendices

July 2022

A Facility Reports: Elementary Schools

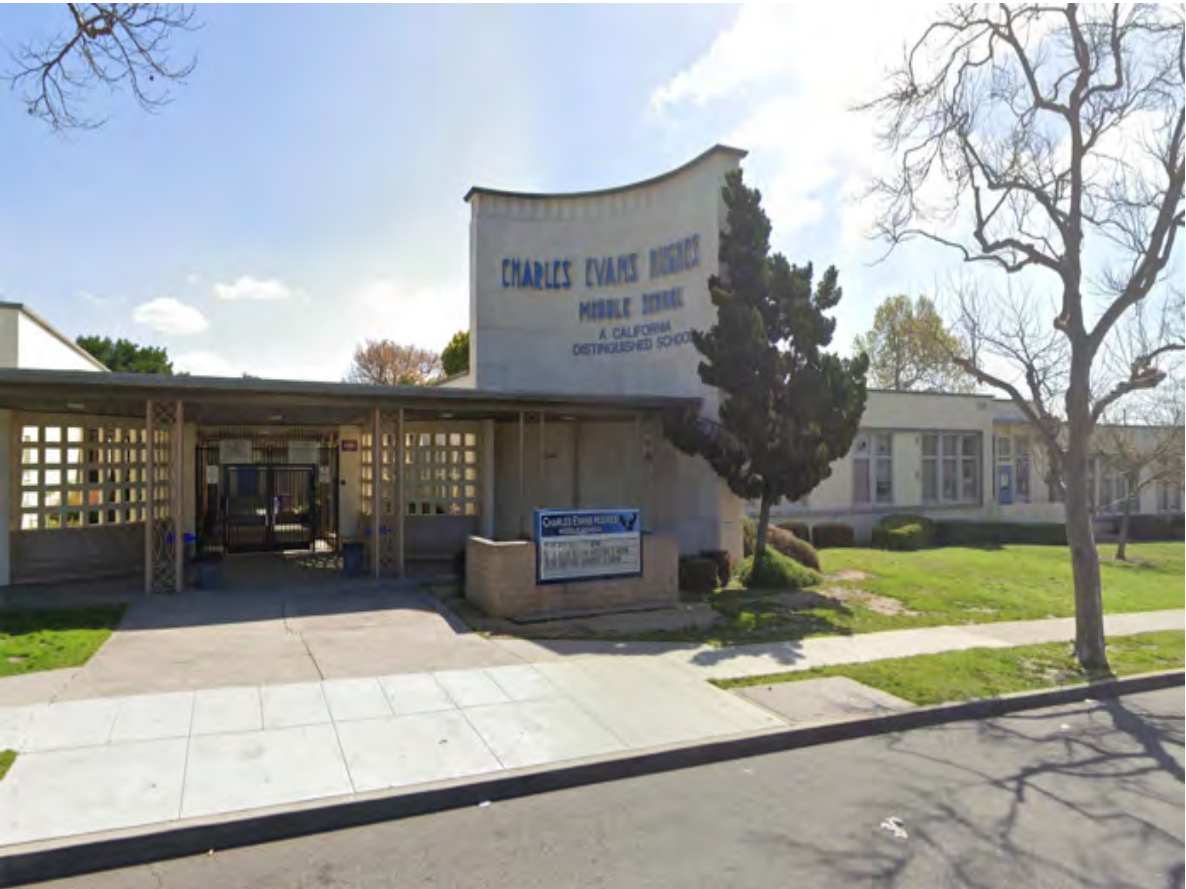
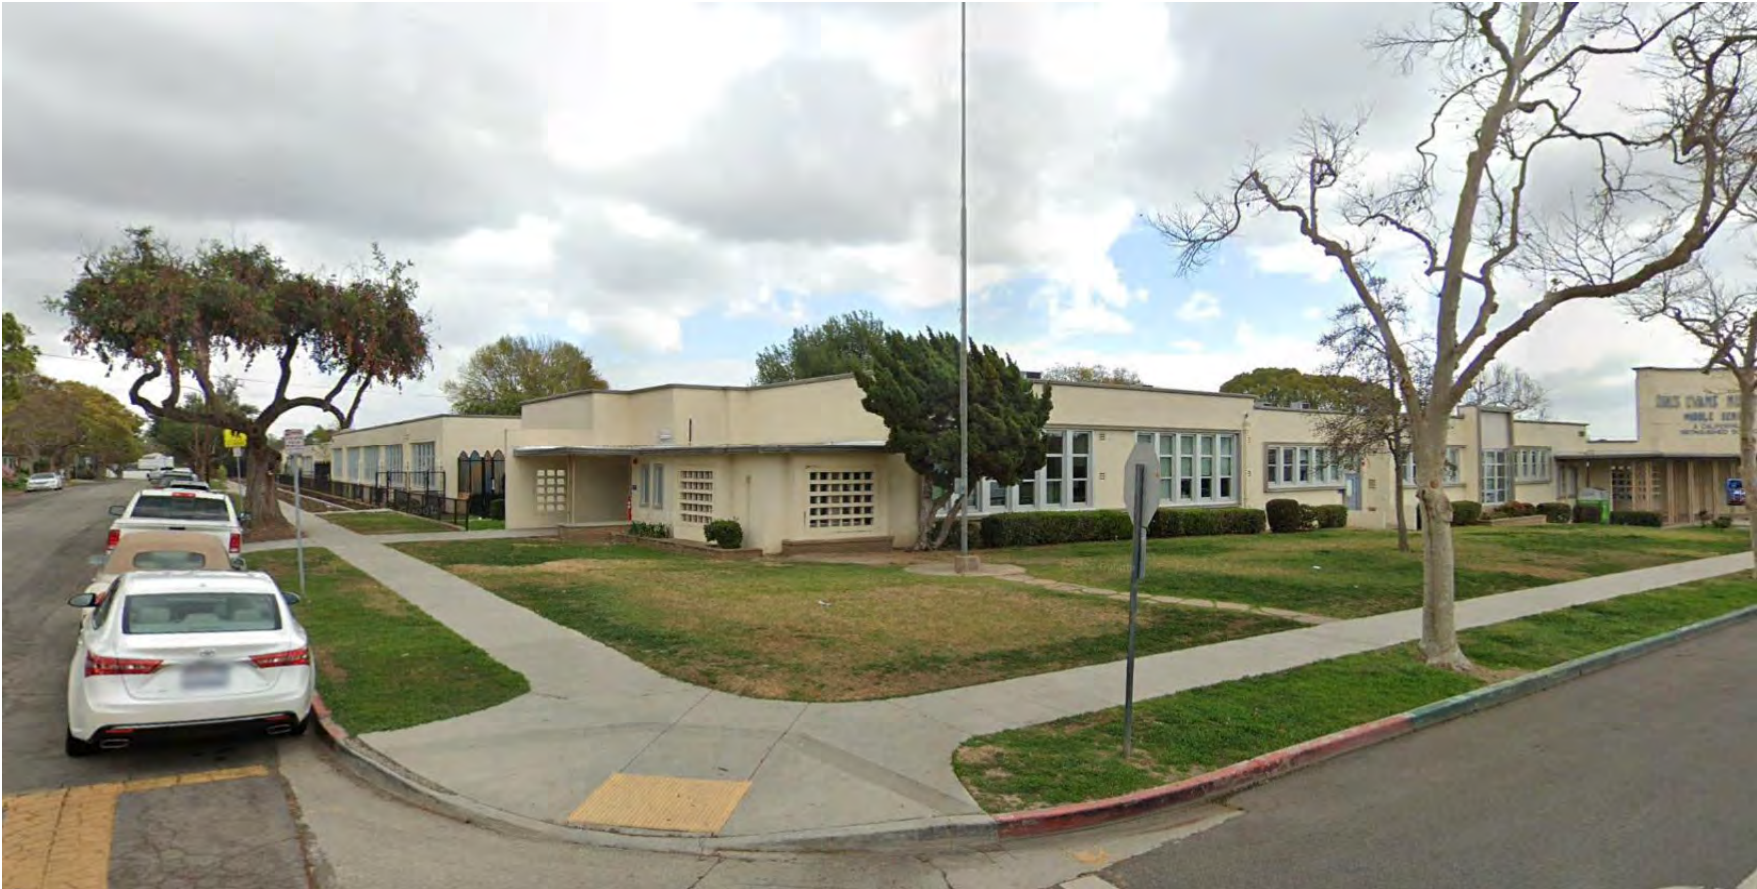
Charles Evan Hughes Middle School – Existing Campus

- A Significant large areas of blacktop without use of reflective paints to reduce heat island and improve quality of play

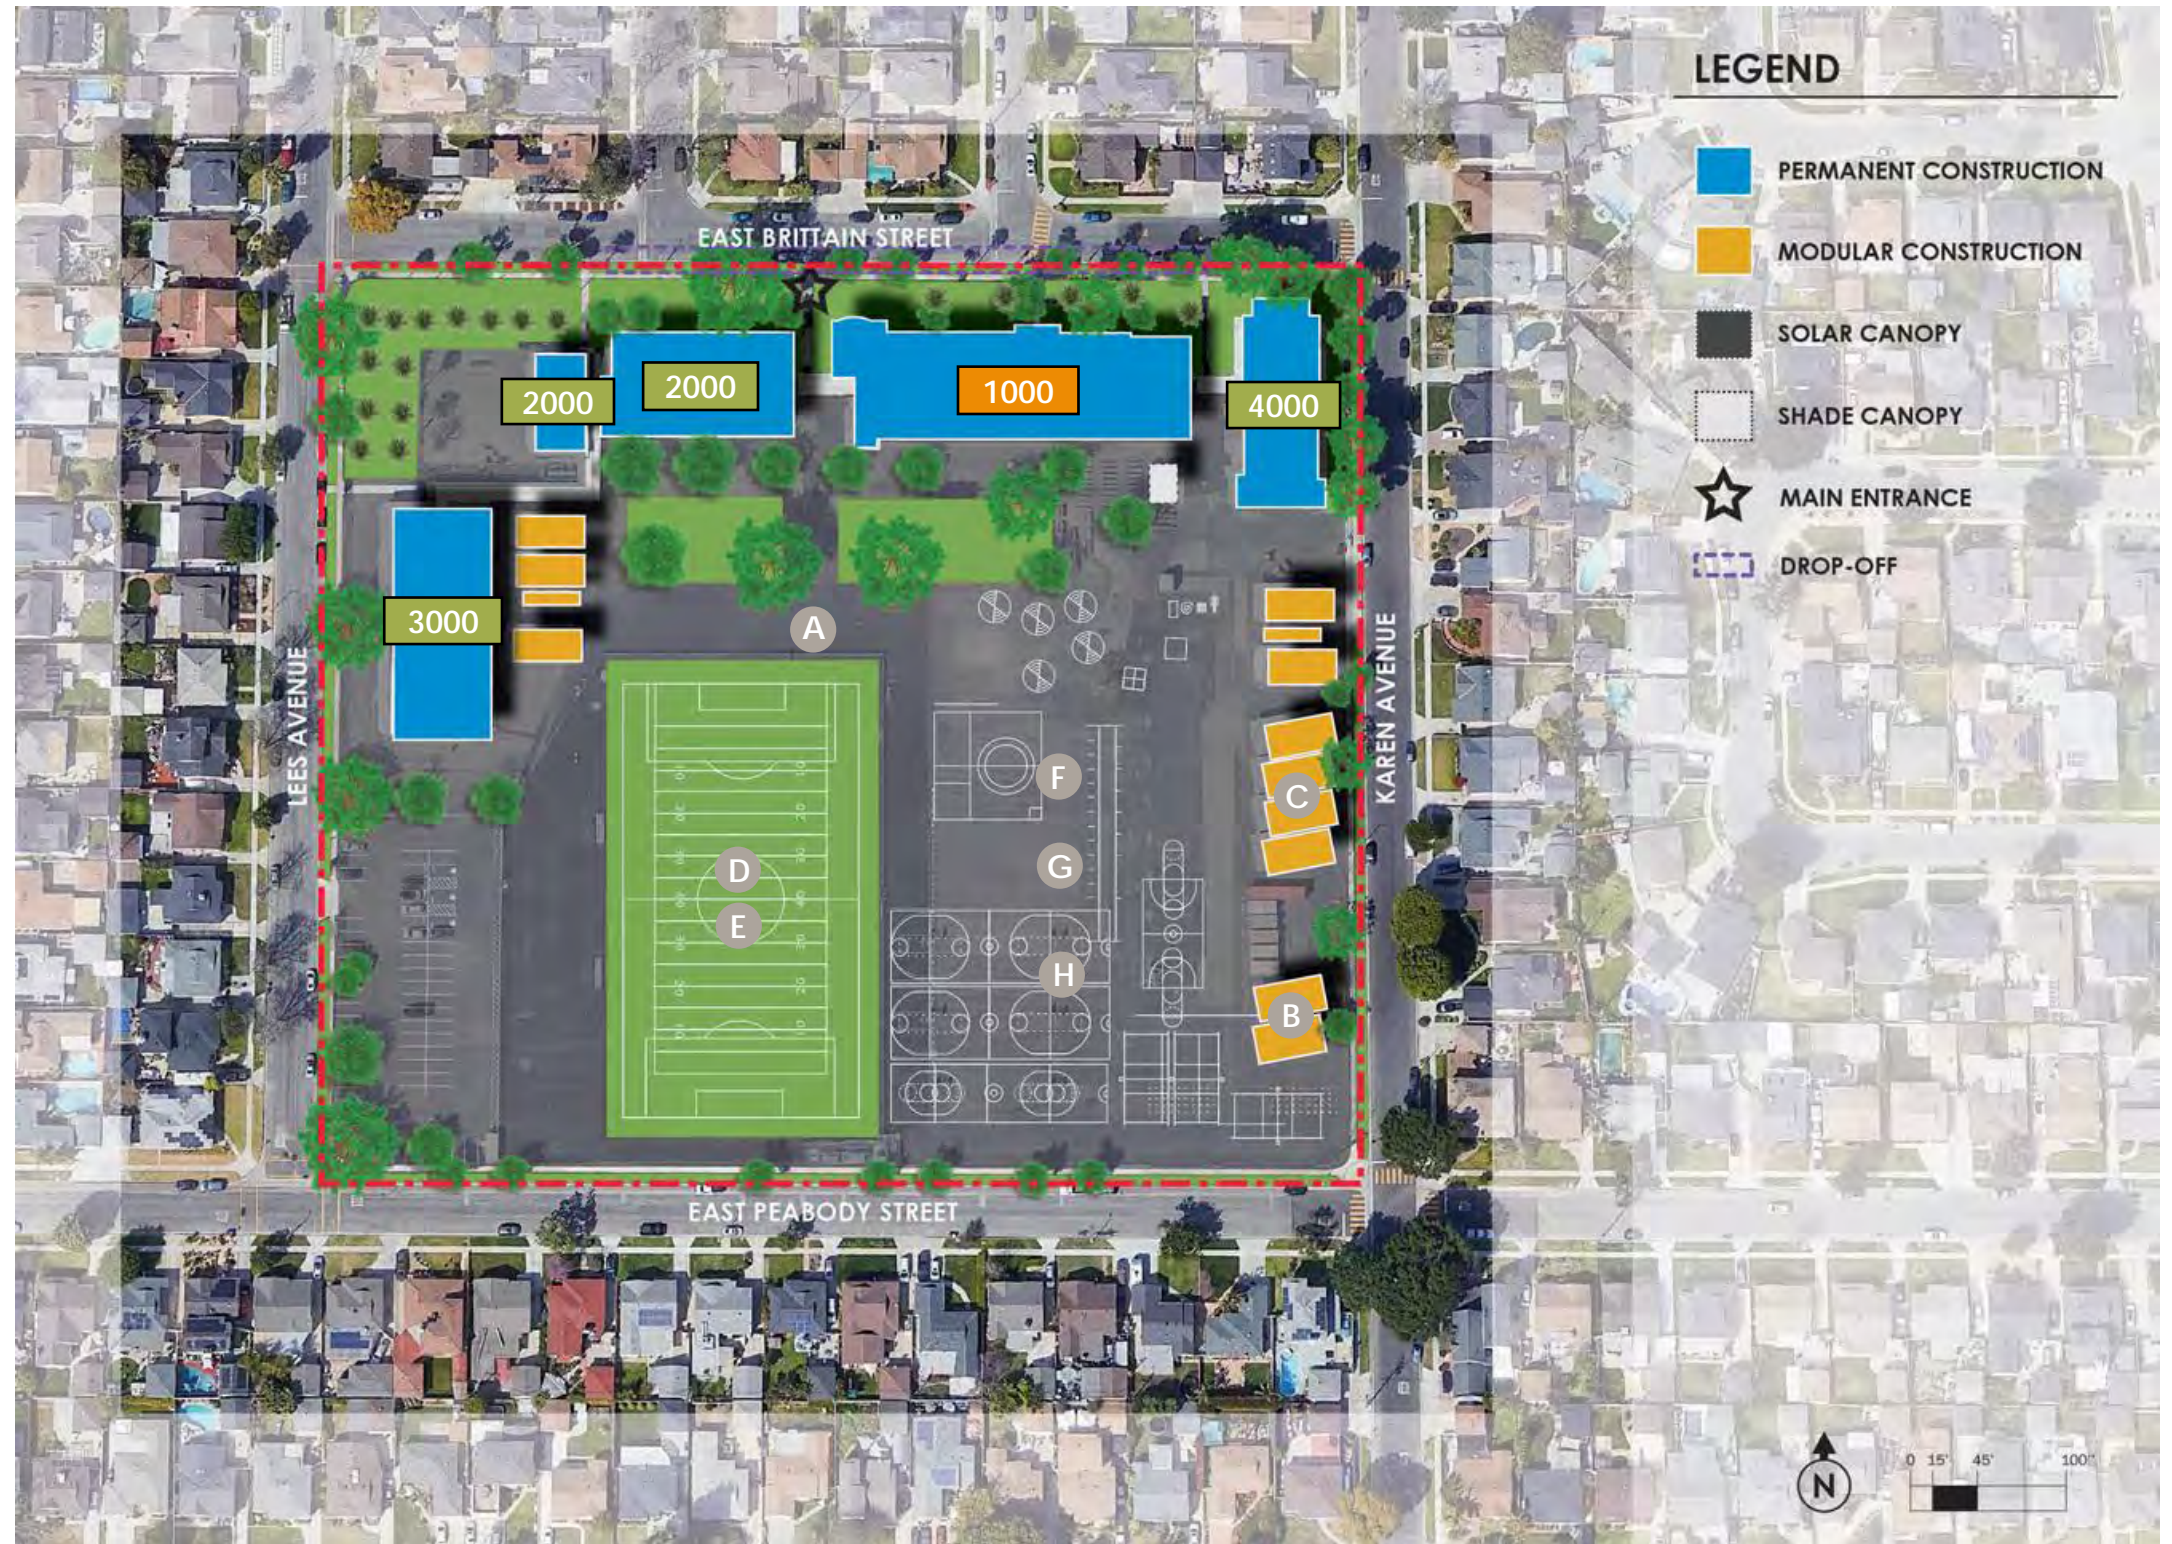
Helen Keller Middle School (Dual Immersion) – Existing Campus

- D** Baseball not provided (included at other Middle Schools)
- E** Soccer facilities (not provided at other Middle Schools)
- F** Lack of shade trees at play area
- G** Significant large areas of blacktop without use of reflective paints to reduce heat island and improve quality of play
- H** Gymnasium facilities not provided (included at other Middle Schools)

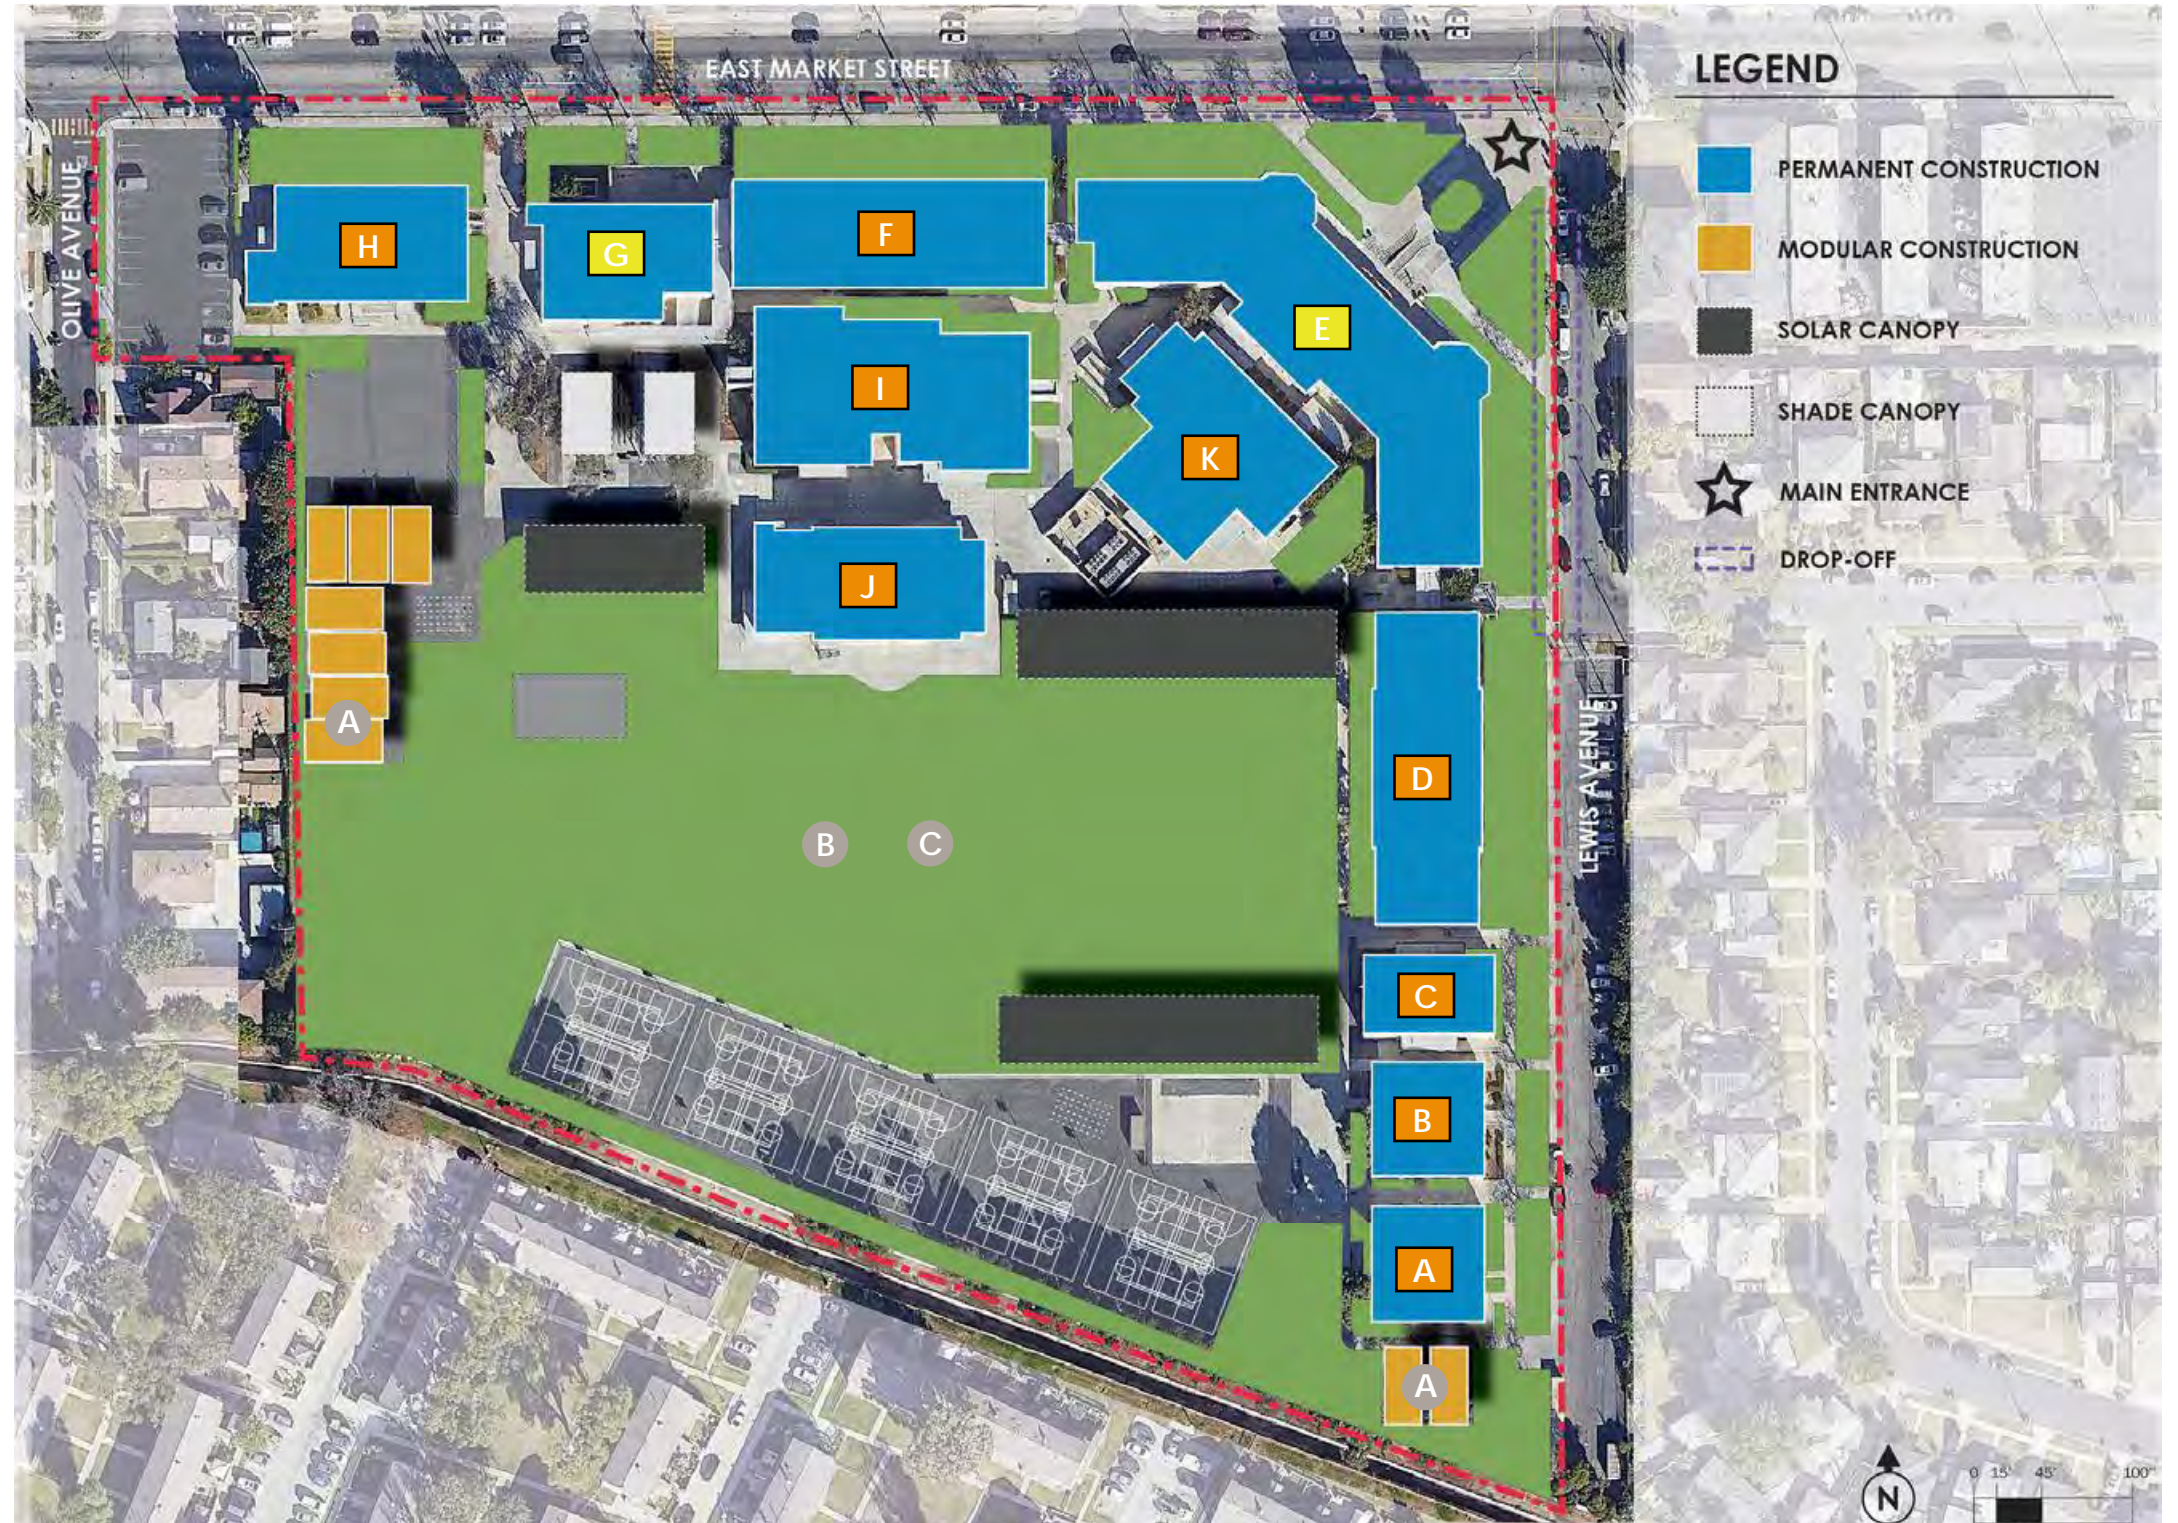
Lindbergh STEM Academy – Existing Campus

- B** Baseball not provided (included at other Middle Schools)
- C** Lack of shade trees at play area

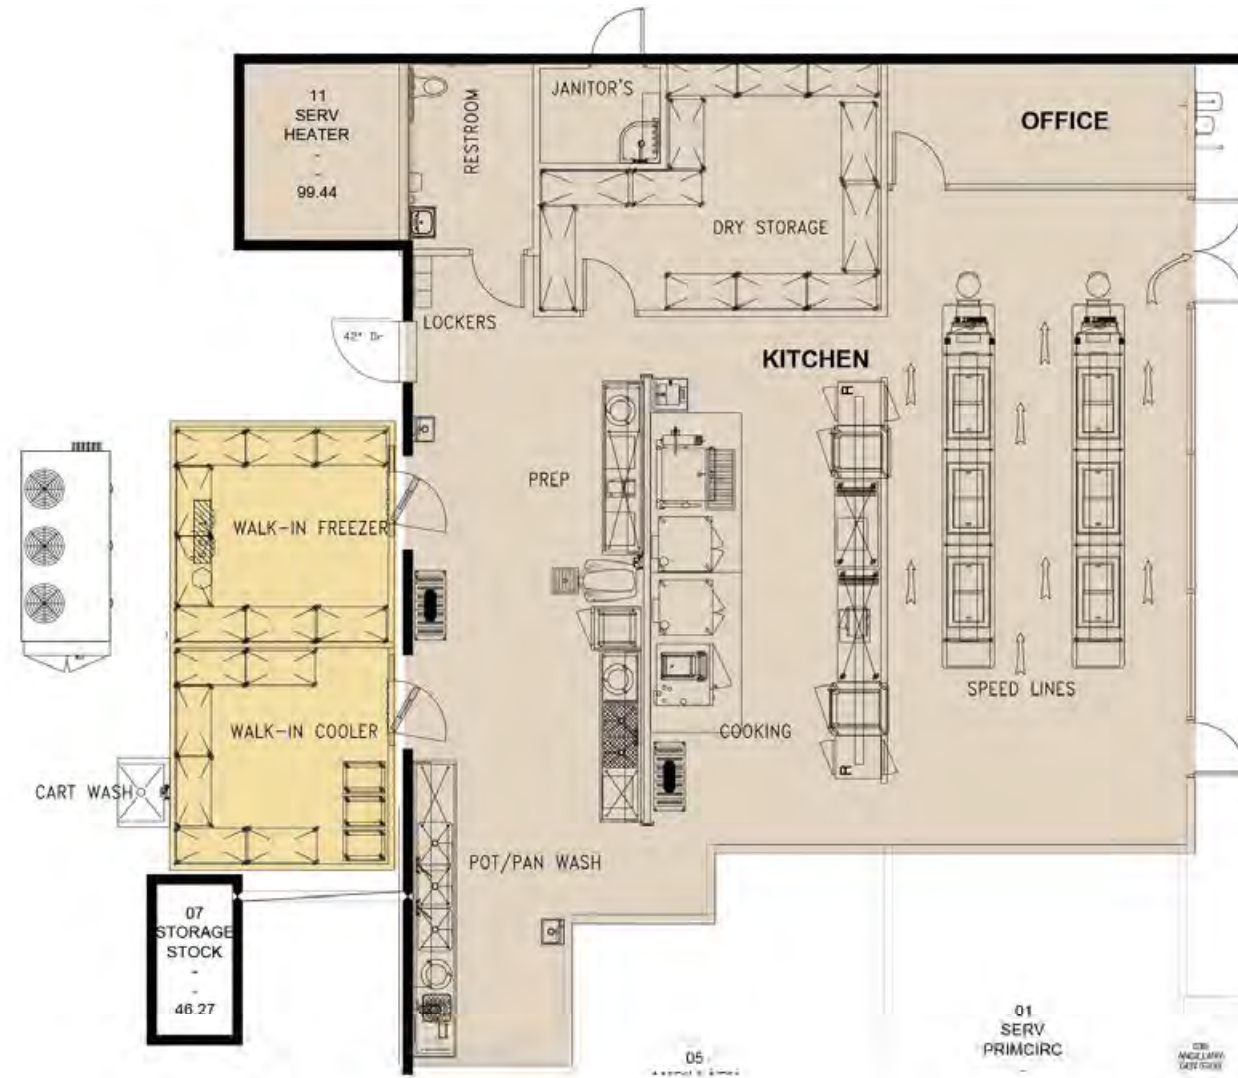
"TO FIT" DESIGN

At 2450 square feet (including the Dry Storage area), the kitchen is large for the student population and the number of meals served per day. The Lindbergh Middle School kitchen is a full production kitchen with the capability of preparing and serving far more meals than are currently served daily. The food service areas at Lindbergh Middle School meet most current ADA and EHS requirements. The kitchen's dedicated dry storage in conjunction with storage that is interspersed throughout the kitchen is adequate. Code requires that a hood must have specific overhang clearances to be deemed code compliant, however, this hood does not meet these requirements. Air curtains must have enough velocity to inhibit flying insects from entering through open doors/windows. One of the air curtains in the cafeteria is mounted at +18" above the door opening and two are mounted at +40" above the door opening. The cfm's on the existing units are not sufficient to meet EHS requirements. The Lindbergh Middle School kitchen has been updated and upgraded to meet most codes, however, it could benefit from some minor improvements to remedy the few areas where compliance falls short.

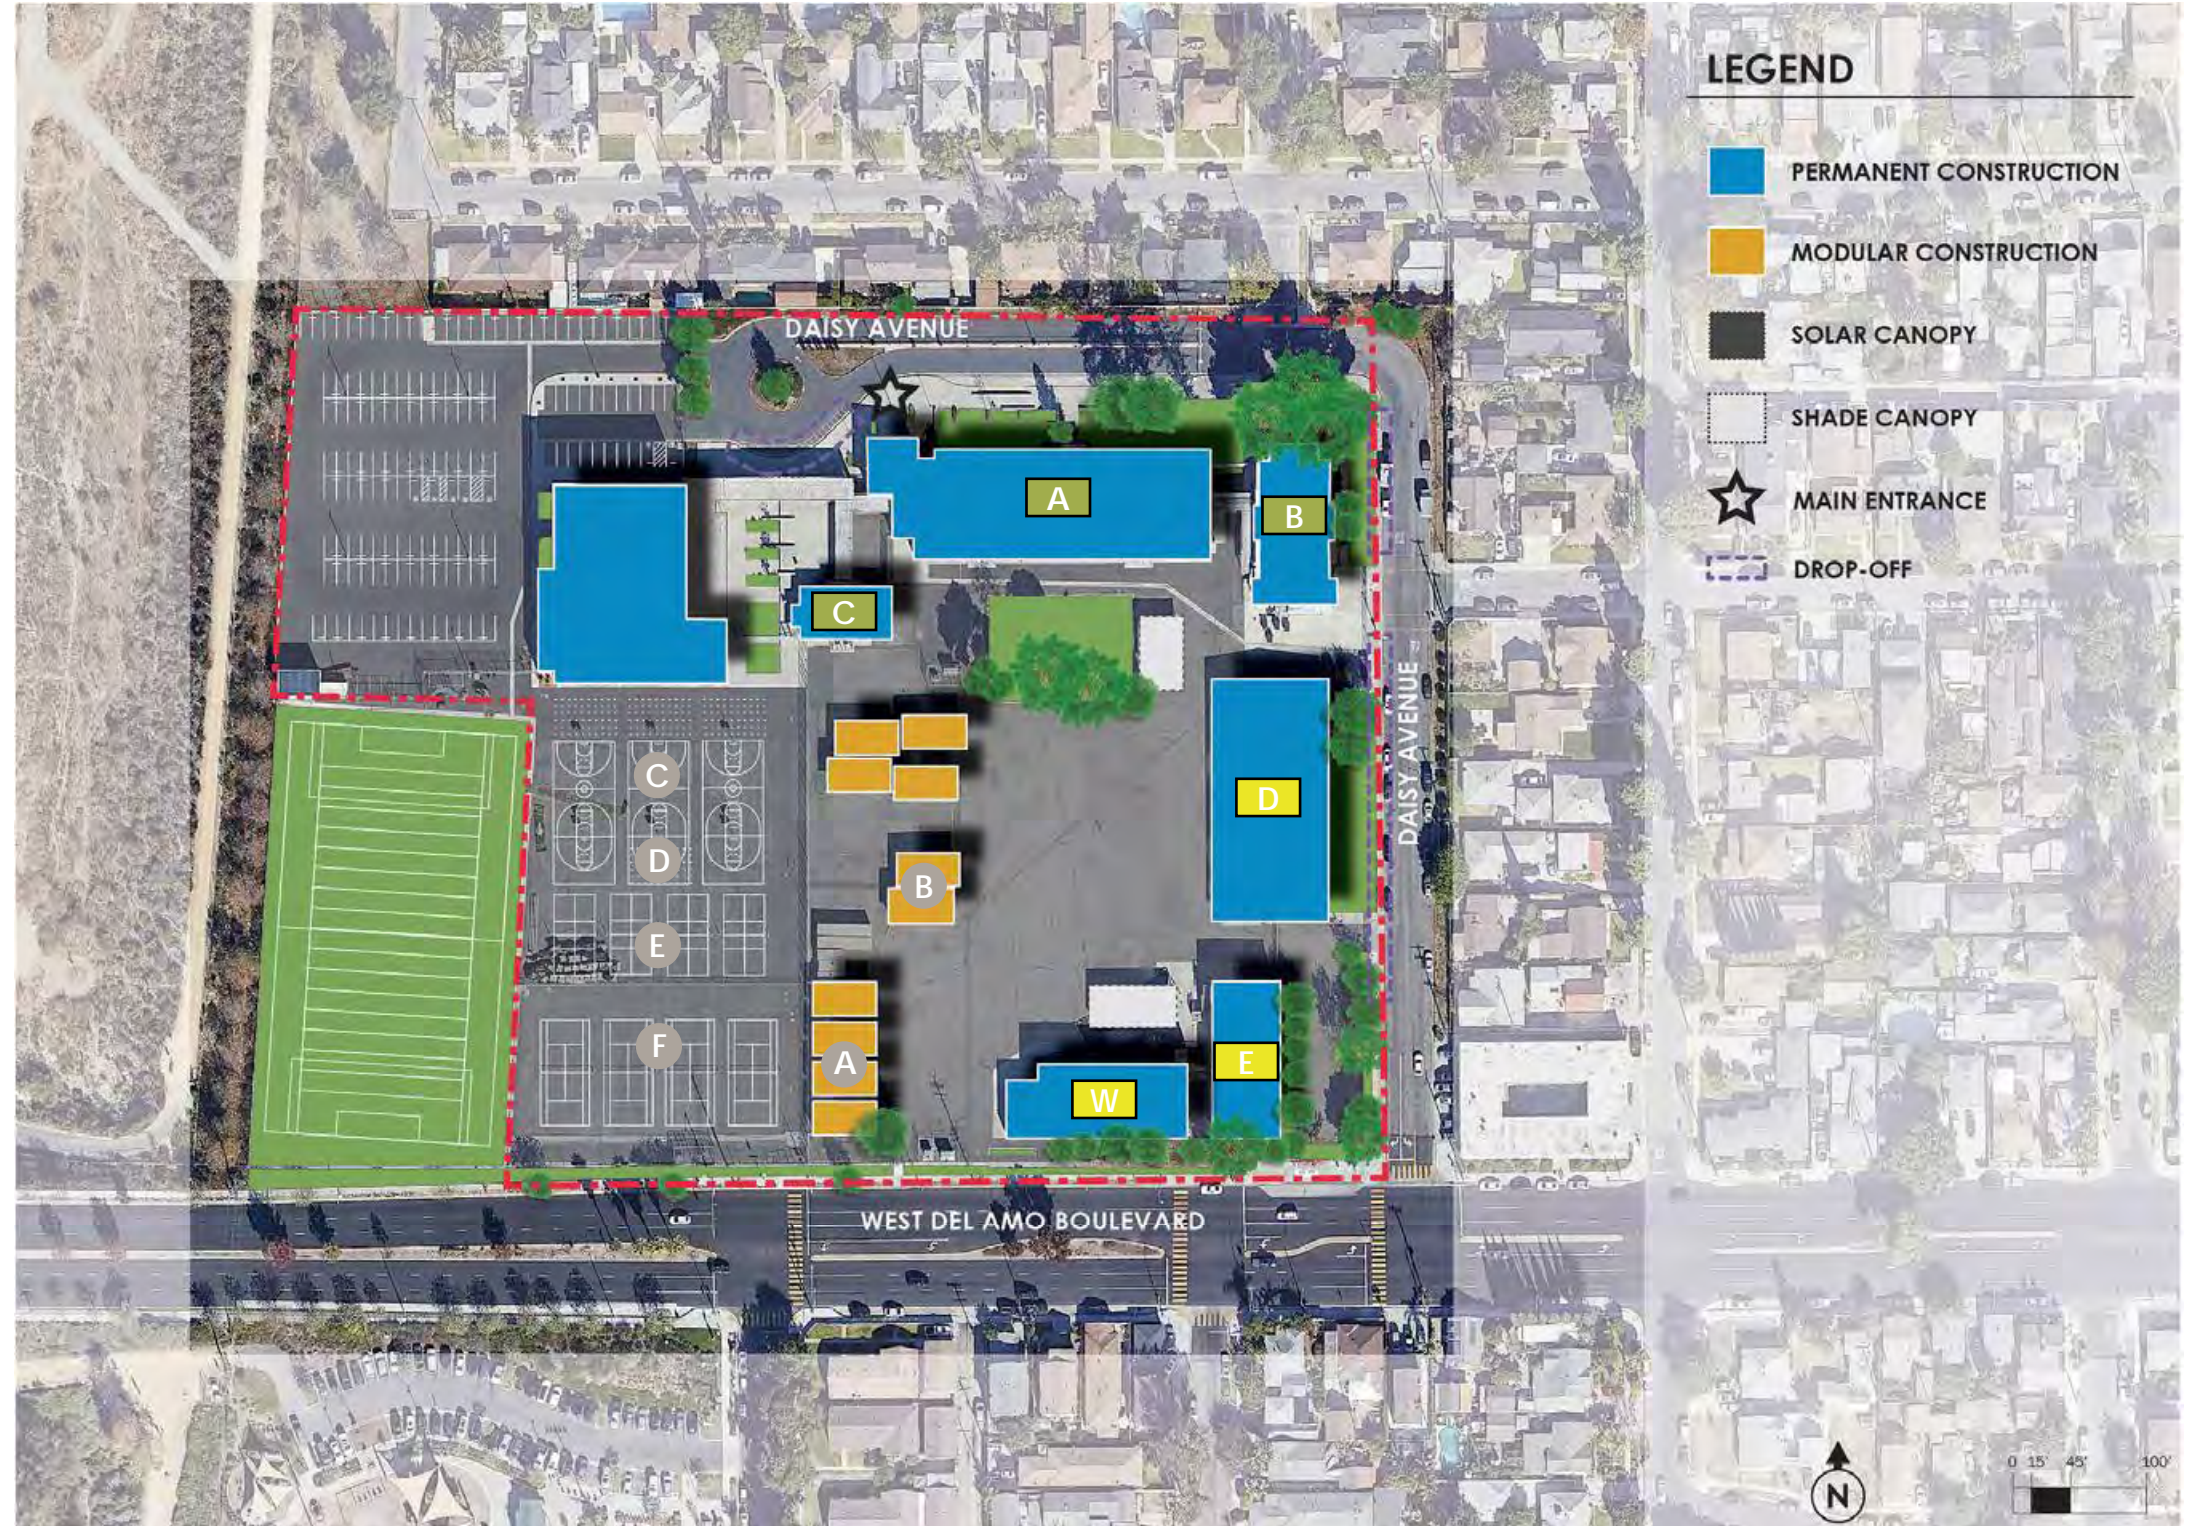
Lindsey Middle School – Existing Campus

- C** Baseball not provided (included at other Middle Schools)
- D** Lack of lawn/turf area at main play area
- E** Lack of shade trees at play area
- F** Significant large areas of blacktop without use of reflective paints to reduce heat island and improve quality of play

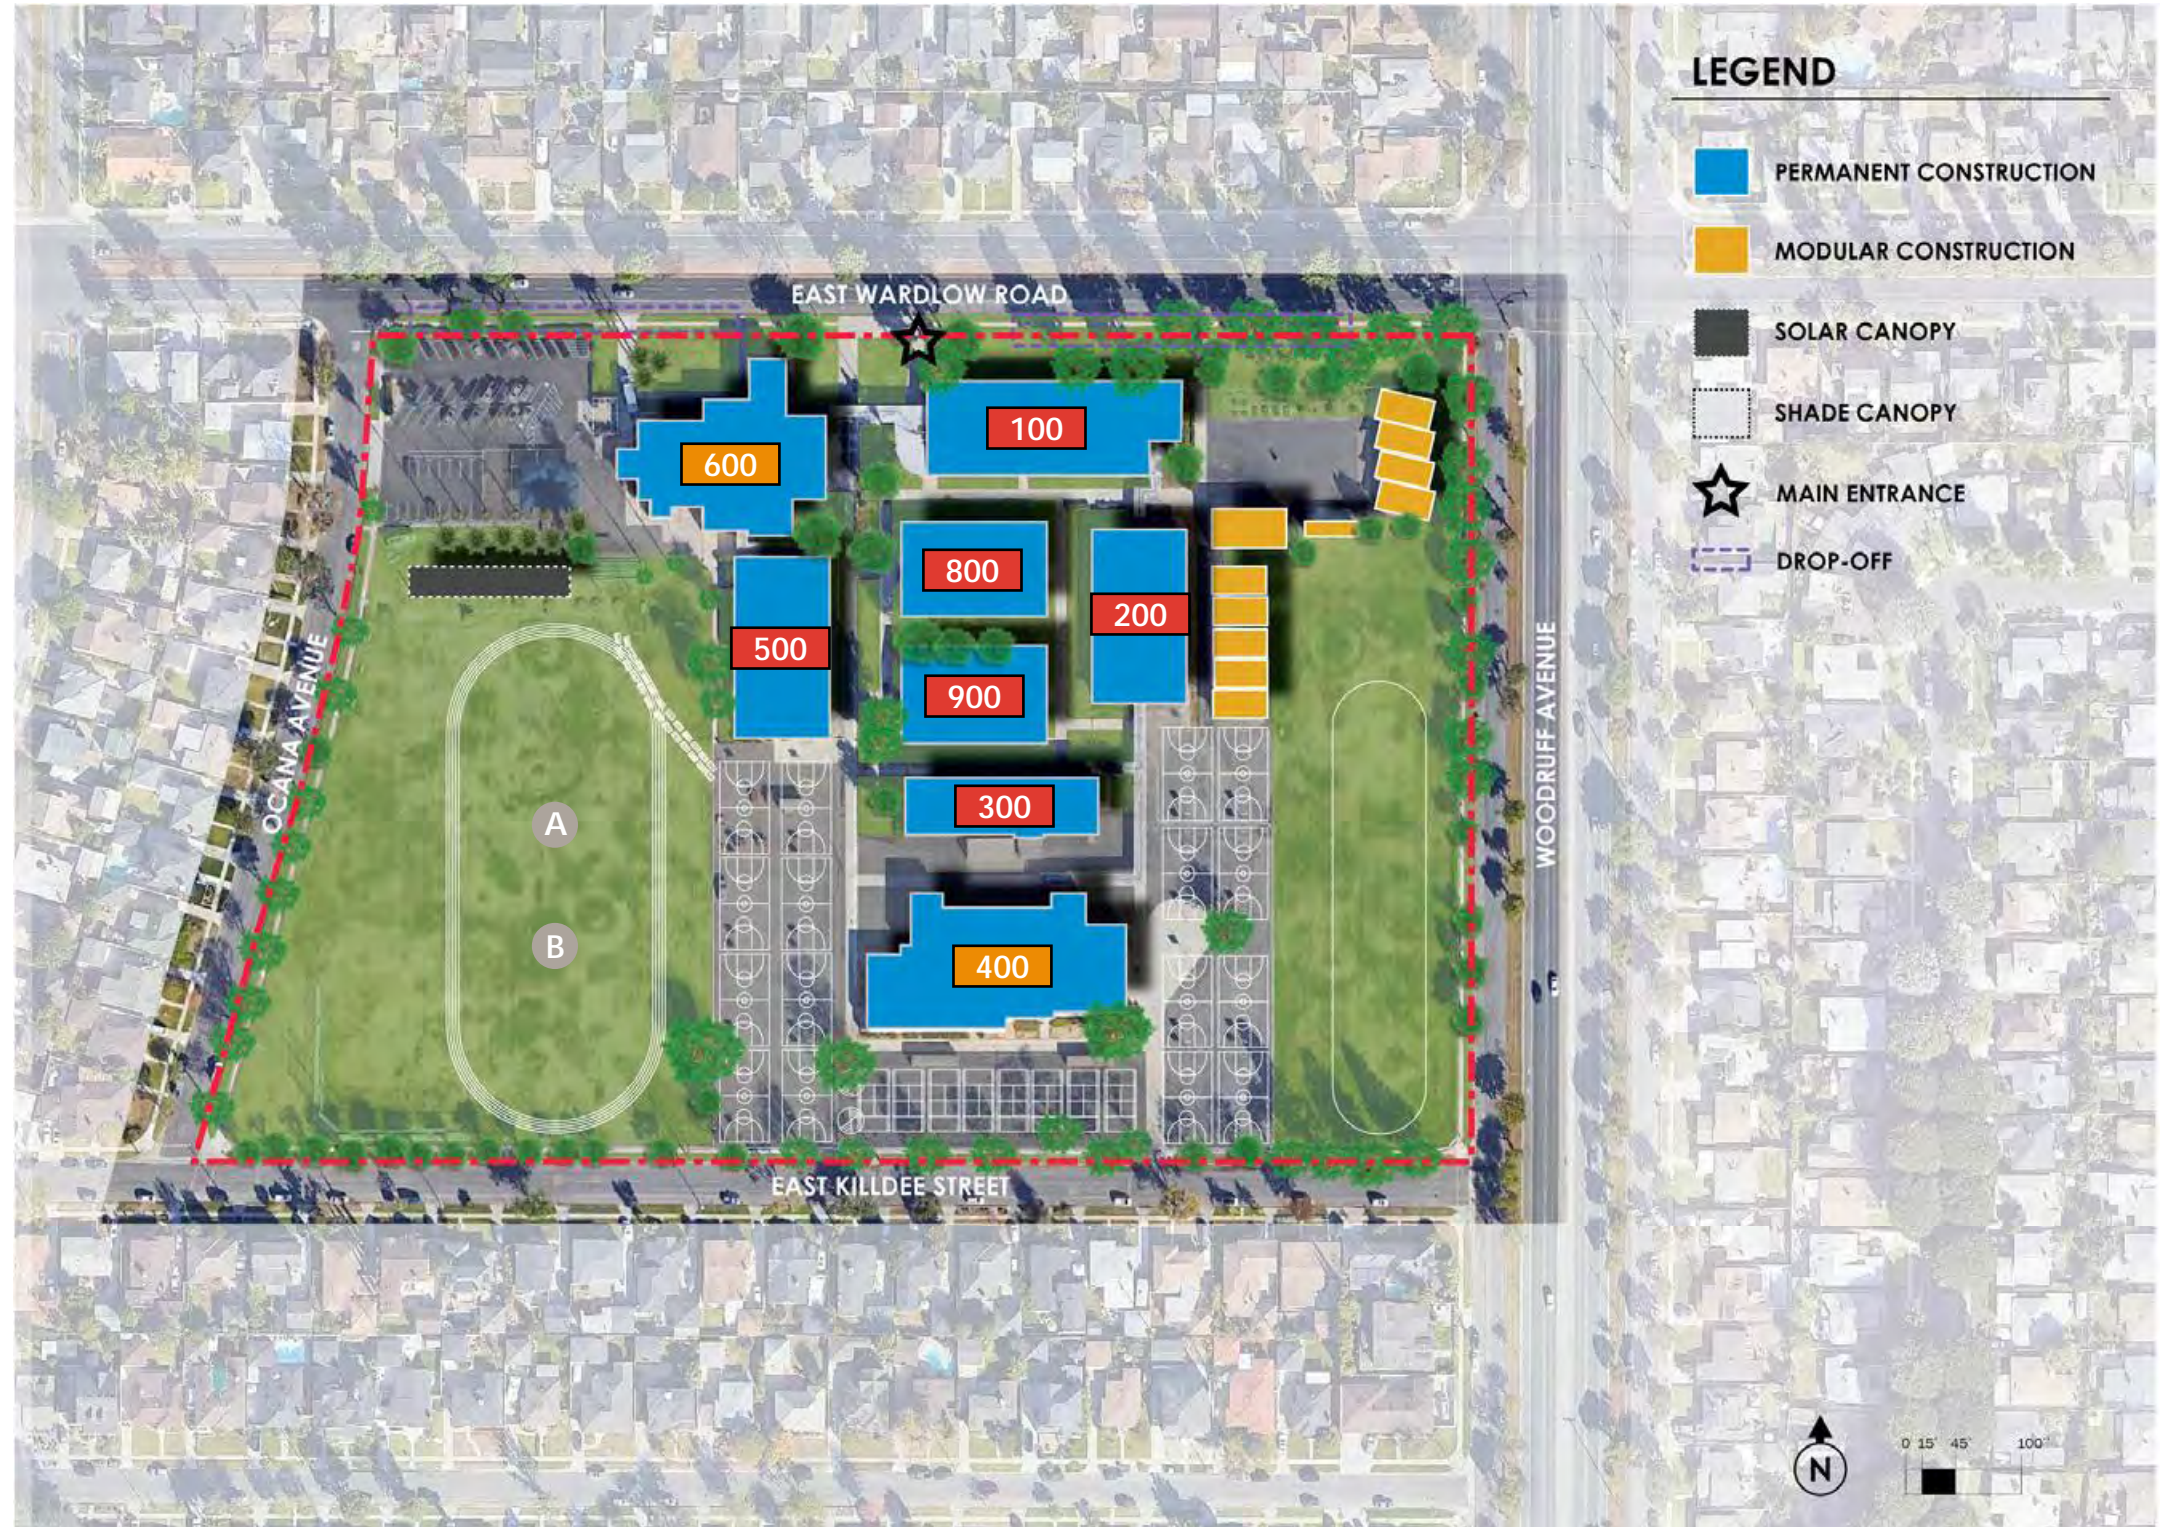
Marshall Academy of the Arts – Existing Campus

- A Baseball not provided (included at other Middle Schools)
- B Lack of shade trees at play area

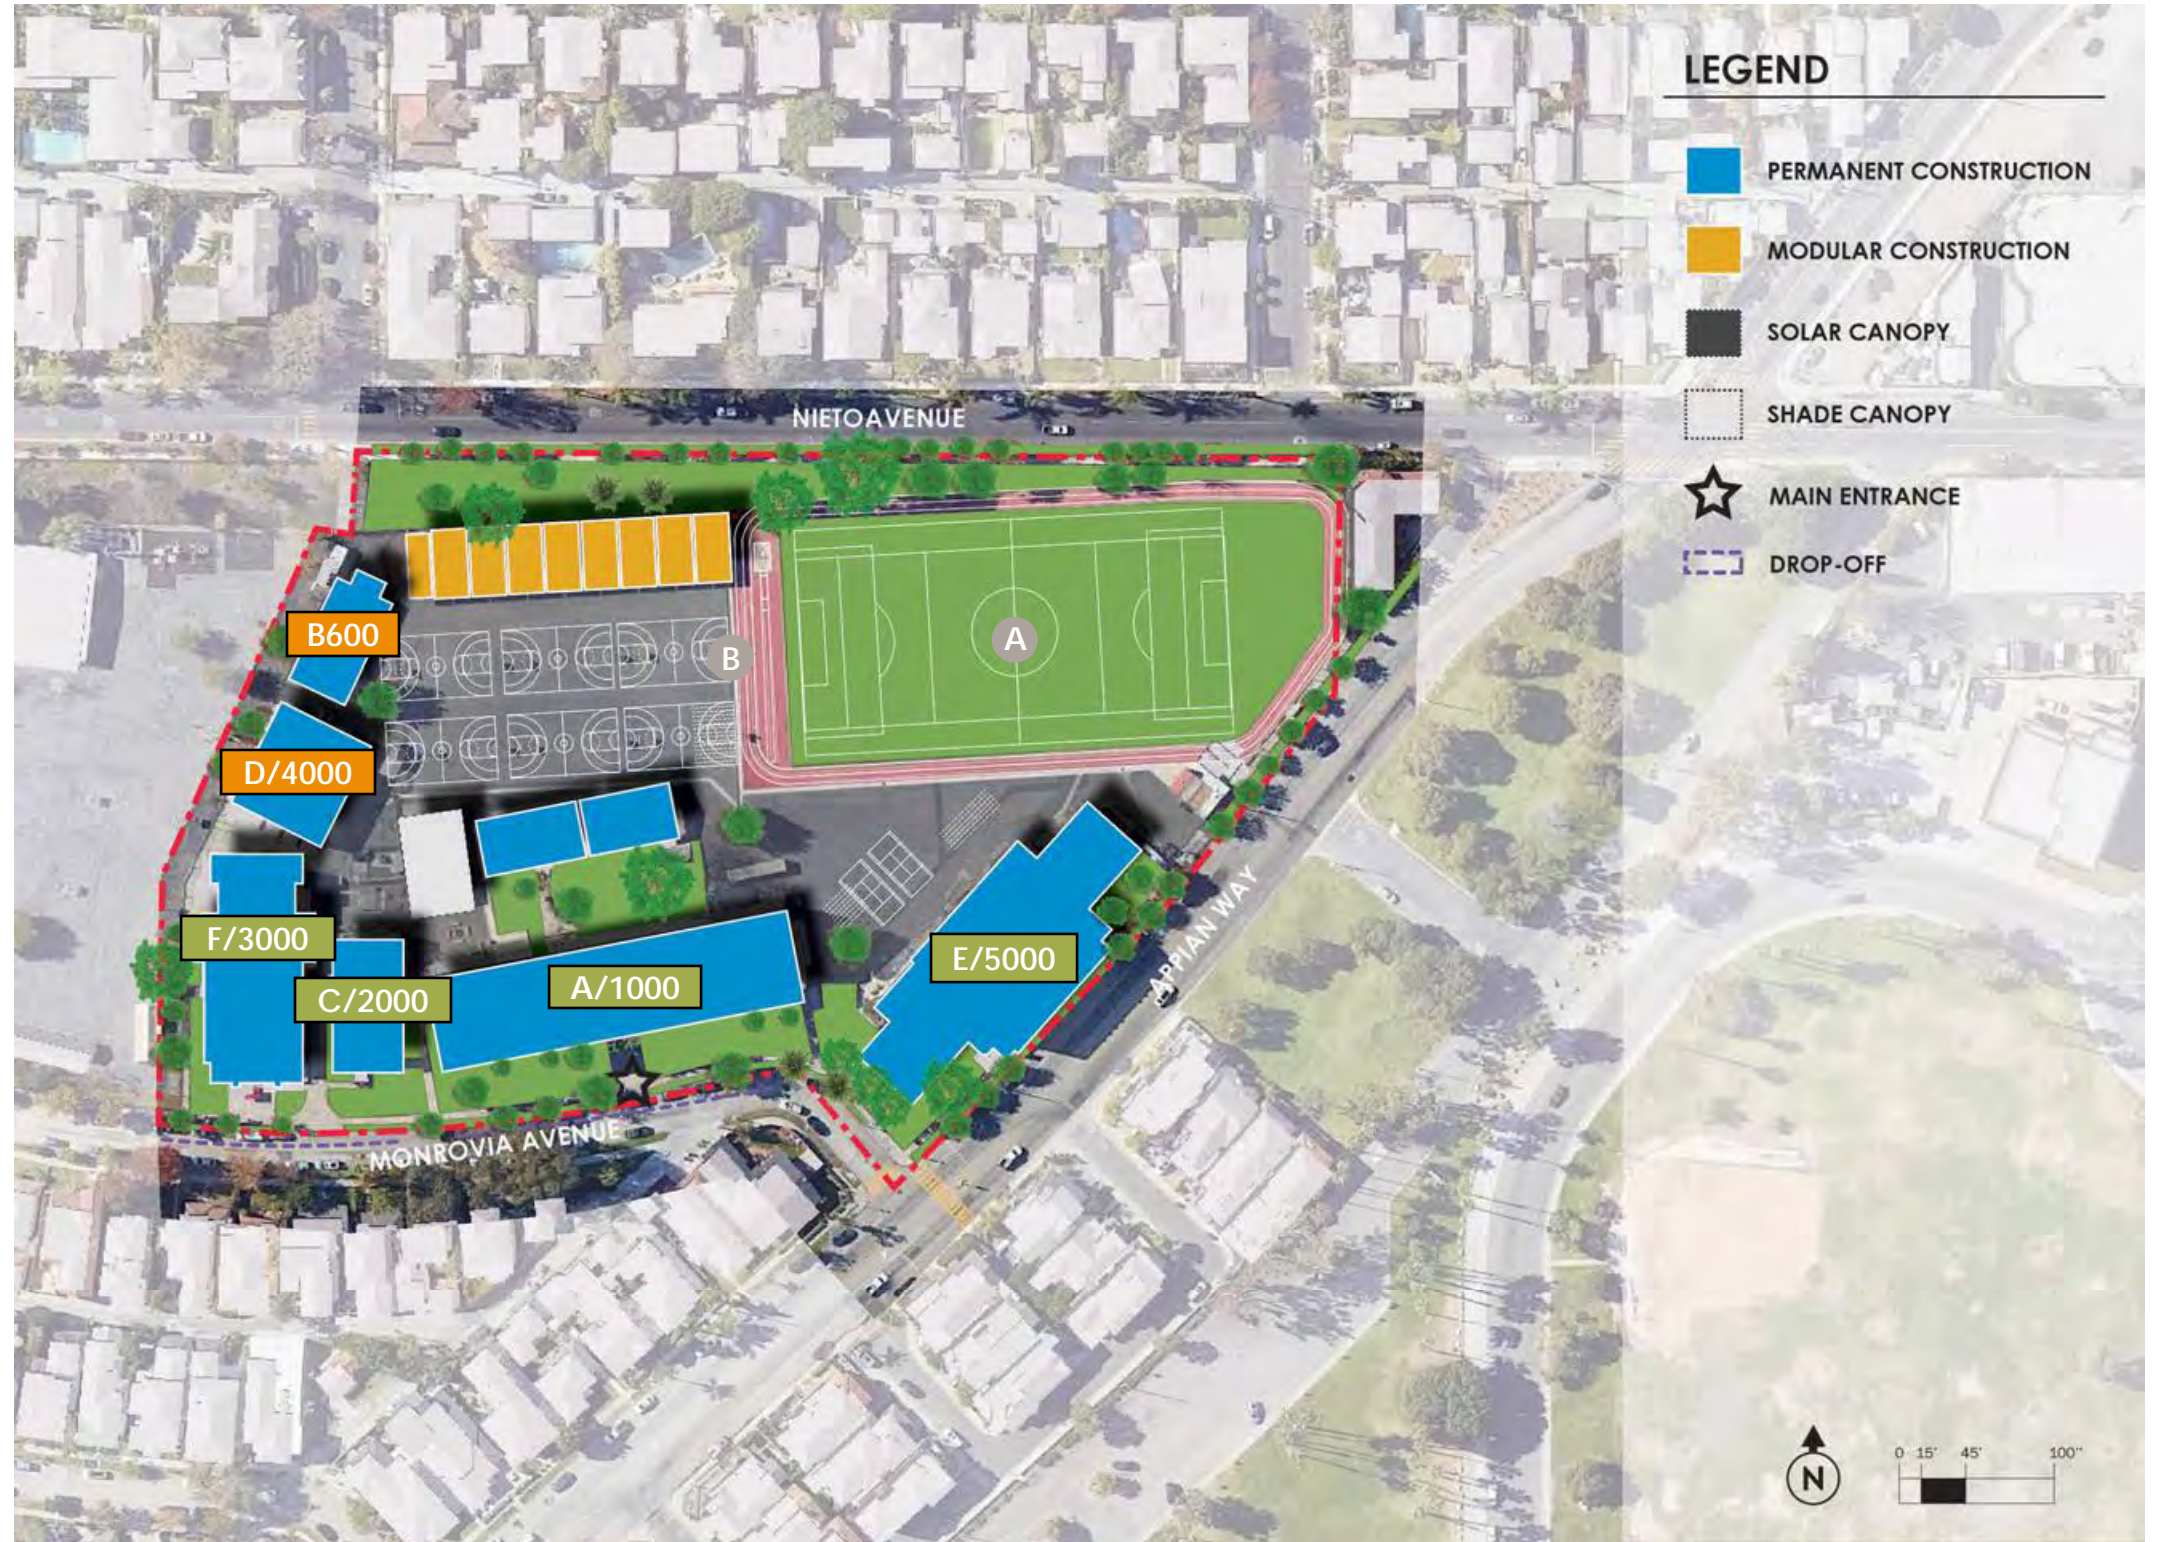
Will Rogers Middle School – Existing Campus

- A** Baseball not provided (included at other Middle Schools)
- B** Lack of shade trees at play area
