LBUSD 2022 Facility Master Plan

Long Beach Unified School District
Appendices

July 2022

A Facility Reports: Elementary Schools

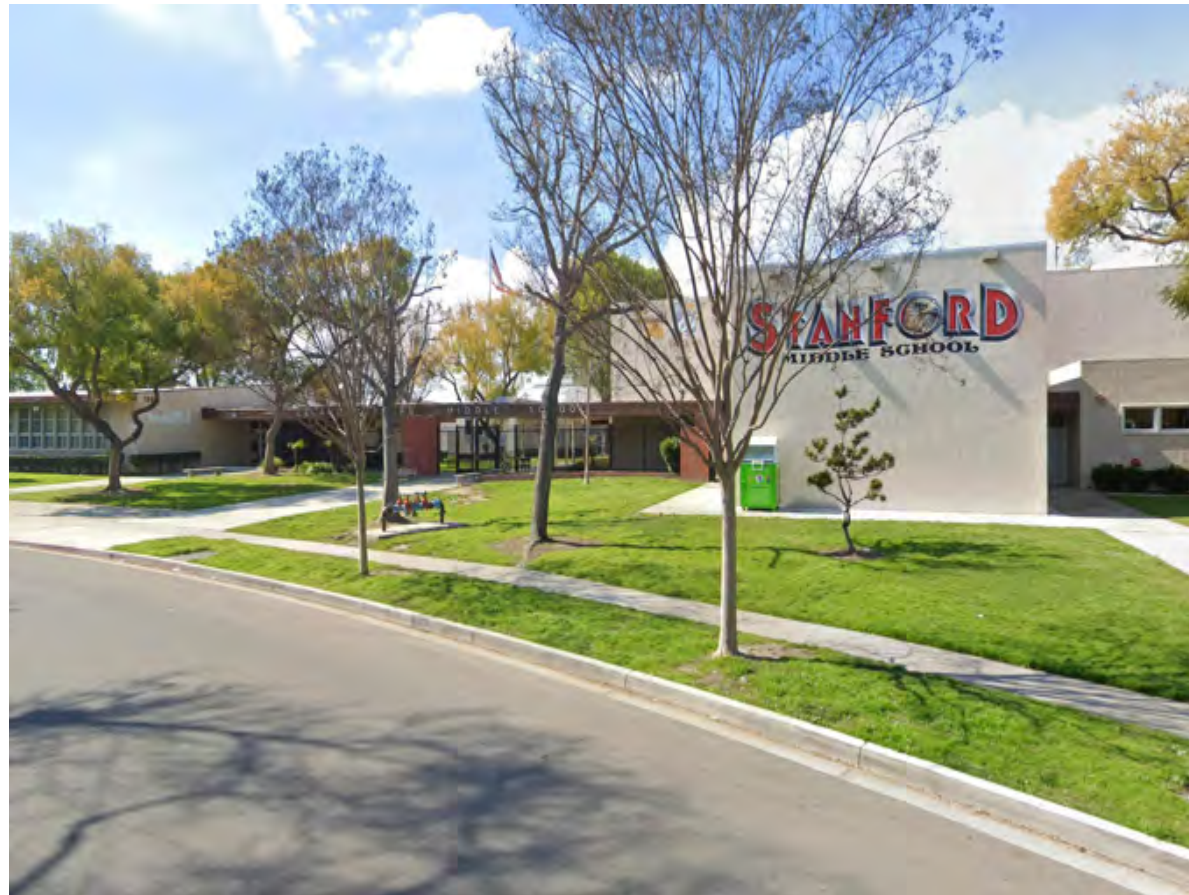
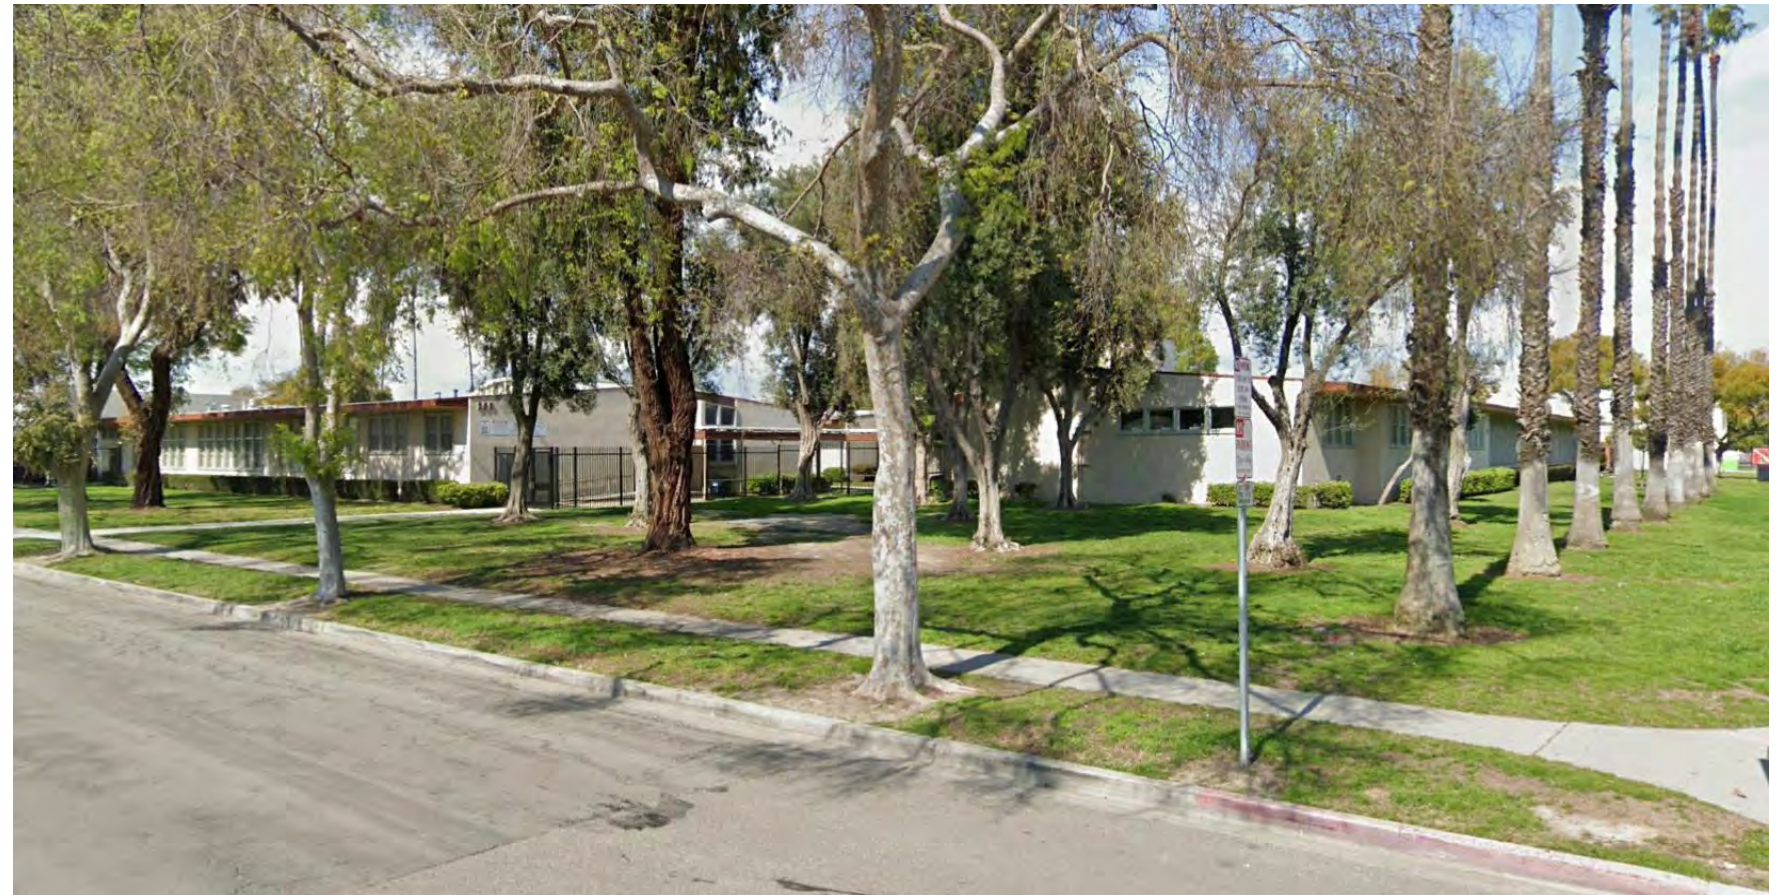
Stanford Middle School – Existing Campus

- A** Baseball not provided (included at other Middle Schools)
- B** Lack of shade trees at play area

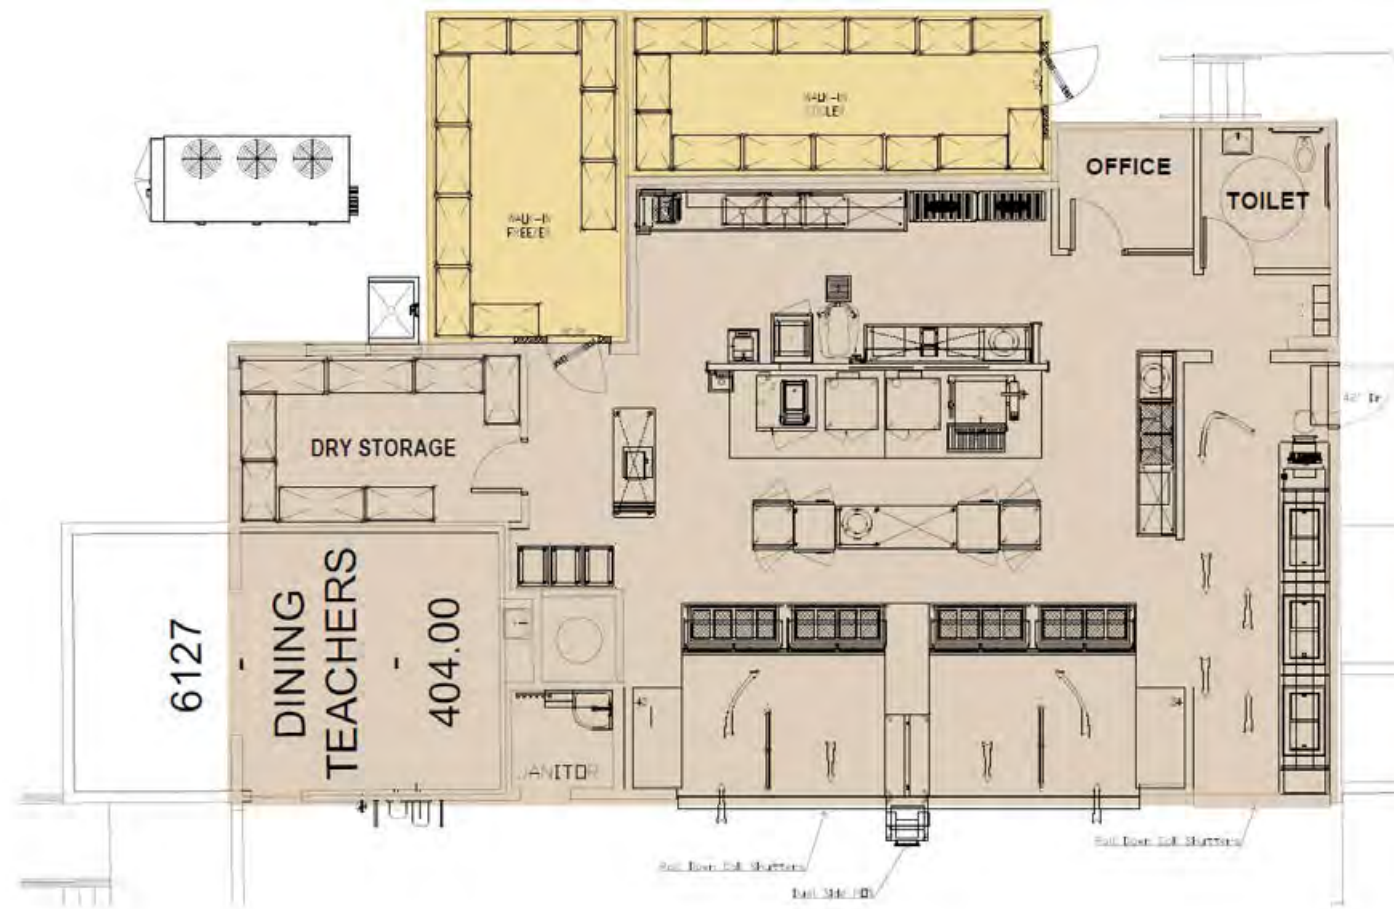
"TO FIT" DESIGN

At 1153 square feet (including the Dry Storage area), the kitchen is large. The food service areas at Stanford Middle School are largely meeting current ADA or EHS requirements. The primary service line is accessed by entering the kitchen. The window service cabinet finishes at +35" AFF and has no ADA compliant workstation. There are no screens or air curtains at the service windows. One window is ADA Accessible to students. There are two double exit doors in the cafeteria that do not have EHS required, full width, plunger activated air curtains. Though the Stanford Middle School kitchen has been updated and upgraded to meet most codes, however, it could benefit from some minor improvements to remedy the few areas where compliance falls short.

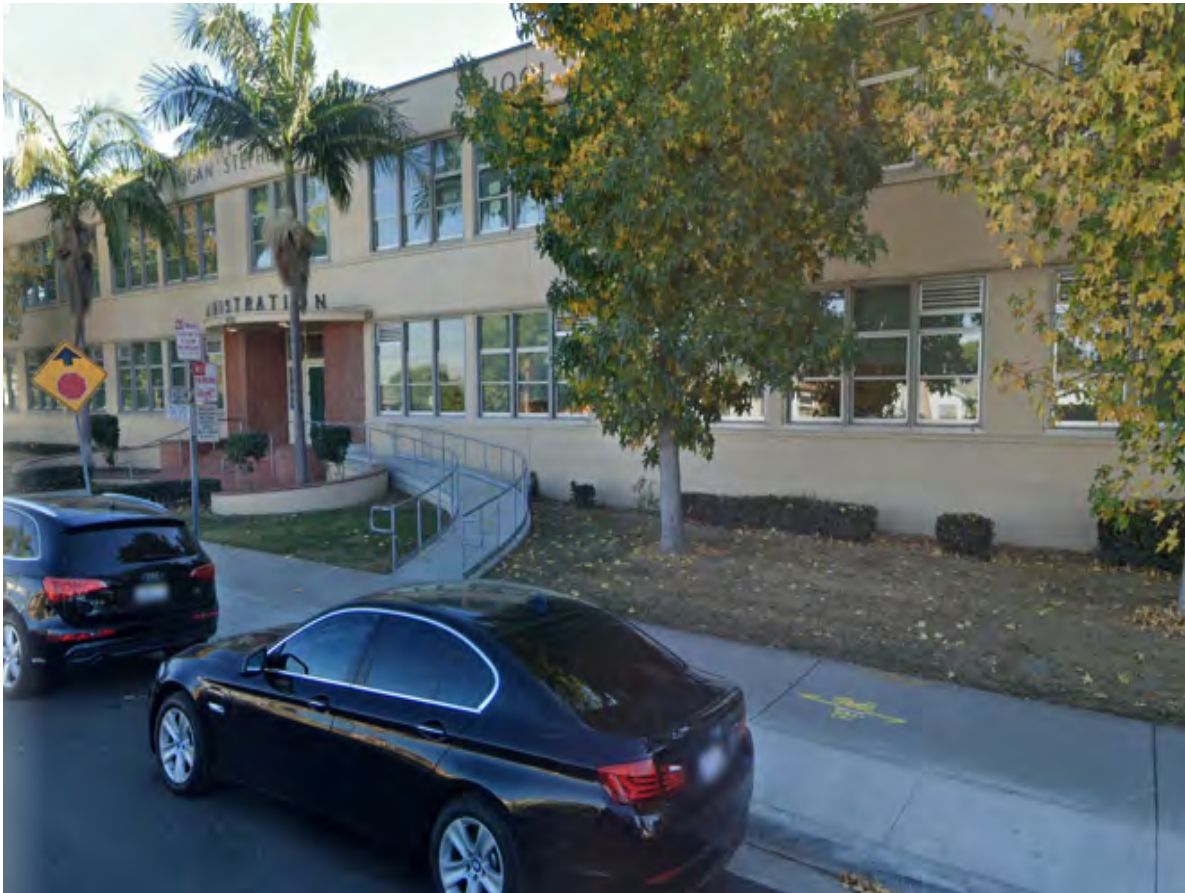
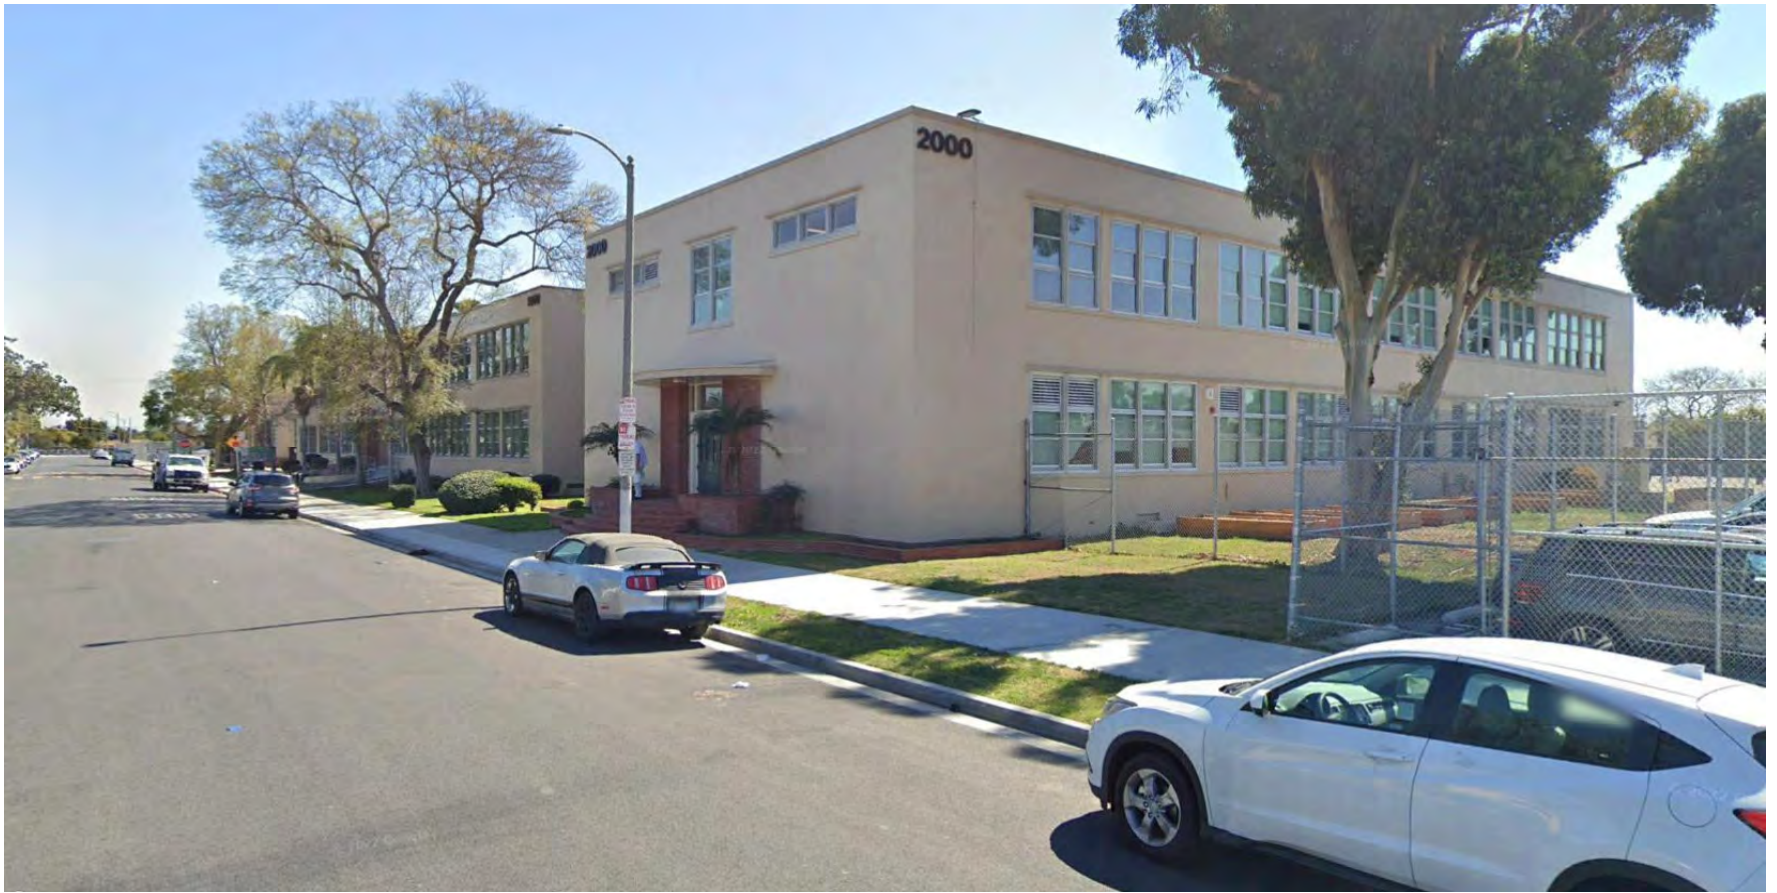
Stephens Middle School – Existing Campus

- A** Baseball not provided (included at other Middle Schools)
- B** Soccer facilities (not provided at other Middle Schools)
- C** Lack of shade trees at play area
- D** Significant large areas of blacktop without use of reflective paints to reduce heat island and improve quality of play

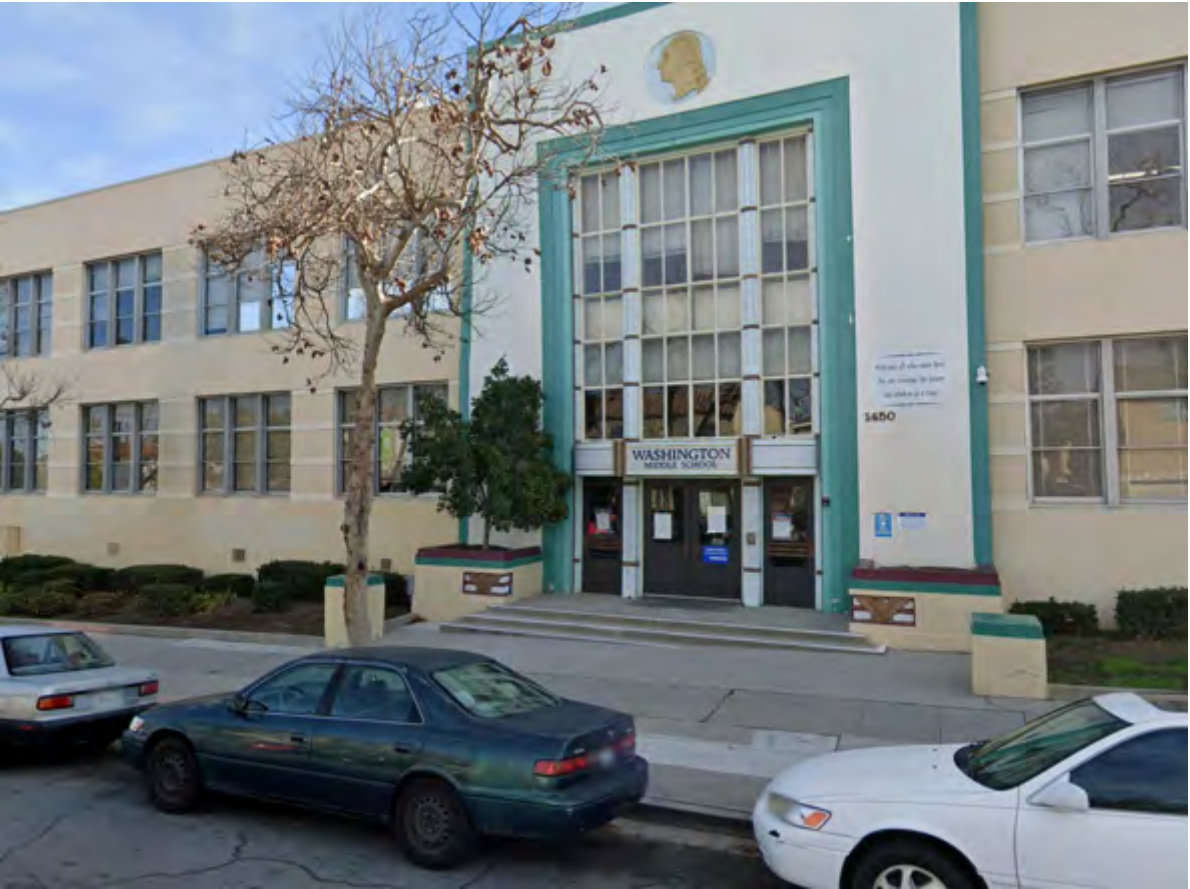
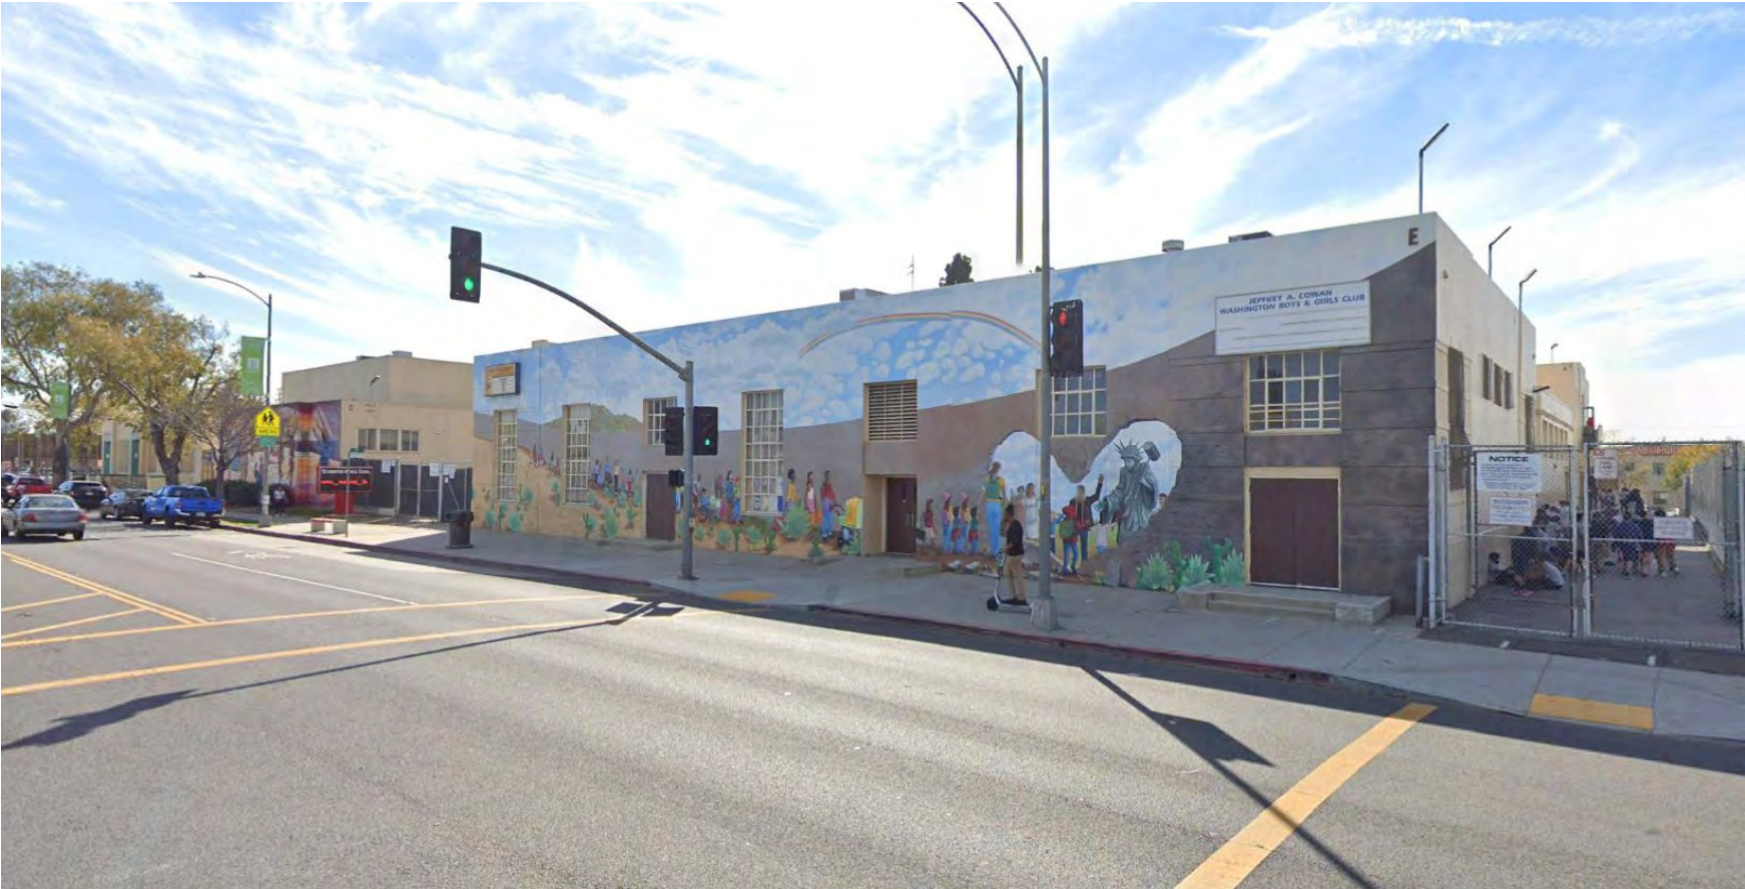
George Washington Middle School – Existing Campus

- A** Baseball not provided (included at other Middle Schools)
- B** Lack of shade trees at play area
- C** Significant large areas of blacktop without use of reflective paints to reduce heat island and improve quality of play

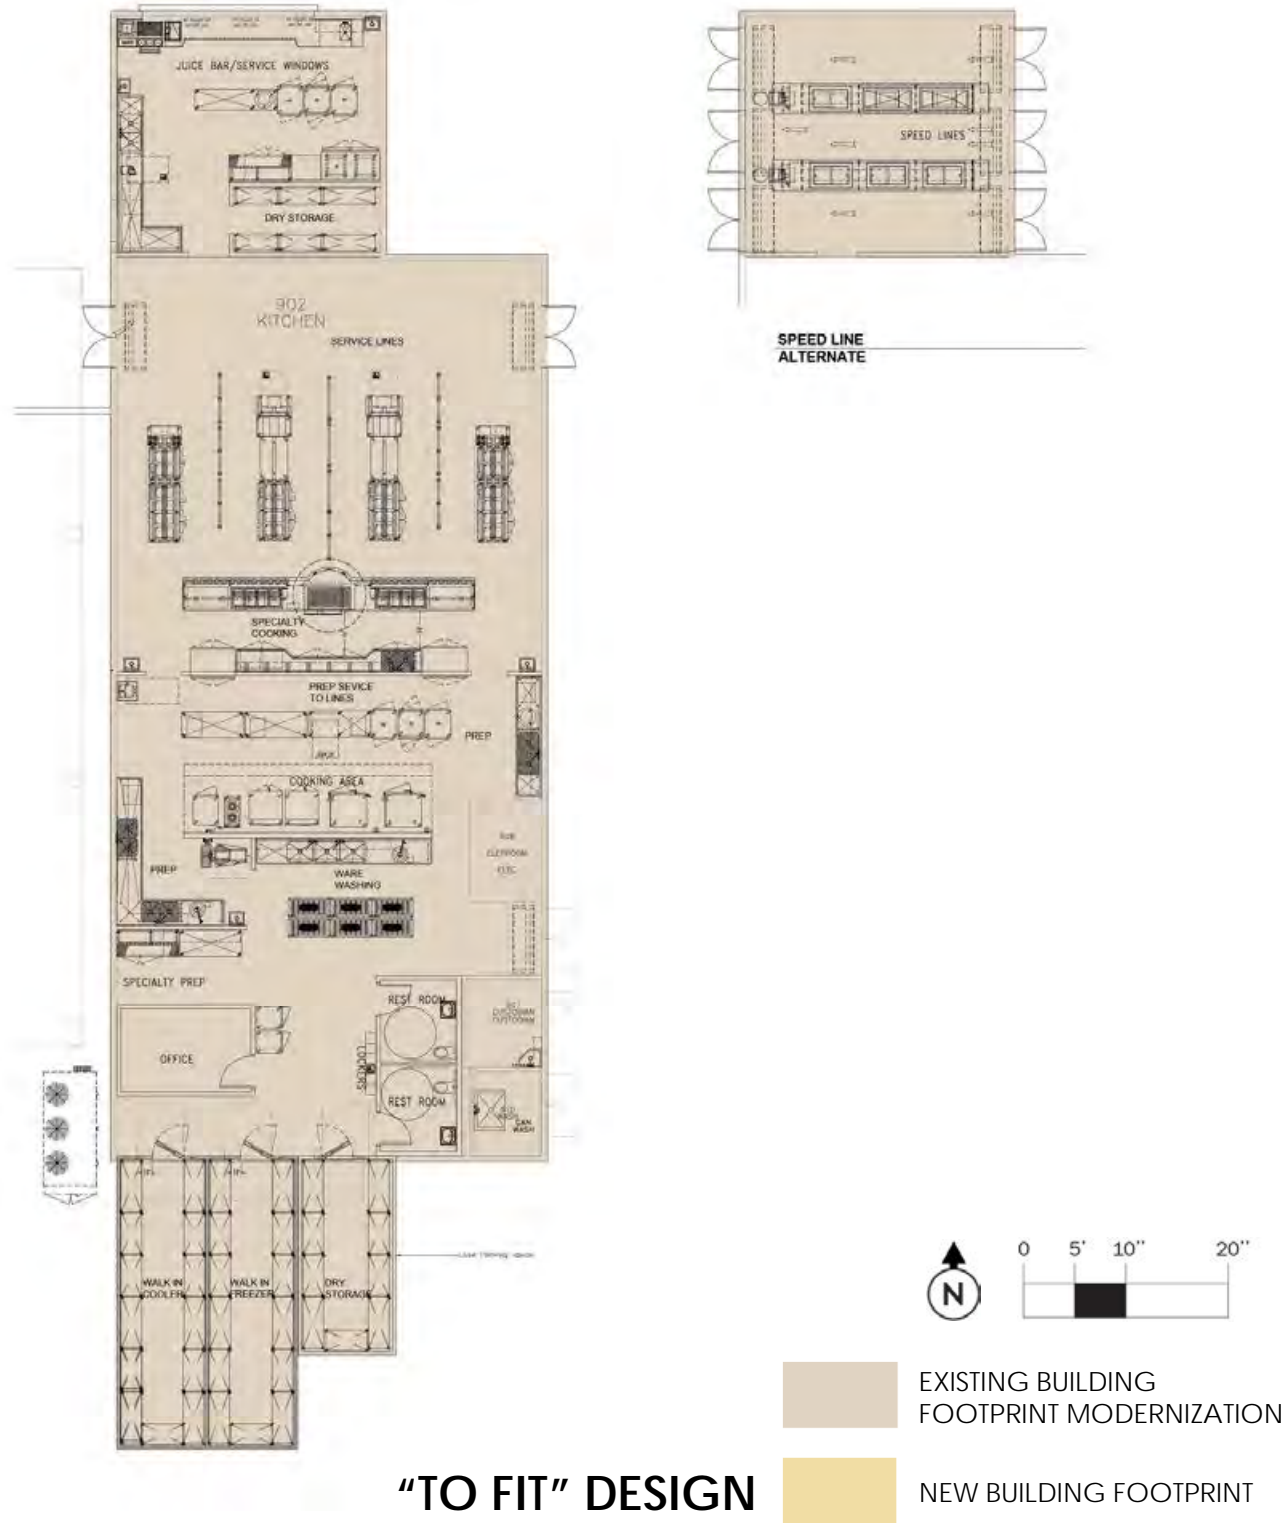
Summary Improvement Plan

At an overall square footage of 2344, the Cabrillo High School kitchen is large. This space is adequate for the 2021-2022 Enrollment and service model. The food service areas at Cabrillo High School meet current ADA and EHS requirements. The kitchen has sufficient dedicated dry storage and refrigeration. The walk-in freezer wall panels are delaminated. There is a possibility of mold within the walls because of this condition and the units should be evaluated by a professional to determine if this mold is present. The walk-in freezer was not operational at time of site visit. The walk-in cooler has a slow drip onto the floor from between two ceiling panels. This is a hazard. The air curtains in both remote kiosks are wired to be switch activated. Per EHS code, air curtains should be plunger activated to avoid the possibility of shutting them off while service is in process. One of the air curtains in the kitchen was not operational at time of site visit. Though this site has been updated and meets most current codes, it would benefit from some minor repairs and improvements to address existing EHS and ADA code issues.

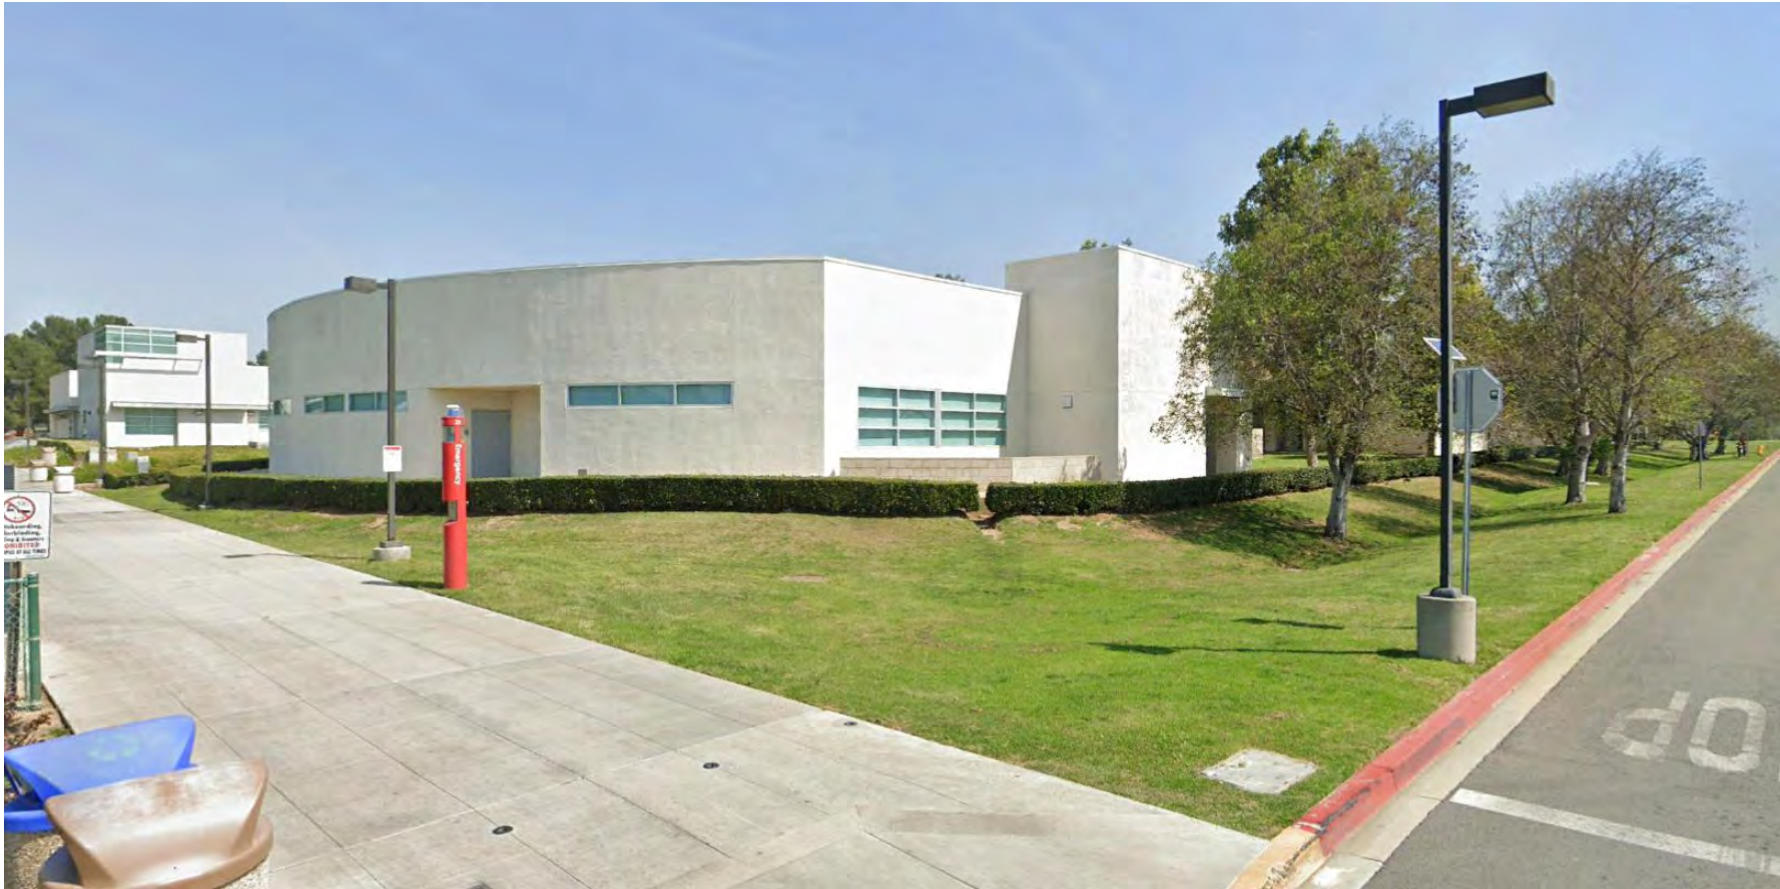
California Academy of Mathematics & Science – Existing Campus

C Lack of shade trees and canopies at outdoor area

D Significant large areas of blacktop without use of reflective paints to reduce heat island and improve quality of play

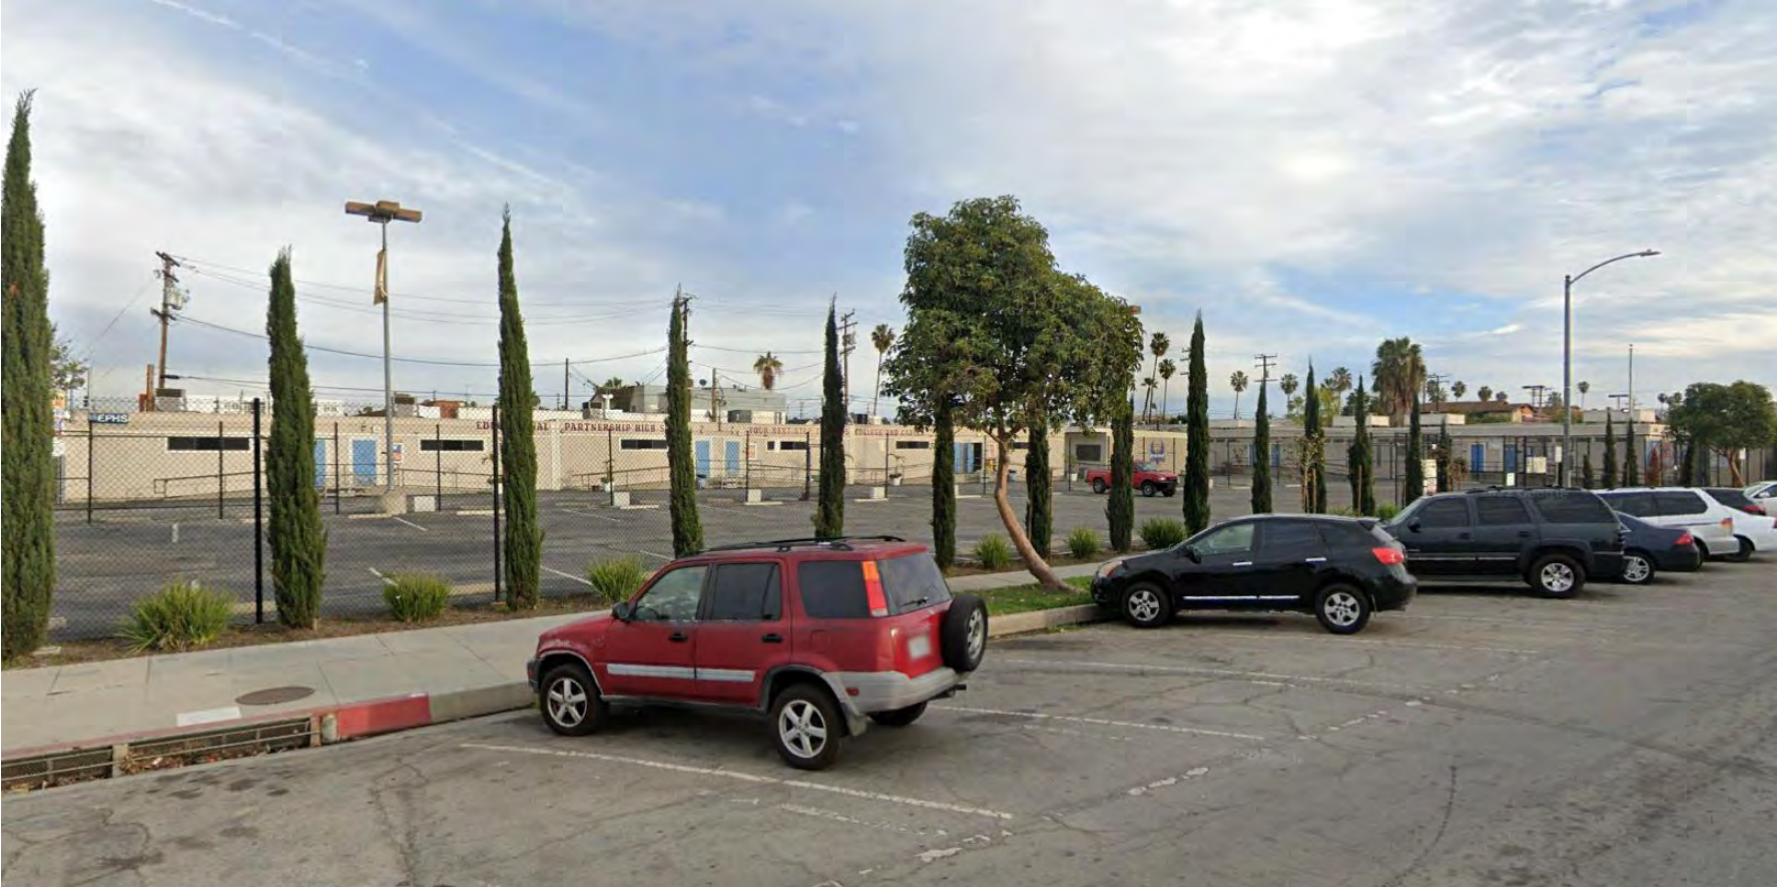
Educational Partnership High School – Existing Campus

C Lack of shade tree and canopies at outdoor area

D Significant large areas of blacktop without use of reflective paints to reduce heat island and improve quality of play

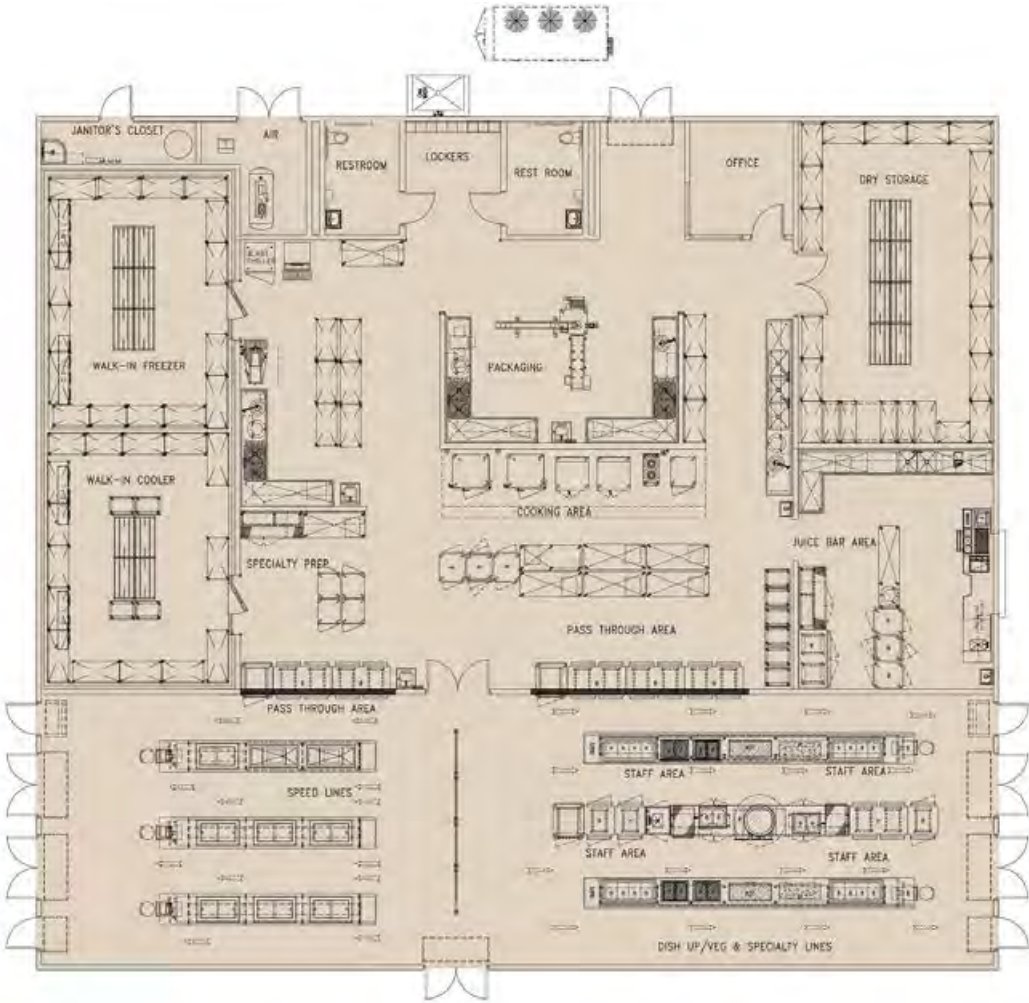
Summary Improvement Plan

Overall Evaluation: At 2389 square feet, the Millikan High School kitchen is large and adequate for the 2021-2022 Enrollment and service model, however, the layout lacks flow, much of the equipment and finishes are old and outdated and the food service areas do not meet current ADA, EHS or CMC requirements. The kitchen lacks sufficient dry storage (which is located in a corner of the kitchen in lieu of a dedicated room). The service line is accessed within the kitchen space. Due to the size constraints of the servery, the aisleways for the students are undersized and do not meet ADA requirements. Neither of the tray rails are ADA compliant. There are no ADA compliant workstations within the kitchen or servery spaces. The existing cooking equipment must be covered by a Type I, UL Listed Exhaust Hood. This type of hood and the equipment below require a UL 300 Fire Suppression System. Code also requires that a hood must have specific overhang clearances to be deemed code compliant. This hood does not meet these requirements. Refrigeration is accommodated by eleven units within the kitchen space and supplemented with overflow refrigerated equipment in the faculty lounge. At time of site visit, one of the freezers had excessive condensation on its front fascia. The pooling water on the floor below and in front of the unit is a hazard. There is no floor sink in the immediate vicinity of the ice machine. A floor sink is required for proper drainage. Exposed wood in the kitchen is a potential harbinger for pests and/or vermin and is not allowed per EHS code. The wood shelving, the wood ledges above the sinks and the wood cabinetry (upper and lower) are not EHS code compliant. There are (3) double exit doors in the cafeteria that do not have EHS required, full width, plunger activated air curtains. There are no screens or air curtains at the service windows. Wall flashing is required behind (which includes below) all wet areas including but not limited to sinks and disposers. There is no employee hand sink or dedicated food preparation sink within the kitchen space. This site would benefit from a prototype design to address EHS and DSA code compliance issues and provide an equipment package to meet current and future CNS needs.

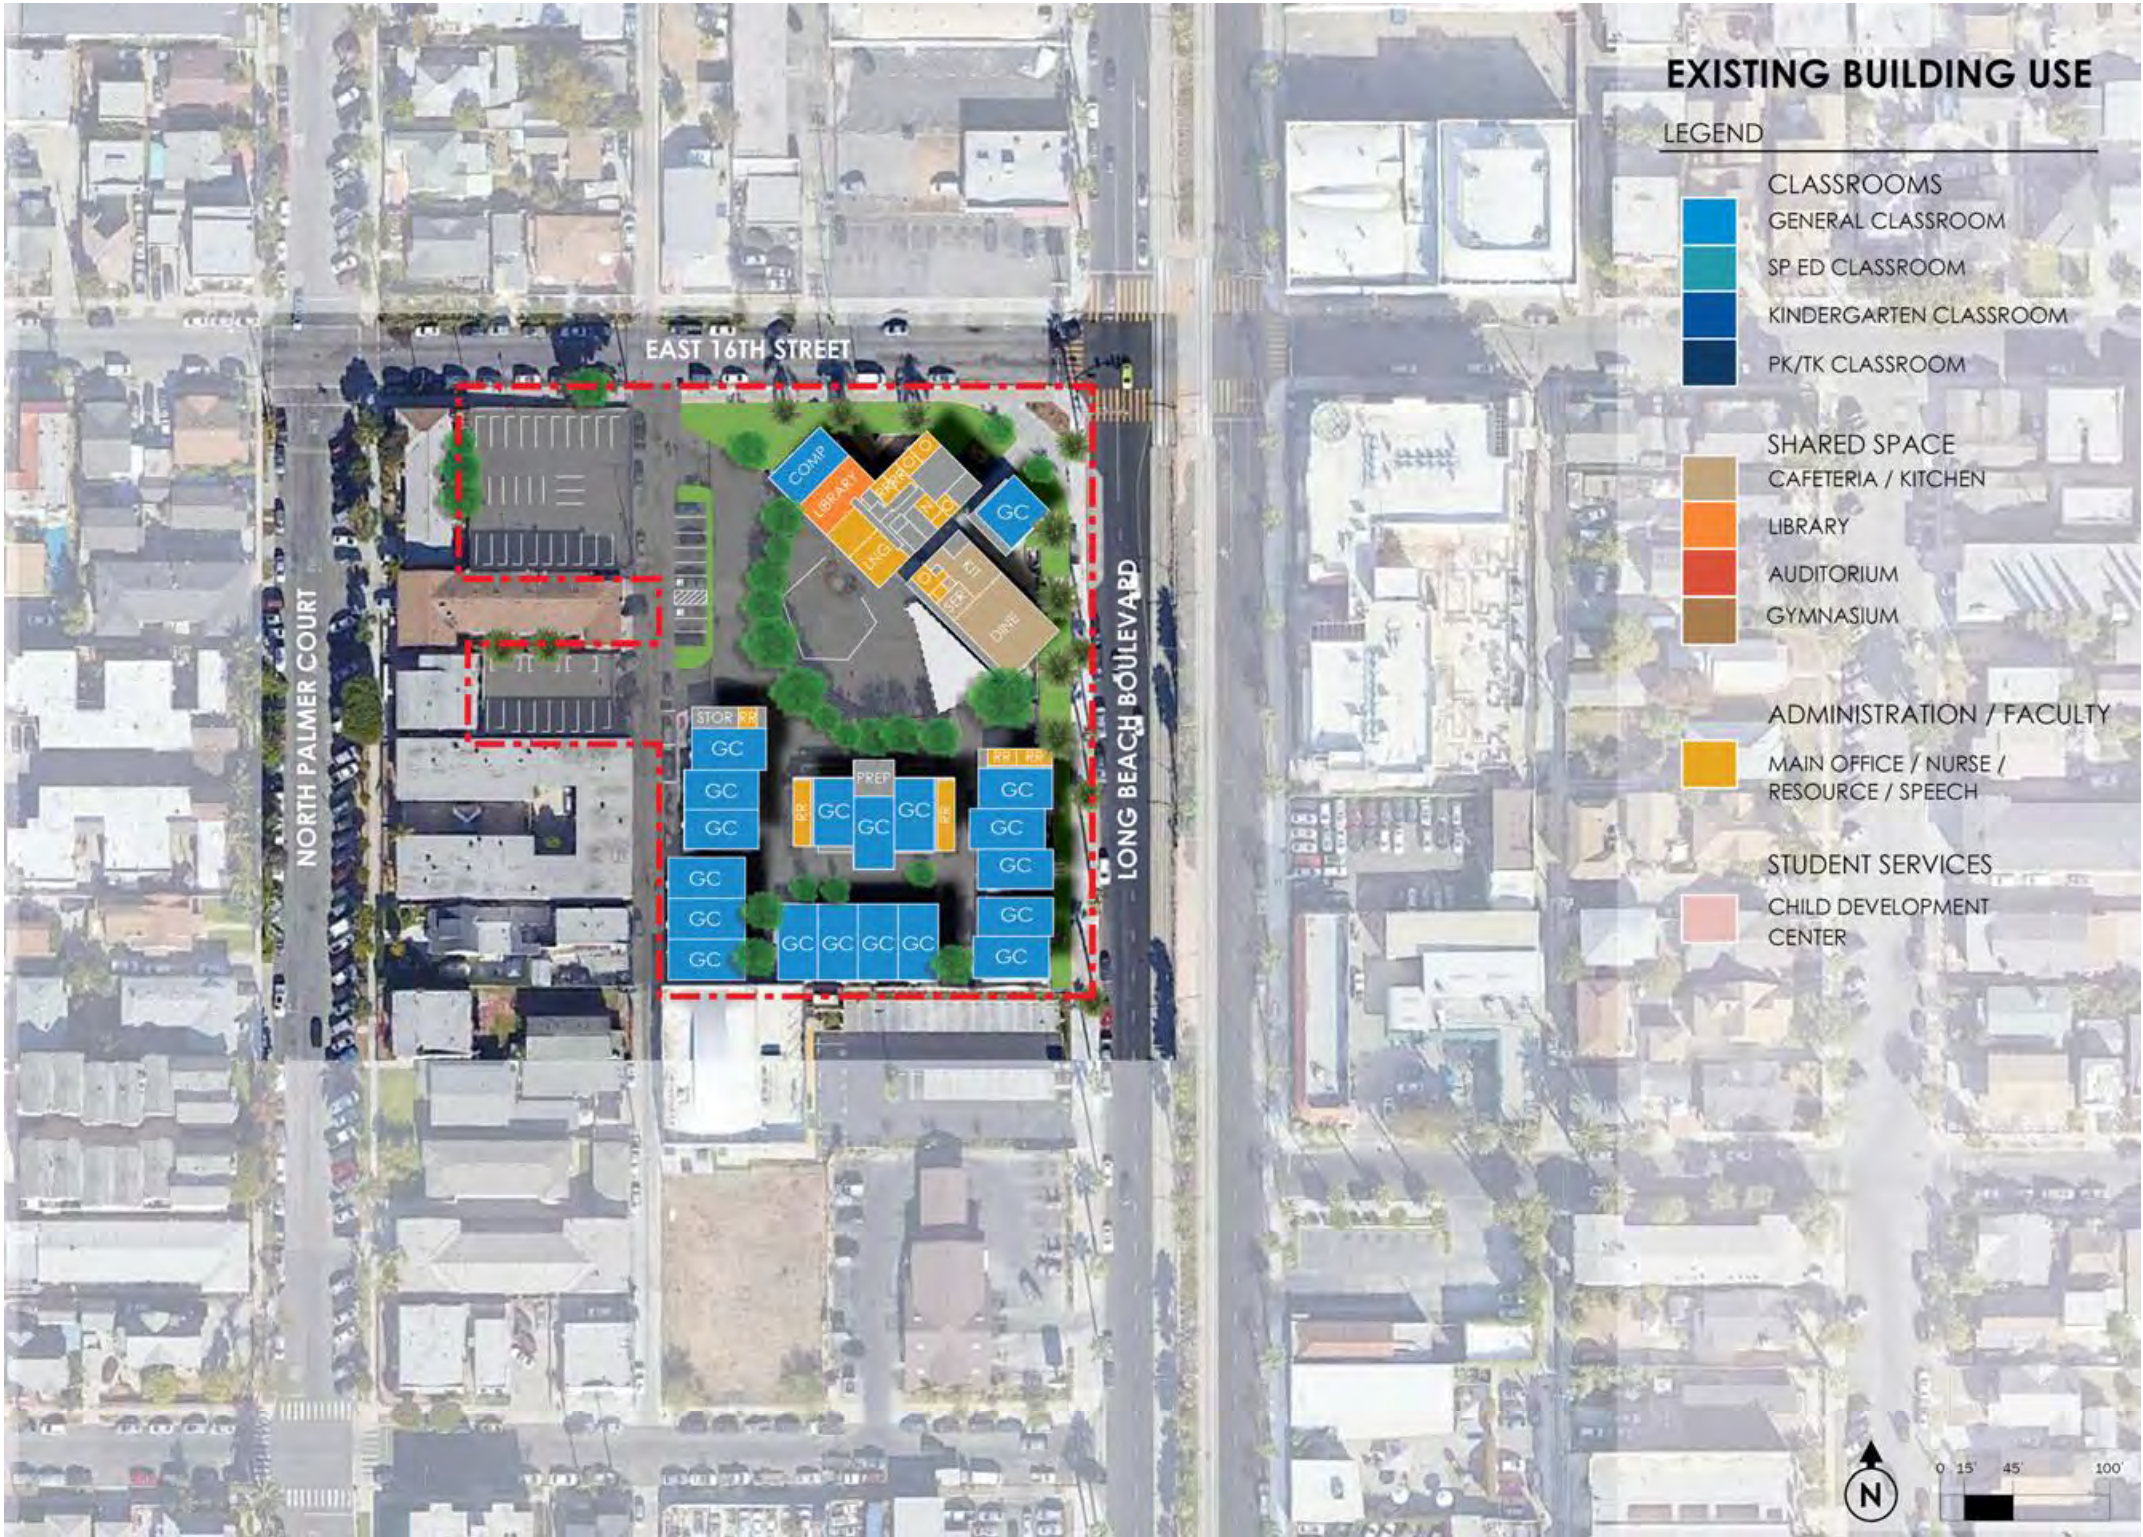
Poly Academy of Achievers and Leaders – Nutrition Services Plan 2022-2032 PAAL

At 1357 square feet (including the Dry Storage area), the PAAL High School kitchen is small and cramped and the food service areas do not meet current ADA or EHS requirements. The kitchen lacks sufficient dry storage (which shares space with the supervisor's office). Chemicals are being stored in the dry storage room. Although not a compliance issue, it is also not considered best practices. The steam kettle requires a front (below the draw off) floor trough to accommodate spills, cleaning, etc. Due to the location of the existing, inadequate, floor sink the steam kettle was installed outside of the exhaust hoods capture zone rendering the hood non-compliant. Code requires that a hood must have specific overhang clearances to be deemed code compliant. This hood does not meet these requirements. The tilting kettle requires a floor trough as well. There are no ADA compliant workstations within the kitchen or servery spaces. The window service counter is too high to be ADA compliant. There are no screens or air curtains at the service windows. Refrigeration is accommodated by four units within the kitchen space and supplemented with two mobile milk coolers. There are three double exit doors in the cafeteria that do not have EHS required, full width, plunger activated air curtains. At time of site visit, there was a worktable that had only three casters. This is a hazard. This site would benefit from a prototype design to address EHS and DSA code compliance issues and provide an equipment package to meet current and future CNS needs
