LBUSD 2022 Facility Master Plan

Long Beach Unified School District
Appendices

July 2022

A Facility Reports: Elementary Schools

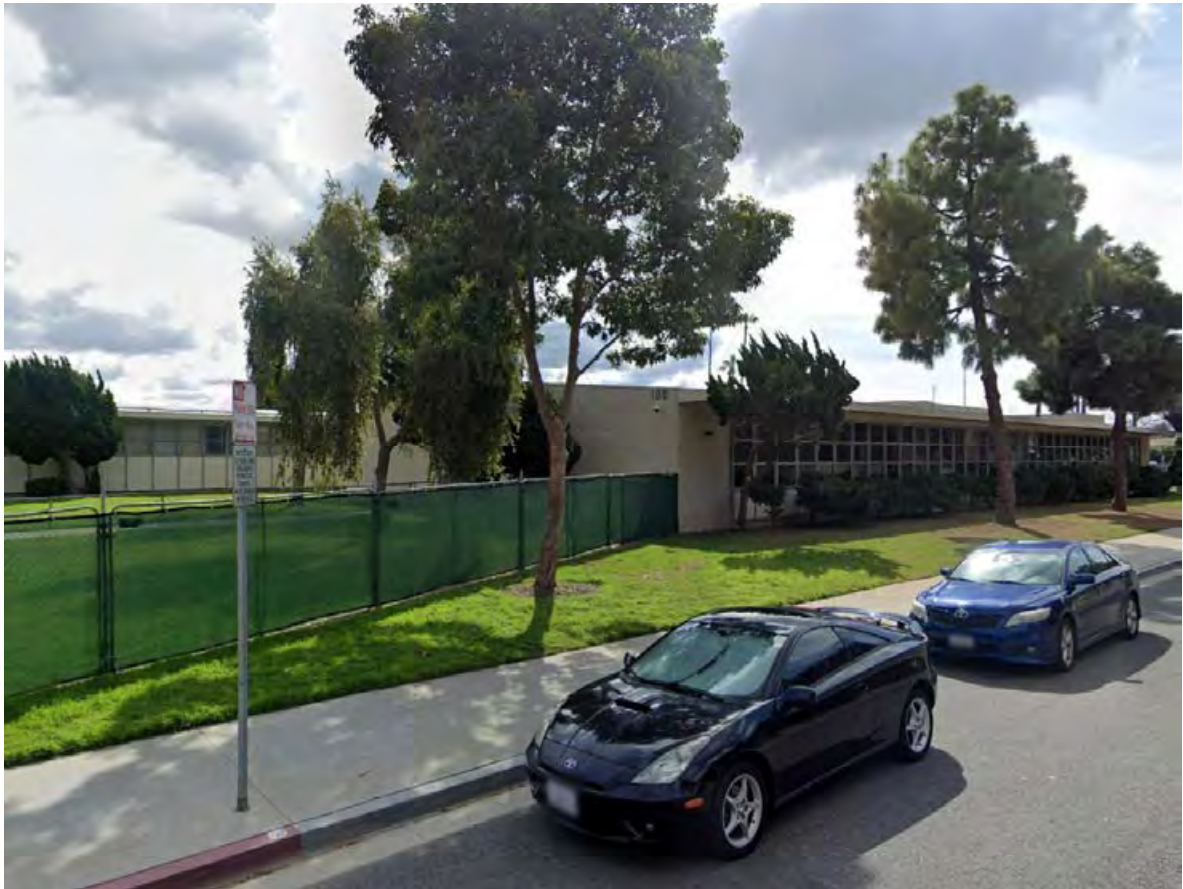
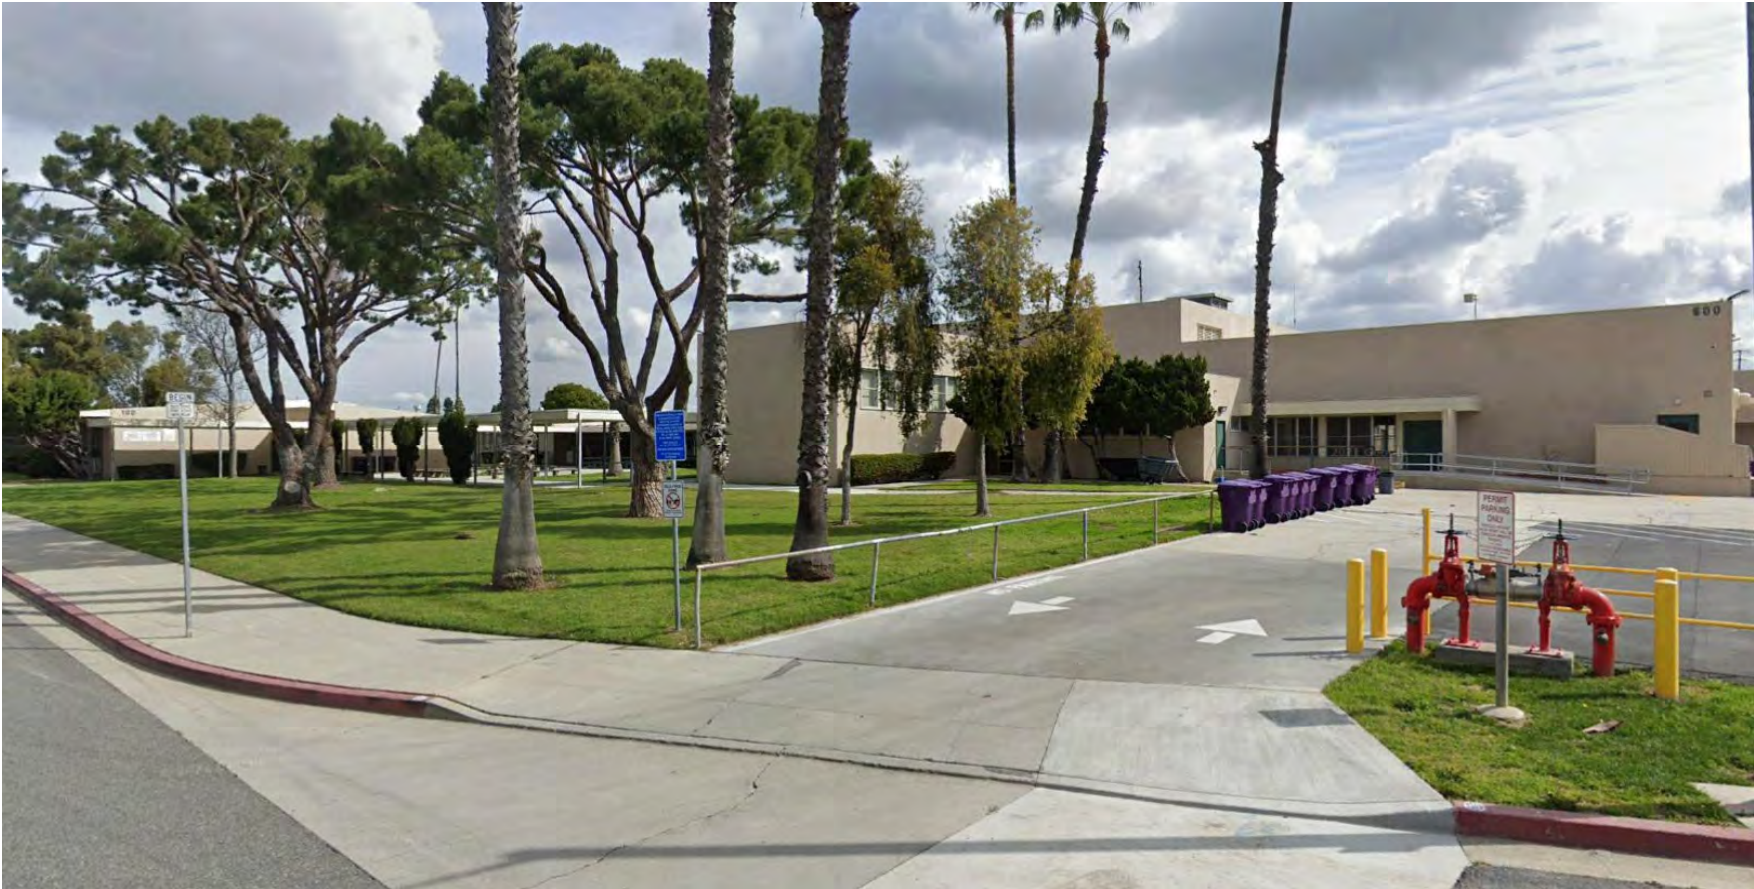
Sato Academy of Mathematics & Science – Existing Campus

C Lack of shade tree and canopies at outdoor area

D Significant large areas of blacktop without use of reflective paints to reduce heat island and improve quality of play

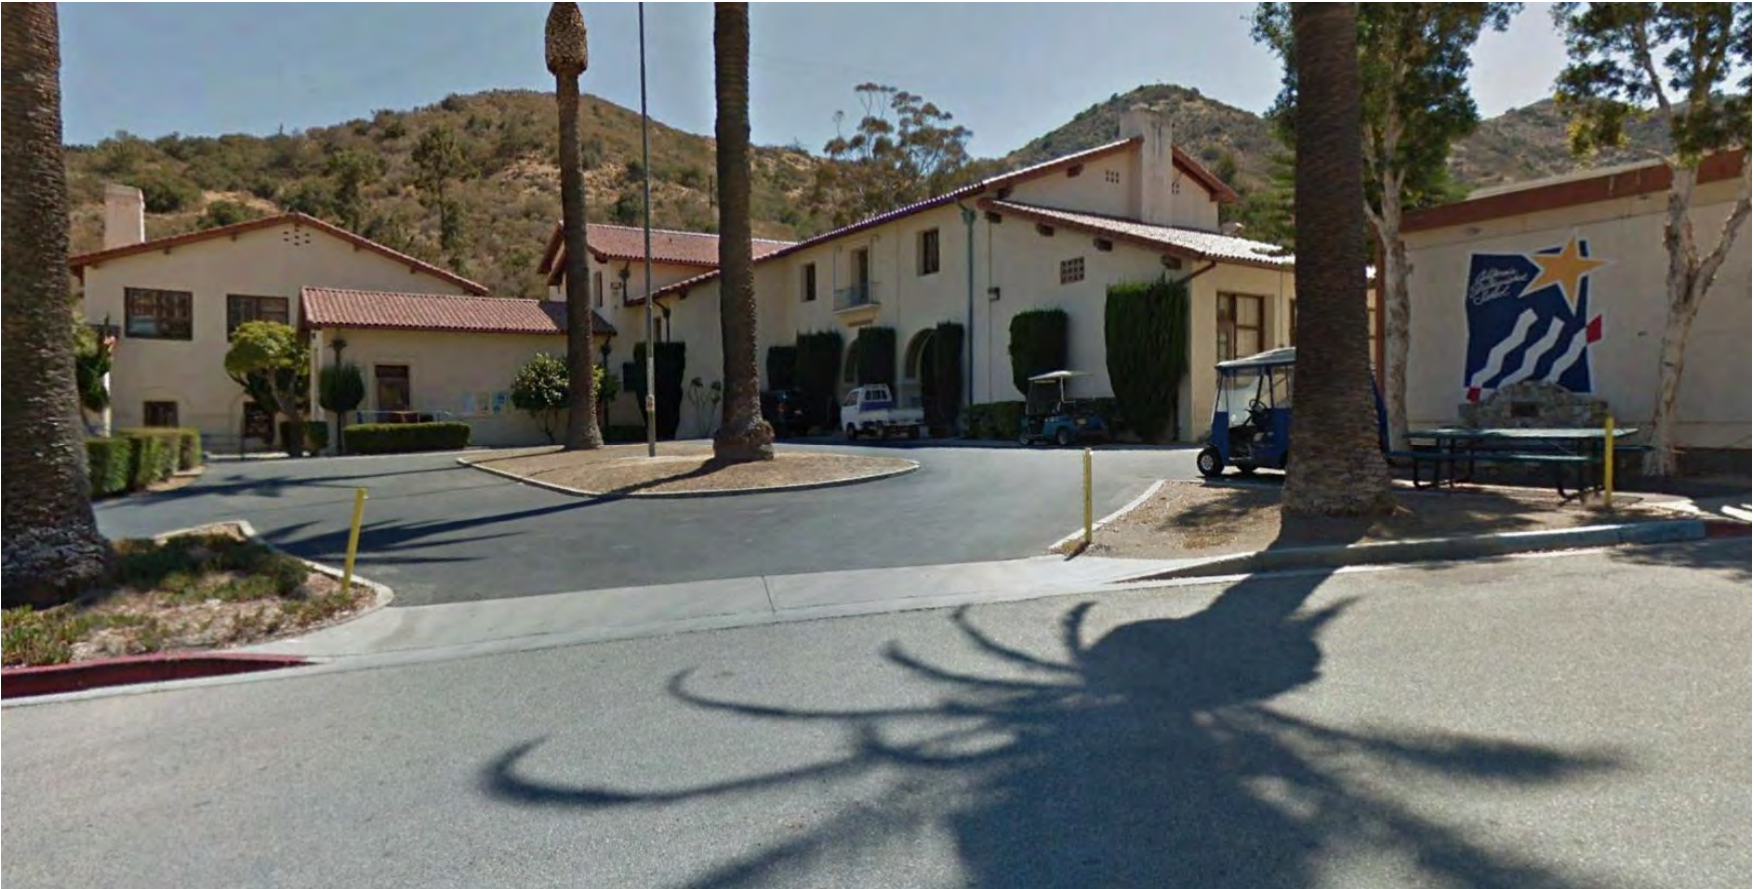
Avalon K12 School – Existing Campus

Location P.O. Box 557 Avalon CA 90704 200 Falls Canyon Road Avalon CA 90704	Total Campus Area 11.39 Acres	Years Constructed 1935, 1936, 1952, 1987, 1988, 1991, 1993, 1995, 1996, 1998, 2003	Total Parking 12 Stalls	Total Building Area Permanent Construction 53,400 SF
Type TK-12	2021-2022 Enrollment 467	Factored Capacity 1,122	Permanent Capacity 477 Temporary Capacity 645	Total Building Area Portables 24,101 SF

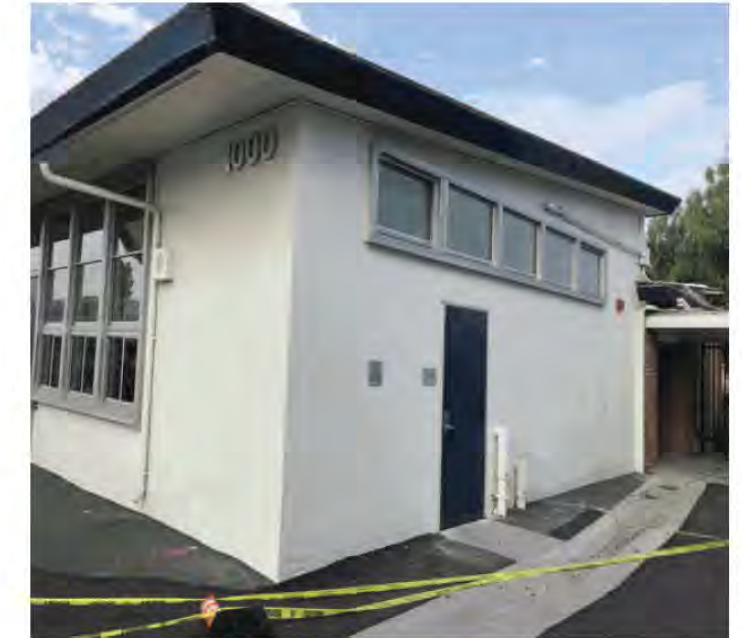
FACILITY CONDITION ASSESSMENT

Disciplines	5 Year DCI Score
Architectural	98
Plumbing	100
Mechanical	100
Fire Protection	100
Electrical	100
Communications	96
Safety and Security	93
Structural	91
5-YR FCI Score, buildings only:	
	97
Civil	100
5-YR FCI Score including Civil:	
	98

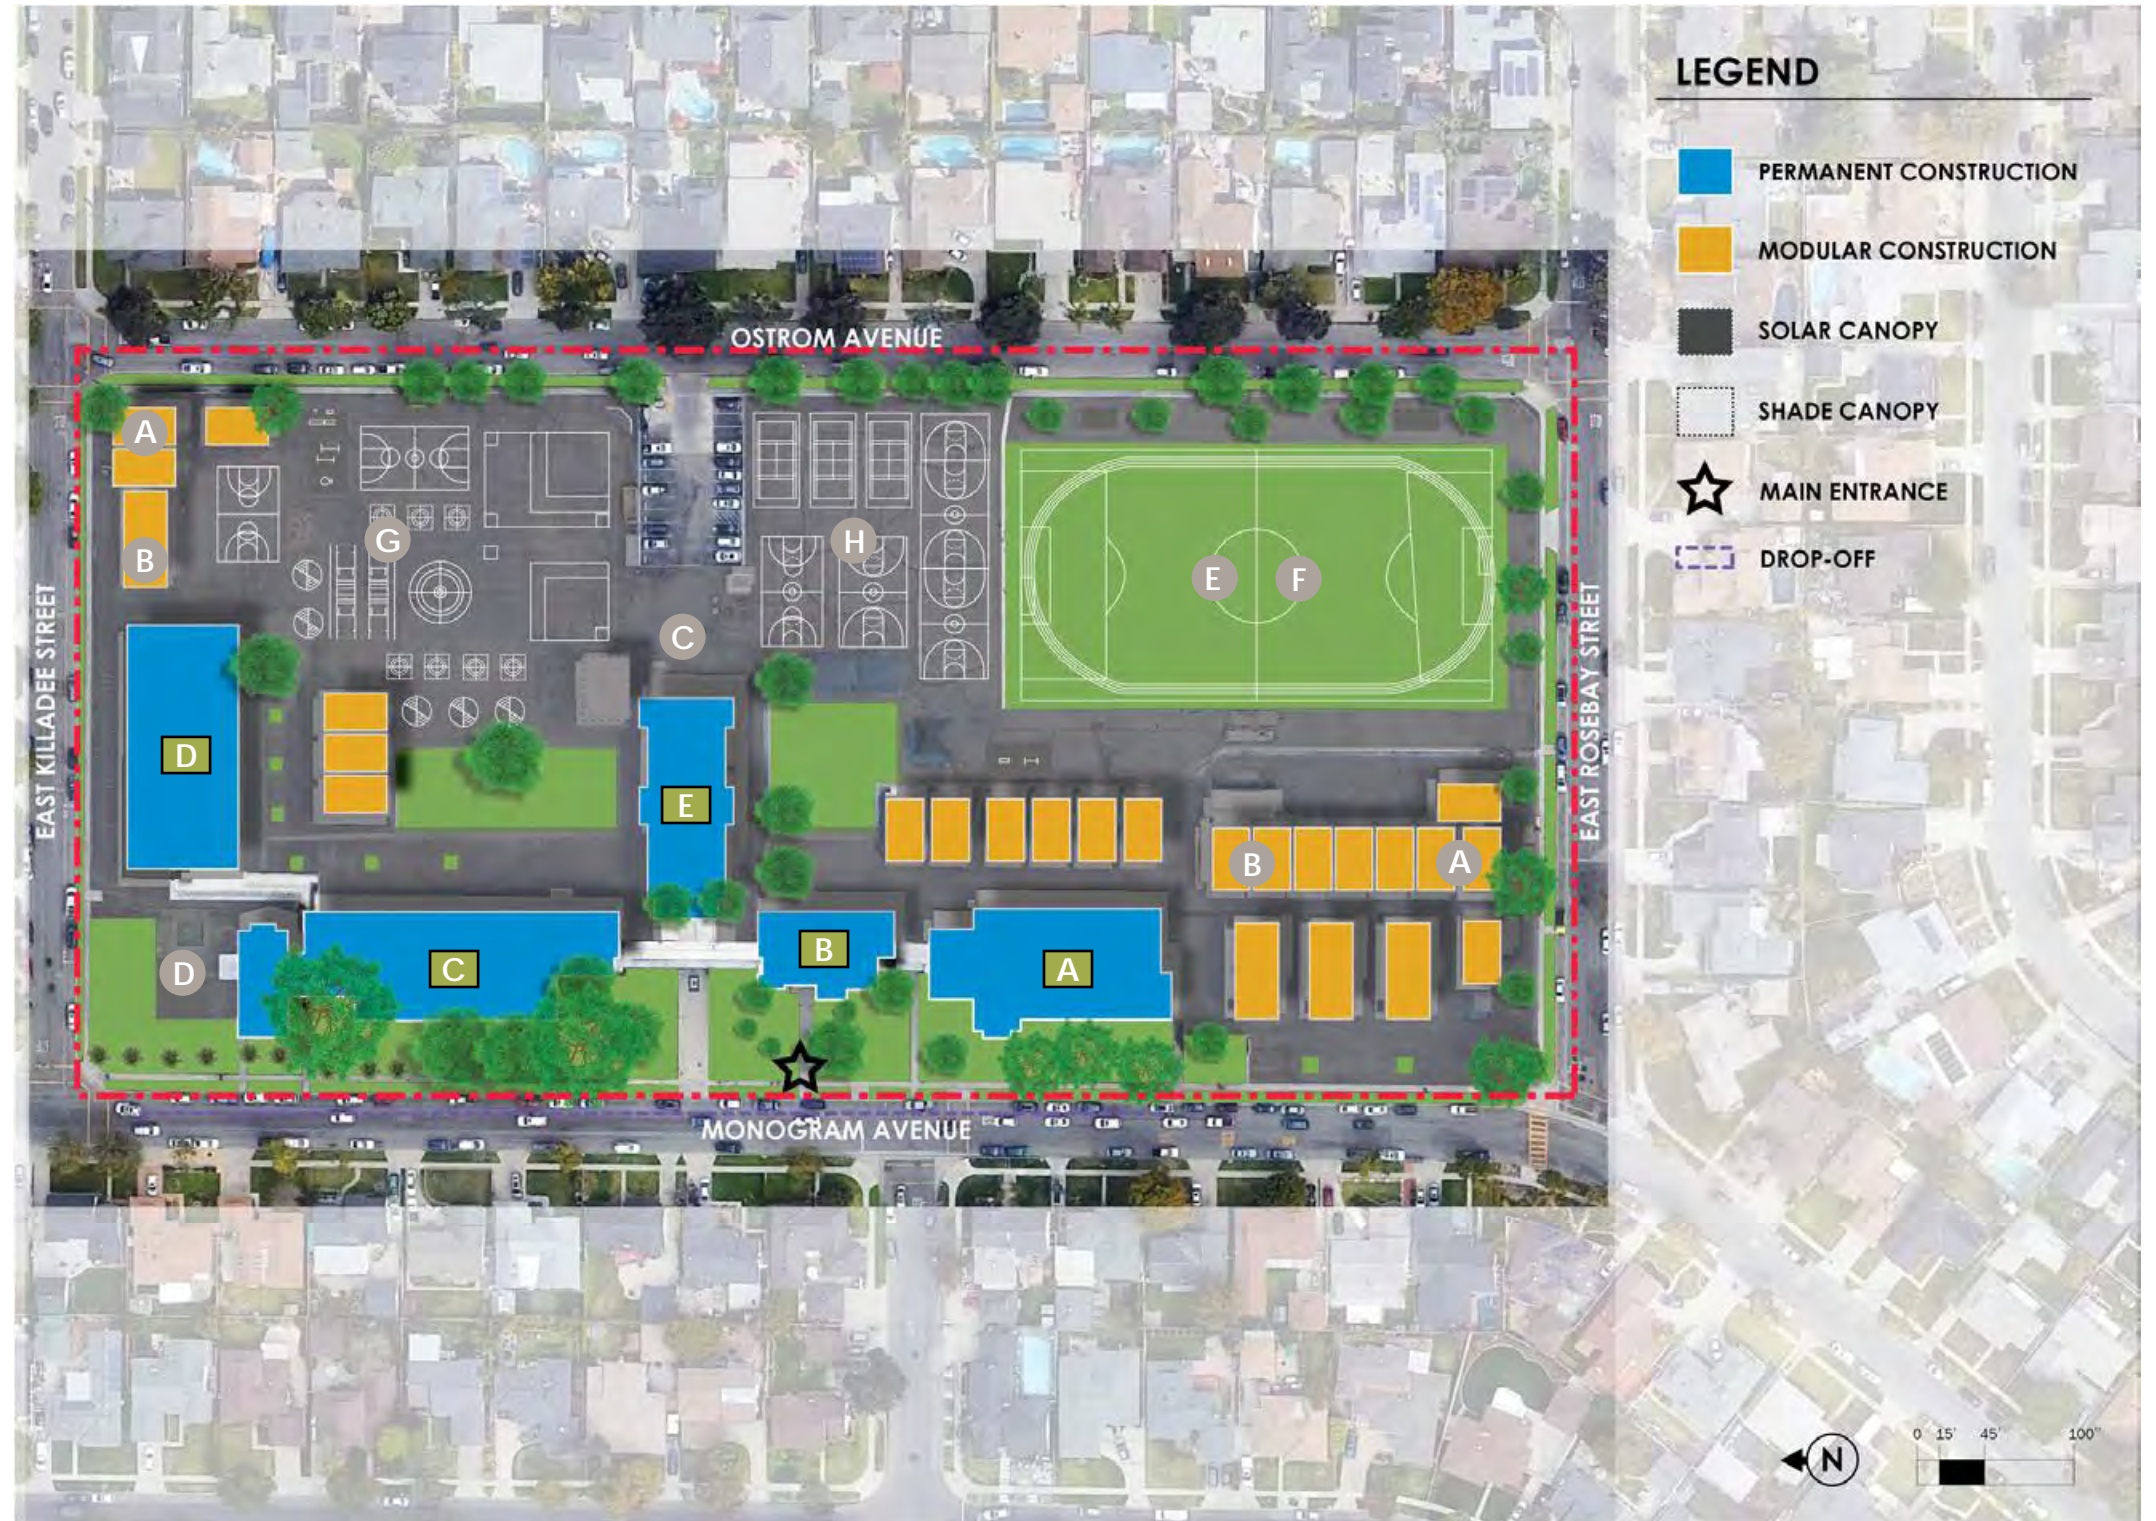
Cubberley K8 School – Existing Campus

- D** Visibility of outdoor Kinder play from street
- E** Baseball not provided (included at other Middle Schools)
- F** Soccer facilities (not provided at other Middle Schools)
- G** Lack of shade trees at play area
- H** Significant large areas of blacktop without use of reflective paints to reduce heat island and improve quality of play

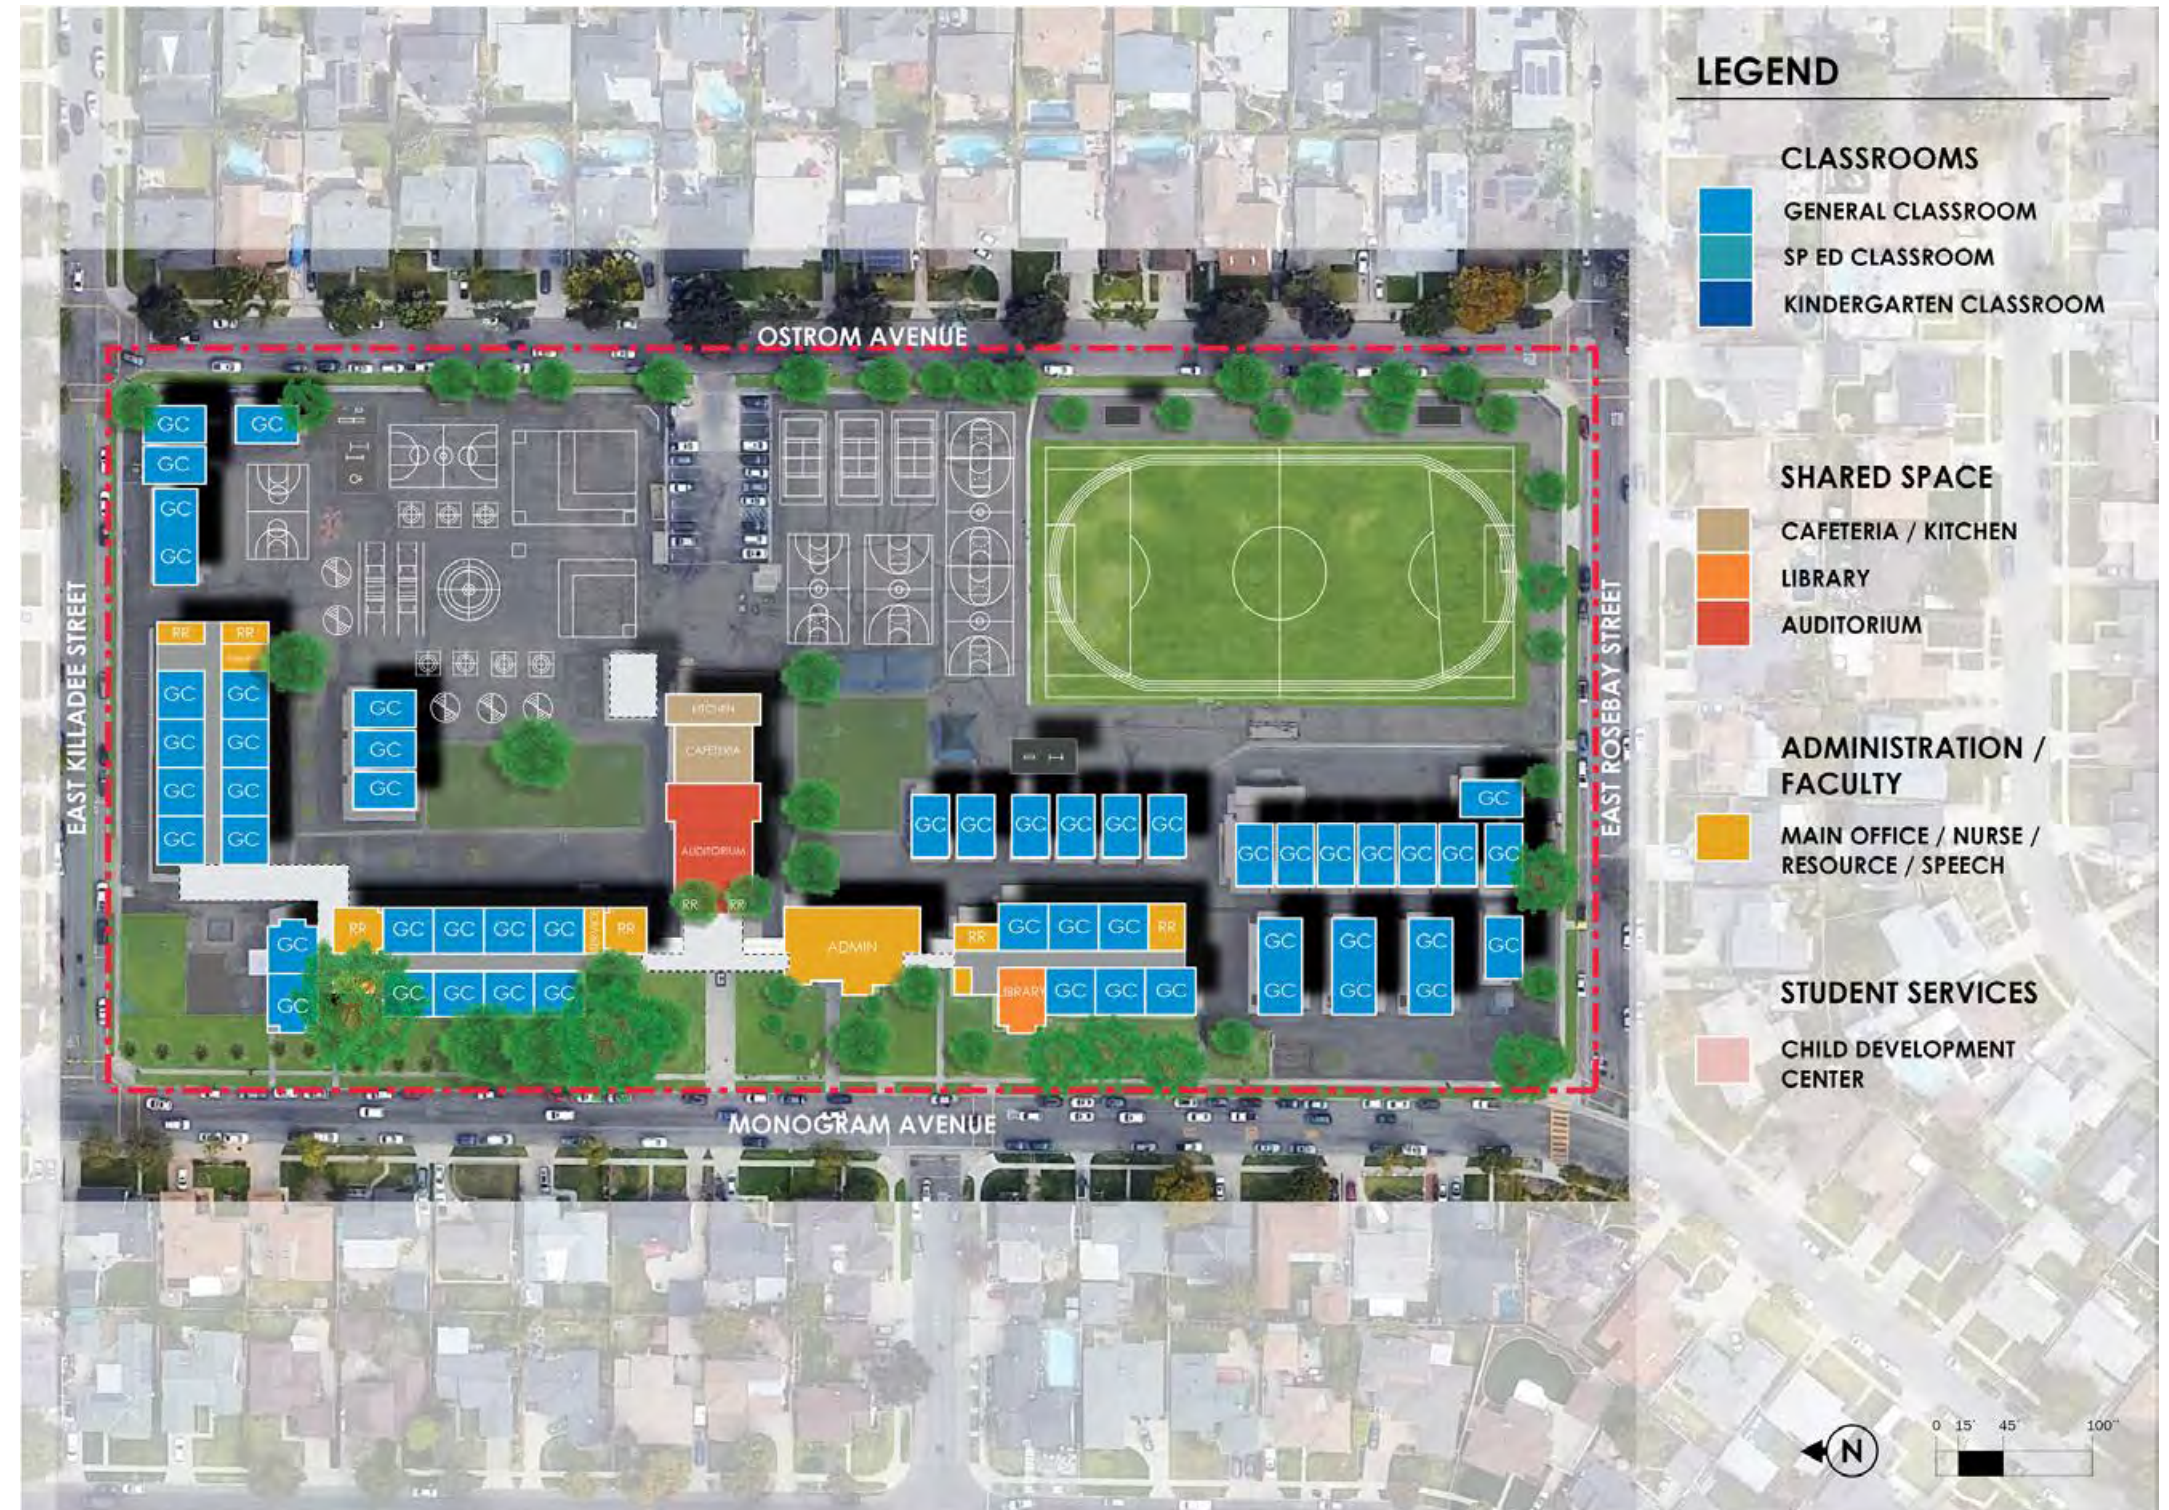
Cubberley K8 School – Existing Space Utilization

Category	Existing	Planning Capacity
Administration	2,632 SF	1,868 SF
Auditorium	3,679 SF	5,697 SF
Library	1,652 SF	2,802 SF
Nutrition Services		
Cafeteria	2,137 SF	3,176 SF
Food Service	723 SF	1,214 SF
Lunch Shelter	820 SF	2,802 SF
Site		
Playground	5.9 Acres	2.3 Acres
Parking	21 Stalls	80 Stalls

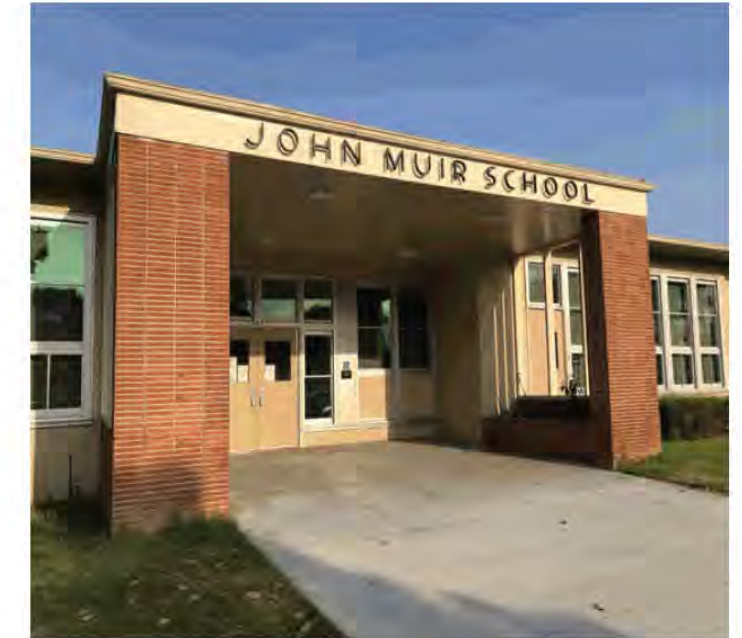
FACILITY CONDITION ASSESSMENT

Disciplines	5 Year DCI Score
Architectural	84
Plumbing	100
Mechanical	99
Fire Protection	99
Electrical	92
Communications	99
Safety and Security	100
Structural	99
5-YR FCI Score, buildings only:	91
Civil	100
5-YR FCI Score including Civil:	93

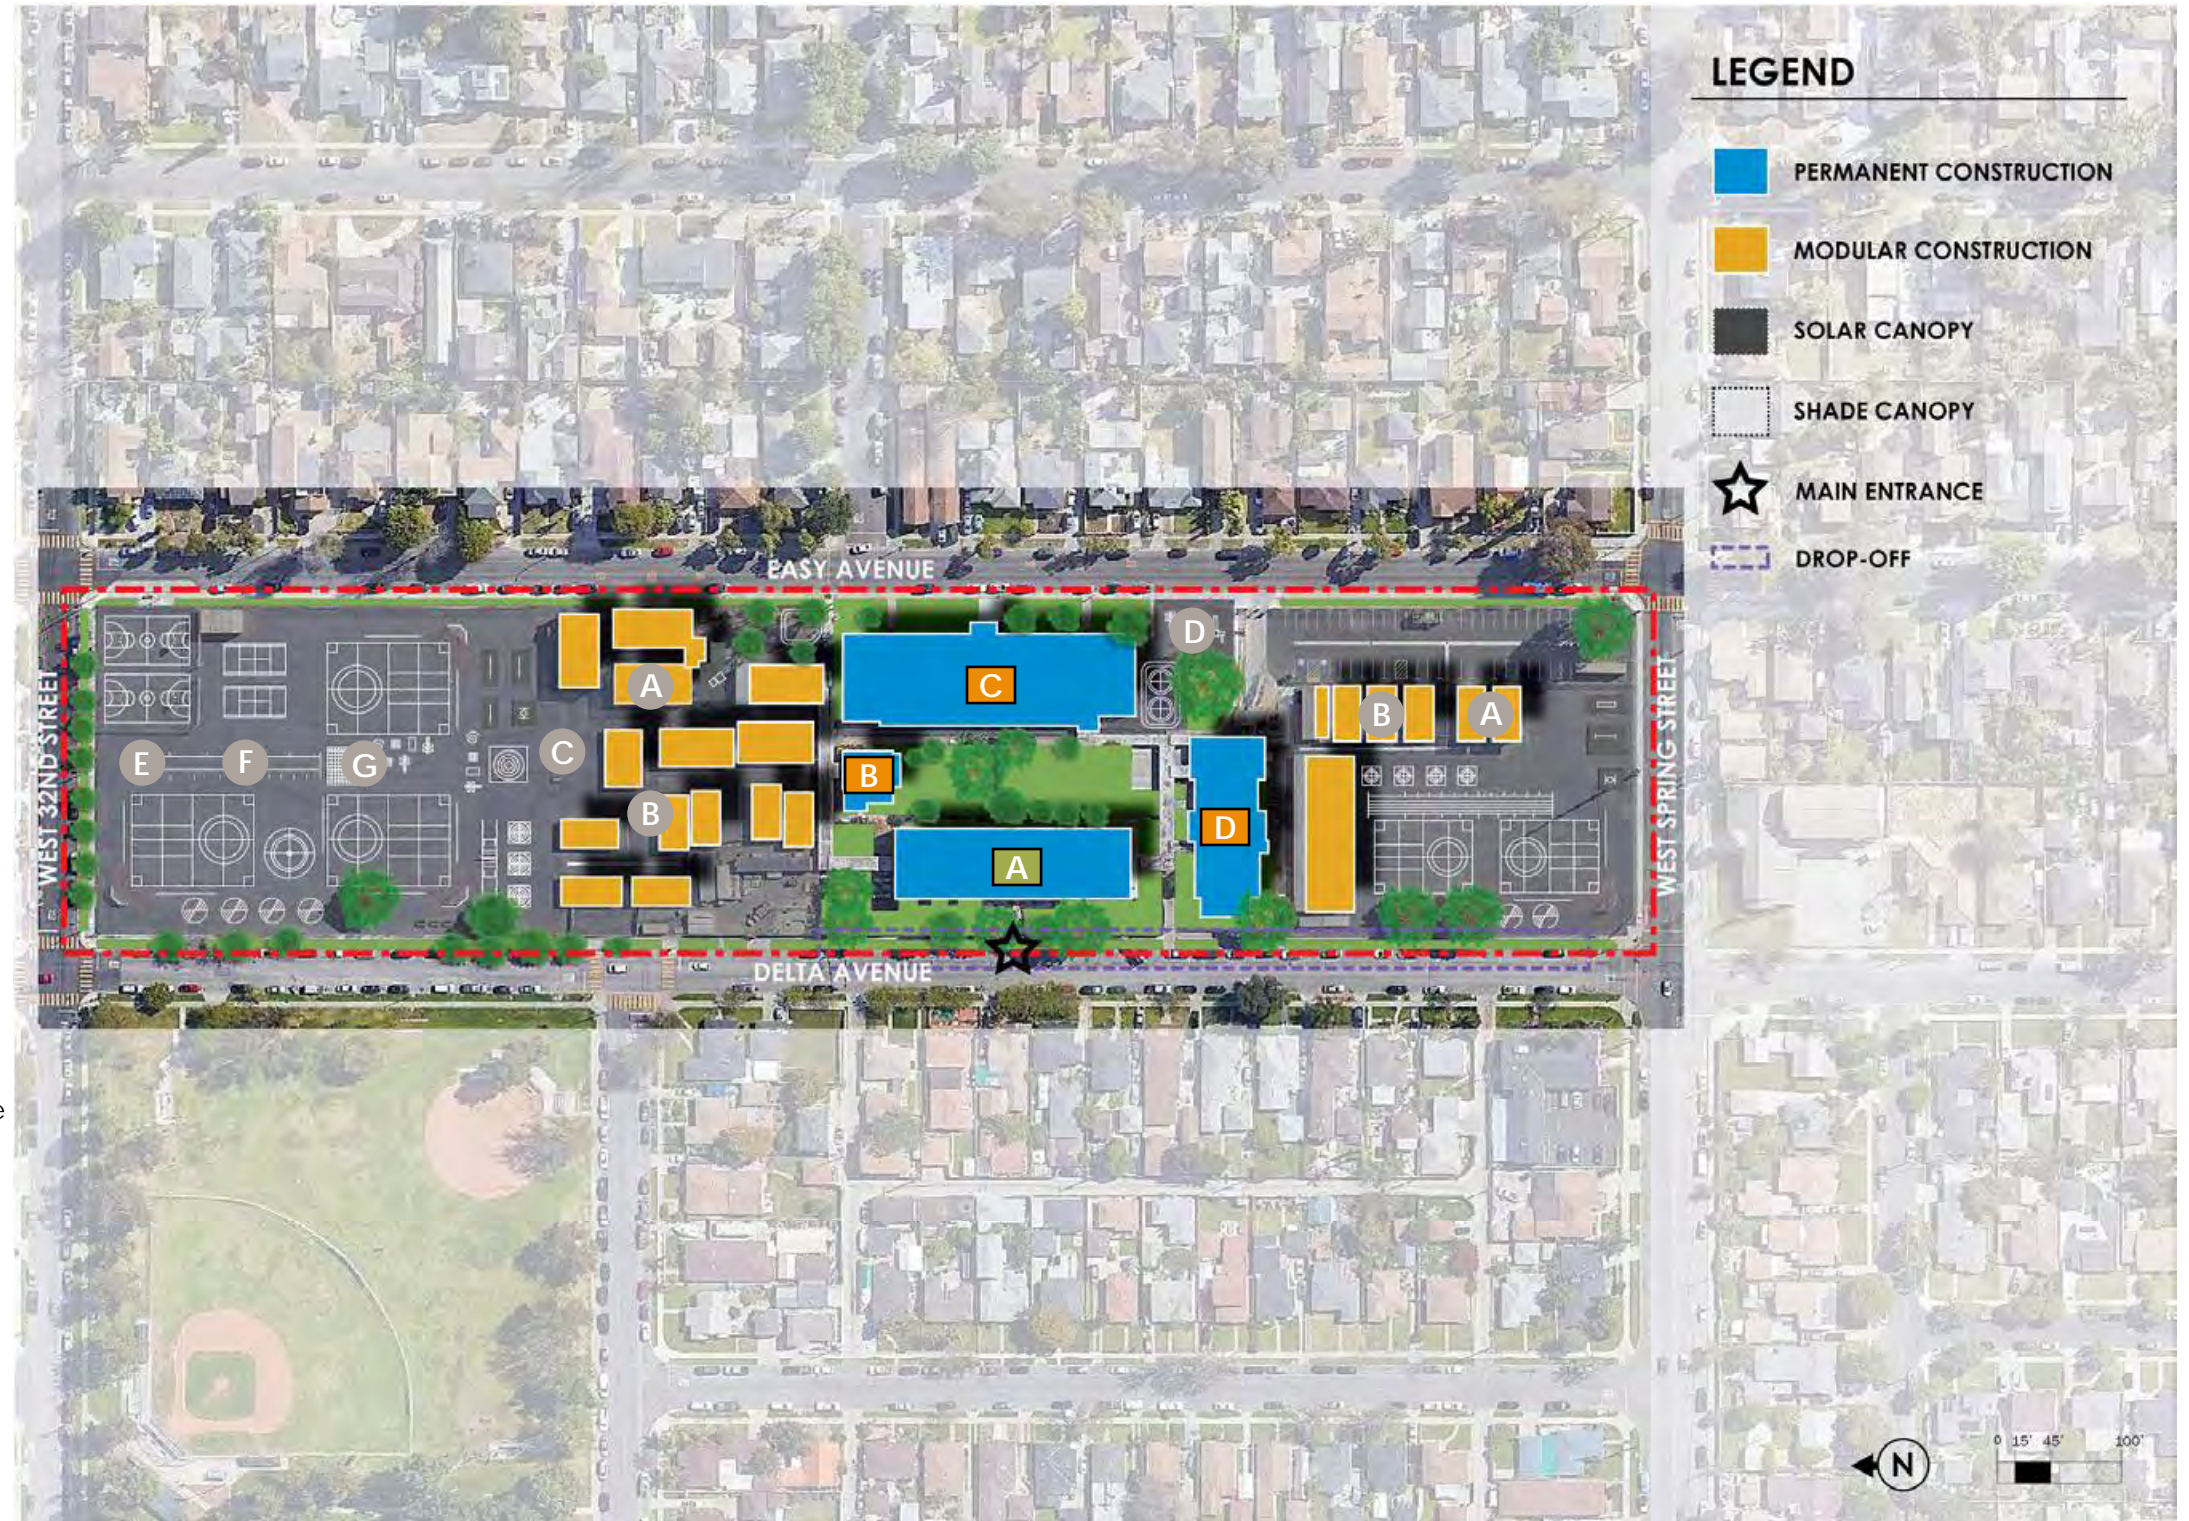
Muir Academy – Existing Campus

- D** Visibility of outdoor Kinder play from street
- E** Baseball not provided (included at other Middle Schools)
- F** Lack of shade trees at play area
- G** Significant large areas of blacktop without use of reflective paints to reduce heat island and improve quality of play

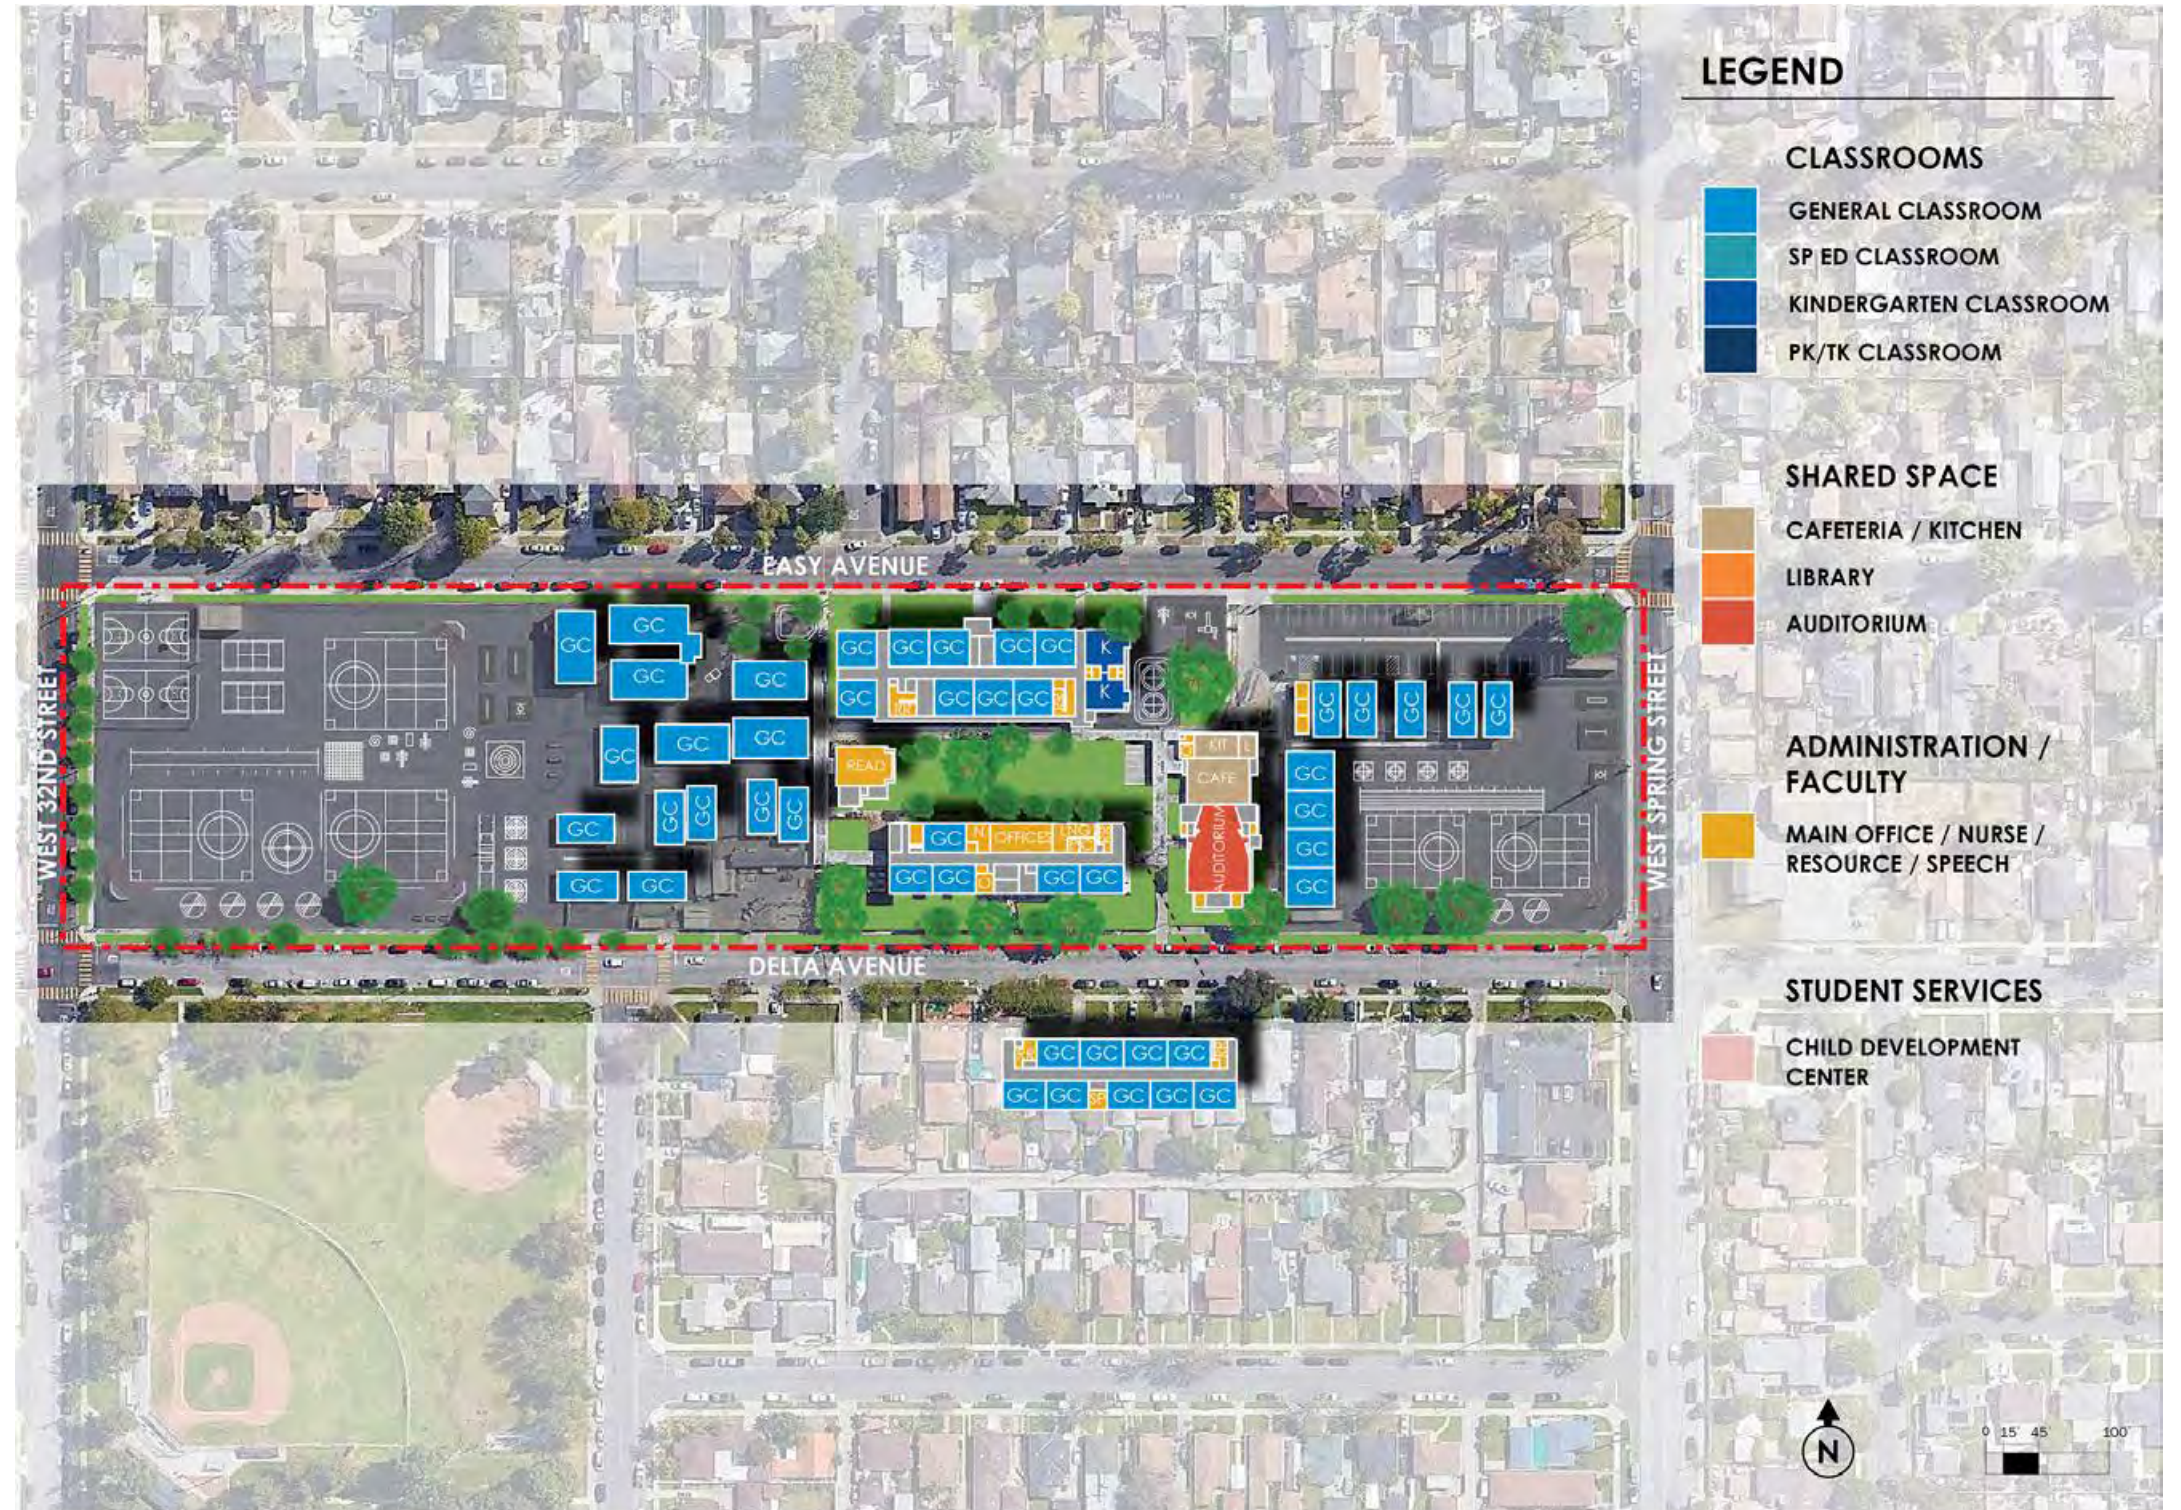
Muir Academy – Existing Space Utilization

Category	Existing	Planning Capacity
Administration	2,999 SF	2,286 SF
Auditorium	2,388 SF	3,534 SF
Library	1,465 SF	2,772 SF
Nutrition Services		
Cafeteria	2,123 SF	2,356 SF
Food Service	733 SF	1,455 SF
Lunch Shelter	----	2,079 SF
Site		
Playground	3.6 Acres	2.4 Acres
Parking	53 Stalls	80 Stalls

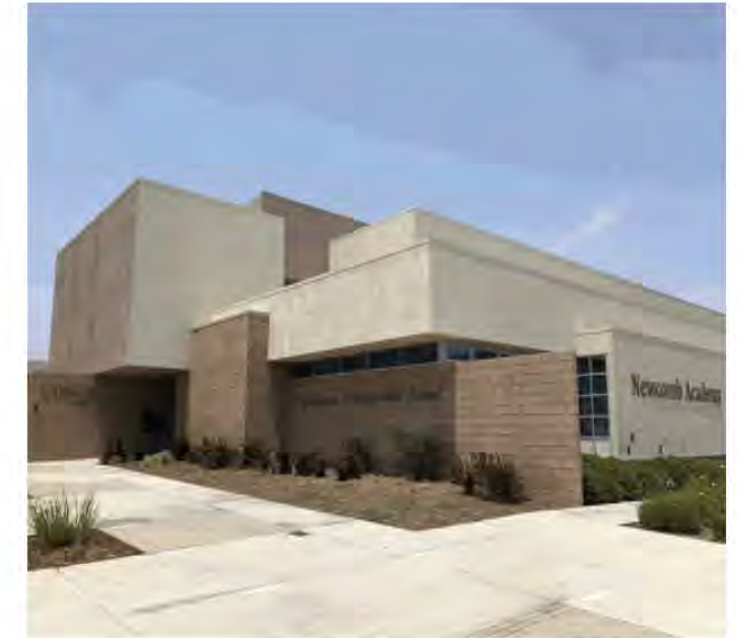
FACILITY CONDITION ASSESSMENT

Disciplines	5 Year DCI Score
Architectural	99
Plumbing	100
Mechanical	100
Fire Protection	100
Electrical	99
Communications	100
Safety and Security	100
Structural	100
5-YR FCI Score, buildings only:	
	99
Civil	100
5-YR FCI Score including Civil:	
	100

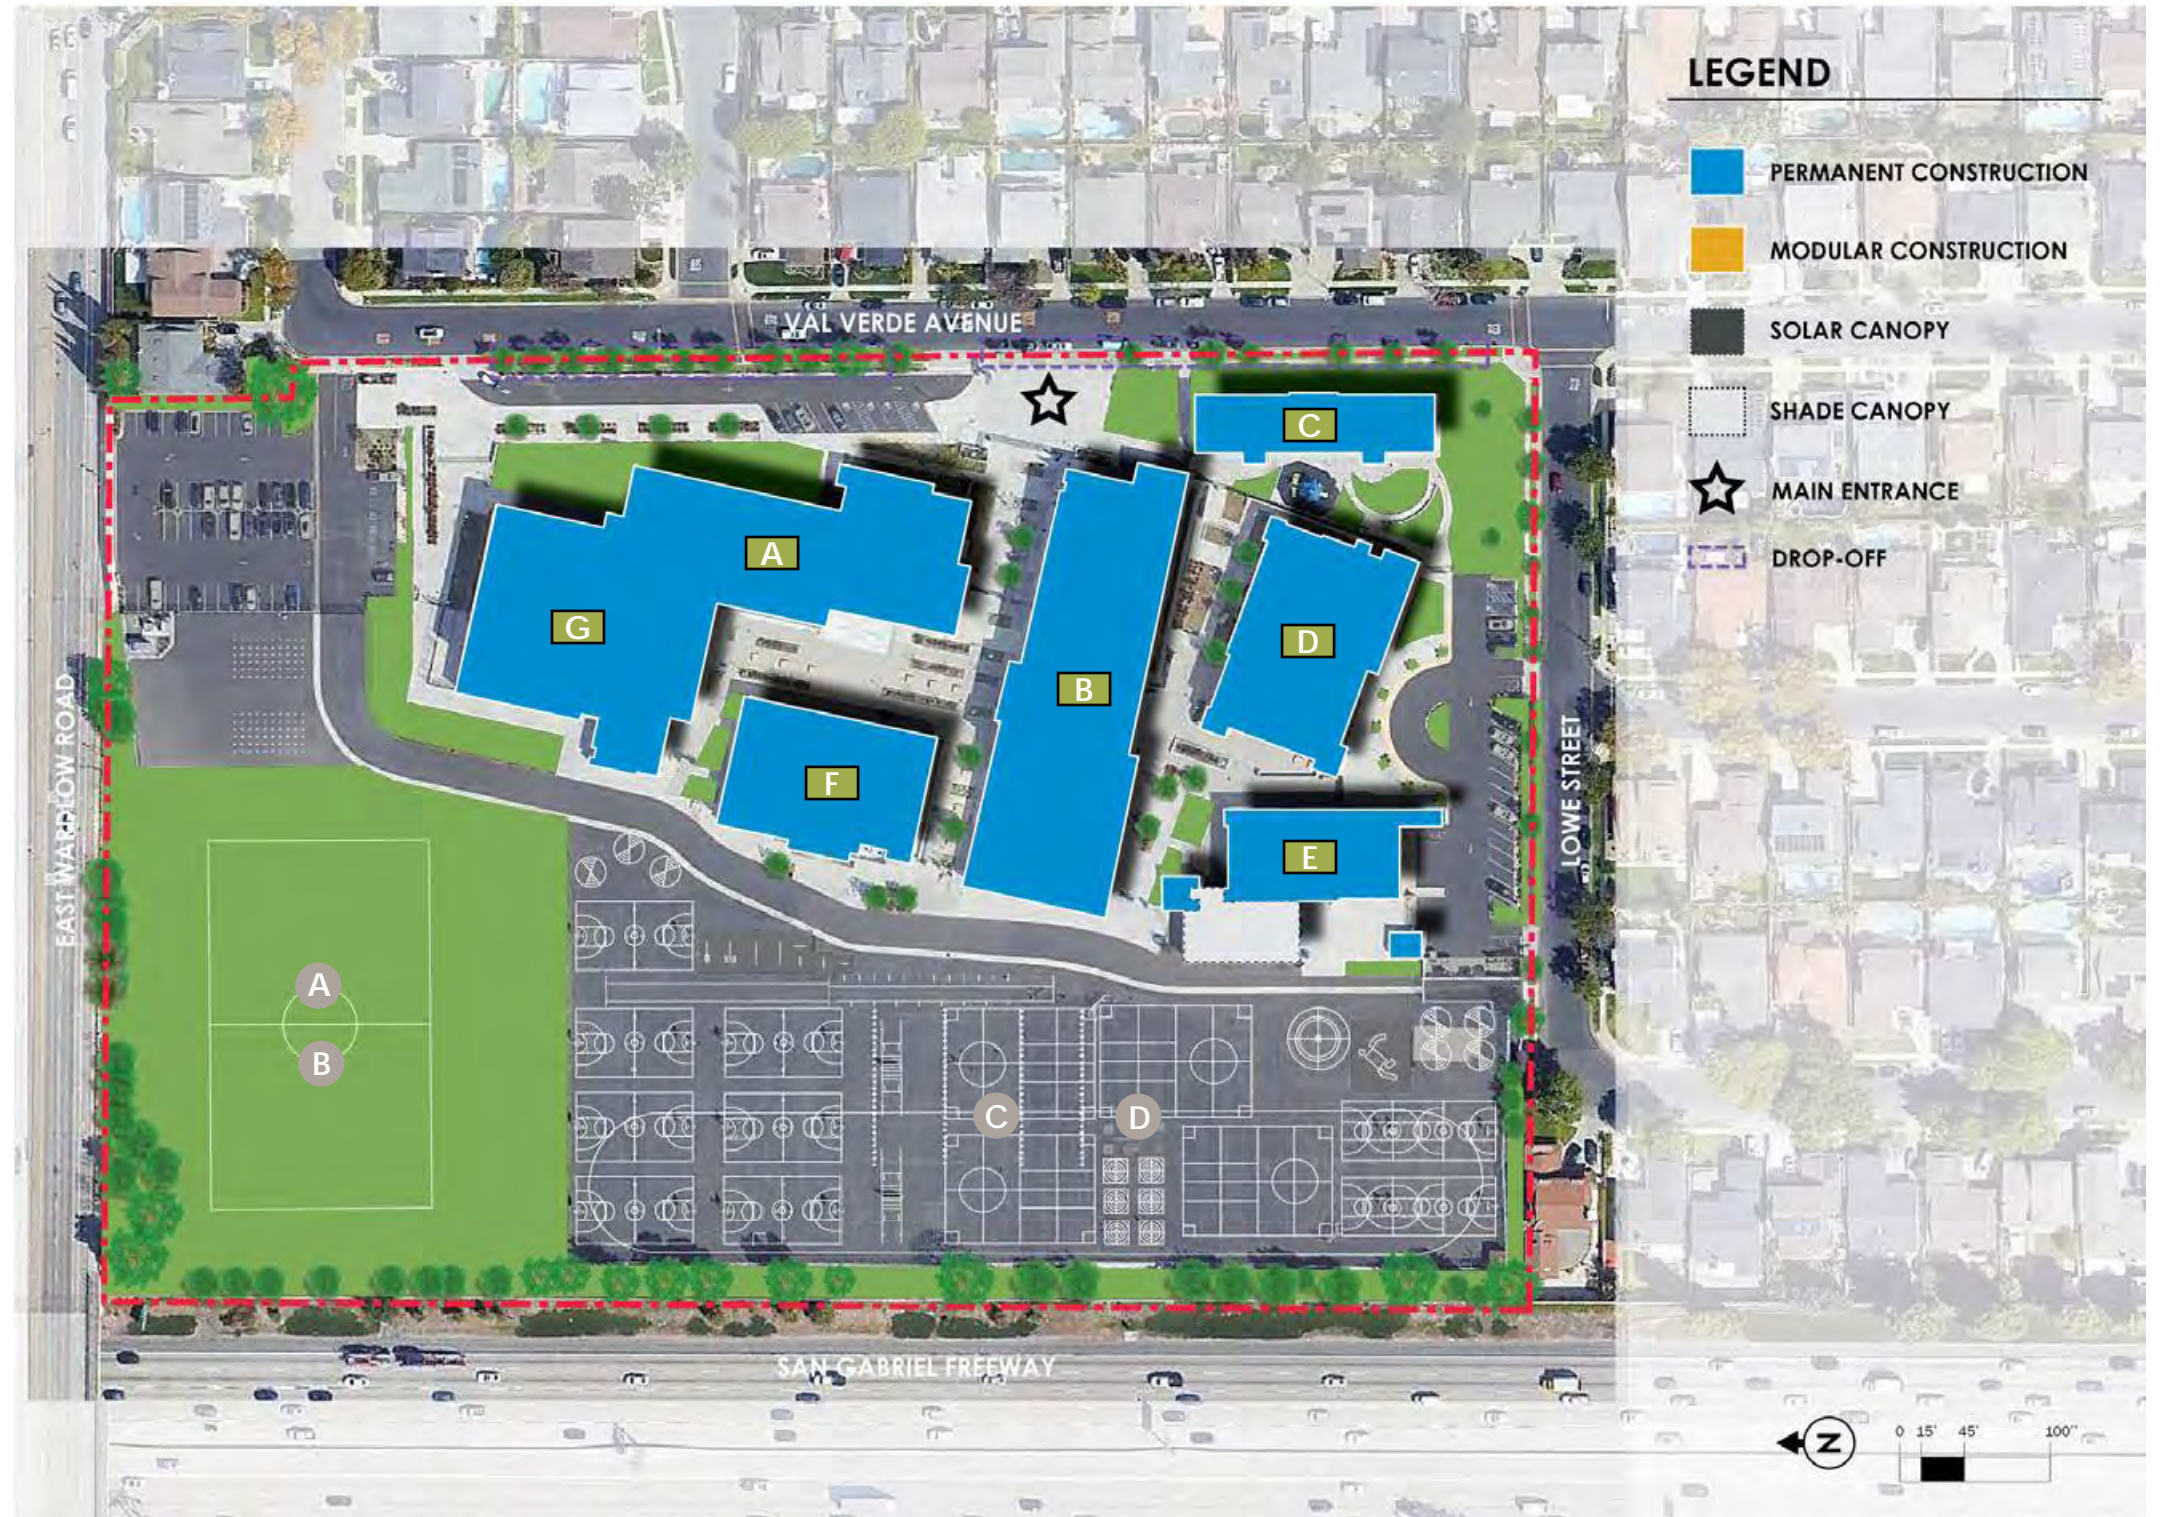
Newcomb K8 Academy School – Existing Campus

- A** Baseball not provided (included at other Middle Schools)
- B** Soccer facilities (not provided at other Middle Schools)
- C** Lack of shade trees at play area
- D** Significant large areas of blacktop without use of reflective paints to reduce heat island and improve quality of play
