LBUSD 2022 Facility Master Plan

Long Beach Unified School District
Appendices

July 2022

A Facility Reports: Elementary Schools

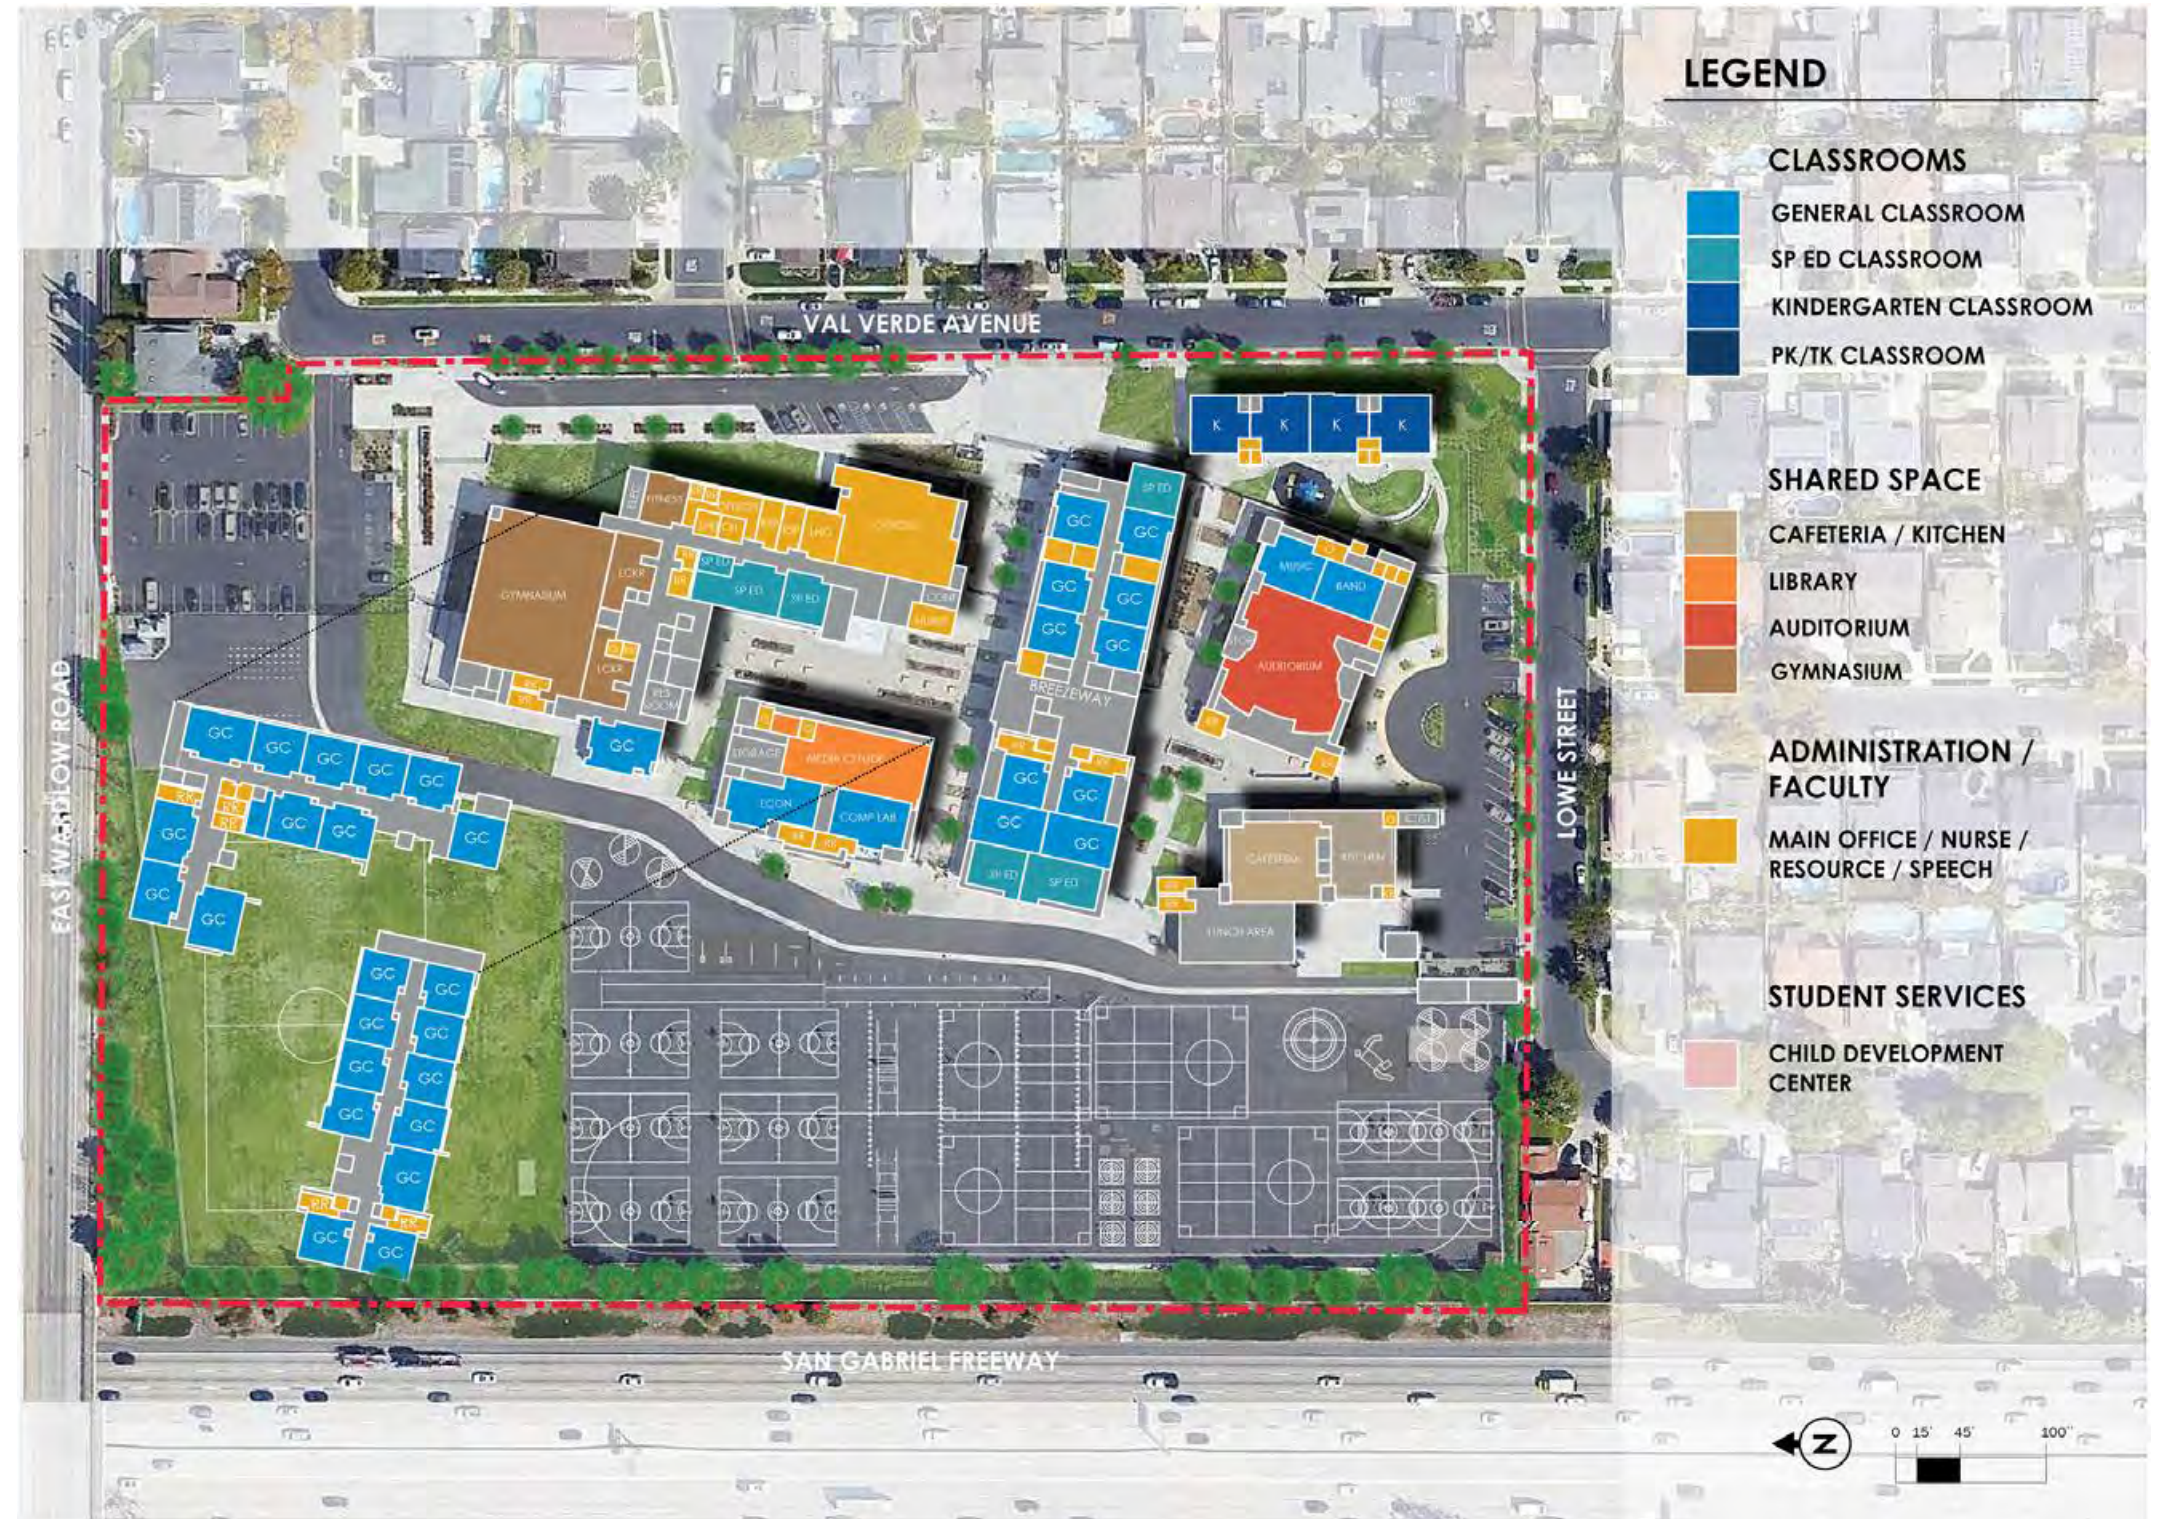
Newcomb K8 Academy School – Existing Space Utilization

Category	Existing	Planning Capacity
Administration	11,653 SF	1,610 SF
Auditorium	6,719 SF	2,489 SF
Gymnasium	10,088 SF	8,052 SF
Library	3,051 SF	1,952 SF
Nutrition Services		
Cafeteria	6,719 SF	1,659 SF
Food Service	2,289 SF	1,025 SF
Lunch Shelter	6,400 SF	1,464 SF
Site		
Playground	5.9 Acres	1.9 Acres
Parking	79 Stalls	55 Stalls

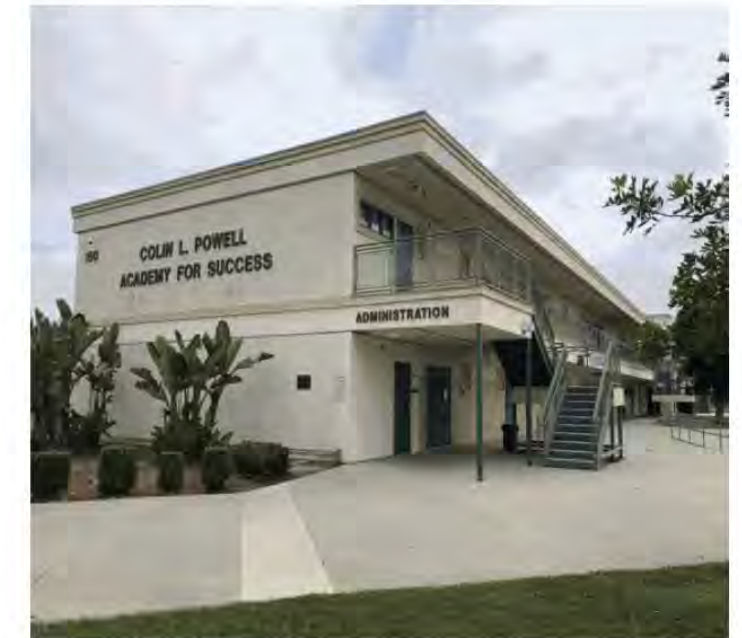
FACILITY CONDITION ASSESSMENT

Disciplines	5 Year DCI Score
Architectural	100
Plumbing	100
Mechanical	98
Fire Protection	100
Electrical	97
Communications	100
Safety and Security	96
Structural	98
5-YR FCI Score, buildings only:	99
Civil	96
5-YR FCI Score including Civil:	98

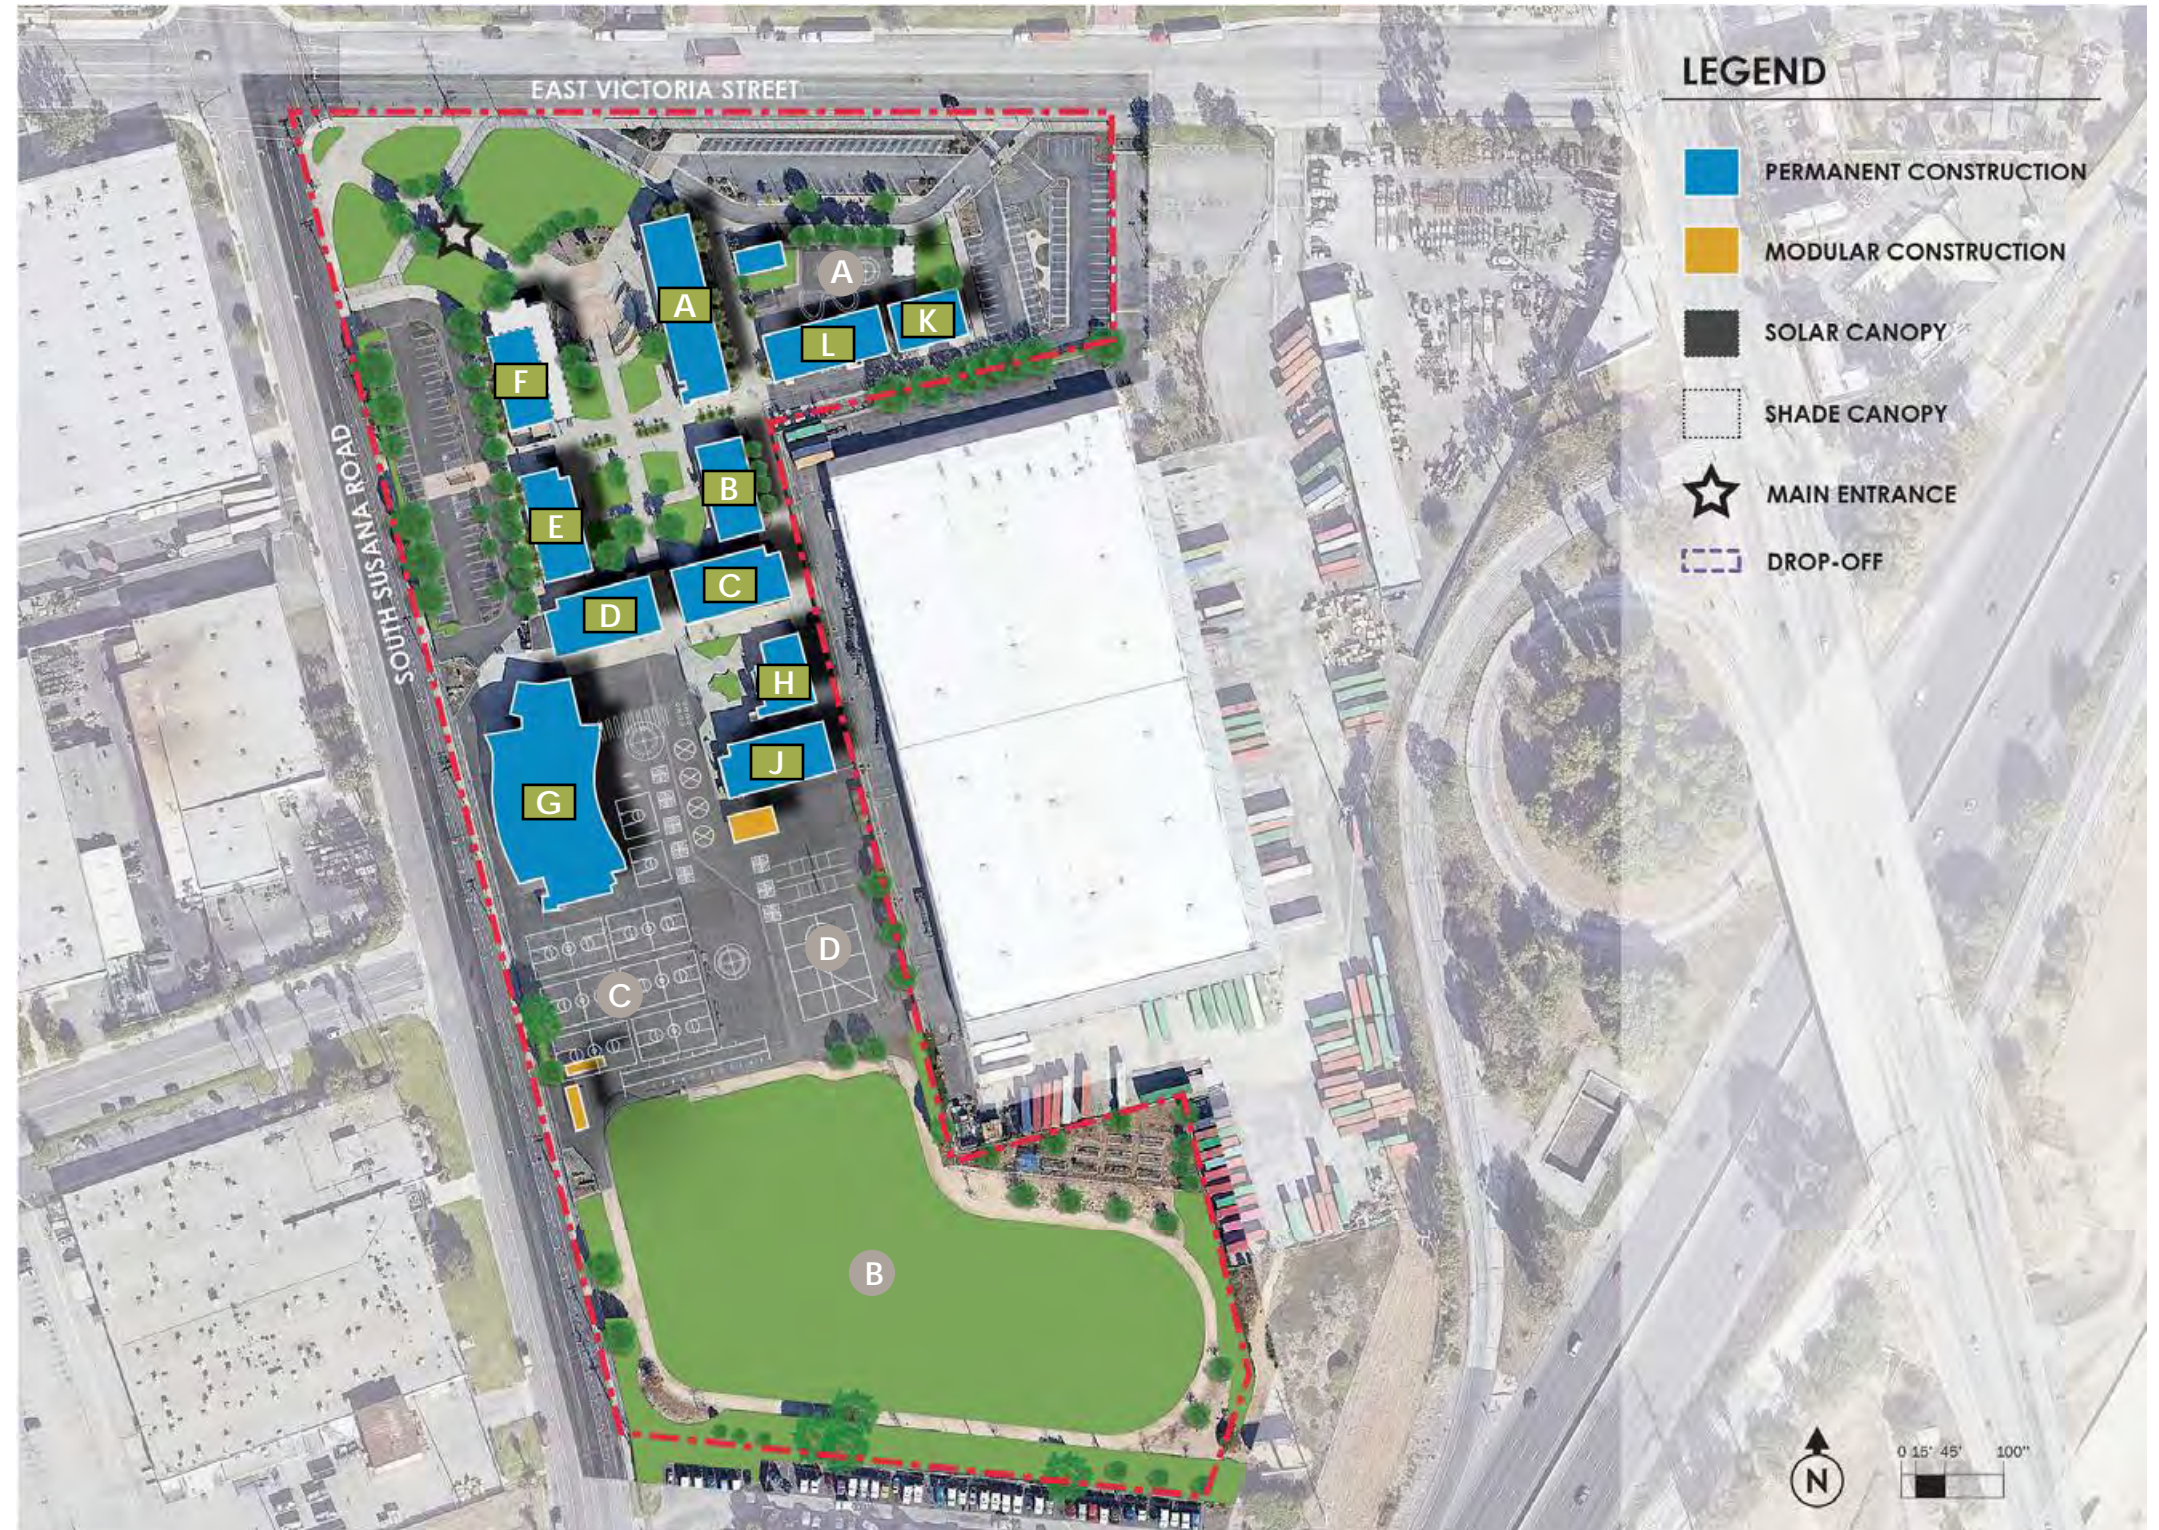
Colin Powell K8 Academy for Success – Existing Campus

- A** Visibility of outdoor Kinder play from street
- B** Baseball not provided (included at other Middle Schools)
- C** Lack of shade trees at play area
- D** Significant large areas of blacktop without use of reflective paints to reduce heat island and improve quality of play

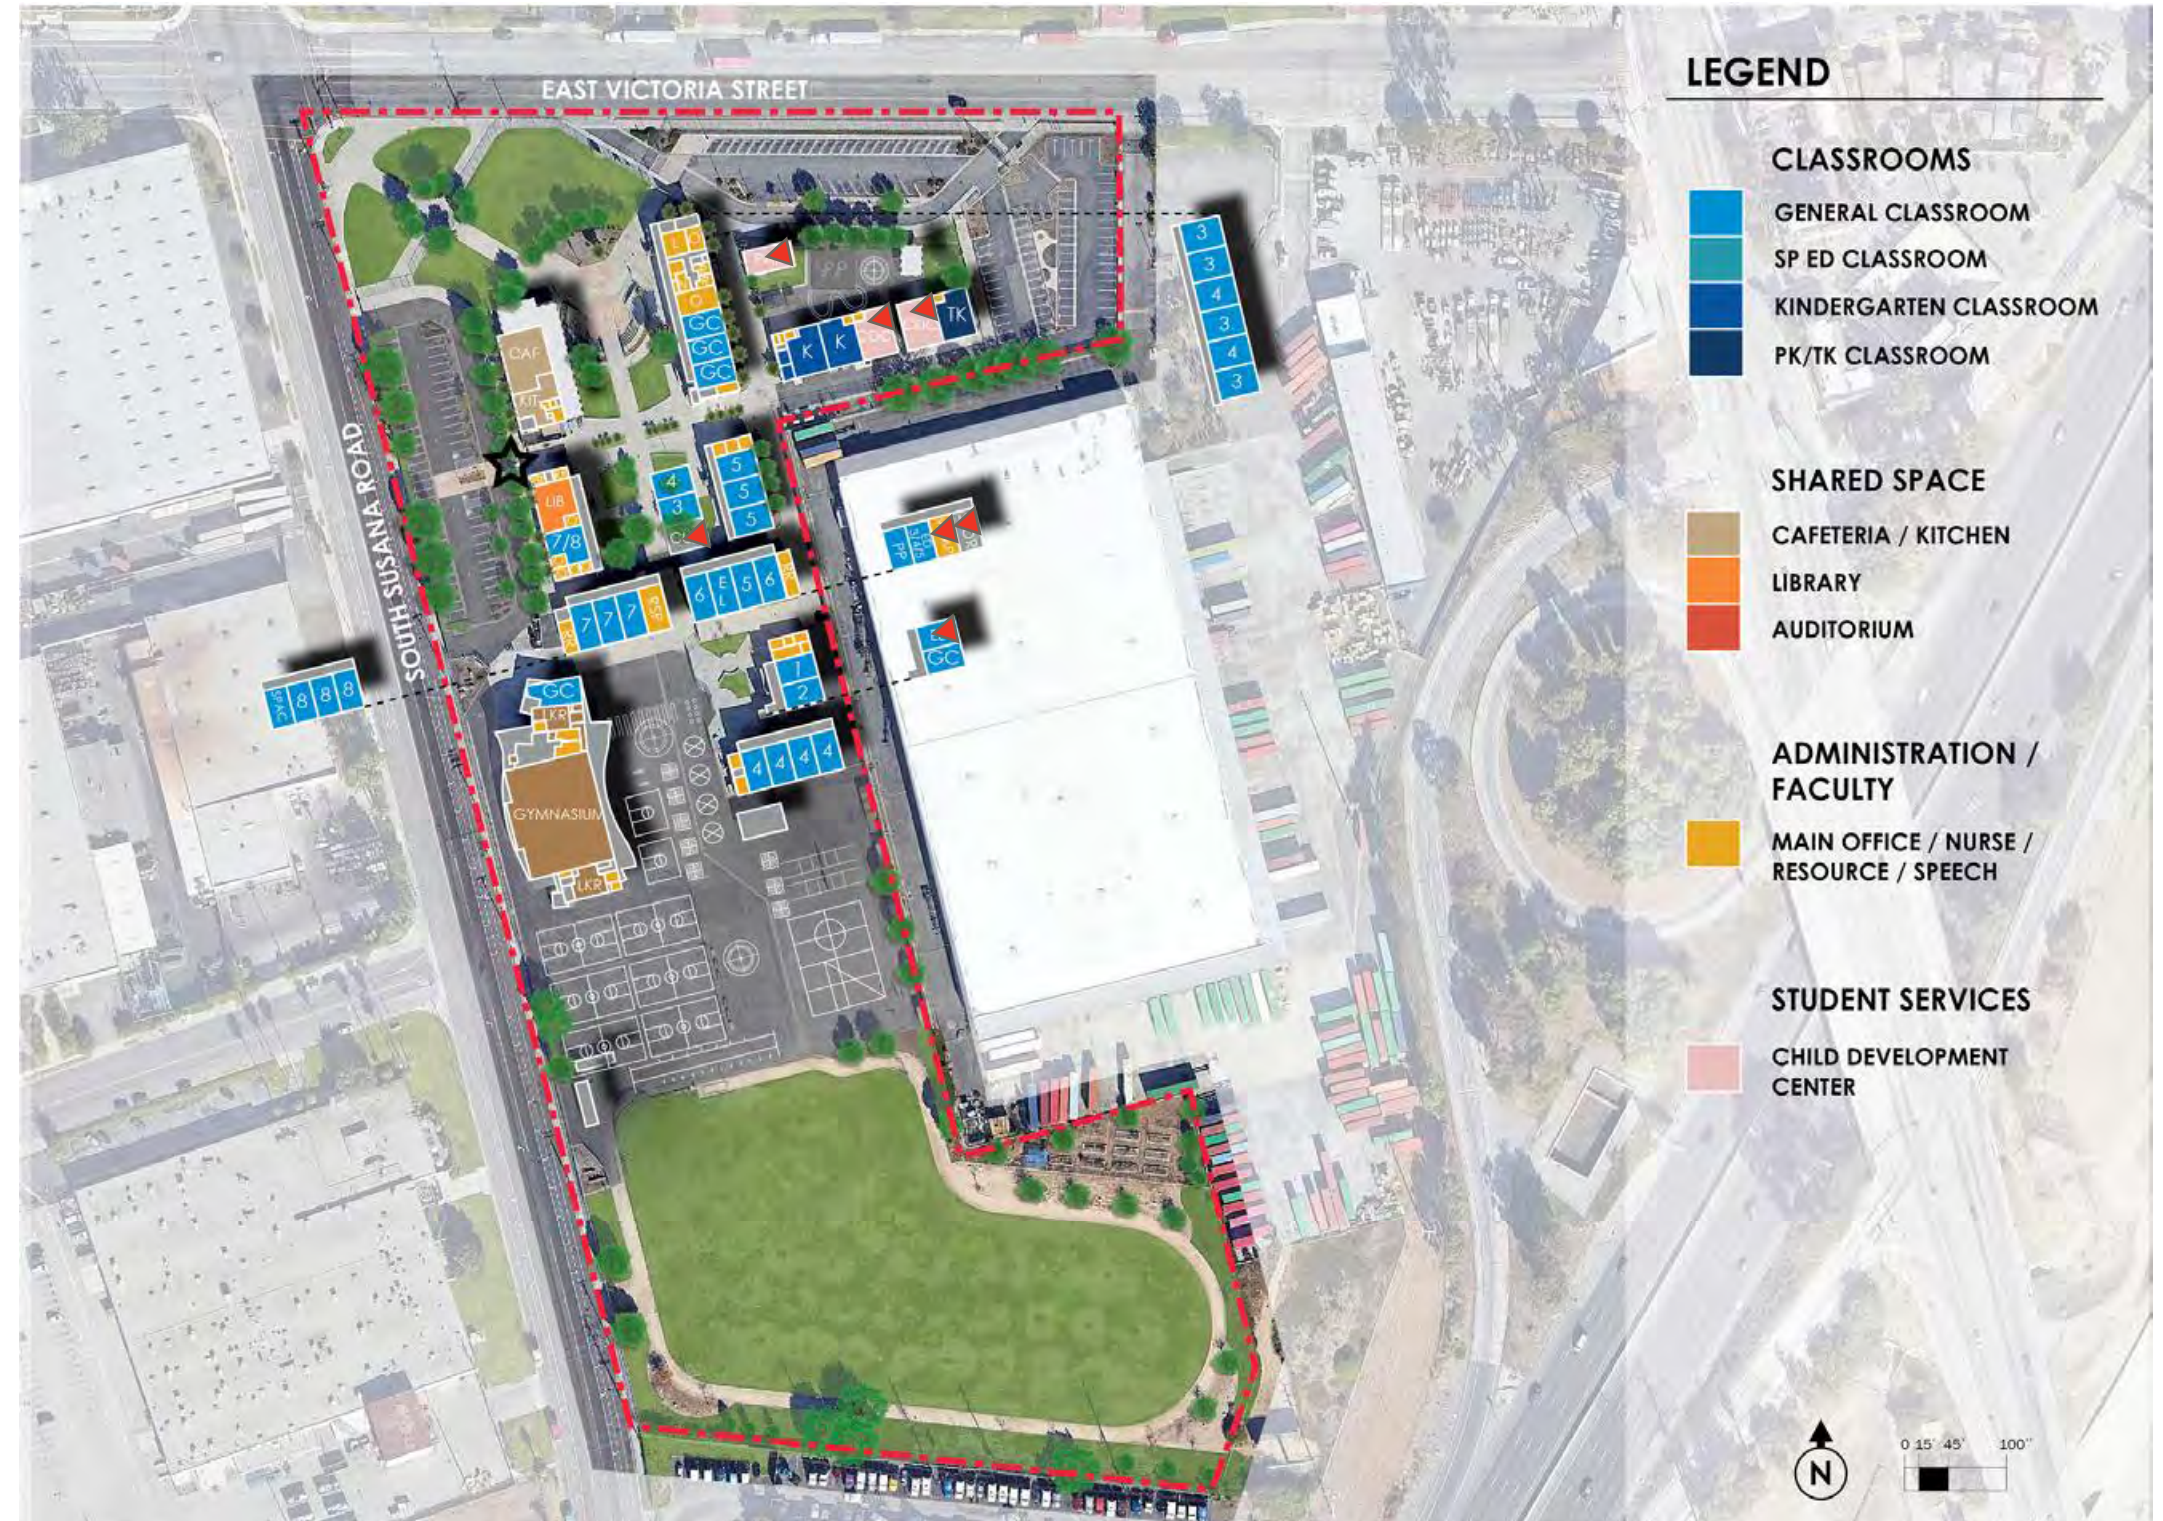
Colin Powell K8 Academy for Success – Existing Space Utilization

Category	Existing	Planning Capacity
Administration	3,000 SF	2,934 SF
Gymnasium	10,556 SF	14,668 SF
Library	4,789 SF	3,556 SF
Nutrition Services		
Cafeteria	2,637 SF	3,023 SF
Food Service	1,620 SF	1,867 SF
Lunch Shelter	880 SF	2,667 SF
Site		
Playground	----	2.2 Acres
Parking	167 Stalls	75 Stalls

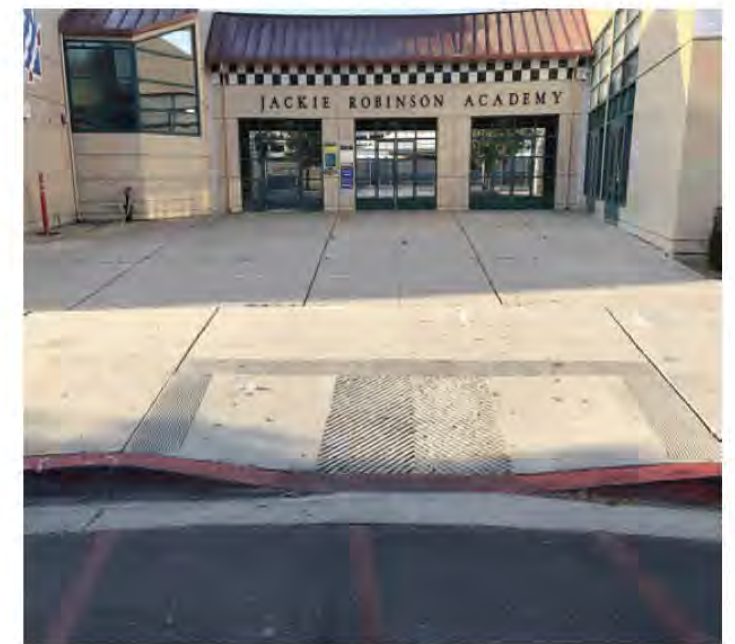
FACILITY CONDITION ASSESSMENT

Disciplines	5 Year DCI Score
Architectural	88
Plumbing	98
Mechanical	92
Fire Protection	95
Electrical	90
Communications	93
Safety and Security	100
Structural	97
5-YR FCI Score, buildings only: 91	
Civil	100
5-YR FCI Score including Civil: 94

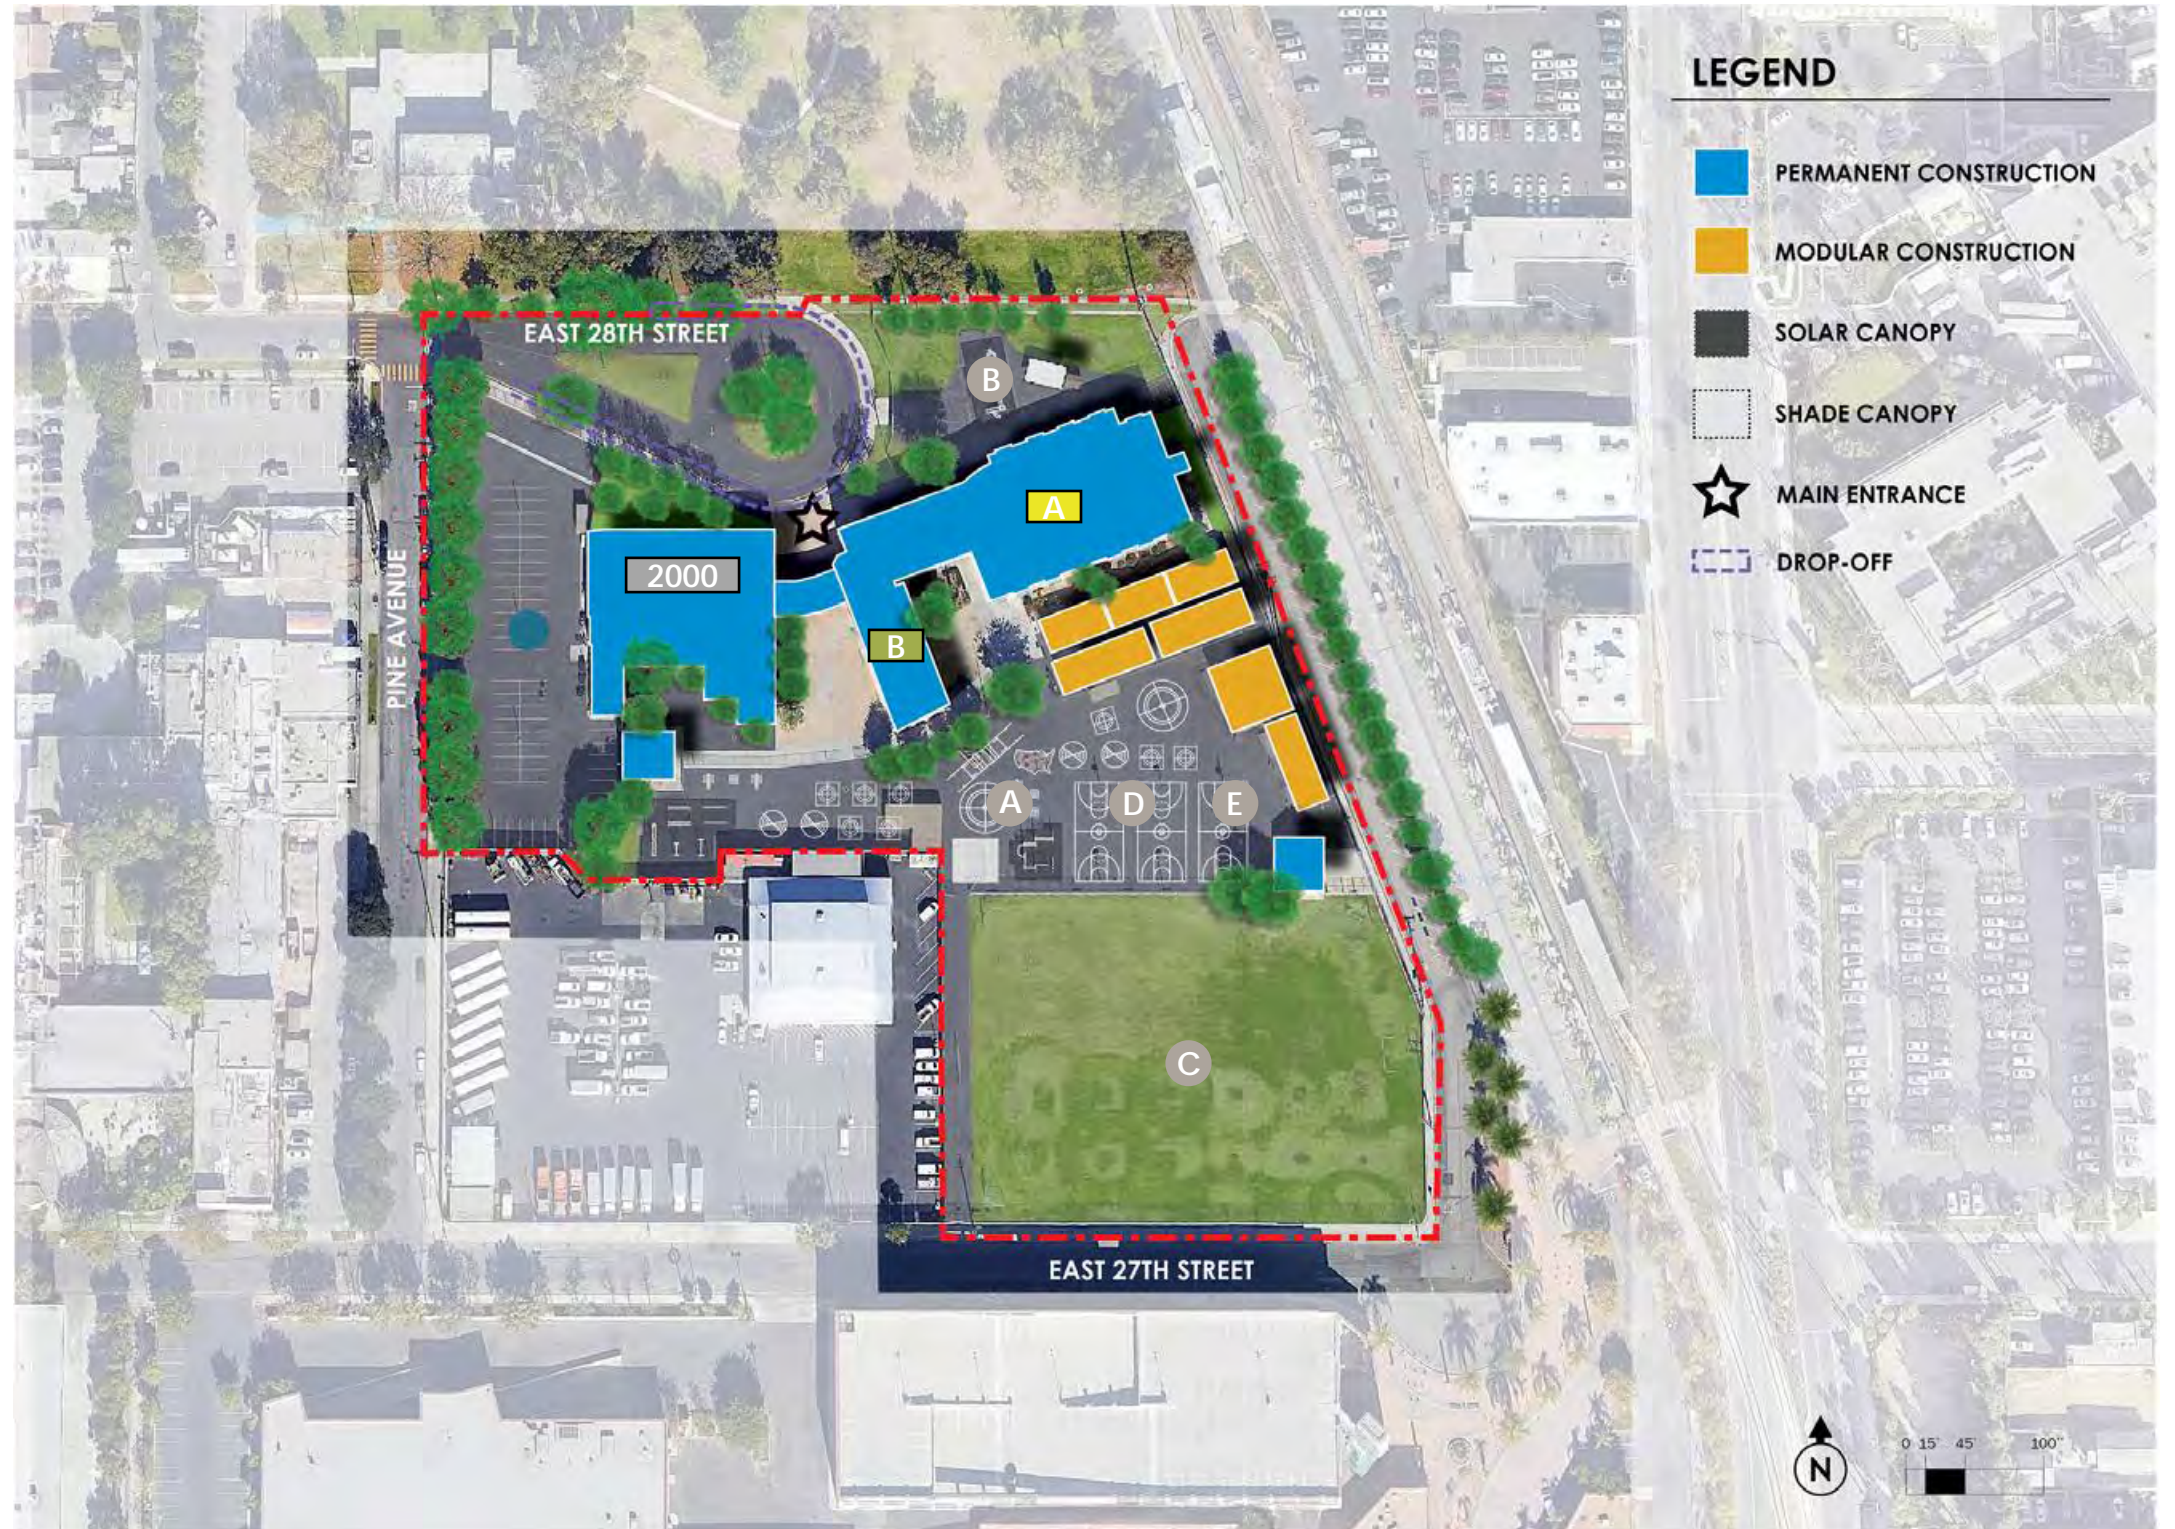
Jackie Robinson Academy – Existing Campus

- B** Visibility of outdoor Kinder play from street
- C** Baseball not provided (included at other Middle Schools)
- D** Lack of shade trees at play area
- E** Significant large areas of blacktop without use of reflective paints to reduce heat island and improve quality of play

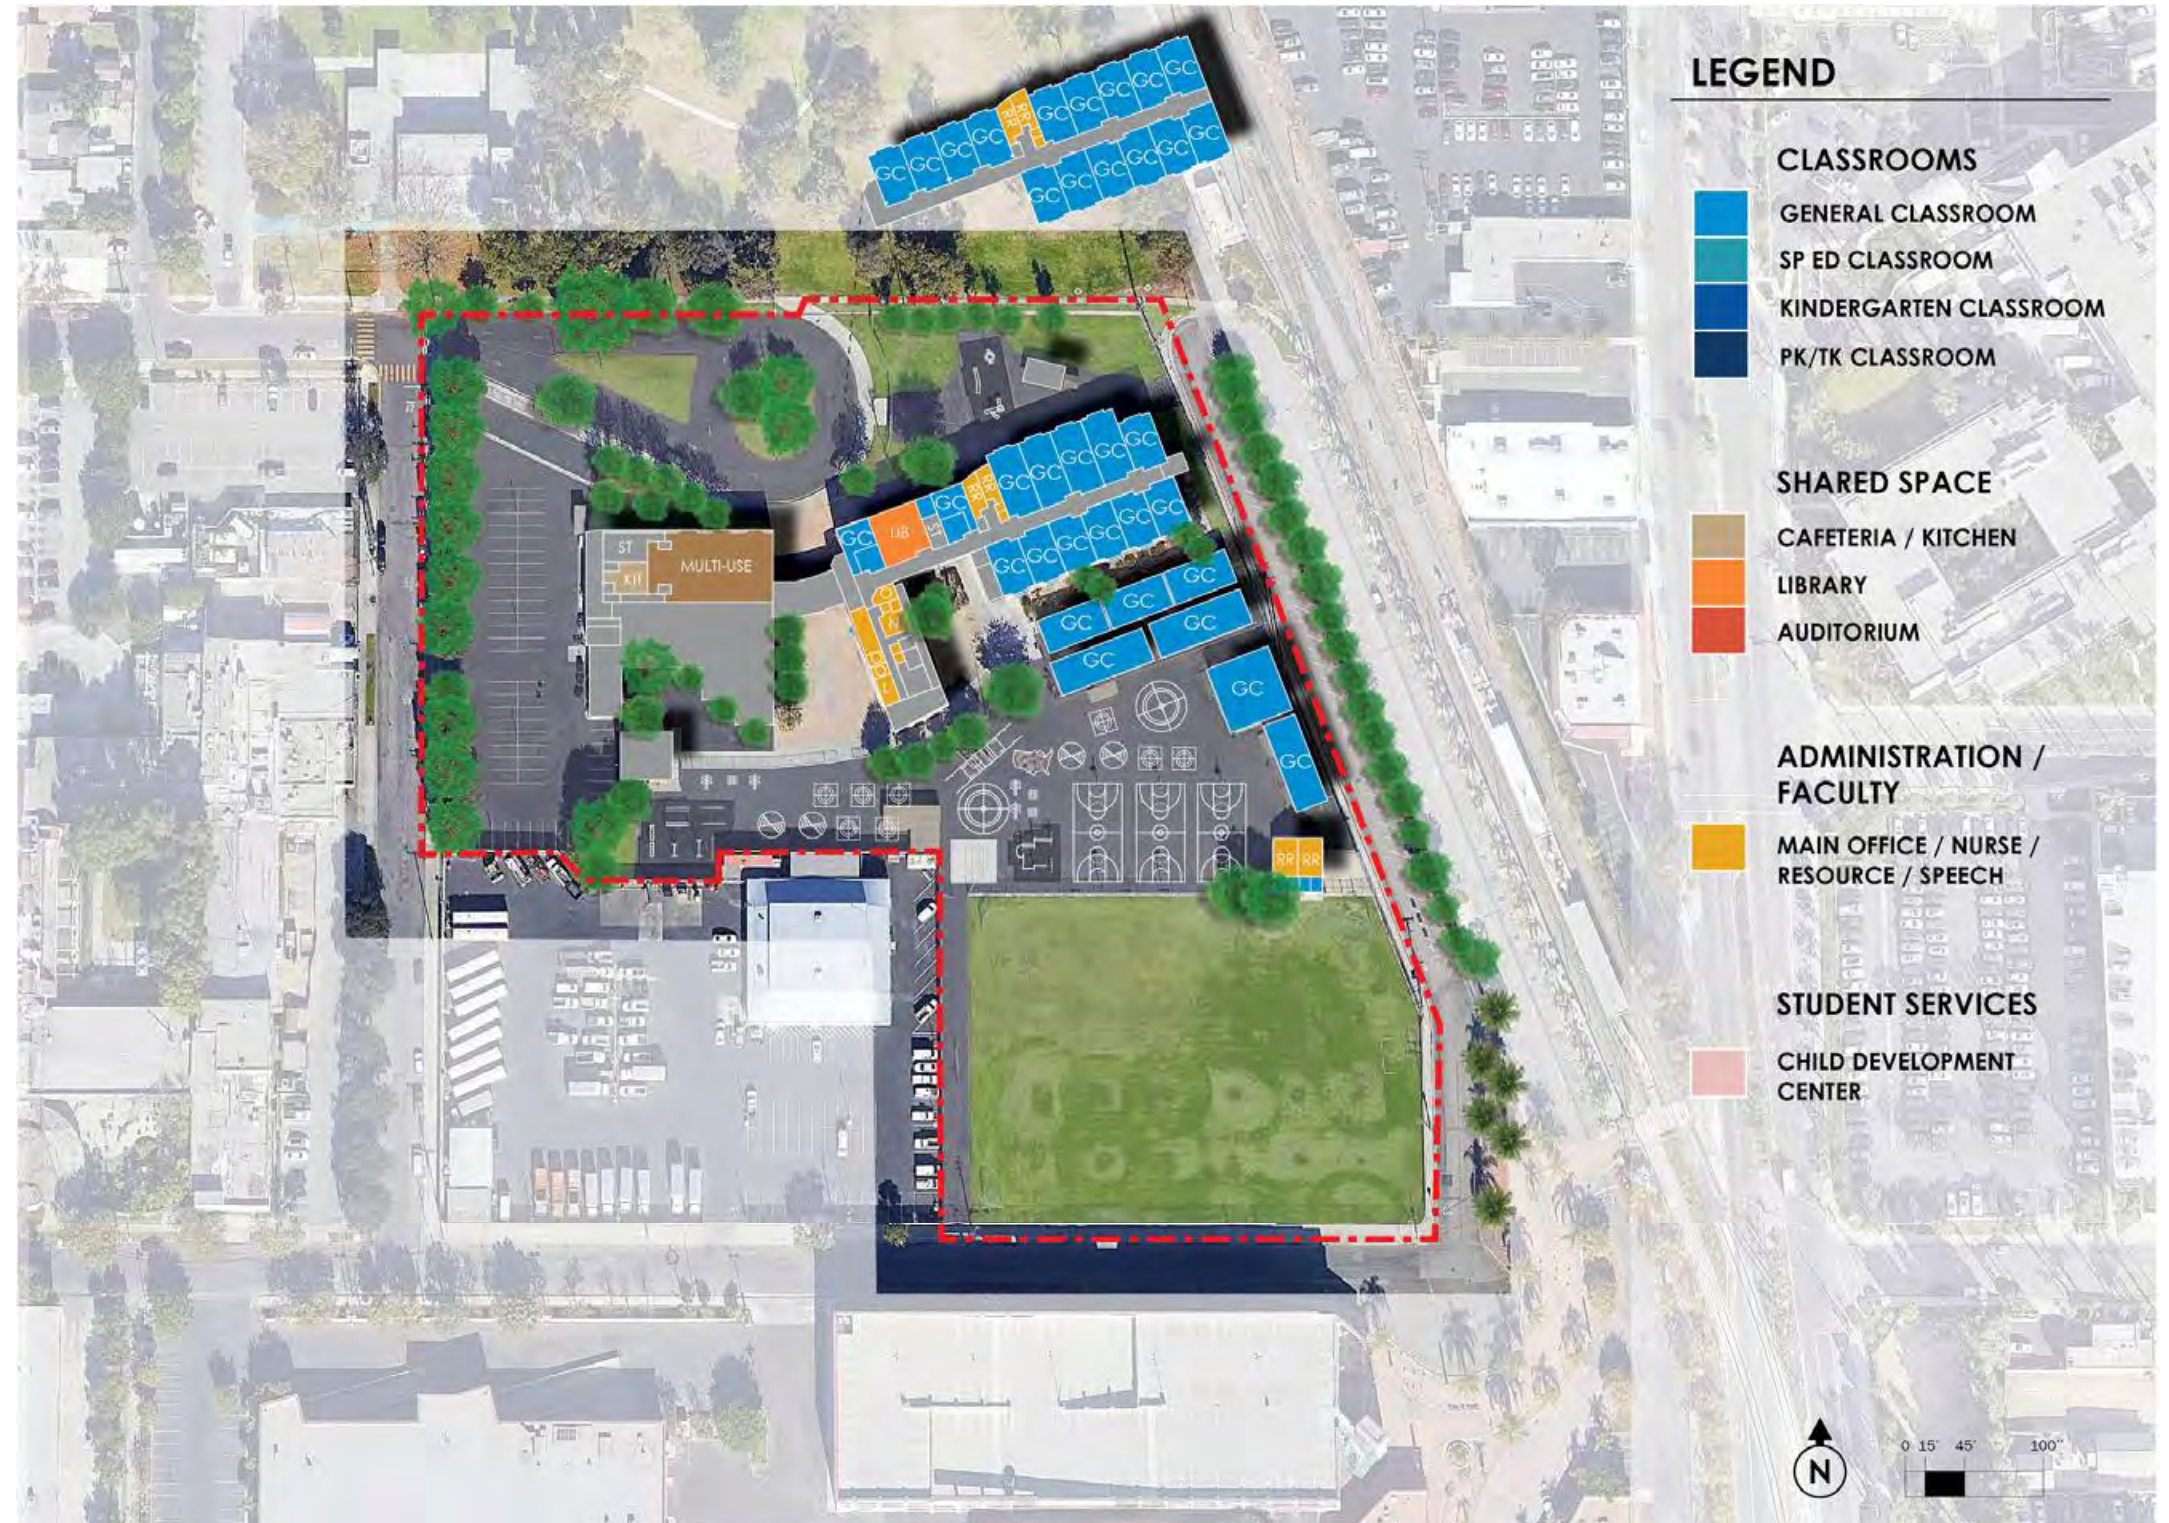
Jackie Robinson Academy – Existing Space Utilization

Category	Existing	Planning Capacity
Administration	2,029 SF	2,597 SF
Auditorium/MPR	4,153 SF	4,014 SF
Library	1,640 SF	3,148 SF
Nutrition Services		
Cafeteria	(See MPR)	2,676 SF
Food Service	812 SF	1,653 SF
Lunch Shelter	3,840 SF	2,361 SF
Site		
Playground	---	2.0 Acres
Parking	60 Stalls	65 Stalls

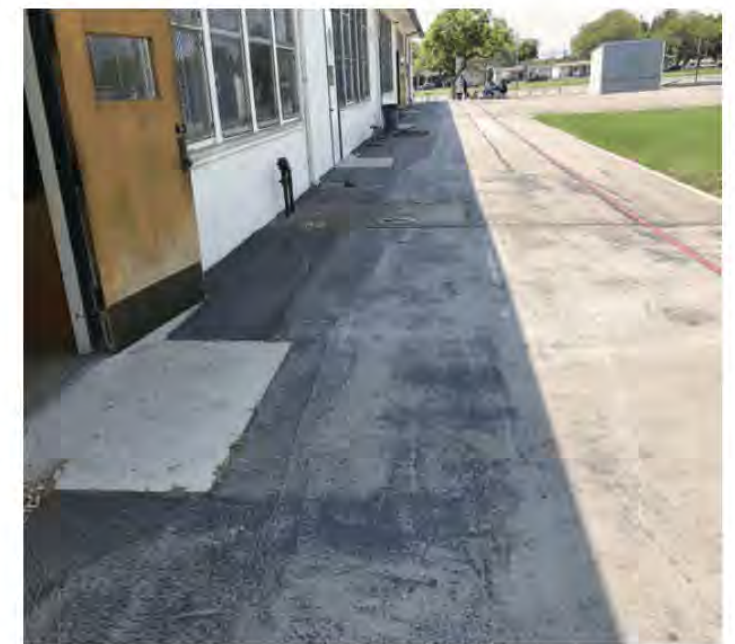
FACILITY CONDITION ASSESSMENT

Disciplines	5 Year DCI Score
Architectural	47
Plumbing	62
Mechanical	71
Fire Protection	90
Electrical	58
Communications	85
Safety and Security	100
Structural	85
5-YR FCI Score, buildings only:	
	63
Civil	96
5-YR FCI Score including Civil:	
	73

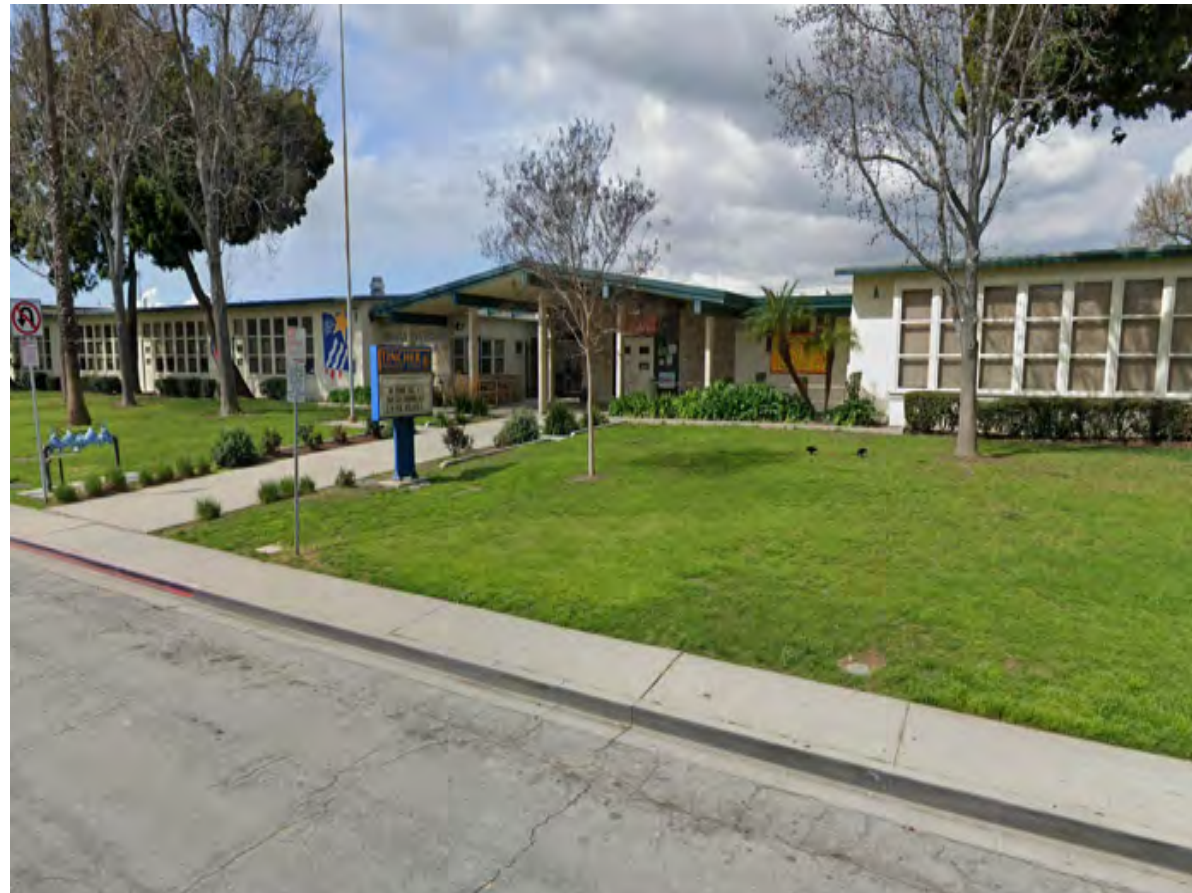
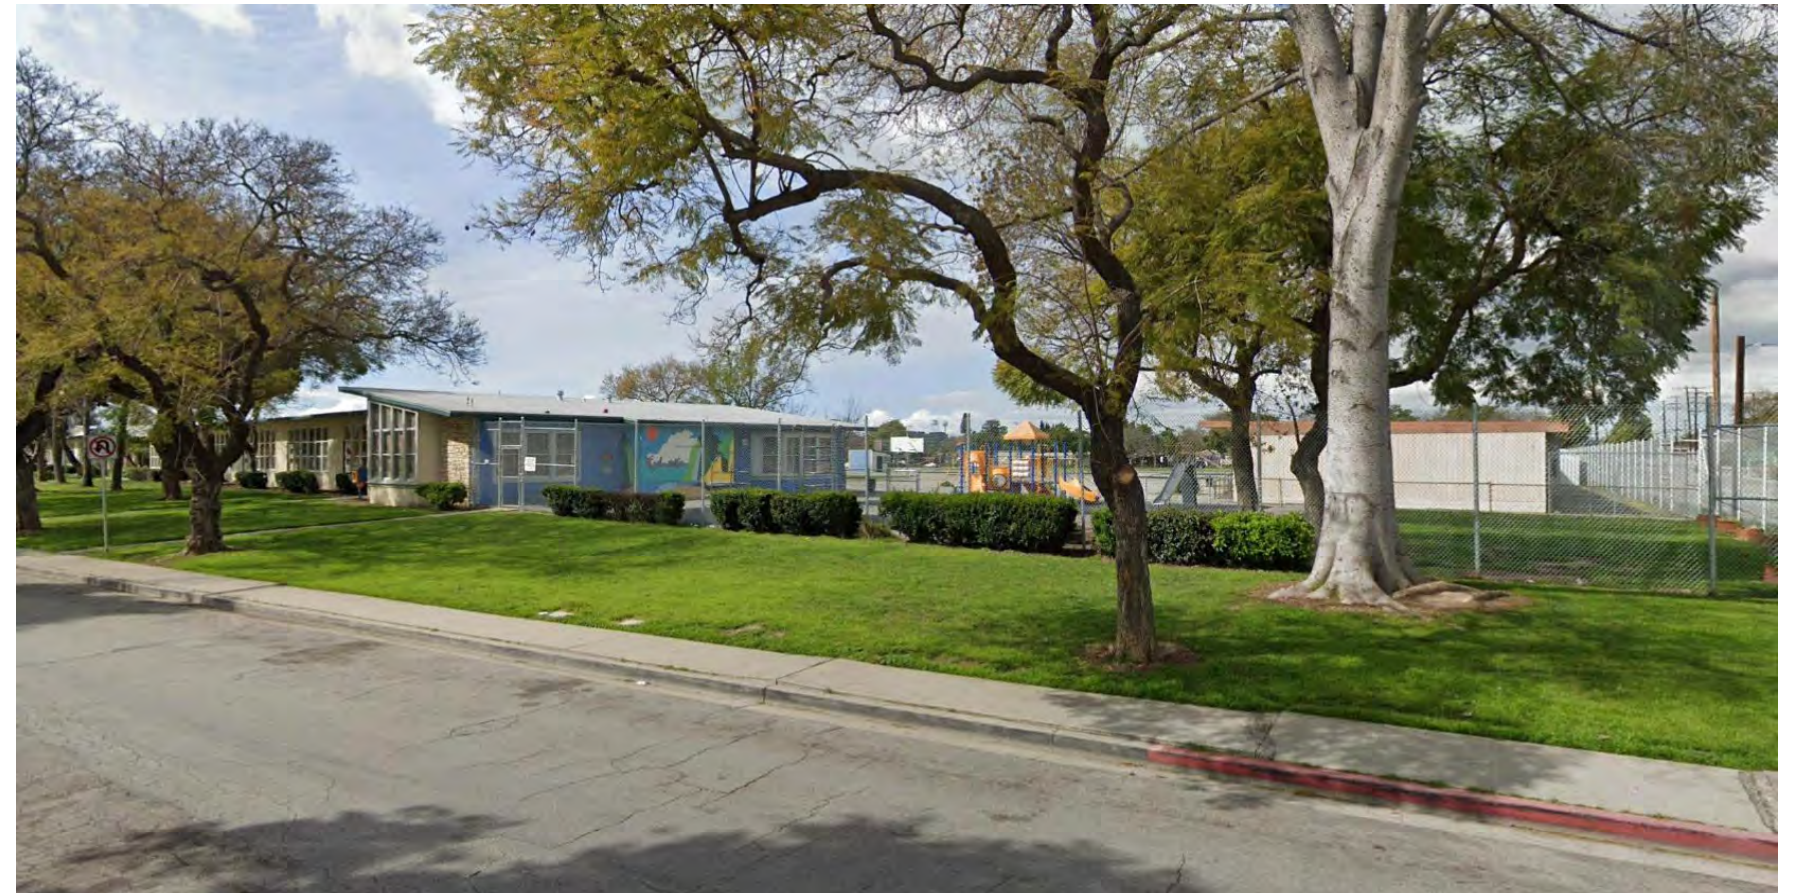
Tincher K8 Preparatory School – Existing Campus

Facility Condition (by Bldg)
