LBUSD 2022 Facility Master Plan

Long Beach Unified School District
Appendices

July 2022

A Facility Reports: Elementary Schools

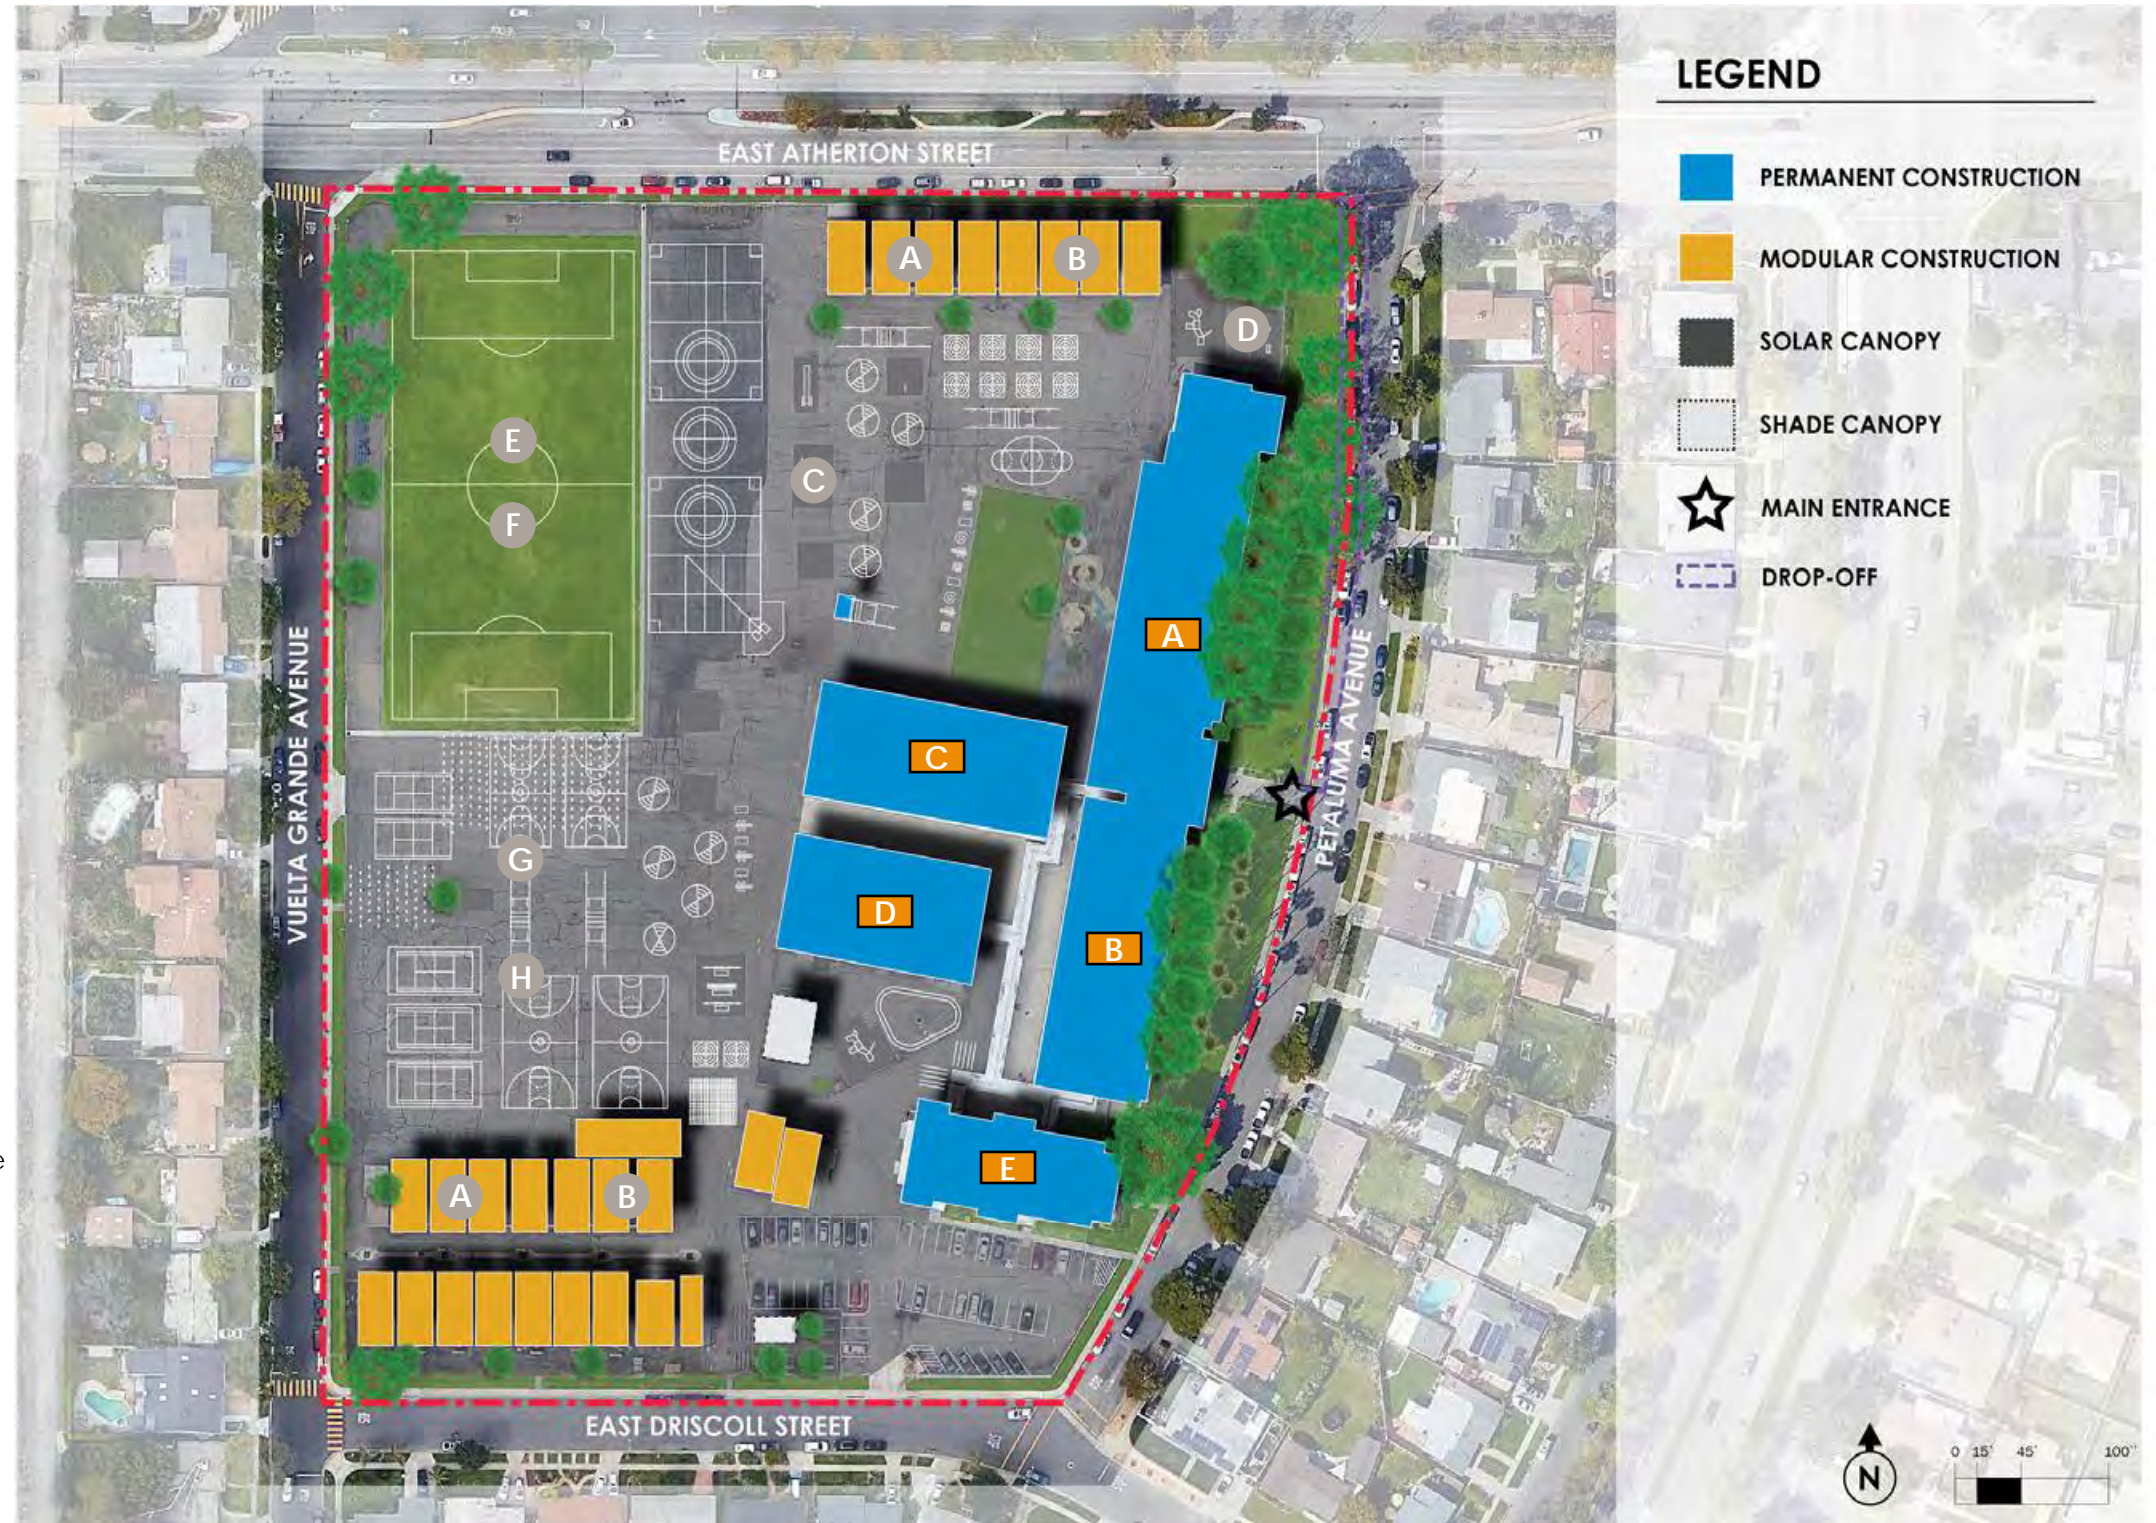
Activity Zone – Athletics/Physical Education

- D** Visibility of outdoor Kinder play from street
- E** Baseball not provided (included at other Middle Schools)
- F** Soccer facilities (not provided at other Middle Schools)
- G** Lack of shade trees at play area
- H** Significant large areas of blacktop without use of reflective paints to reduce heat island and improve quality of play
